Office of Transport Safety Investigations

TECHNICAL INSPECTION FINDINGS

FIRE INVOLVING WESTBUS BUS

21 SEPTEMBER 2010

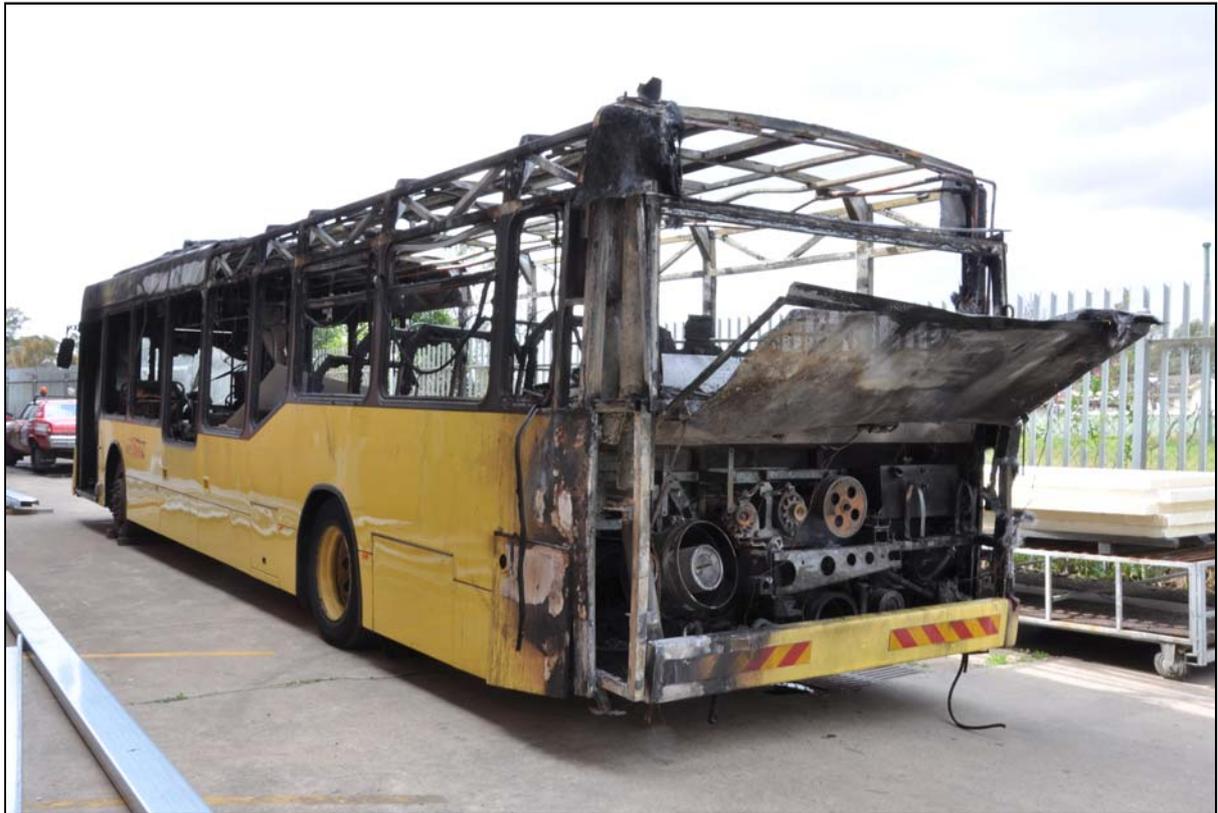
The Fire Brigade extinguished the fire but the bus was gutted throughout.

Photograph 1: Overview of the fire damage

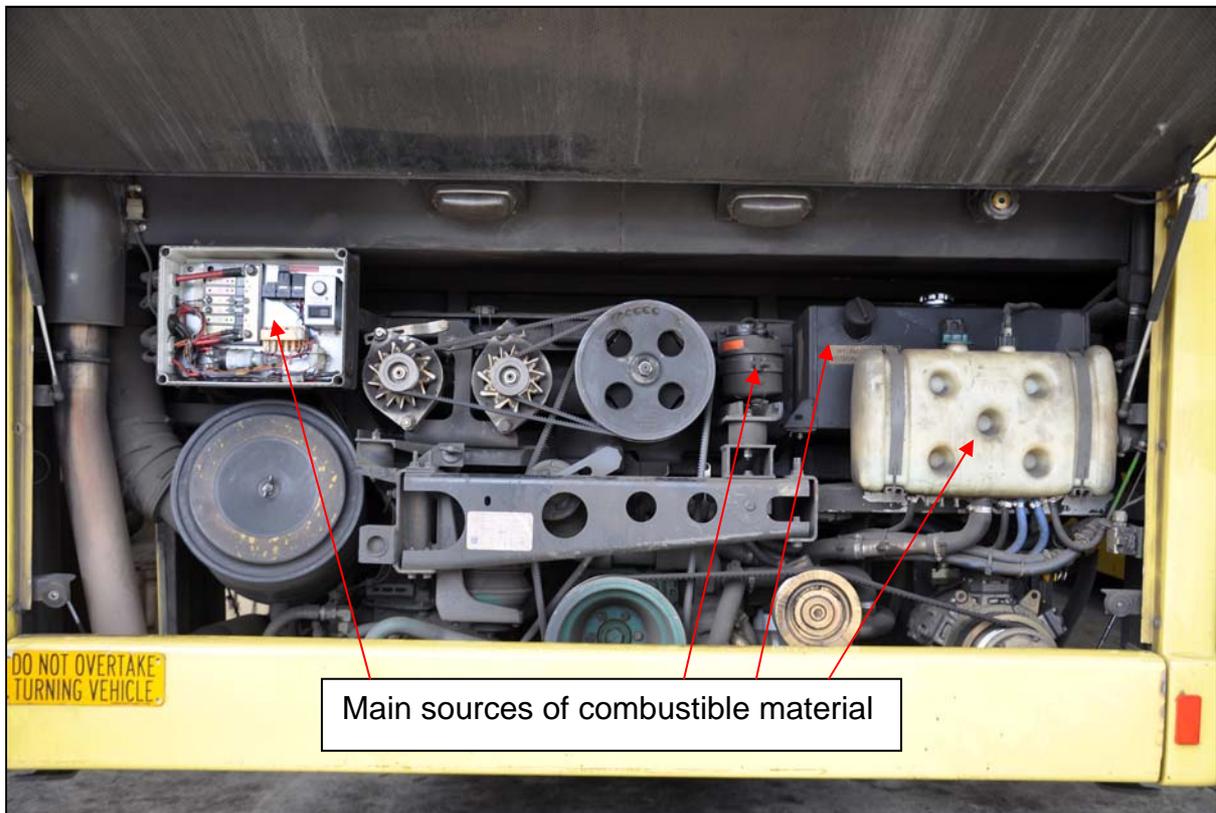
Within the engine compartment, the main components containing or consisting of significant amounts of combustible materials were the main electrical box, hydraulic fluid filter, hydraulic fluid reservoir and the radiator header reservoir tank. These can be seen, from left to right respectively, in the photograph of the engine compartment of an identical bus (*Photograph 2*). It is considered that, should the ignition temperatures of these materials be reached, they would provide secondary fuel sources for a fire and promote its spreading. The plastics commonly used for such components have ignition temperatures in the range of approximately 410°C and 580°C, and considerably lower melting points.

Photograph 2: Engine compartment of identical bus

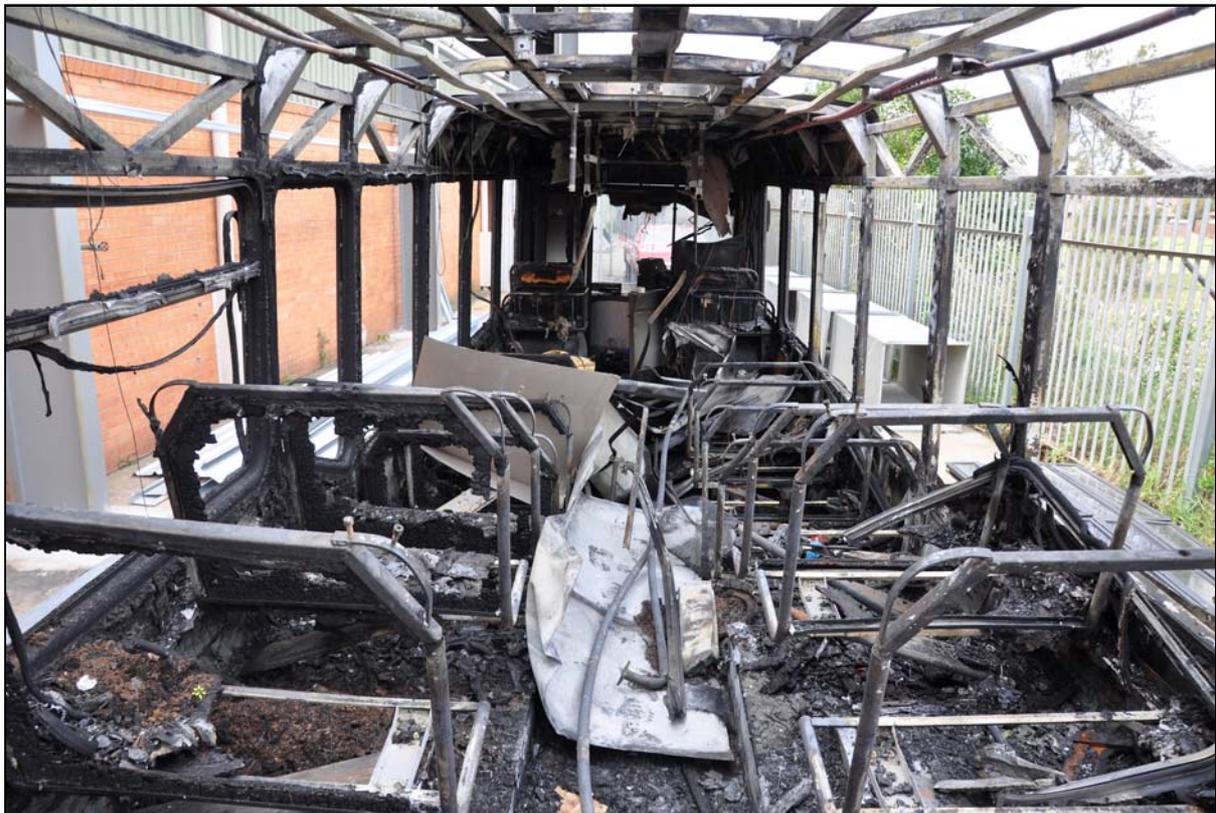
It was reported that the fire gutted the bus within four minutes of its entering the cabin (see *Photograph 3*). The linings within the body of the bus were made up of a combination of plastic and fibreglass. The seats were steel framed and upholstered using a combination of high density foam covered with material containing 50% synthetic fibre. The floor consisted of 18 mm grade H3/F14 marine plywood which burnt through wherever the underside was exposed to an outside air source, predominantly along the aisle.

Photograph 3: Interior looking from the rear

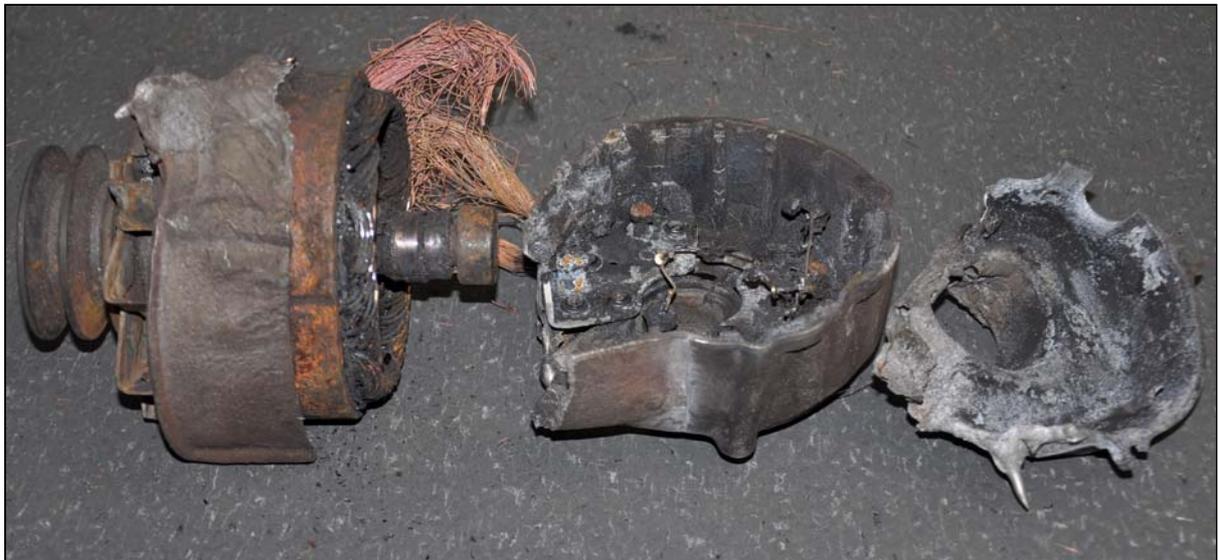
Two identical Bosch alternators with an output of 80 amps per unit were fitted to the vehicle. The right hand alternator (driver's side) showed only superficial damage and the shaft could still be turned. However, the left hand alternator had suffered severe damage, particularly the casing, due to exposure to excessive heat (see *Photograph 4*). This alternator was removed to enable a bench top examination for evidence of mechanical or electrical failure.

Photograph 4: The damaged alternator

The internal mechanisms of the left hand alternator, including the main bearing, showed no evidence of damage that would have preceded the fire. However, the alternator output terminal was loose at its connection point. A loose connection

creates a high resistance to current flow with the potential to generate excessive heat both at the terminal and within the alternator stator windings. The heat generated could be sufficient to ignite surrounding flammable materials located within the engine compartment. The terminal was significantly discoloured indicating exposure to high temperatures, and it was turned inwards and jammed tightly against an adjacent terminal also located on the rear of the alternator. However, the aluminium casing beneath the terminals exhibited no significant heat damage.

Maintenance records showed that the vehicle had been returned to the depot at Bonnyrigg for a service the day before the fire and that this service included the replacement of the alternator drive belts. The alternator main terminal connections may have already been loose, or may have been inadvertently loosened during the service. Further, a locking washer was missing from beneath the nut securing the cable leading to the battery. This washer is needed to ensure the nut does not loosen during bus operation.

The aluminium housing of the alternator had been melted away and distorted due to heat, with a complete loss of aluminium around the stator at the original 9 o'clock mounting position leaving the steel laminations of the stator completely exposed. This pattern showed that intense heat was generated from, or directed at, this area of the alternator. The damage pattern suggested that the stator became hot enough to melt the surrounding aluminium housing, yet not enough to melt the copper conductors within its winding. This suggests exposure to a temperature between approximately 660°C and 1080°C.

It is considered most likely that the heat source which initiated the fire was electrical in origin and came from the alternator either at the output terminal as a result of heat build-up due to the effects of a loose connection or a catastrophic internal failure within the alternator. The heat caused the main electrical box, which sits beside the alternator and is made predominately of plastic, to catch fire. The fire then travelled to the left hand side of the bus, up the exhaust well, and into the interior of the bus. Once the fire had spread to the interior, it quickly travelled the length of the bus
