## BUS SAFETY INVESTIGATION REPORT

BUS FIRE

VALLEY HEIGHTS

30 JUNE 2017

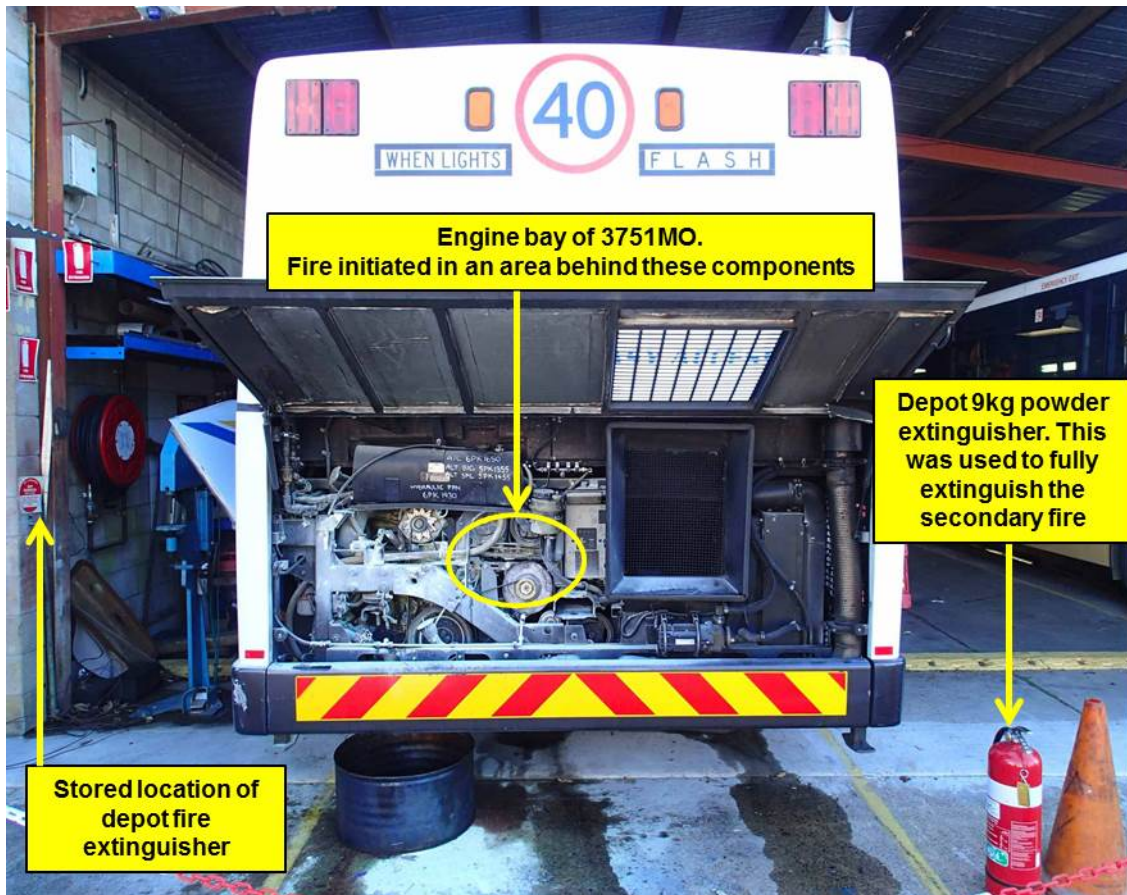
- 1.13 The engine bay of the bus suffered moderate fire damage, mainly confined to wiring looms adjacent to the alternator and the alternator rear housing.
- 1.14 OTSI received notification of the incident and deployed an investigator to the scene that afternoon. The bus was quarantined at the Valley Heights Depot pending further examination.

Figure 2: Engine bay of bus 3751MO

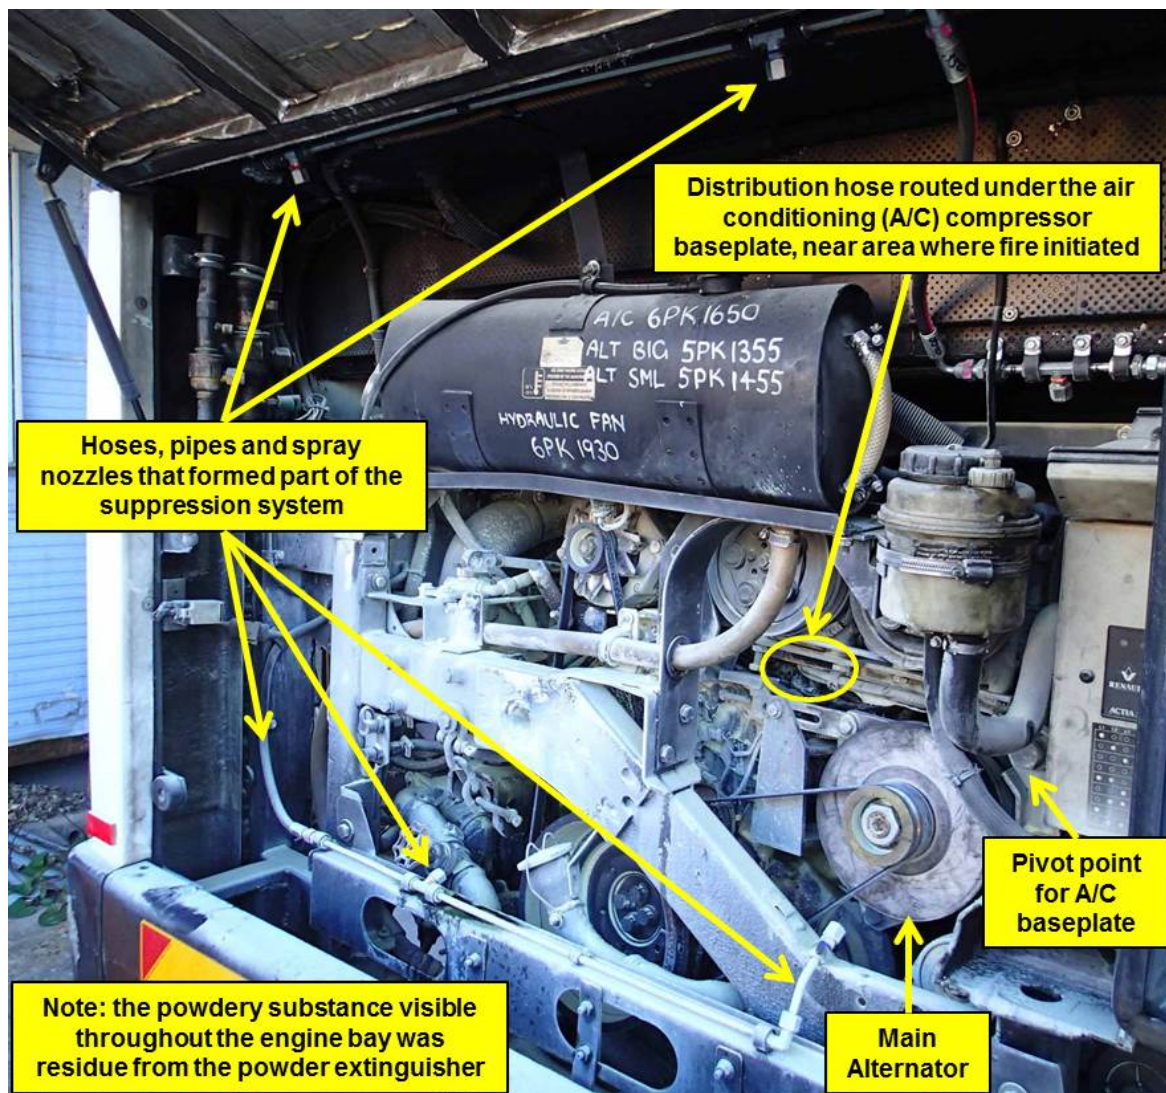
Figure 3: Engine bay showing part of the FSS network of hoses, pipes and nozzles

- 2.4 It was observed that the routing of this distribution hose transverses across the top of the main alternator cable, placing downward pressure on the cable. It was also intermingled amongst existing electrical cabling, static mechanical components and moveable components. Notably, it ran perpendicular to one end of the framework of the air conditioner (A/C) compressor baseplate (See *Figures 3 and 4*). It was noted that this baseplate pivoted on an axis point at the opposite end (See *Figure 3*). The routing of this hose restricted available

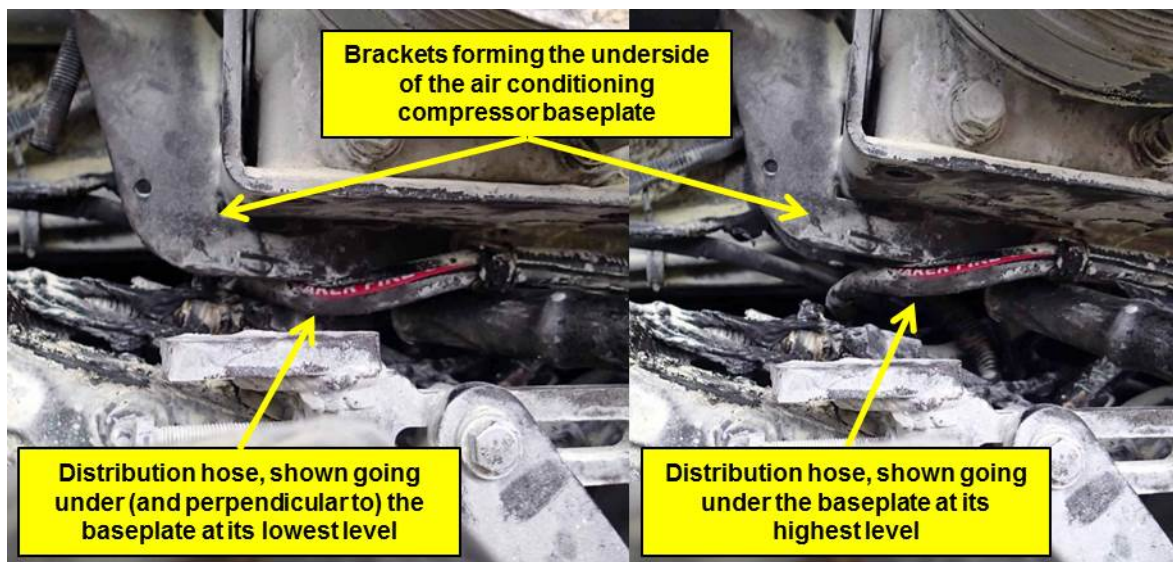
Figure 4: Distribution hose routed underneath the A/C compressor baseplate

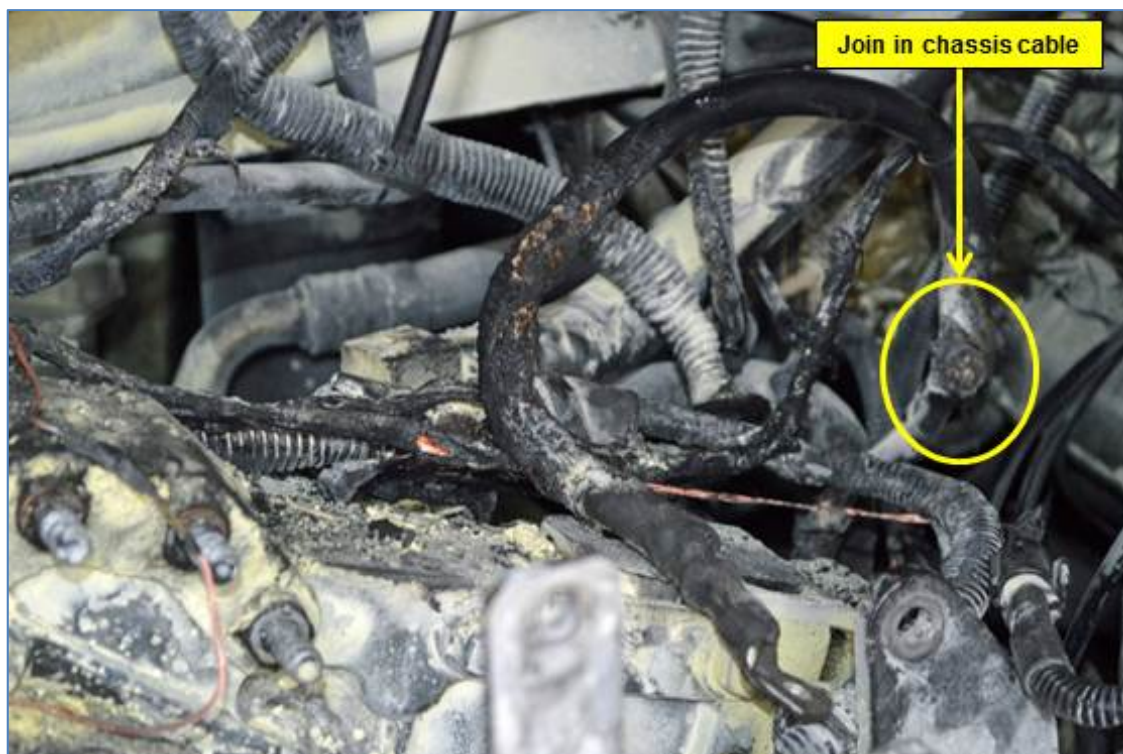
- 2.3 There was evidence of electrical arcing on both the join in the cable and alternator end casing. The main area of fire damage was concentrated on cabling near, and attached to, the alternator. A variety of cabling was located in this area. These included a pre-existing main chassis wiring harness and electrical cabling associated with the alternator. These were immediately adjacent to or in the vicinity of a newly installed distribution hose<sup>10</sup> associated with the FSS network.

Figure 5: Alternator cable, showing the join where an extension was attached

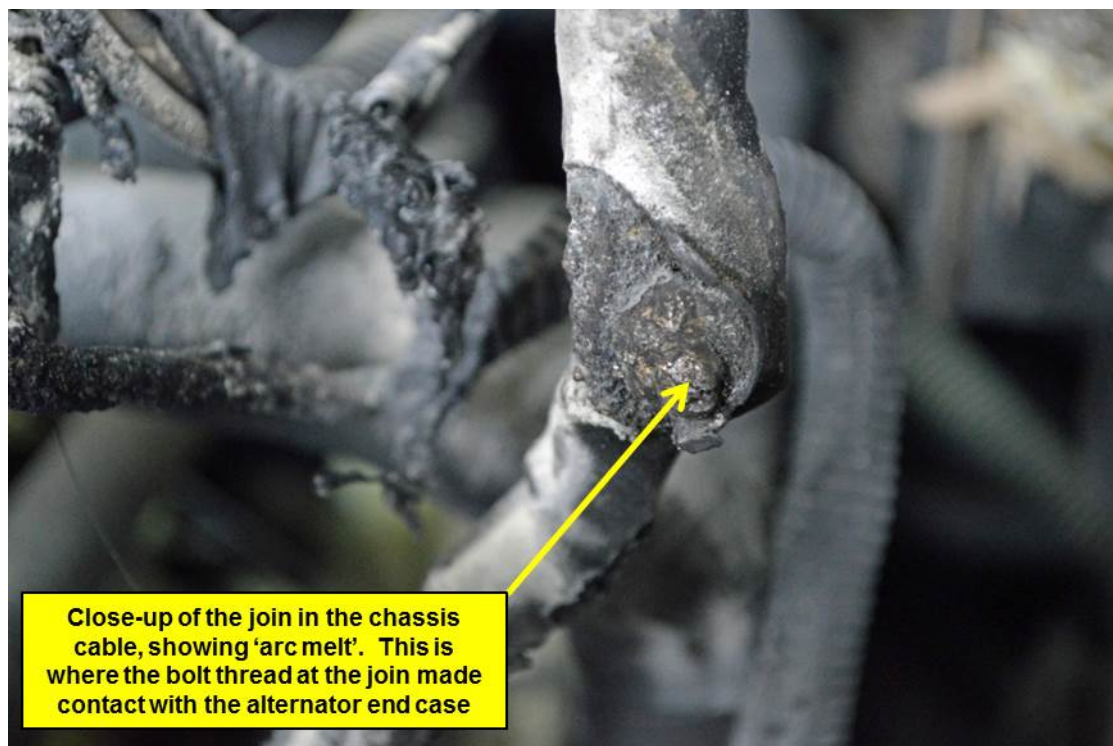
- 2.8 The TfNSW forensics report confirmed: *'Examination of the bolt clearly depicts copper deposition/fusion derived of the cable terminal..... The scanning revealed clear evidence of copper deposition fused to the aluminium alloy which is consistent with electrical arcing.'*<sup>12</sup> (*Refer to Figures 5 through to 8 which highlight the damage to the chassis cable and alternator end case*).

Figure 6: Cable showing close-up of the join and evidence of 'arc melt'

- 2.18 The TfNSW forensics report stated “*insulation was diminished due to abrasion*” in reference to the alternator end case (See Figure 6 and 7). Abrasion of this protective insulation would have diminished its effectiveness as a protective barrier. Ongoing abrasion would have increased the risk that the insulation would fail, leaving the internal conductive components exposed and prone to damage, failure, or in this case, damage from contact with other metallic components causing unwanted current flow, leading to short circuiting.

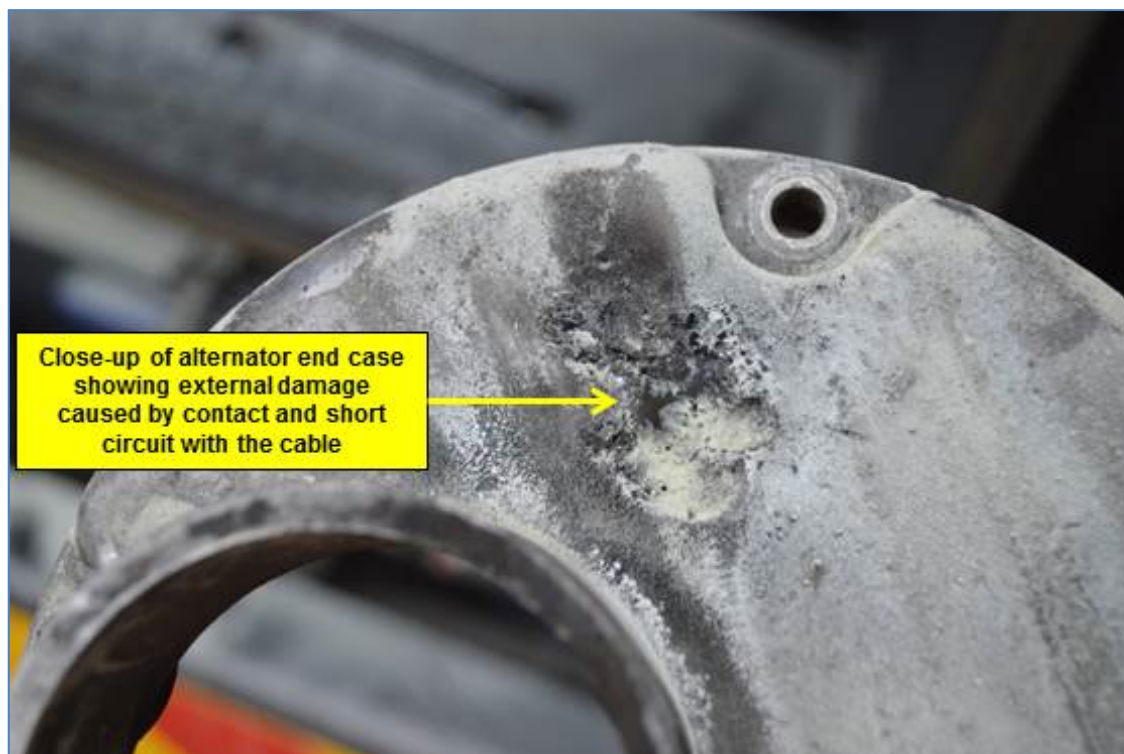
Figure 7: Exterior of the alloy alternator end case.

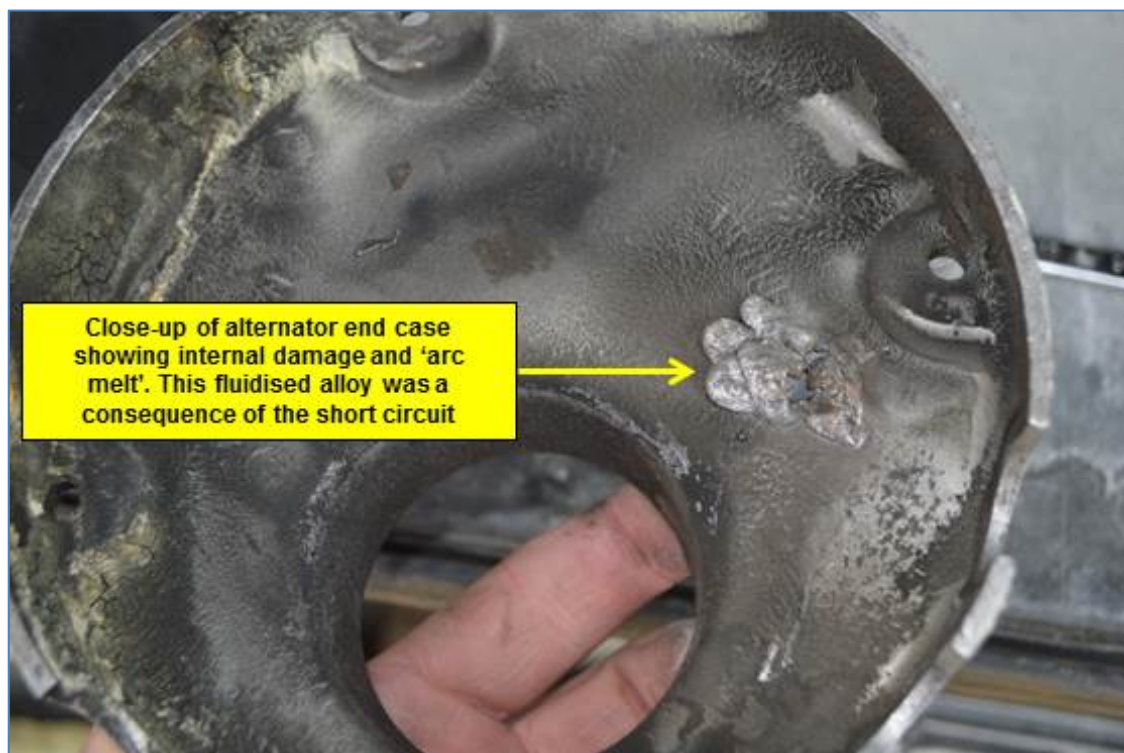
Figure 8: Interior of the alternator end case.

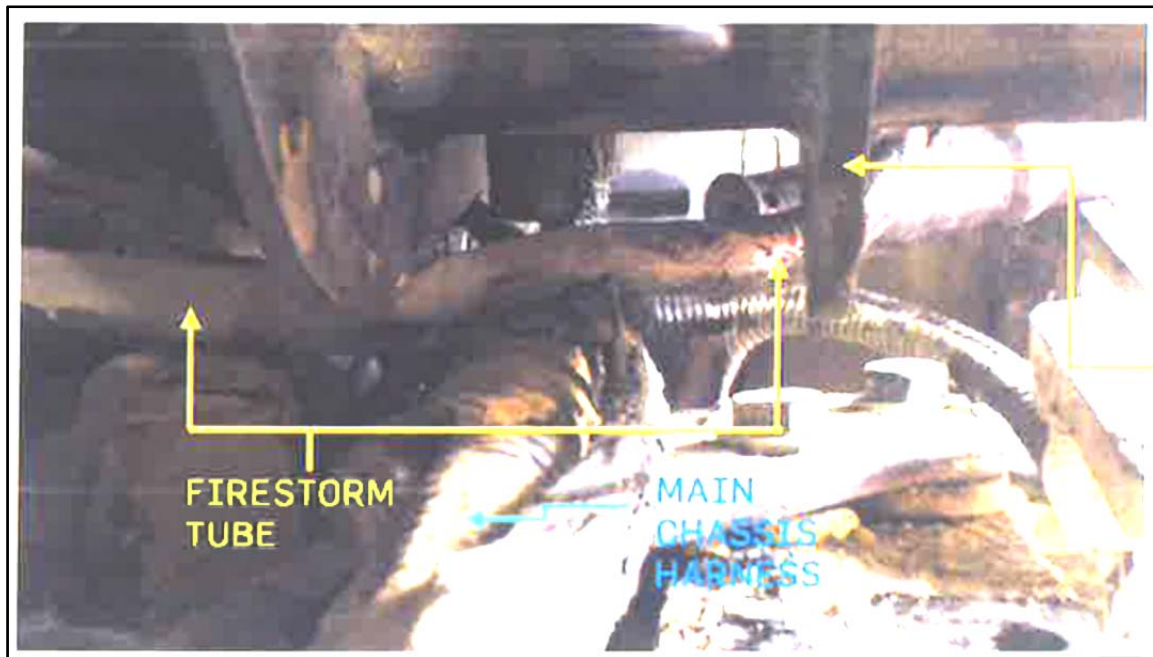
- 2.6 The pressure exerted on the main chassis harness by the distribution hose was exacerbated by the A/C compressor drive belt not being fitted at the time of the incident. In normal operation the A/C drive belt is tensioned by an air bellows pushing against the A/C base plate frame in an upwards direction which in turn keeps tension on the A/C compressor drive belt. This results in the A/C compressor base plate maintaining an operating height above that which was observed following the fire incident.

Figure 9: Contact between distribution hose / main chassis harness (alternator)

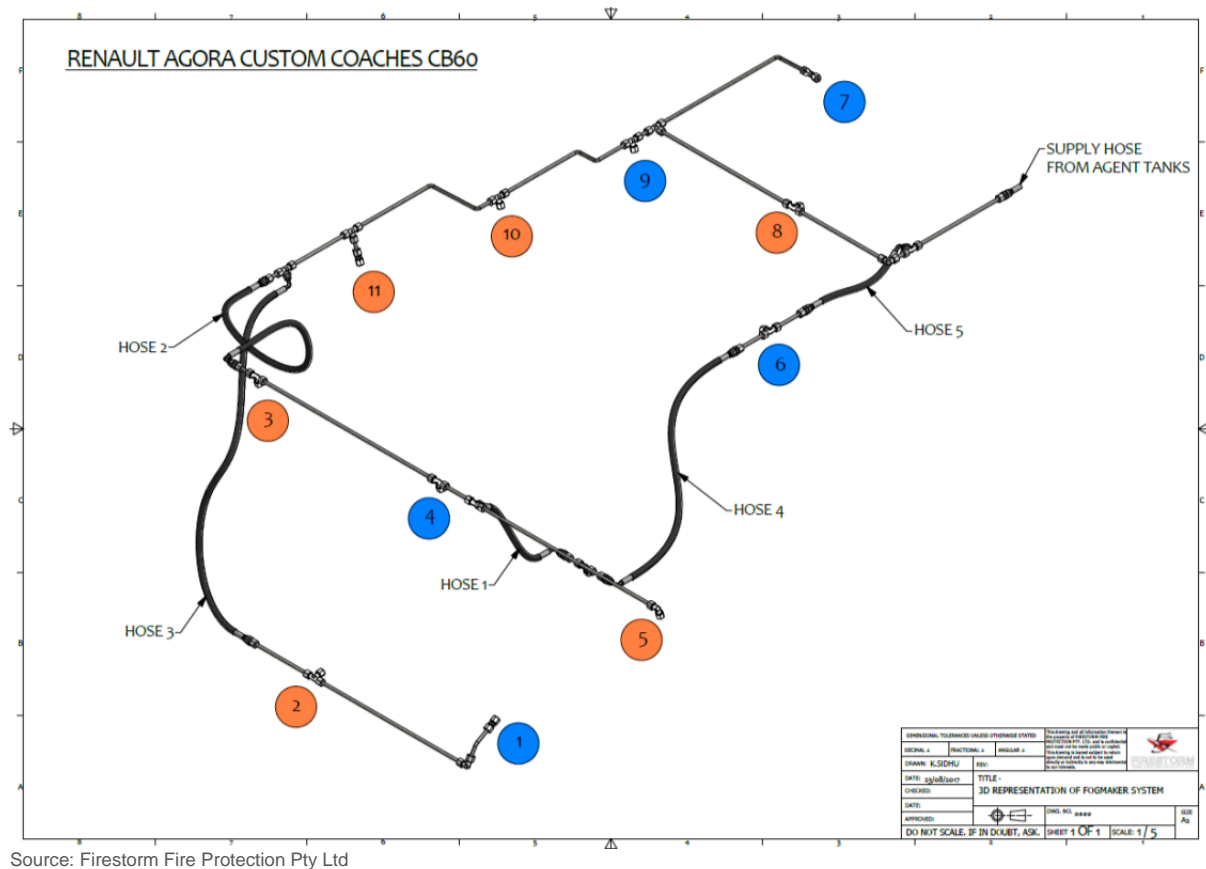
2.25 The only schematic received for the installation from the FSS contractor was generic in nature and did not contain dimensions or locations for fitment of the discharge or detection network components (See Figure 10).

Figure 10: Distribution network for bus 3751MO
