TECHNICAL INSPECTION FINDINGS

STATE TRANSIT AUTHORITY BUS MO 3881 FIRE

FRENCHS FOREST

1 OCTOBER 2013

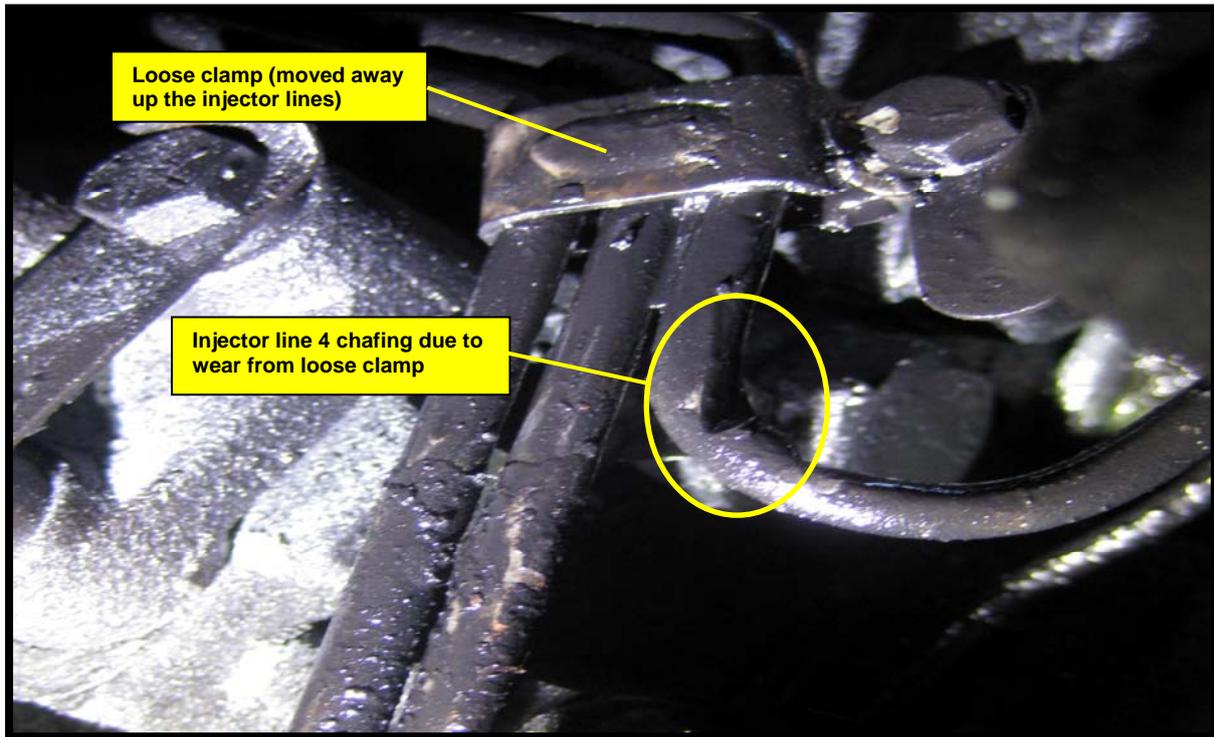
Examination of the high pressure fuel lines identified a retaining clamp on the Nos. 4, 5 and 6 injector lines near the injector end that had slipped downwards along the lines. It had come to rest at a bend in the No. 4 injector line and, over a period of time, had worn through the line until a hole had been created (see *Photograph 1*). This hole would allow diesel fuel under pressure of approximately 210 bar (3050 psi) to spray from the fractured line on to the hot turbocharger housing and exhaust manifold surfaces. As it burnt off on contact with the hot surfaces, the diesel fuel would have produced a significant volume of black smoke. It was this smoke that alerted the driver to a problem, in conjunction with the backfiring of the engine.

Photograph 1: No. 4 injector line chafing

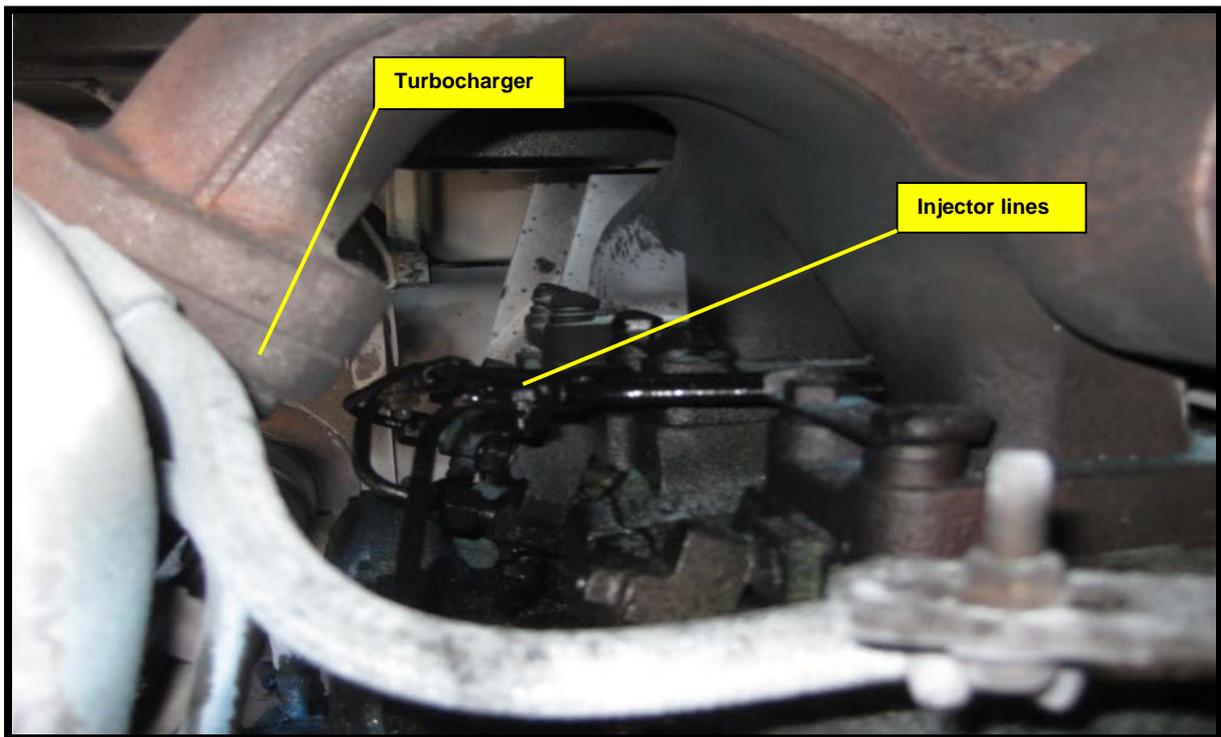
The 1-2-3 injector lines were accessible for both visual and manual inspection. However, the 4-5-6 injector lines were located in a position inaccessible for manual and visual inspection due to their close proximity to the turbocharger (see *Photograph 2*). The clamp on the 4-5-6 lines should have a flexible rubber insert separating the line from the metal clamp to prevent friction and wear. This rubber insert also acts to absorb some of the vibration of components.

Photograph 2: Injector lines in close proximity to the turbocharger

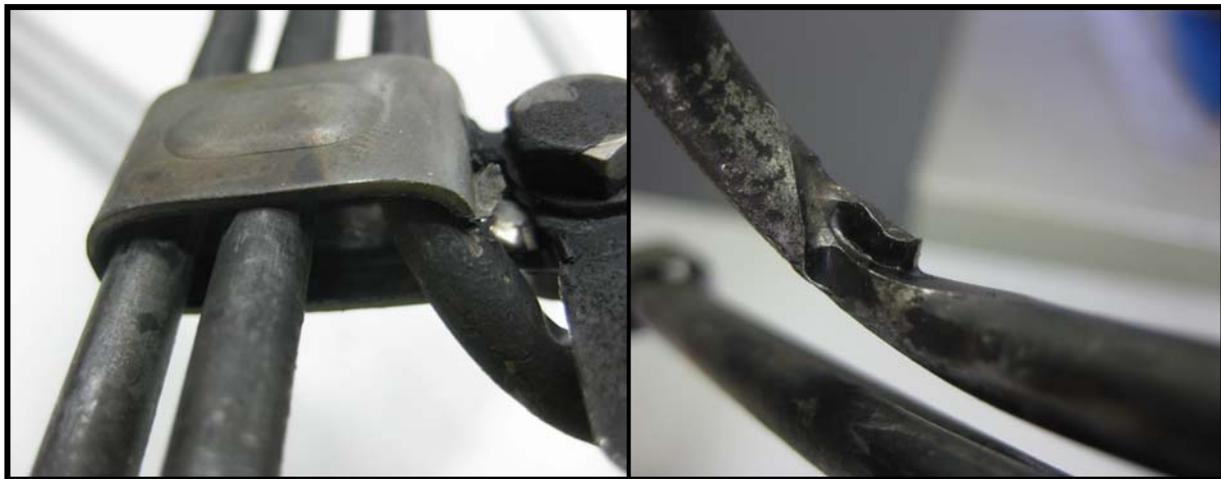
The rubber insert was found to be missing between the clamp and the injector. This allowed the clamp to move from its installed position down to the bend in the line which prevented it from moving further. The resulting metal to metal contact had worn through the wall of the injector line under the effect of the vibration of the engine under normal operating conditions (see *Photograph 3*).

Photograph 3: Clamp and injector and resultant wear

The fire in the engine bay of the STA bus MO 3881 was caused by fuel spraying under high pressure from a hole in the No.4 injector line on to the hot exhaust manifold and turbocharger causing the fuel to ignite. The breach in the injector line was the result of friction between the line and a loose retaining metal clamp which had become loose and moved from its installed position after its flexible rubber insert went missing.

After determining the cause of the fire the STA immediately issued Maintenance Alert No. WI 26.01.33 to all depot service managers requiring all the 124 Volvo model B10BLE and B10B buses in the fleet to be inspected without delay (see *Annexure A*). The inspection required high pressure injector lines to be examined for signs of leakage or insecurity with particular attention for signs of injector line wear or missing clamp rubber insert gaskets.

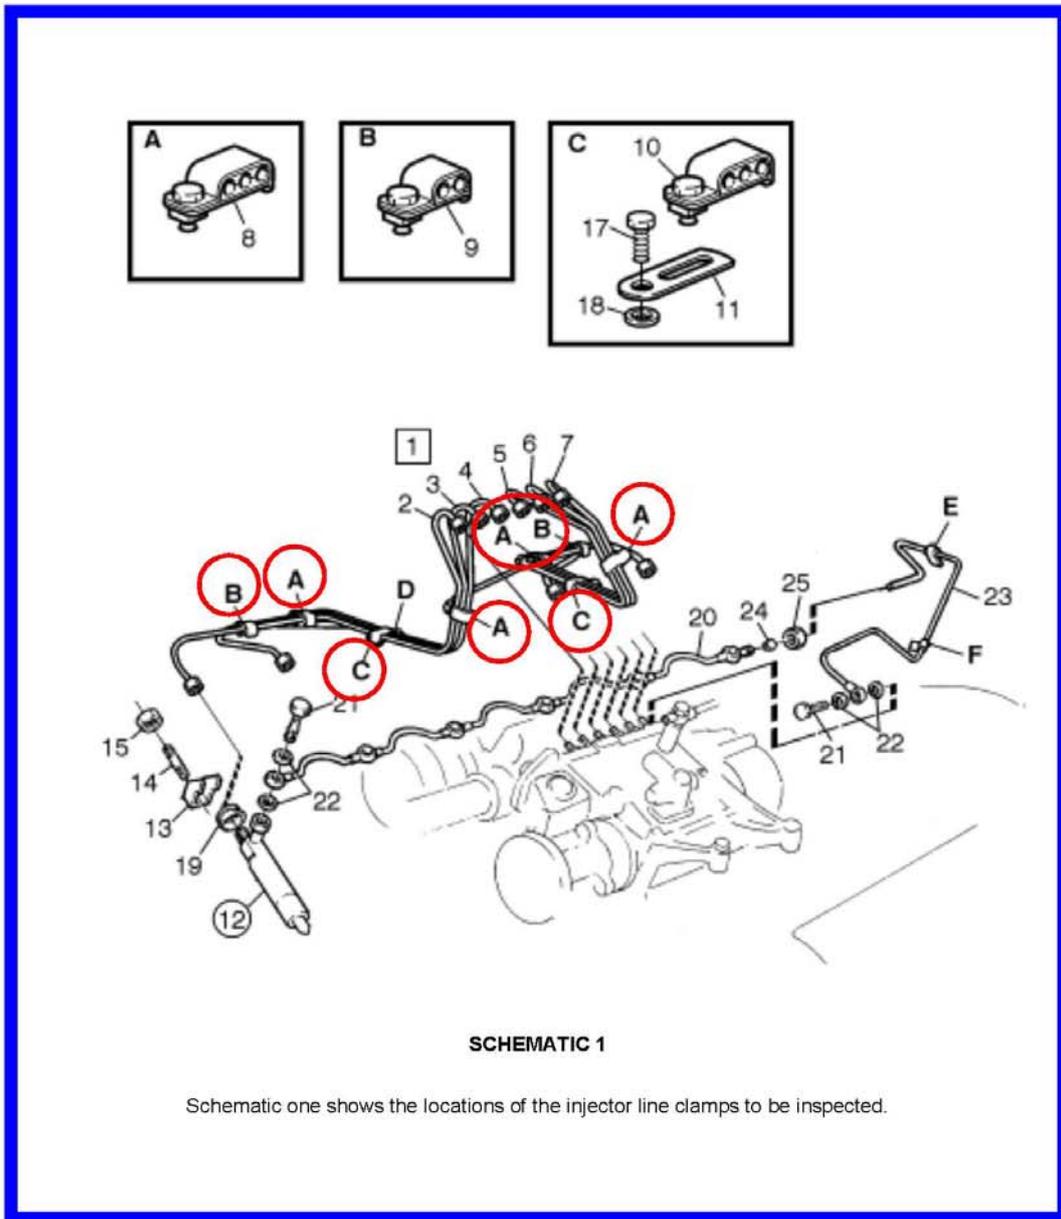
SCHEMATIC 1

Schematic one shows the locations of the injector line clamps to be inspected.

MAINTENANCE ALERT	
Title: VOLVO B10BLE & B10B – SECURITY OF INJECTOR LINES	
Attention of: Regional Fleet Managers, Regional Service & Compliance Manager, Service Managers, Service Coordinator (Burwood & Mona Vale)	
Date Issued: 2nd October 2013	Maintenance Alert No: WI 26.01.33
ISSUE	
Following a thermal incident with a Volvo B10BLE on 1 October 2013, and an earlier incident of similar nature on a Volvo B10BLE on 13 May 2012 there is a need to ensure high pressure injector lines are examined for signs of leakage, damage or insecurity.	
INSTRUCTION	
Particular attention is to be paid to the high pressure injector line clamping for security, signs of injector line wear or missing clamp rubbers.	
Inspection and checking of the following must be undertaken:	
<ol style="list-style-type: none"> 1. All clamps are correctly fitted, positioned and secured (see Schematic 1), 2. Particular attention must be given to clamping on injector lines 4, 5 and 6 in the area behind the Turbocharger (Caution – beware of possible hot turbo and exhaust components), 3. Remaining injector lines and clamps are to be checked. 4. Return lines should also be checked for obvious signs of deterioration. 5. Where injector clamps are insecure, or signs of clamp movement are evident, the injector line must be examined for signs of wear. 6. If there are signs of wear on high pressure injector lines prompting replacement of the component, vehicles are to be stopped and referred for a further assessment by management. 7. If any injector line has wear that requires replacement, the lines are to be replaced as a complete set and in conjunction with Maintenance Instruction MI 07.06.01. 8. Work orders are to be created in Ellipse for any additional work as a result of this inspection. 9. Where management decide it is safe to reschedule injector line replacement, the Ellipse work order must be updated to keep an appropriate record of that decision. Works orders must be raised and correctly prioritised.
