FERRY SAFETY INVESTIGATION

COLLISION AND GROUNDING OF THE *LADY NORTHCOTT*

SYDNEY HARBOUR

11 and 13 December 2012

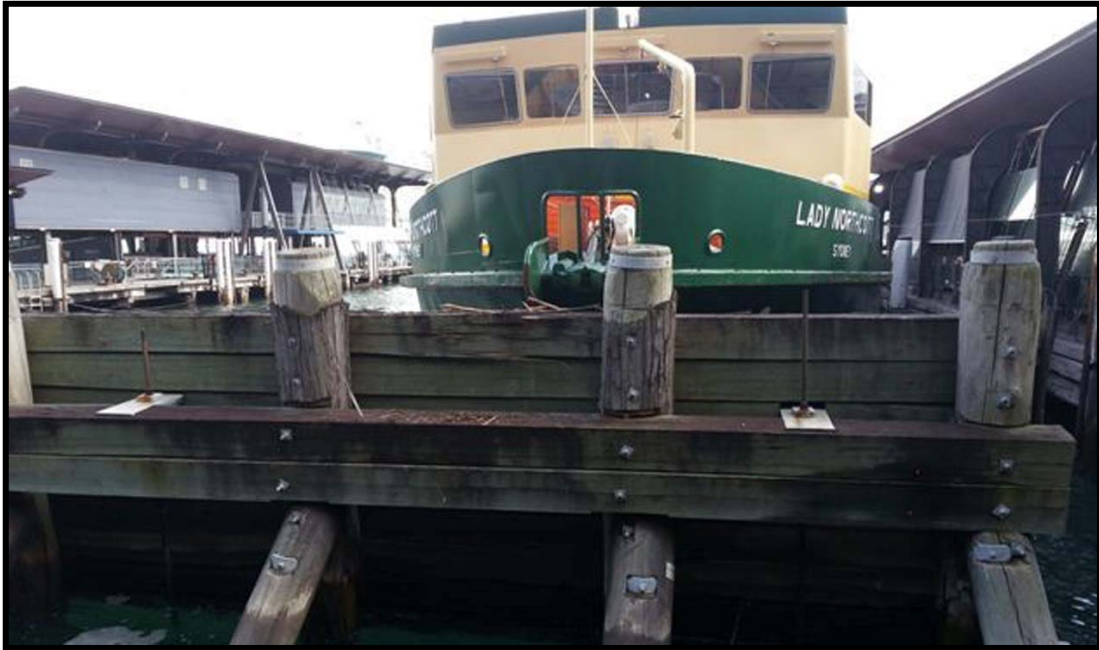
Photograph 2: Circular Quay timber backboard

- 1.15 As the ferry had completed services for the day and was to be berthed overnight at the southern end of the wharf, lines were removed and the Master selected '*slow ahead*' to move the ferry forward about 30 metres. He then selected '*astern*' to stop the ferry. However, instead of '*astern*' being engaged on the No.2 propeller, the ferry responded by rapidly moving ahead on the No.1 propeller. This caused it to collide with the timber backboard at a speed of 2.2 knots (see *Photograph 2*). The ferry suffered only minor paint damage as it was the bow anchor and fairlead⁶ that came into contact with the backboard. However, the backboard was displaced backwards about one metre and its top timbers were slightly damaged.

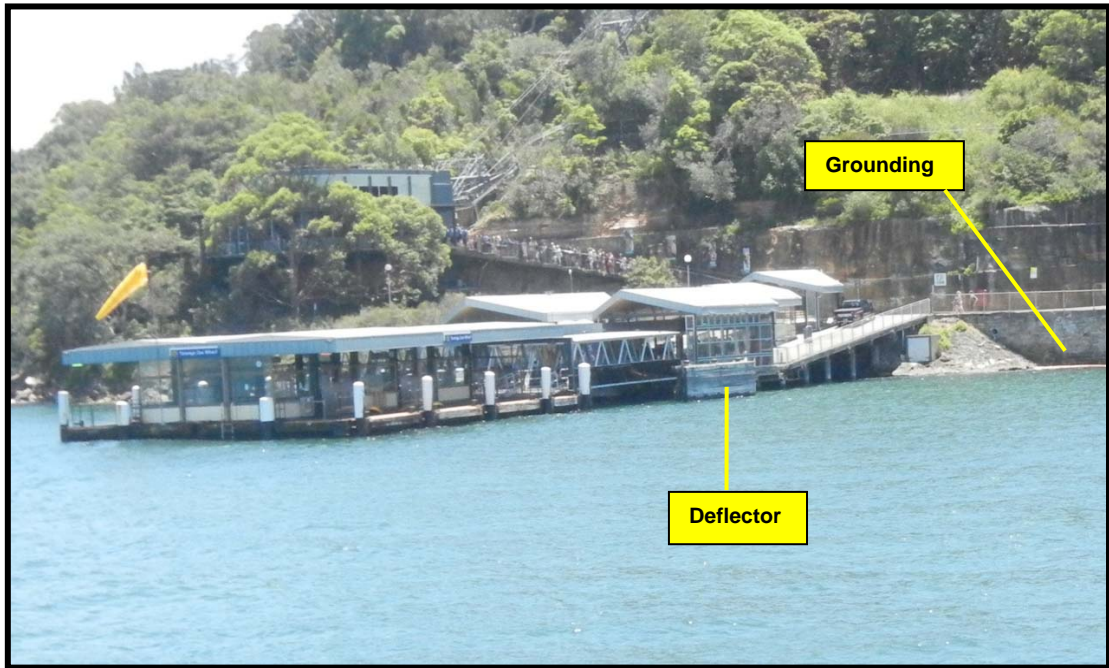
Photograph 3: Taronga Zoo Wharf

- 1.16 The second incident occurred on 13 December 2012 when approaching the eastern side of Taronga Zoo Wharf. This wharf is a 'dead end' wharf similar to those at Circular Quay. It consists of a large floating pontoon 24 metres in length attached to a bridge which in turn is attached to a fixed structure on piles over the water and the shore. The timber backboards, or deflectors, are in place on both sides 32 metres from the southern end of the wharf. They are angled at 17 degrees to the wharf so as to deflect a vessel away from the fixed structure of the wharf should it over-shoot the berthing position (see *Photograph 3*).

- 1.21 There was no damage caused to the deflector or wharf. However, an inspection of the hull, rudder and propeller by divers identified damage to the blades of the propeller on the No.1 shaft where it had impacted on the rocks.

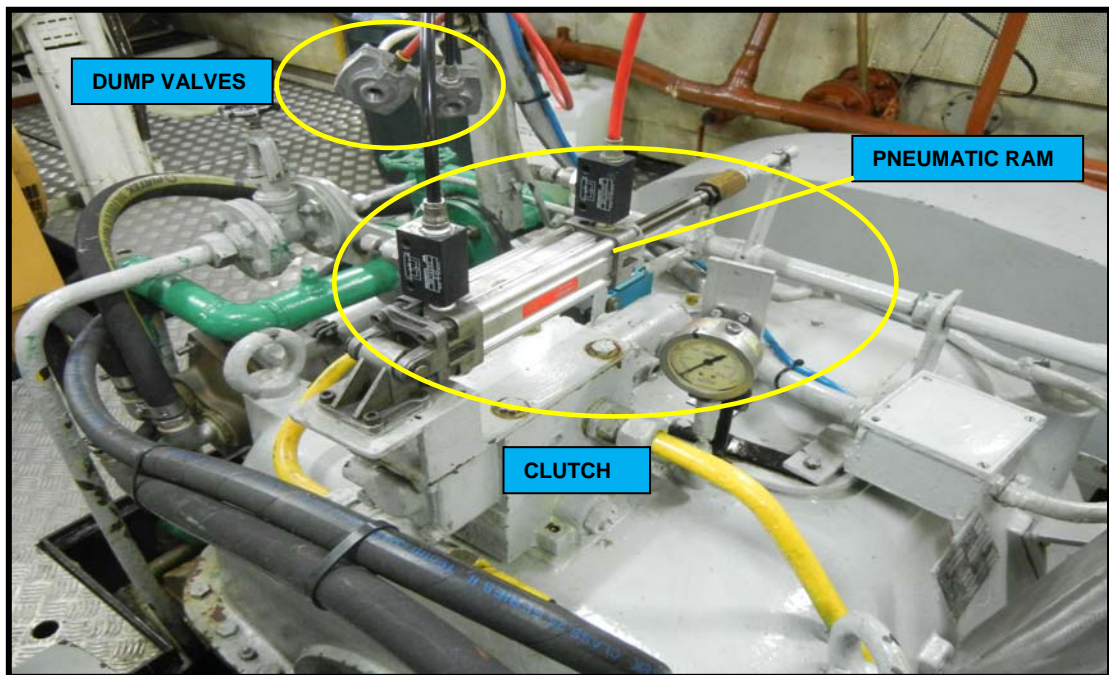
Photograph 7: *Lady Northcott*'s pneumatic clutch at the gearbox

- 2.4 During the initial inspection of the *Lady Northcott* by OTSI investigators on 14 December 2012, a leak was found in the air supply to the pneumatically operated ram which engaged and disengaged the clutch on the No.2 propeller shaft. Additionally, one of the air exhaust valves was found not to be working, possibly due to the air leak reducing the pressure in the line. The ram did operate during testing although with a slight hesitation and with not as smooth an action as compared to the ram on the No.1 shaft. However, the clutch engaged and disengaged correctly. Minor air leaks were also detected in the

pneumatic supply lines from the stored compressed air to both operating pneumatic cylinders (see *Photograph 7*).

2.32 In response to the leaks detected in the pneumatic system, HCF replaced the clutch activating cylinders on both gear boxes, sections of the stored compressed air supply lines to the cylinders, the four air control valves (two intake, two exhaust), the pneumatic system water traps and all pneumatic tubing in the air supply system.

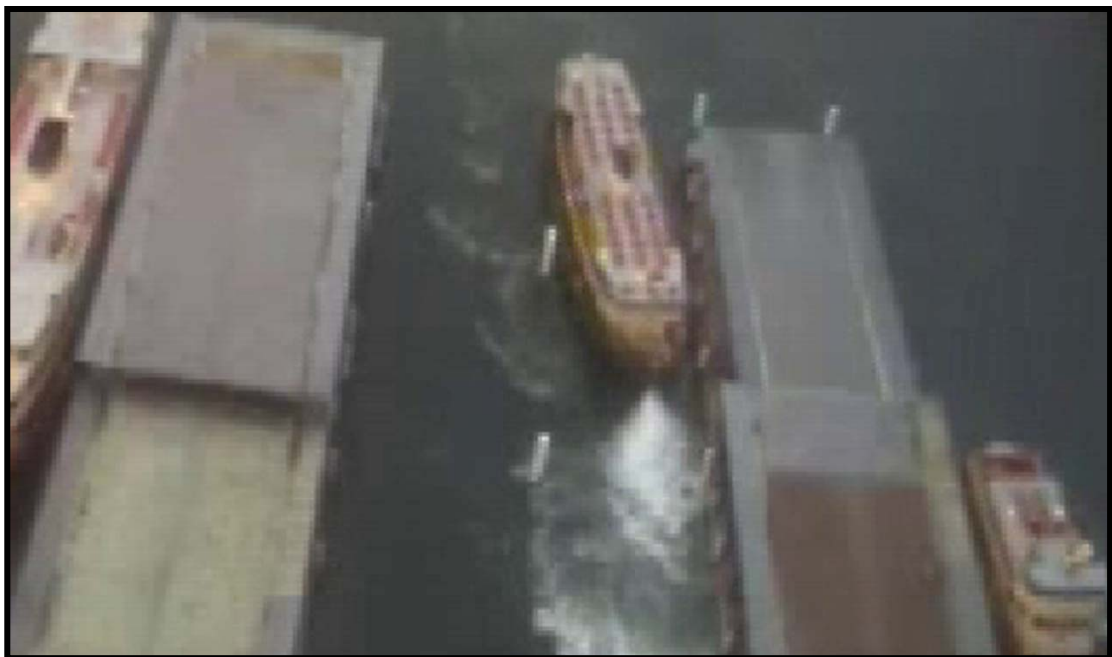
Photograph 8: *Lady Northcott* at No 2 Wharf going astern

- 2.9 The Master then engaged the No.1 shaft to 'slow ahead' to bring the ferry ahead on the spring line, swinging the bow in parallel to the wharf. As evidenced from the CCTV and FLIR, the No.2 shaft engaged instead of the No.1 shaft. The VDR recorded the No.2 clutch engaged with the engine speed at 320 rpm. The ferry commenced to move astern, rapidly swinging the bow of the ferry away from the wharf (see *Photograph 8*). The Master declutched the No.2 clutch and put the Engineer on 'stand by' then asked him via the intercom what had happened. The Engineer did not know.

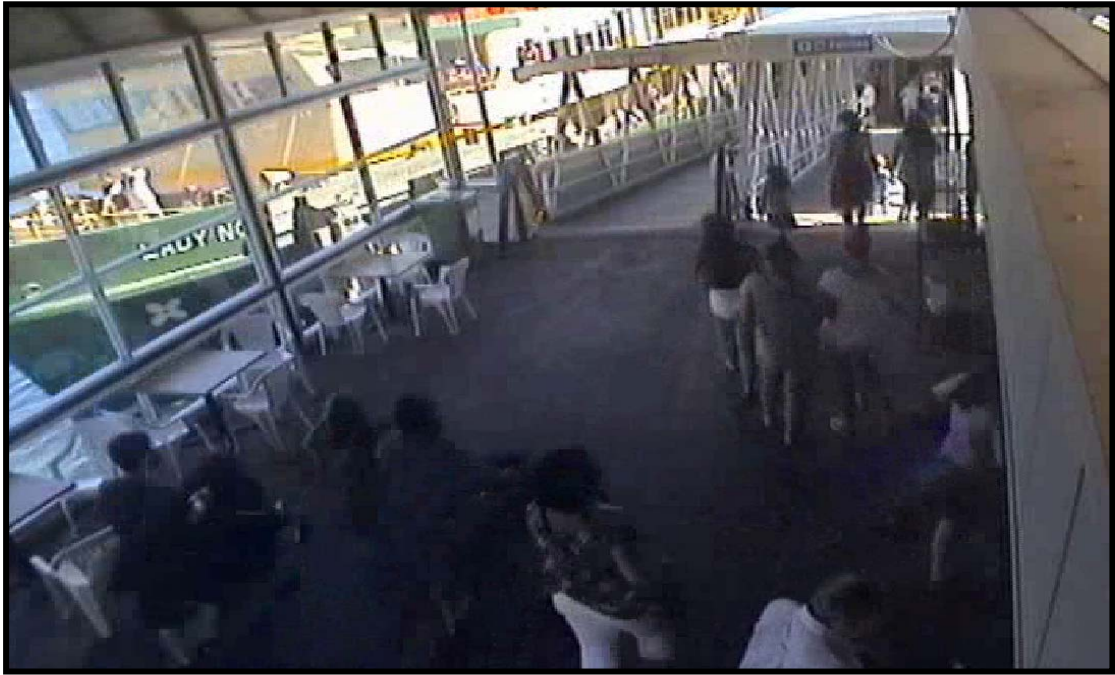
Photograph 9: *Lady Northcott* colliding with timber arrester at Taronga Zoo Wharf

- 2.20 The Master utilised the deflector on the side of the wharf to slow the ferry further. When the port bow hit the board, the ferry was deflected away from the wharf and towards the shoreline as shown by the CCTV wharf recording (see *Photograph 9*).

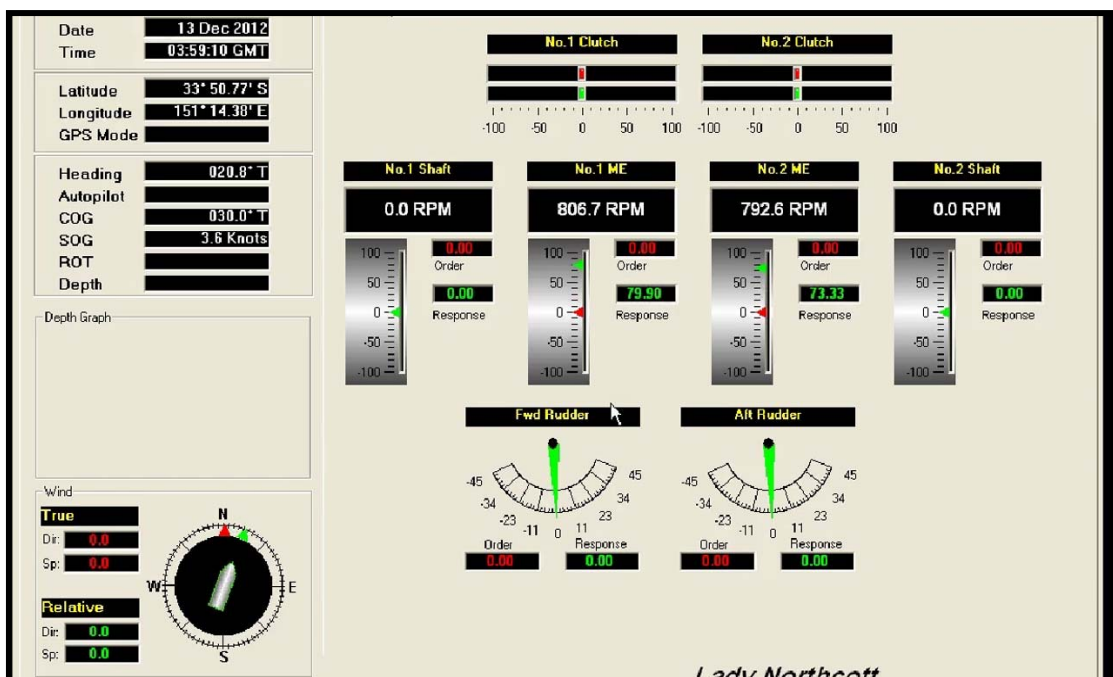
Photograph 10: *Lady Northcott*'s VDR capture at 14:59:10

2.21 At 14:59:10 the FLIR showed the ferry's bow grounding at a speed of 3.6 knots. The VDR recorded the engine revolutions still near the maximum of 800 rpm and neither clutch engaged (see *Photograph 10*). After impact the ferry slid back from the rocks towards the wharf where it was secured, awaiting subsequent recovery to the Balmain Shipyard.

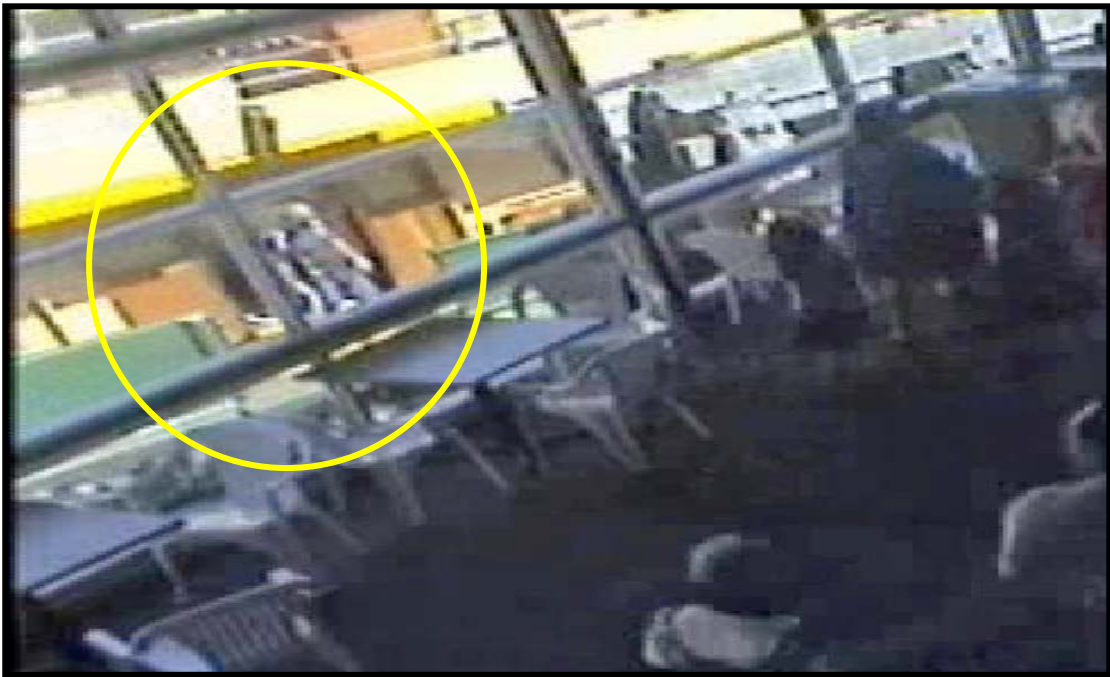
Photograph 11: GPH on open deck

- 2.30 The CCTV footage taken from the Taronga Zoo Wharf shows the GPH throwing lines to the wharf bollards without the protection of a railing, bulwark, or the like to prevent them from falling overboard (see *Photograph 11*). While the GPH followed standard operating procedures in accordance with the Vessel Operating Manual, this clearly constitutes a significant safety hazard. In the event of a heavy berthing where the ferry contacts the wharf or pile at speed causing the ferry to be deflected, GPHs and nearby passengers could lose their footing and fall between the ferry and the piles or wharf resulting in serious injury or death.
