Office of Transport Safety Investigations

INTERIM FACTUAL STATEMENT

LADY NORTHCOTT

COLLISION & GROUNDING

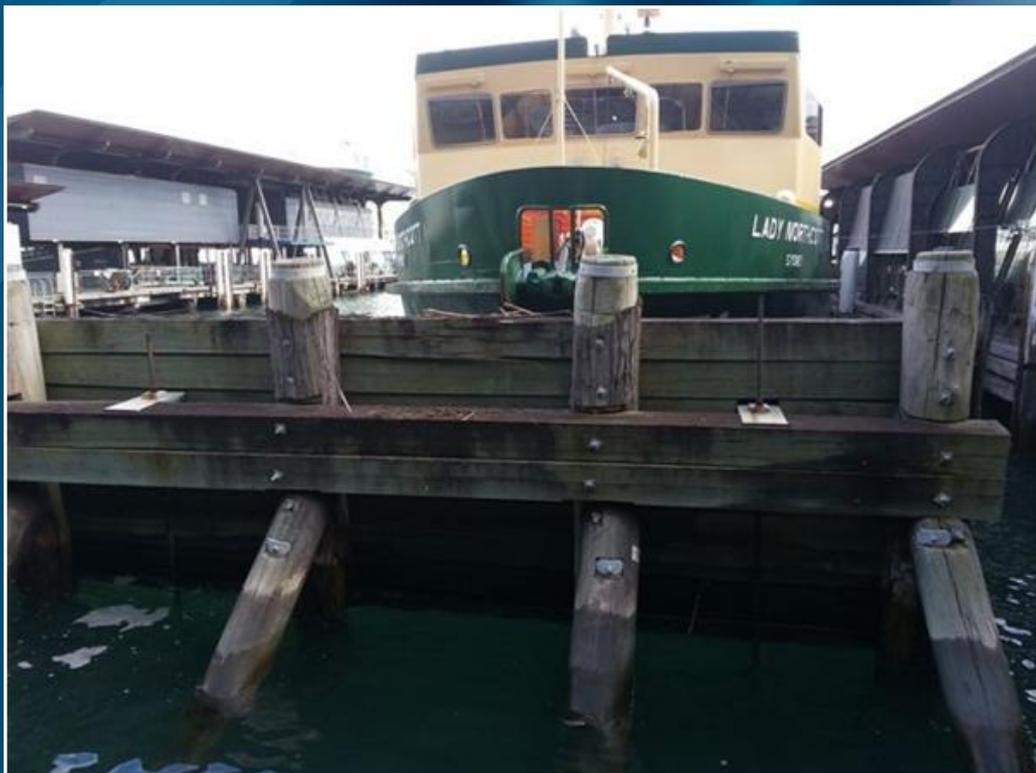
At approximately 19:40 hours on Tuesday 11 December 2012 after disembarking passengers at Circular Quay No. 2 Wharf West, the *Lady Northcott* collided with the timber backboard arrestor while relocating to the southern end of the wharf (see *Cover Photograph*). The ferry, operated by Harbour City Ferries (HCF), failed to respond to engine control commands to go astern and instead went ahead with increased speed. There were no injuries as a result of the collision. The ferry suffered minor damage but substantial damage was caused to the backboard. The ferry was withdrawn from service for examination and testing.

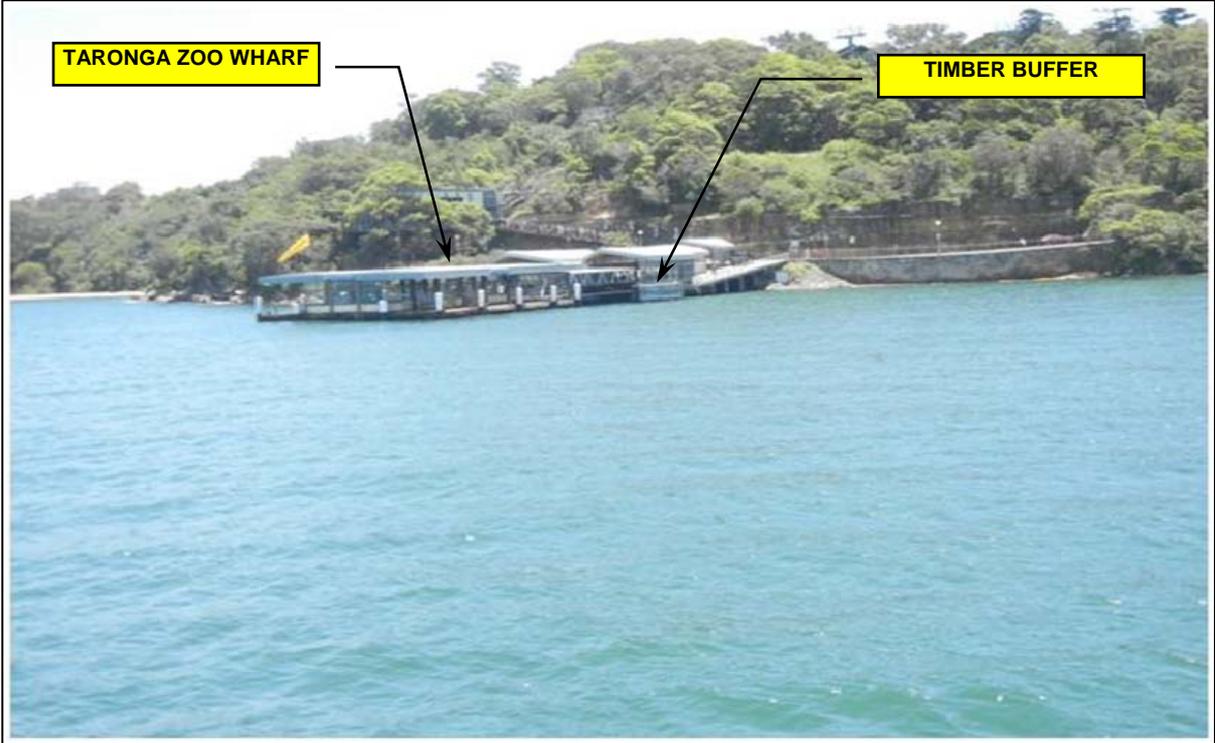
Photograph 1: Taronga Zoo Wharf

On Thursday 13 December 2012, the *Lady Northcott* resumed normal passenger operations on the Circular Quay to Taronga Zoo route. At approximately 15:00 hours on approaching Taronga Zoo Wharf with passengers onboard, the ferry failed to engage astern propulsion and collided with a timber buffer next to the wharf and then continued going aground on the shoreline (see *Photograph 1*). There were no injuries as a result of the collision or grounding. After the ferry was refloated, the passengers were disembarked at the Taronga Zoo Wharf and the *Lady Northcott* was towed to the HCF Balmain Shipyard. An examination found that the No. 2 propeller was damaged as a result of the grounding.
