Office of Transport Safety Investigations

FERRY SAFETY INVESTIGATION REPORT

CLOSE QUARTERS

25 JULY 2012

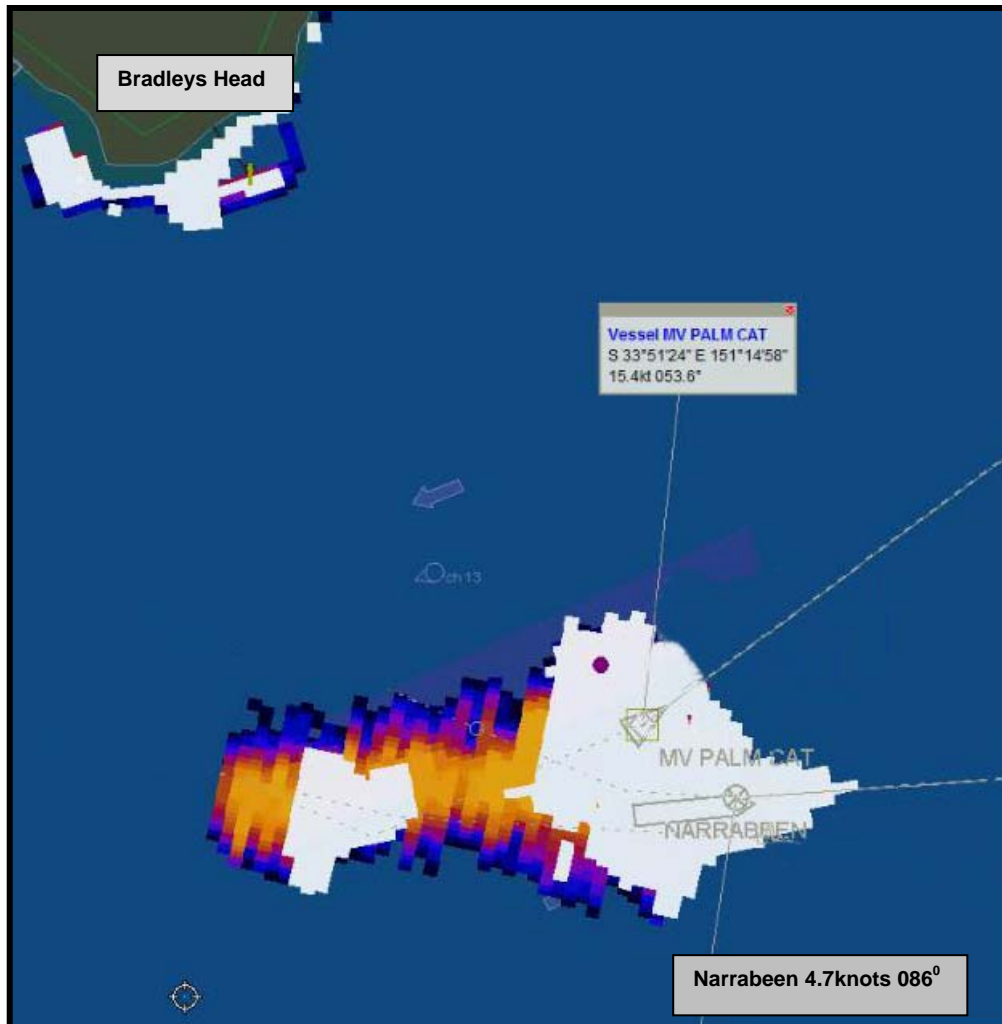
Radar Screenshot 3: *Palm Cat* after close quarter with *Narrabeen*

- 1.42 *Palm Cat* passed *Francesca* and continued on maintaining course and speed. At 6:07:43am *Palm Cat* altered course to 053° and overtook *Narrabeen* very close on the port side (see Screenshot 3). *Narrabeen* was then on a heading of 086° at 4.7 knots. The Master of *Francesca* stated that he slowed further expecting to hear the sound of a collision between *Palm Cat* and *Narrabeen*. He estimated the distance between *Palm Cat* and *Narrabeen* as “no more than 5 to 10 metres with the *Palm Cat* travelling far too fast”. The *Palm Cat* then continued south of the safe water mark and turned to port on a course of 014° heading towards the shore line at the north-eastern end of Chowder Bay at 14.5 knots.

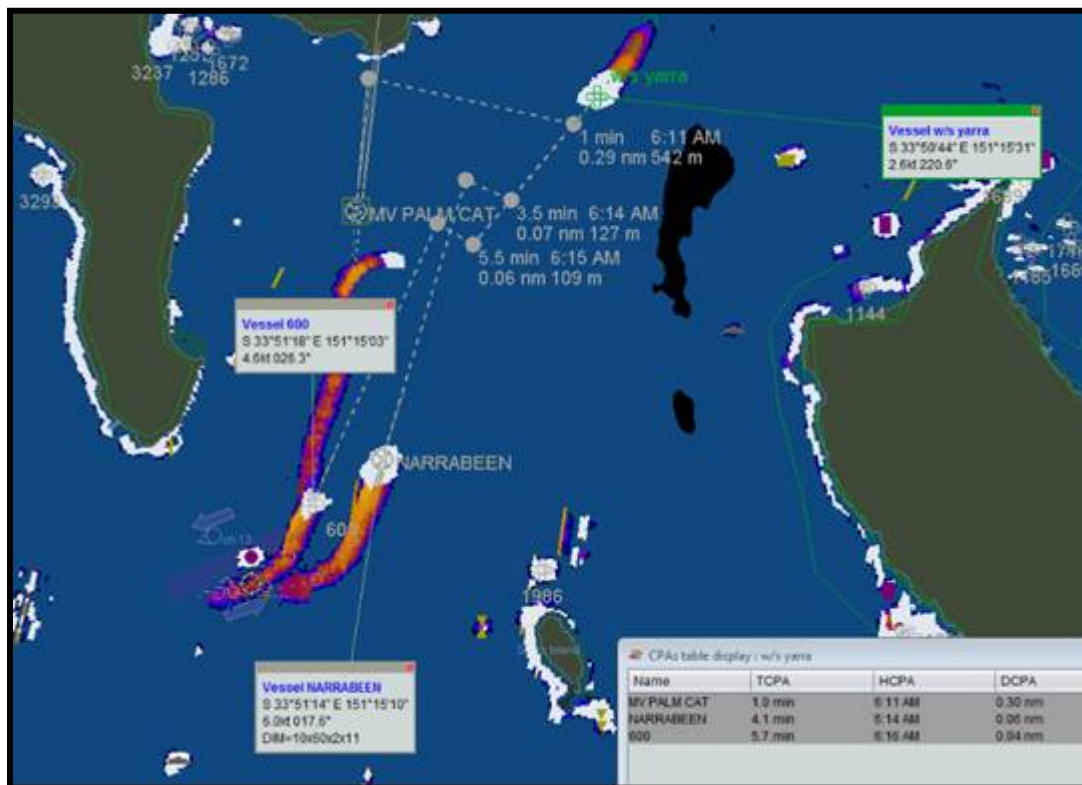
Radar Screenshot 4: *Palm Cat* commences 105° starboard turn

- 1.44 At 6:10:29am, in the words of the Master of *Palm Cat* at interview, “we altered course slightly to starboard”. However, the radar track showed this turn to be 105° (see Screenshot 4).

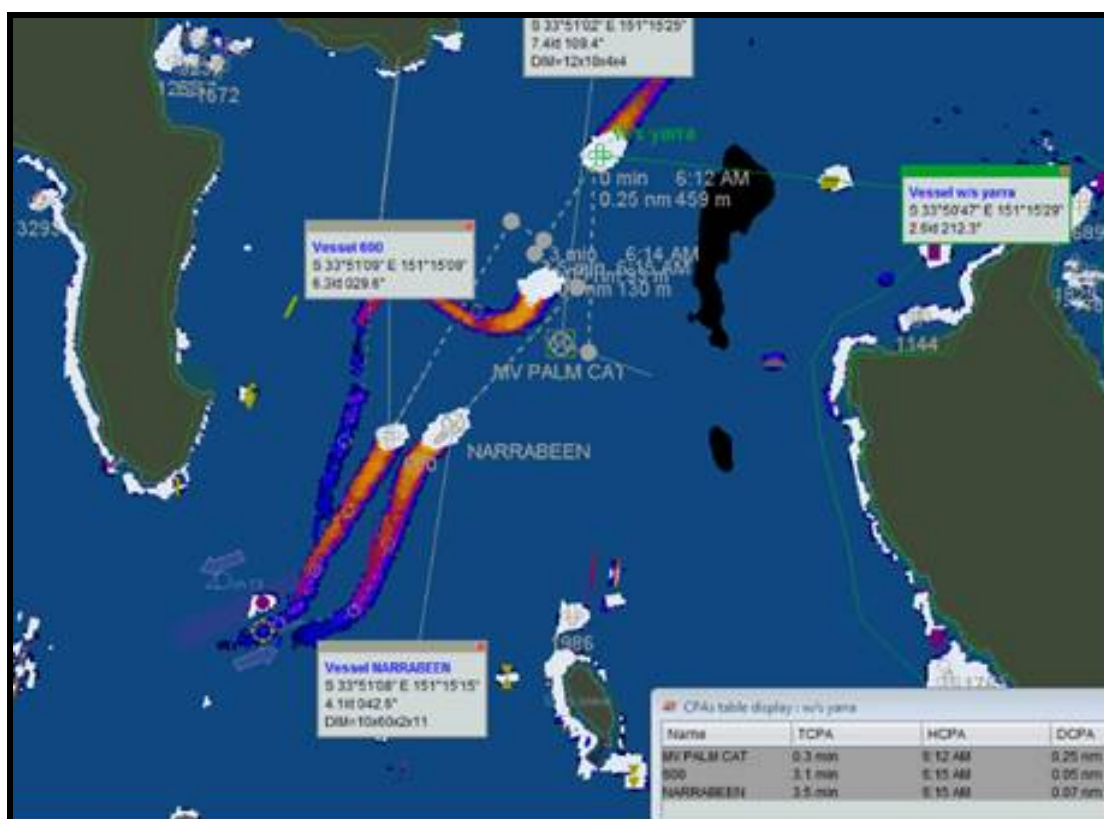
Radar Screenshot 5: *Palm Cat* turns towards *HMAS Yarra*

- 1.45 At 6:11:17am *Palm Cat* crossed the path of *HMAS Yarra* which was on a course of 215° at 2.2 knots. *Narrabeen* was on a course of 036° at 4.5 knots and *Francesca* was on a course of 029° at 6.1 knots.
- 1.46 At 6:11:35am *Palm Cat* altered course 85° to port towards *HMAS Yarra* which was keeping a steady course and speed. In this manoeuvre, *Palm Cat* had made a turn to port towards a vessel forward of her beam in restricted visibility. At this stage, *Narrabeen* was on a course of 043° at 4.3 knots and *Francesca* was on a course of 030° at 6.3 knots (see Screenshot 5). *Palm Cat* passed *HMAS Yarra* port to port then continued on to Manly.

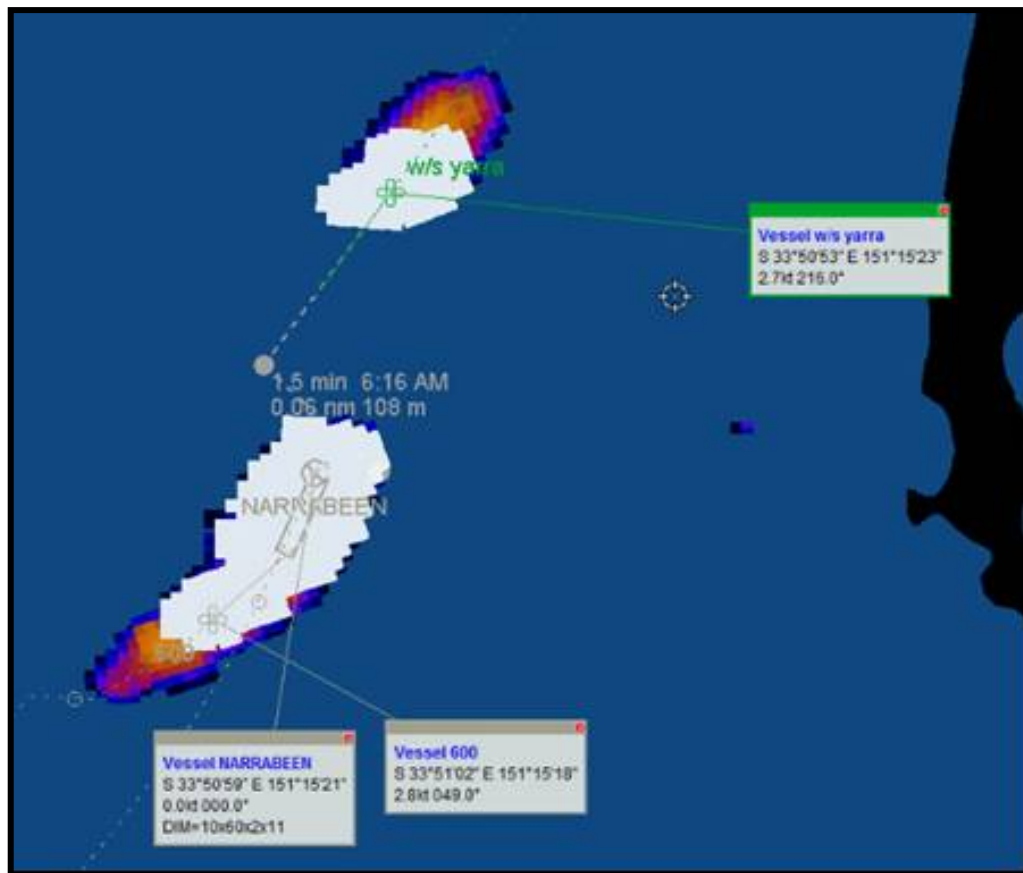
Radar Screenshot 6: *Narrabeen* stationary

- 1.50 At 6:14:50am *Narrabeen* was stationary, *Francesca* was astern of *Narrabeen* on a heading of 051° at 3.3 knots and *HMAS Yarra* was still closing *Narrabeen* and *Francesca* on a heading of 217° at 2.7 knots (see Screenshot 6).

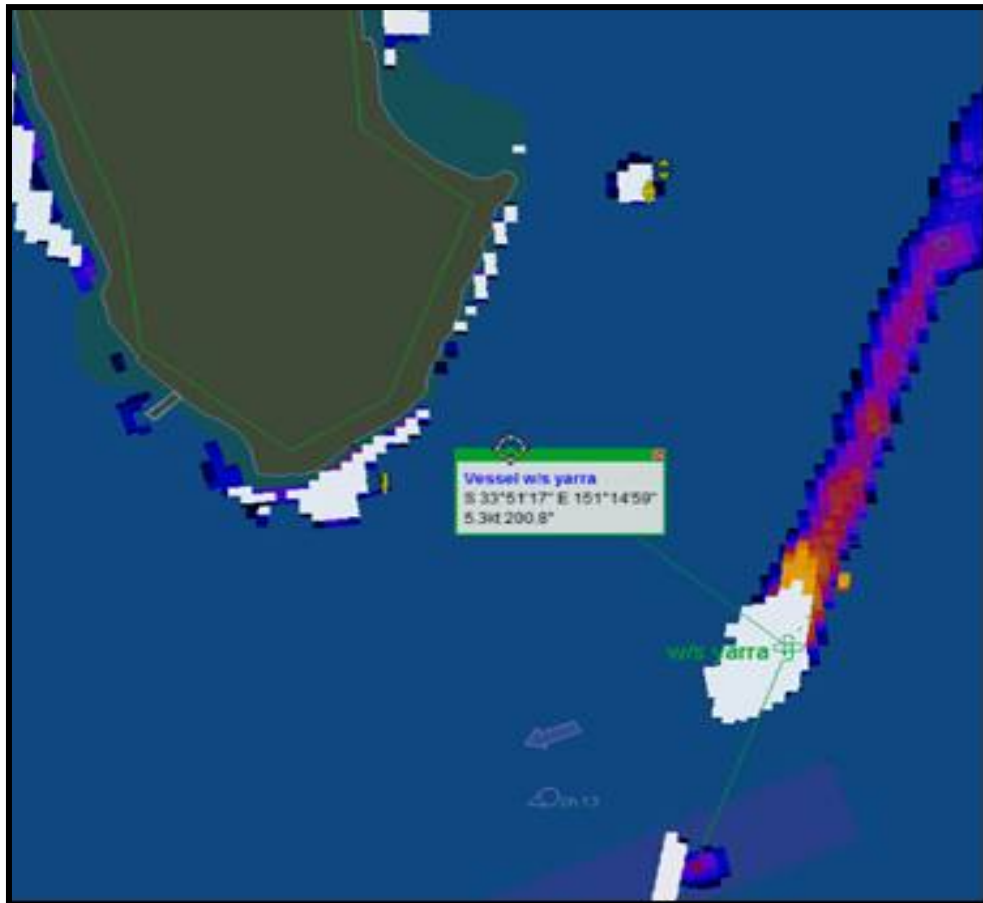
Radar Screenshot 7: VTS notifies *HMAS Yarra* of Safe Water Buoy

- 1.55 At 6:02am VTS had informed *Narrabeen* that they had “*activated the fog sirens here for Bradleys Head*” and asked *Narrabeen* to confirm that the sirens were working, if in a position to do so. No response was ever forthcoming. At interview, Masters from *Narrabeen*, *Palm Cat* and *Francesca* confirmed they did not hear a fog signal from Bradleys Head.
