Office of Transport Safety Investigations

SYSTEMIC INVESTIGATION INTO PUBLIC PASSENGER FERRY SERVICES OPERATED BY CAPTAIN COOK CRUISES WITHIN SYDNEY HARBOUR

FERRY SAFETY INVESTIGATION REPORT

14 SEPTEMBER 2009 TO 14 SEPTEMBER 2010

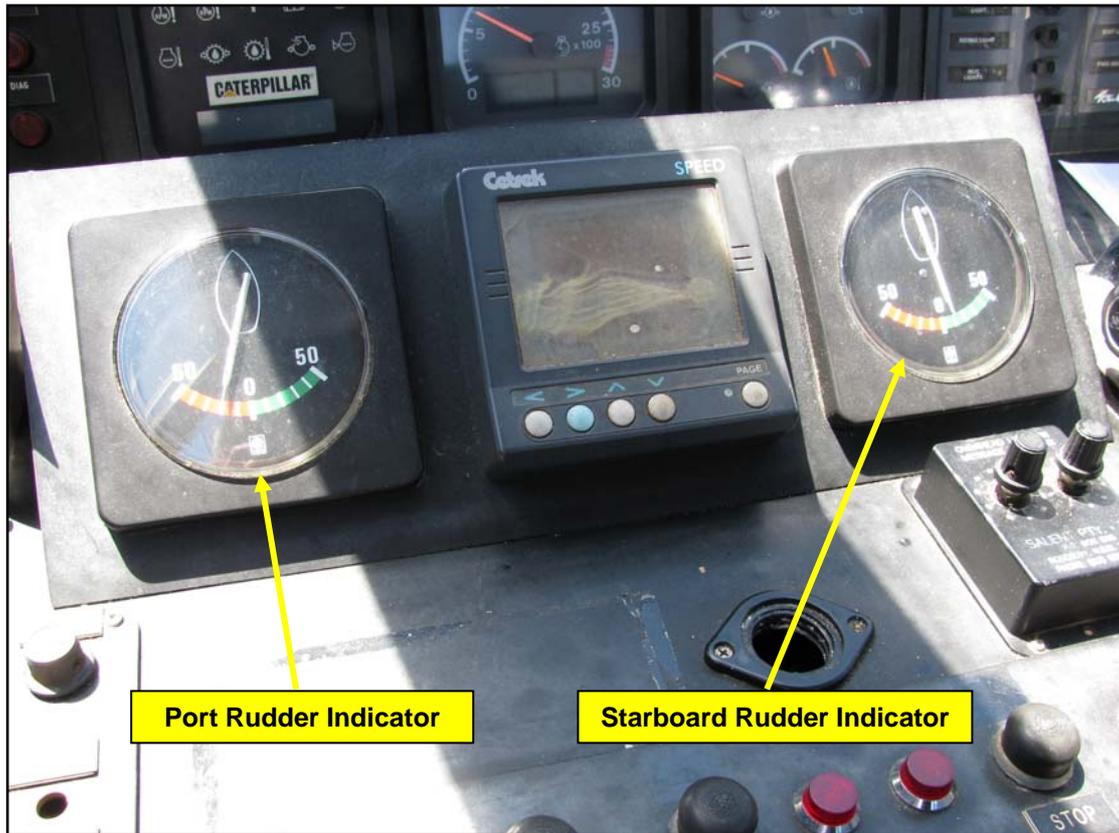
Photograph 1: *Jillian* Rudder Misalignment

- the rudders were 30 degrees out of alignment (see *Photograph 1*);
- the bilge alarm had been reported out of operation by all Masters since 15 November 2010 (resulting in the need for the GPH to visually check the engine room bilge every 30 minutes and engage the pump);
- the VHF radio needed to be replaced;
- washboards required for the Survey Class 1D could not be located; and
- a number of trip hazard and signage matters needed attention.

1.67 The inspection of the *Jillian* on 29 March 2011 noted action had been taken on all these matters with the exception of the trip hazards and signage matters. A number of issues had been brought to the attention of management in November and December 2010, particularly those concerning trip hazards and signage.

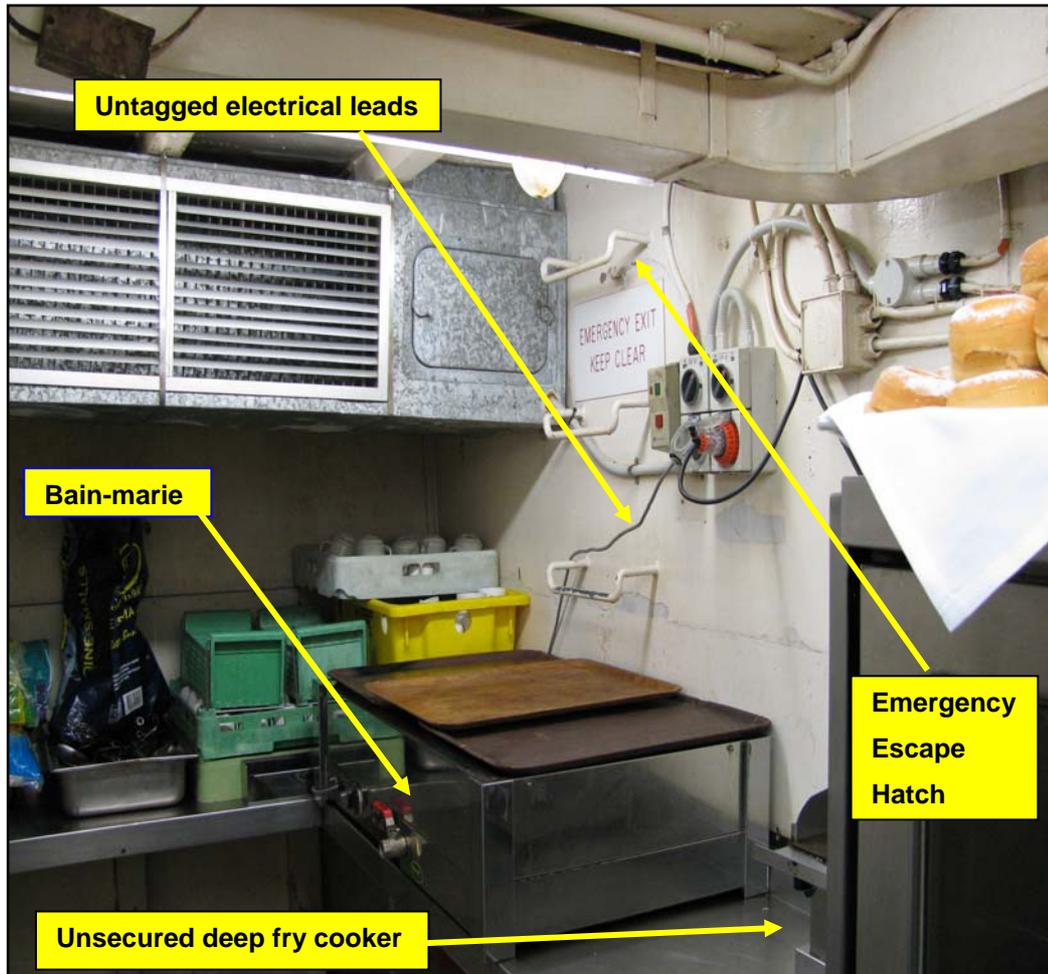
Photograph 2: Galley area of *Captain Cook II*

- 1.73 In the galley, the interior emergency escape hatch into the main saloon deck had no signage indicating its purpose or warning to keep the area clear of obstructions (see *Photograph 2*). Further, access to the hatch was obstructed by a bench on which there was a bain-marie. A deep fry electrical cooker was sitting unsecured on another bench.

- installation of emergency exit signs;
- unblocking of the emergency escape hatch from the galley where the position of a bain-marie made emergency escape impossible;
- securing of deep fryers;
- inspection and tagging of electrical appliance cords;
- signage identifying trip hazards on the aft stairway to the upper deck; and
- signage identifying the location of the emergency escape hatch in the engine room.
