## FERRY SAFETY INVESTIGATION REPORT

**COLLISION BETWEEN SYDNEY FERRIES'  
*BETTY CUTHBERT* AND TWO MOORED VESSELS**

**FERN BAY**

**11 JANUARY 2006**

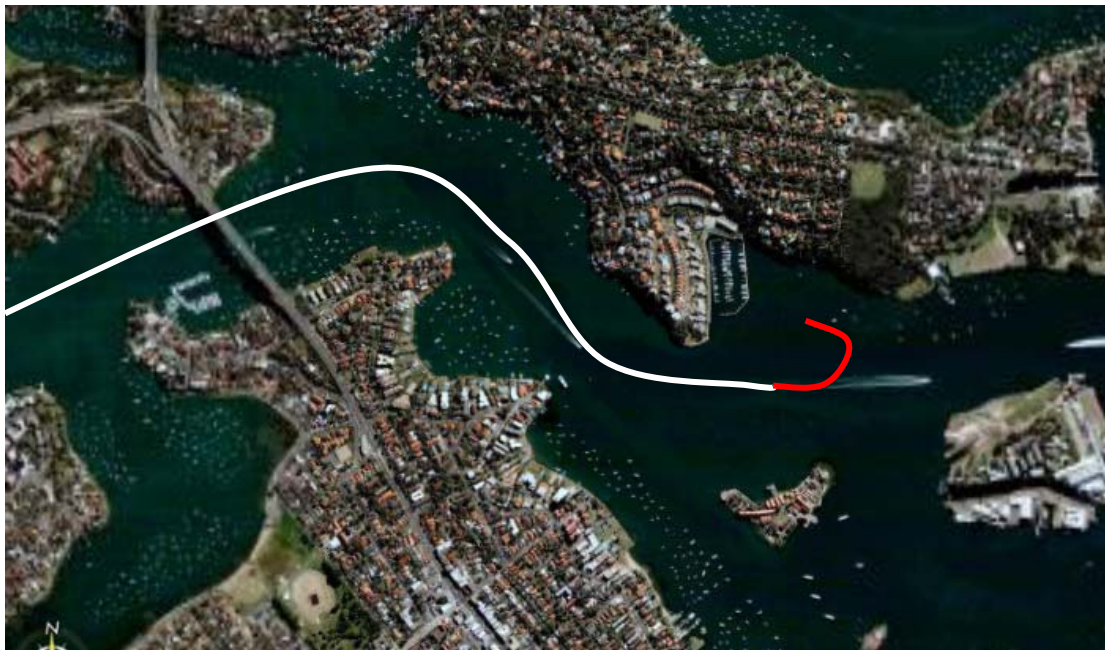
- 2.5 The Master advised that the ferry responded normally to steering and throttle control inputs as he proceeded at the normal operating speed, which varies between 14 and 23 knots, along the Parramatta River. After passing Pulpit Point to his left and approaching Spectacle Island on his right, the vessel made an uncommanded turn to Port. The Master attempted to correct the turn by steering in the opposite direction and reducing throttle settings, but the vessel did not respond to his steering inputs. He shut the engines down but in the process *Betty Cuthbert* collided with a moored yacht and subsequently a moored motor vessel named *BYO*. *Photograph 1* depicts the approximate 'track' of *Betty Cuthbert*, as indicated by the Master.

**Photograph 1: Aerial Photograph showing *Betty Cuthbert*'s 'track', with the 'uncommanded' turn into Fern Bay indicated in Red**

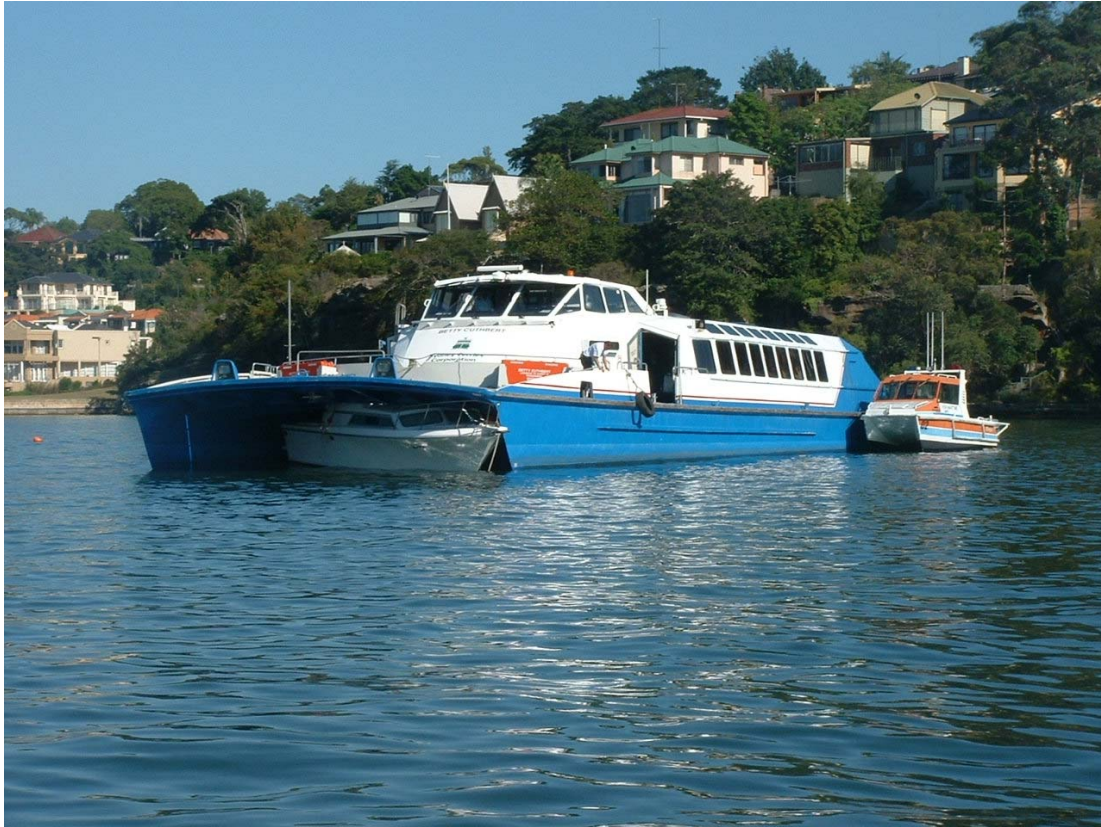
- 2.6 As a result of the collision, the motor vessel *BYO* became wedged between the forward sections of both hulls of *Betty Cuthbert*, as depicted in *Photograph 2*.

Photograph 2: *Betty Cuthbert* with launch *BYO* at the collision site

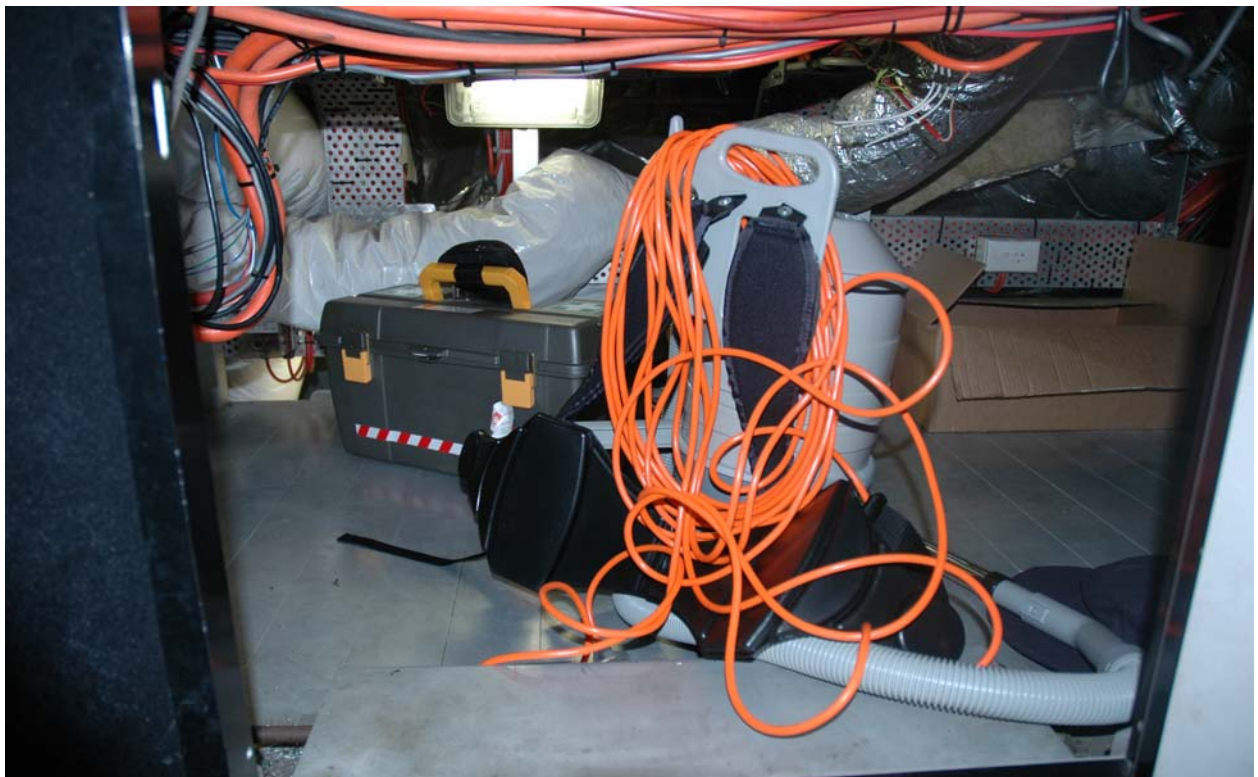
3.1 OTSI sought to establish whether there was any connection between the Master's earlier report of a less than responsive Starboard propulsion unit and the subsequent uncommanded turn to Port. The excessive stiffness of the steering reported by the Master would have to have been the consequence of excessive friction or interference at the mechanical linkages or the controllers on the bridge, as there are no mechanical connections between the bridge and the engines or the propulsion units. OTSI's examination of the related areas identified a number of potential sources of interference. The area below the bridge console was readily accessed via a locker door and as illustrated in *Photo 5*, this area was used for storage. *Photo 6* shows points at which mechanical movement might have been obstructed or limited by stored items.

**Photograph 5: Equipment stored under bridge console**

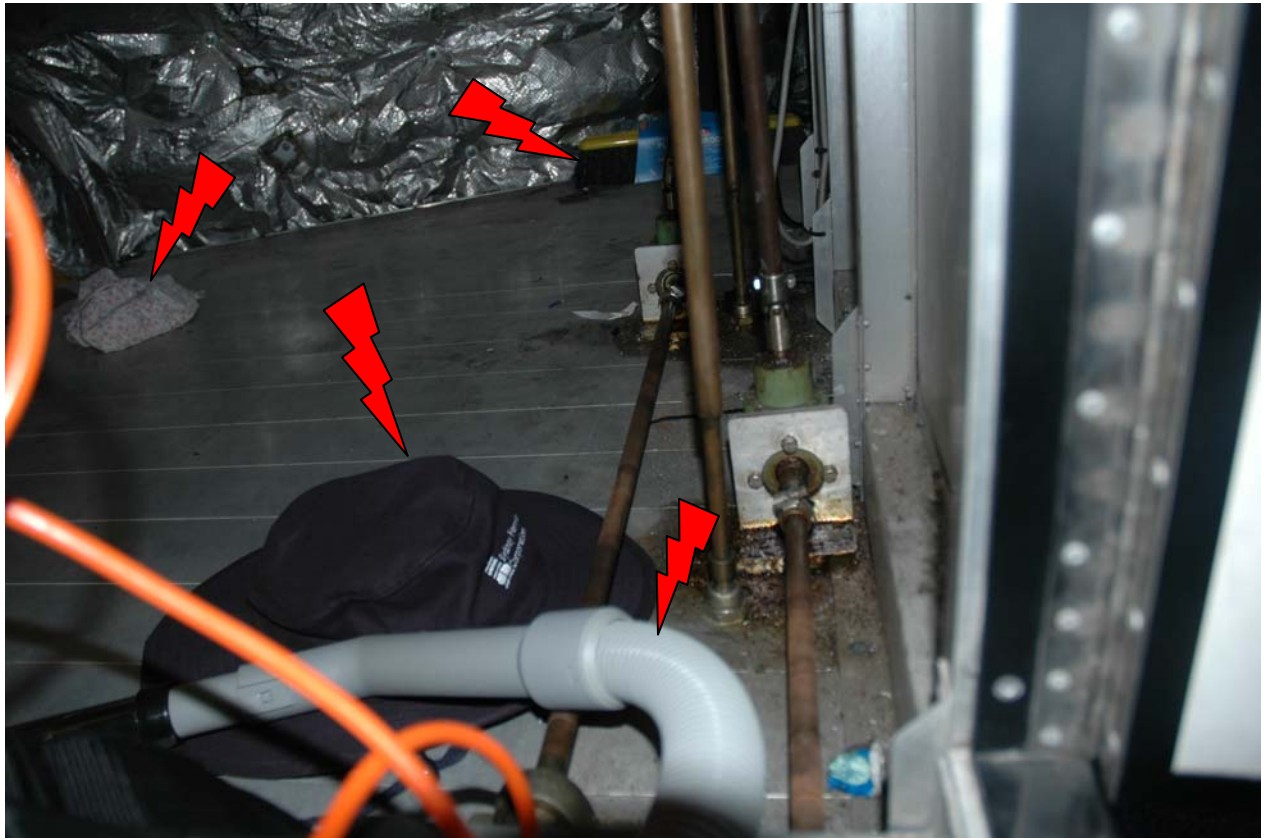
**Photograph 6: Potential sources of interference**

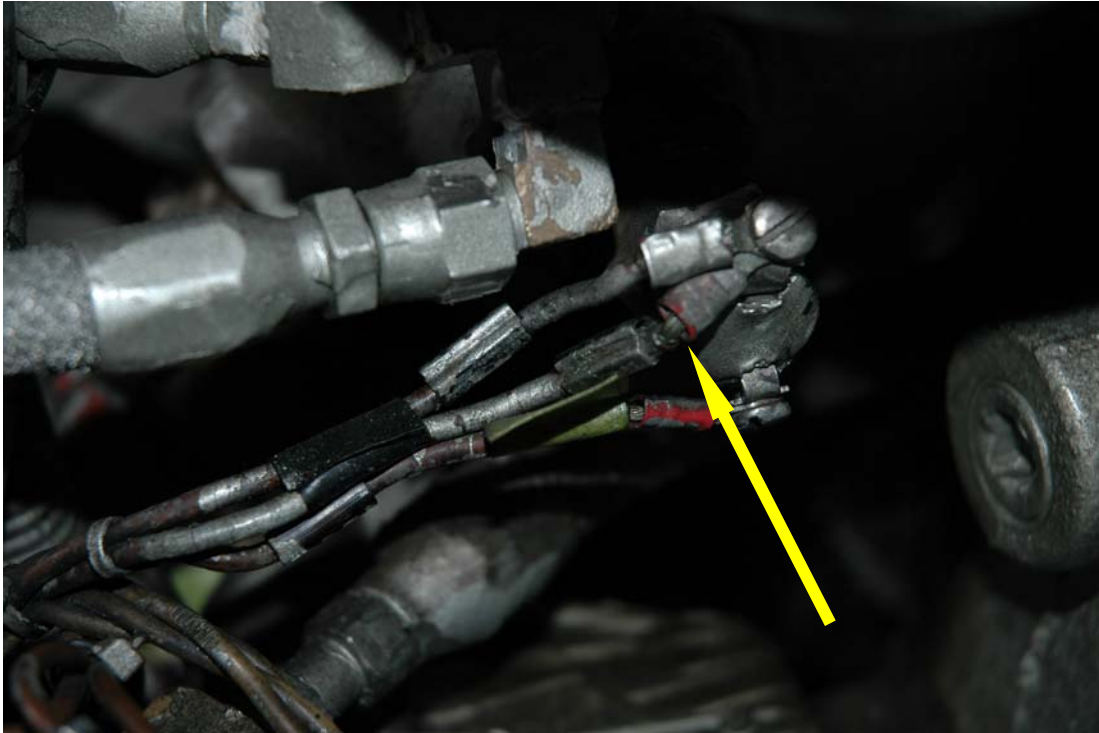
3.5 Whilst pursuing the possibility that the Port engine had shut down, some wiring on the engine's protection system, which automatically shuts down the engine in the event of a loss of oil pressure or overheating, was found to be in poor condition. Specifically, wiring on some crimped terminals and spade connectors to the oil pressure switch was loose and in some instances, poorly insulated, as indicated in *Photograph 7*. The condition of the wiring on the Port engine could be partly attributed to its age and the combined effects of heat, vibration and oil contamination. However, OTSI also noted that the type of connector, routing of wiring and the method of crimping and connection could also have contributed to malfunctions. Further investigation revealed that the engine protection circuit had also been bypassed at some time. On the other hand, OTSI noted that the Starboard engine had recently been replaced and the associated wiring was more adequately secured.

**Photograph 7: Poorly crimped terminals on the Port engine**

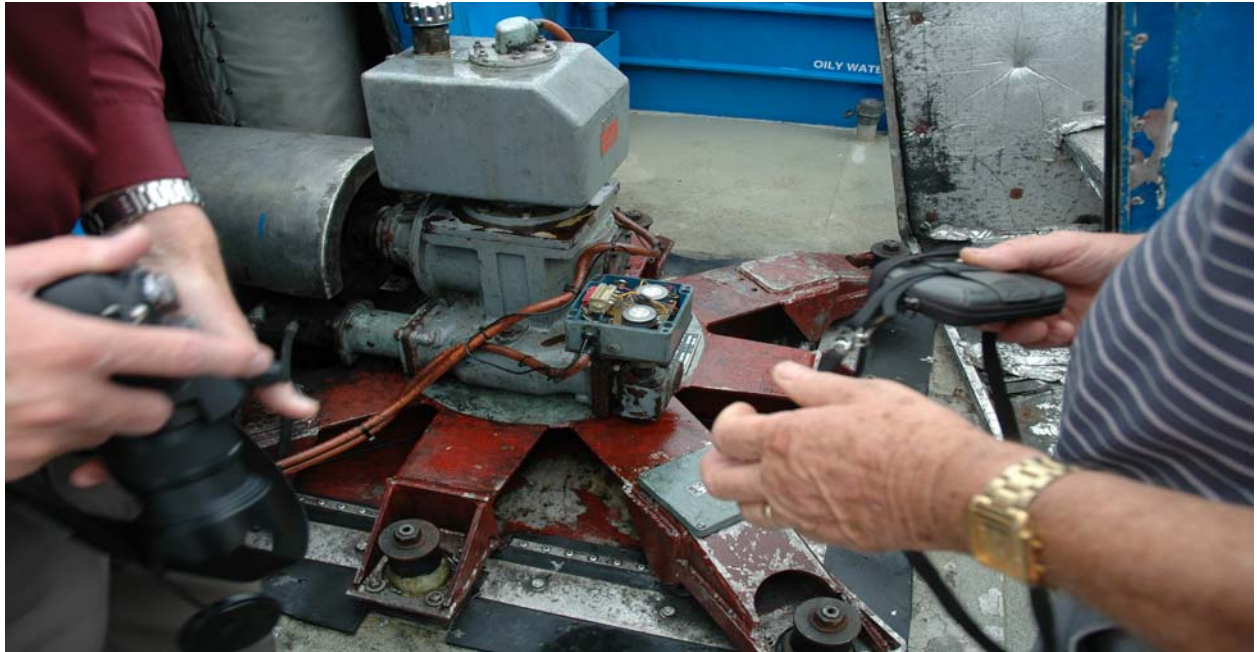
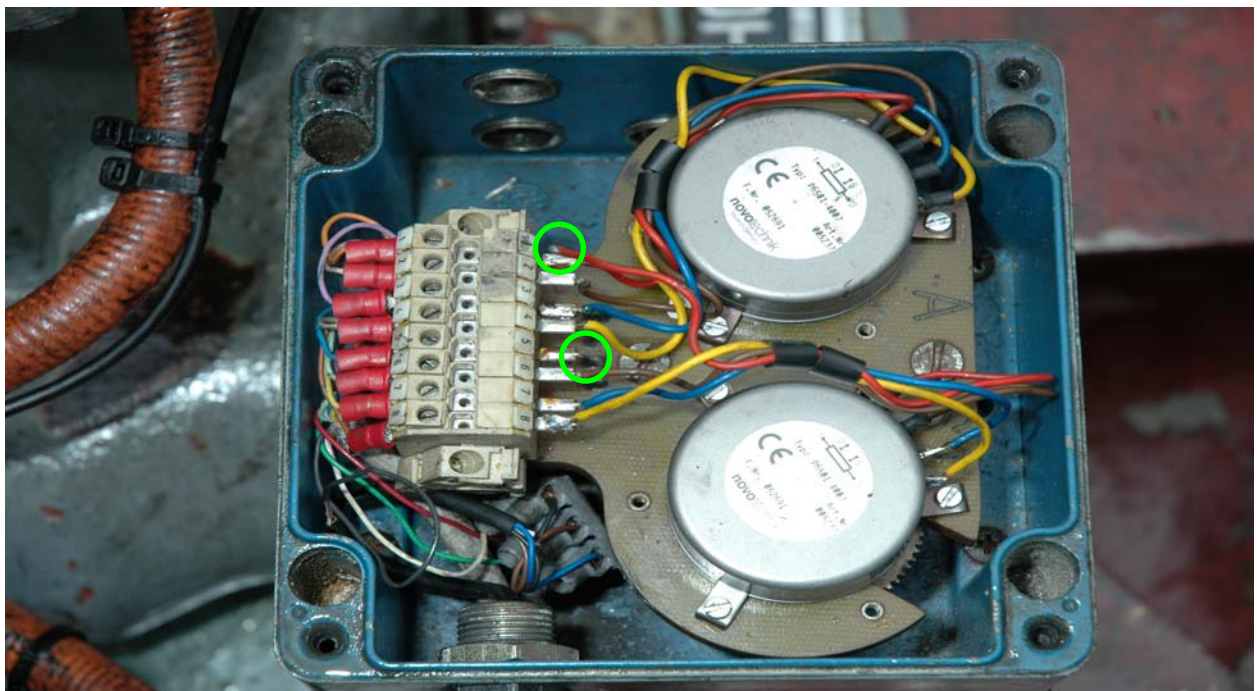
- 3.6 On examining the Starboard engine, it was found that the 'rose' joint securing the Morse™ cable at the engine end of the Speedtronic™ engine speed controller was loose. During trials, it was established that this condition caused the Starboard engine to idle at approximately 850rpm compared to 650rpm at the Port engine. However, the trials also established that this was insufficient to have induced the uncommanded turn.
- 3.7 During preparation for the trials, an alarm on the Starboard propulsion unit was found to be activated. An electrician subsequently located a broken wire inside the feedback potentiometer box (see *Photographs 8 -10*).

Photograph 8: Starboard potentiometer box with lid removed

Photograph 9: Close view of wiring inside the potentiometer box

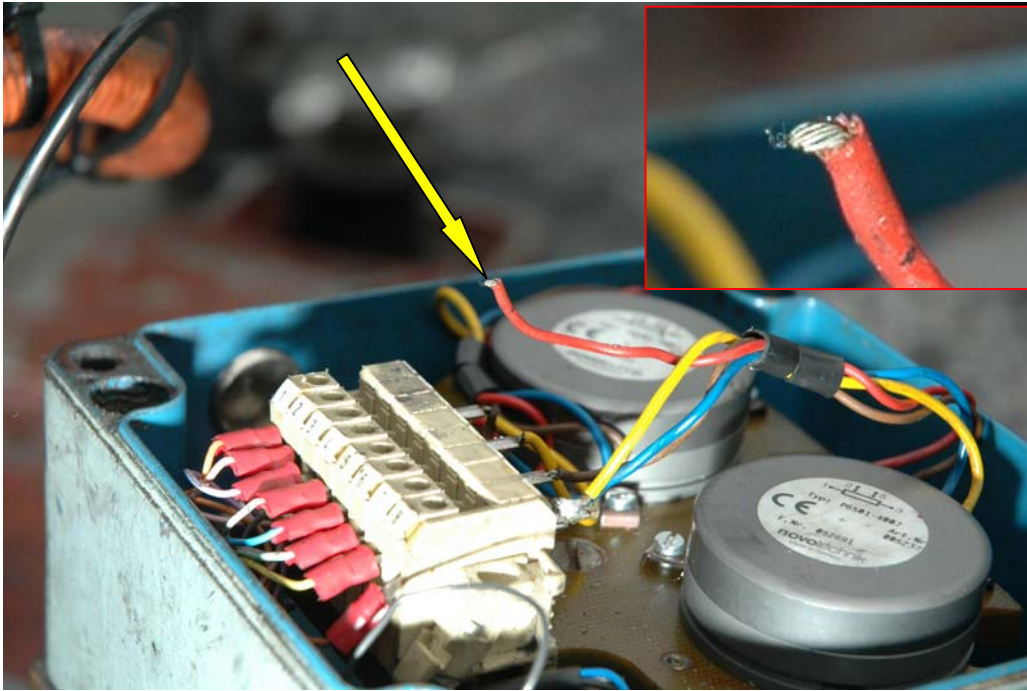
**Photograph 10: Red wire broken away from solder tab on connector block inside potentiometer box**

- 3.9 When the wire was re-soldered, the alarm was de-activated and the controls responded normally. During trials, the same wire was deliberately disconnected several times and on each occasion the Starboard propulsion unit rotated approximately 15° in an anti-clockwise direction, initiating a turn to Starboard. Once rotated, the propulsion unit essentially remained locked in that position. However, throttle control could still be achieved. With the Starboard propulsion locked in such a position, the effect was to induce a turn to Starboard. This allowed OTSI to discount the possibility that the disconnected wire induced the uncommanded turn to Port. However, it did explain the unresponsive steering that the Master experienced whilst berthing at Homebush.
