FERRY SAFETY INVESTIGATION REPORT

COLLISION OF RIVERCAT *BETTY CUTHBERT* NUMBER 5 EAST WHARF, CIRCULAR QUAY 23 SEPTEMBER 2005

OTSI File Ref: 04205

23 February 2006

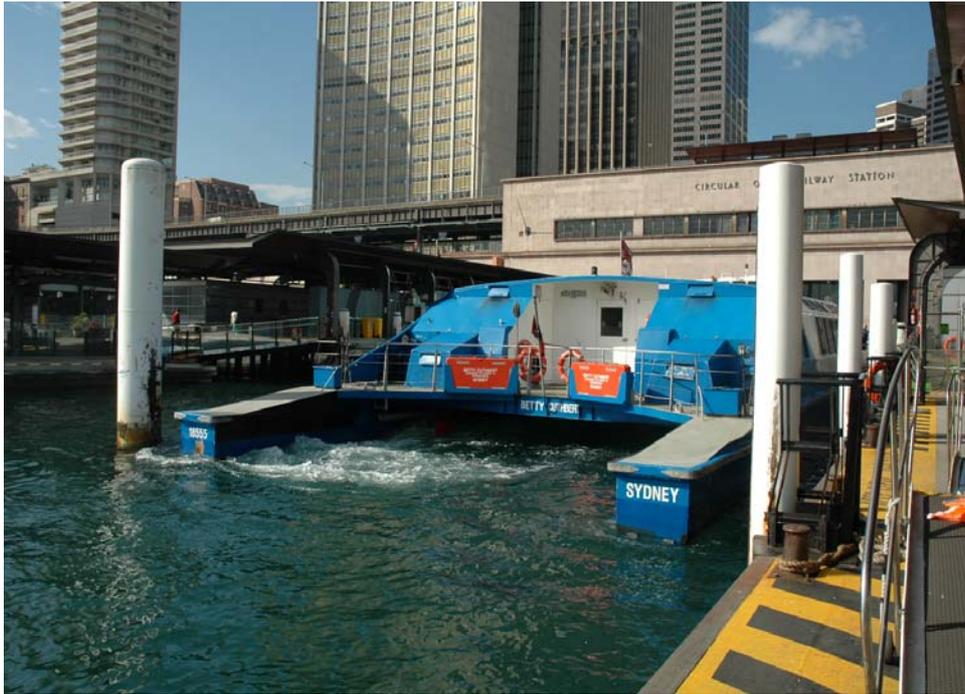
Figure 2. Betty Cuthbert alongside No 5E Circular Quay and the pile it struck at left.

2.7 The incident occurred at No. 5 East Wharf. *Betty Cuthbert* stopped short of the backboard when its momentum was arrested by the pile.

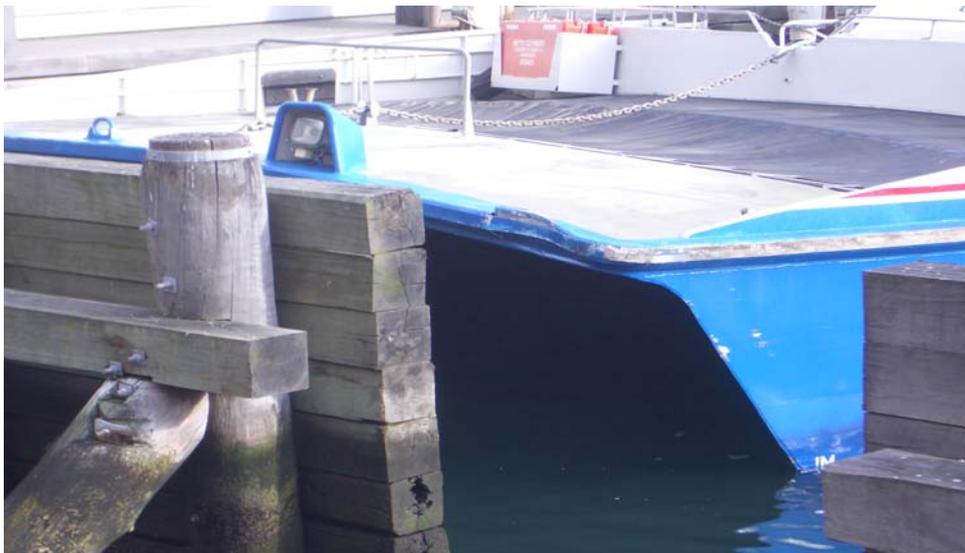
- 2.5 Betty Cuthbert sustained only minor damage to the leading edge of its port bow, above the waterline, as shown in Figure 3, and the pile it struck was undamaged.

Figure 3. Damaged bow area.

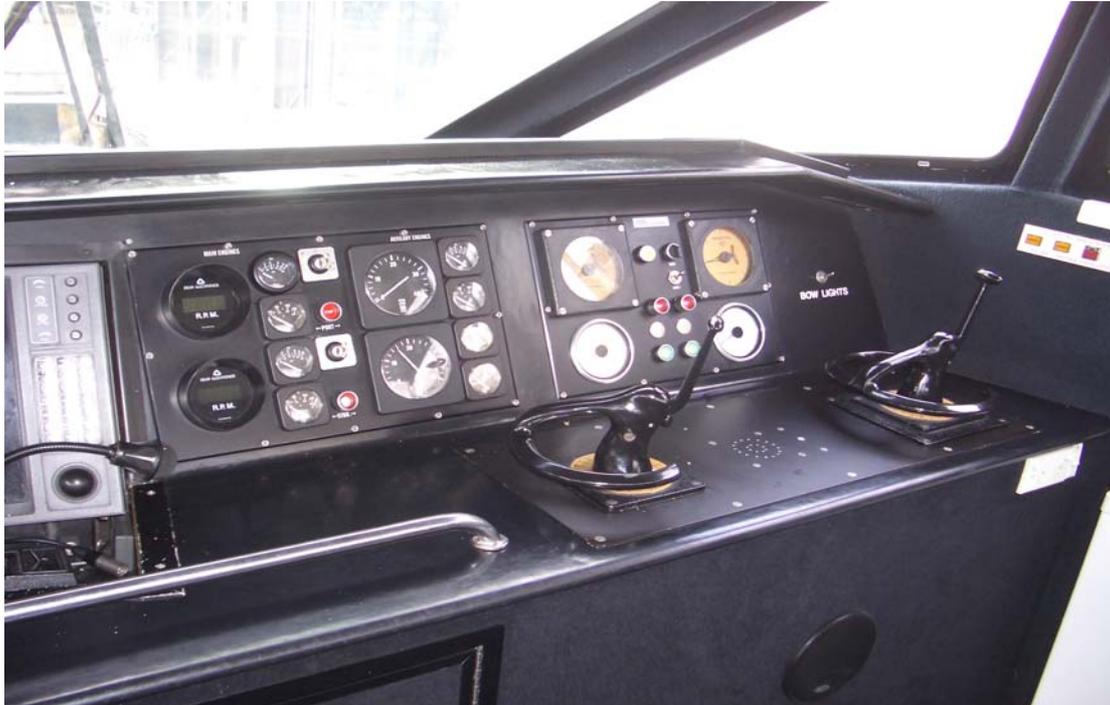
Figure 5. Starboard control station and instrumentation.

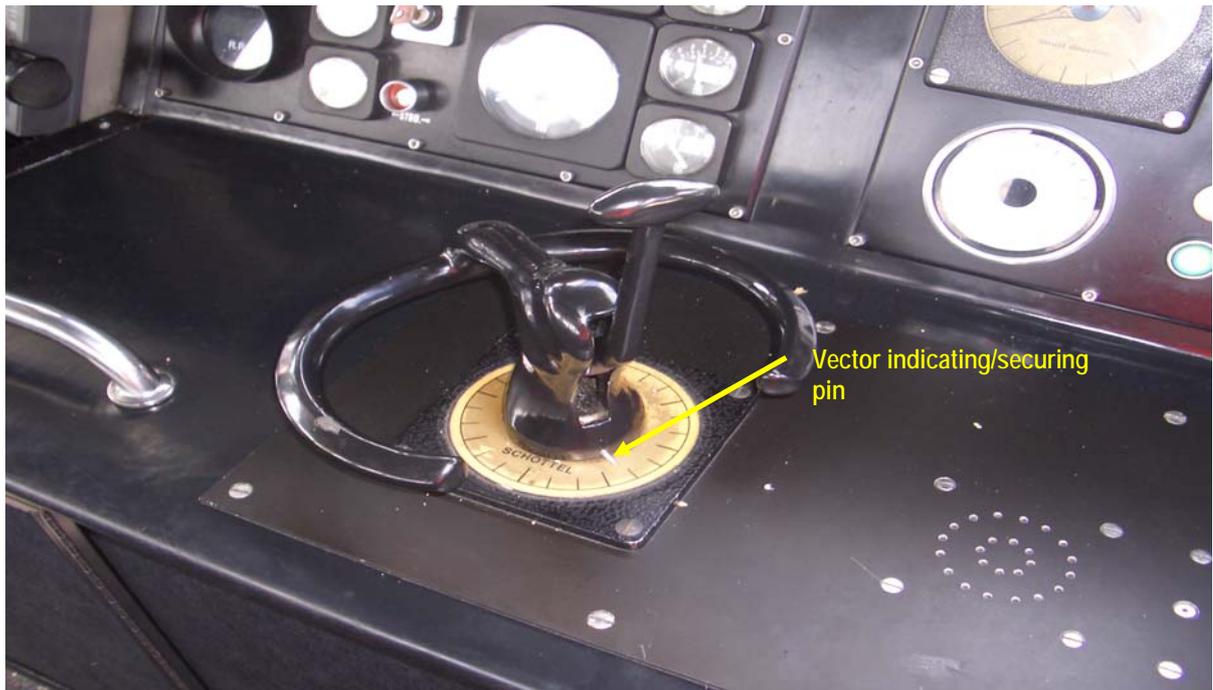
- 3.6 There was little difficulty after the collision in establishing what went wrong at the starboard control station console. A securing pin, which also serves as a vector indicator and which was intended to lock the port-side control steering handle on its threaded spindle, became dislodged, disconnecting the control handle from the spindle and thereby rendered the port propulsion control system inoperable. When the pin was replaced, the control handle and propulsion control system functioned normally. *Figure 6* depicts the way the control handle was secured by the vector indicating/securing pin before the incident.

Figure 6. Port *Schottel* control handle, before modification

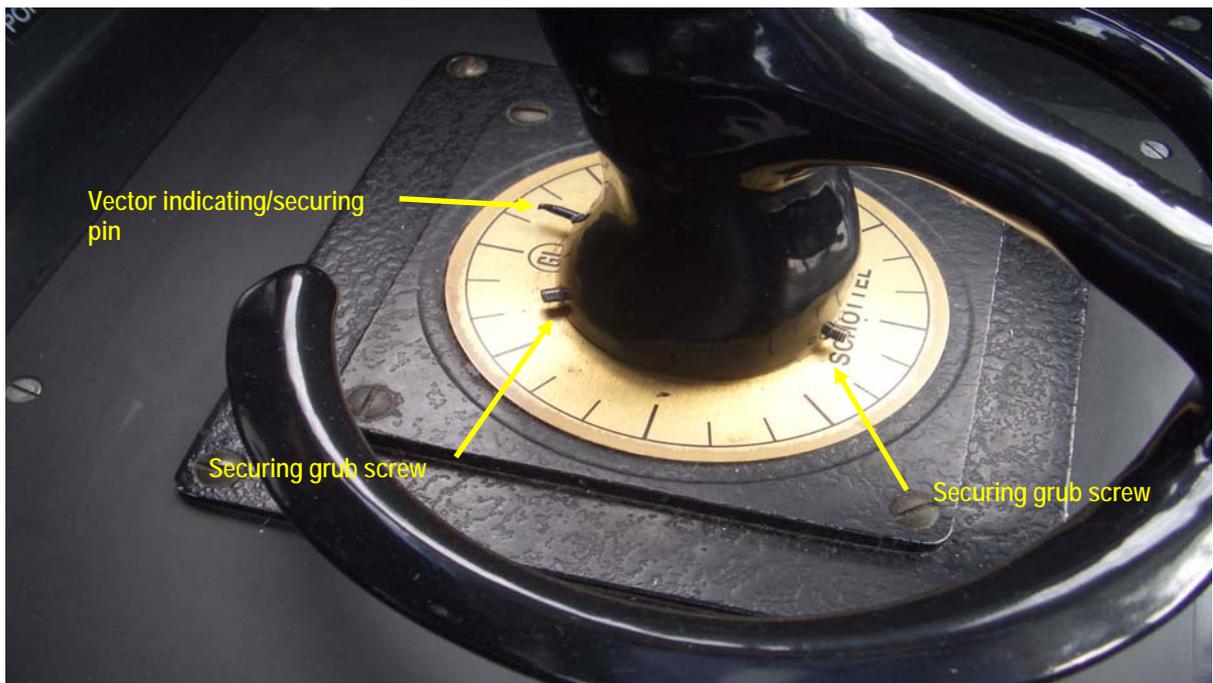
Figure 7. Port *Schottel* control handle, after modification.

3.7 Sydney Ferries subsequently effected an interim modification to reinforce the security of the handle, by adding two 'grub' screws, as shown in *Figure 7*.
