# Ferry Safety Investigation Report

**'Betty Cuthbert' – Collision with wharf**

**The Australian Transport Safety Bureau's report of the  
investigation**

**at Cockatoo Island on 19 February 2004**

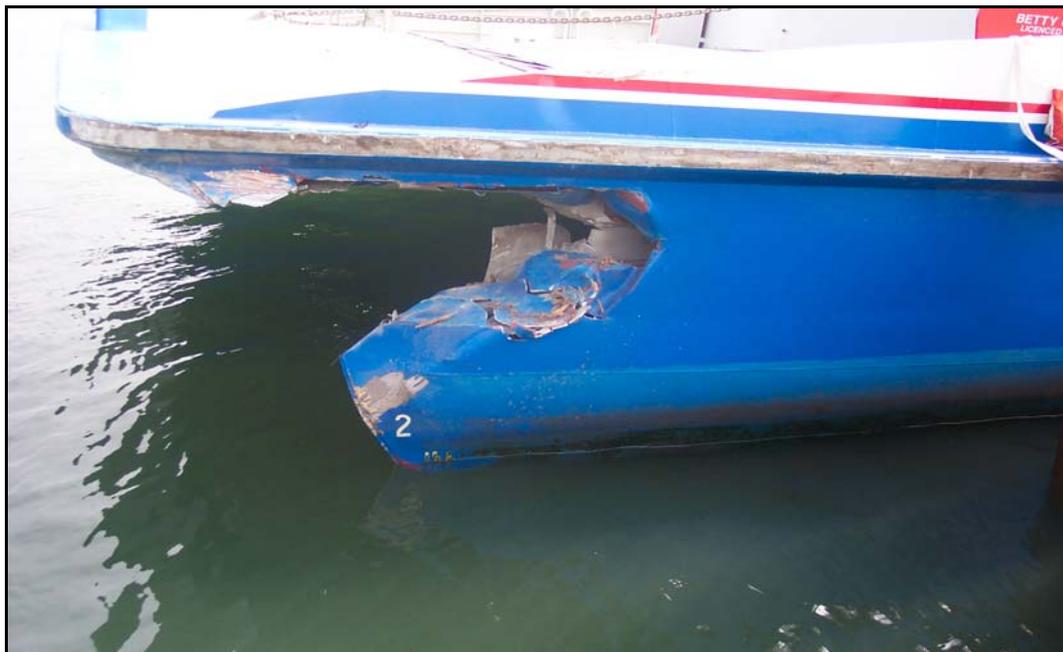
The bow of the *Betty Cuthbert's* port hull, above the waterline, was severely damaged by the impact and the wharf had also sustained some damage to its timber facing and concrete deck.

*Betty Cuthbert* received damage to the shell plate and frames on the port hull, estimated at \$37 000. Damage to Parramatta Wharf on Cockatoo Island was estimated at \$11 000.

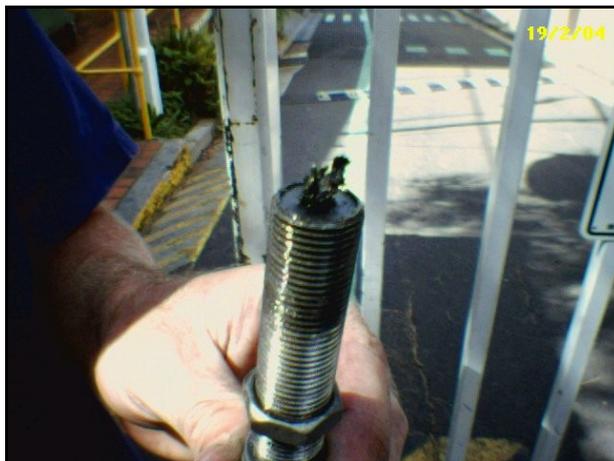
The investigation revealed that the starboard main engine's fuel rack was still in the full fuel (full speed) position and the starboard Schottel unit was in the ahead position. The main engine emergency stop had not been actuated and the normal engine stop was tested and found to operating correctly. No abnormalities were found in the 24 V supply system. These observations suggested that there was failure in way of the engine's speed control system (Speedronic) and/or the Schottel vectoring electronics. Further inspection revealed that the flywheel transducer for the main engine speed sensor had accumulated some ferrous debris which had caused the speed sensor to operate incorrectly.

***Starboard main engine flywheel speed transducer showing debris on end***

Ferrous debris had built up on the flywheel transducer for the speed sensor on the starboard main engine over a period of time. At about 0920 on the day of the accident, the flywheel transducer malfunctioned and caused a contact in the speed sensor's circuit to open and 'switch off' the Schottel Speedronic and Co-Pilot control systems. As fitted, the Schottel control systems do not fail in a safe mode, because when power is lost to the control systems (or they are 'switched off'), the engine speed settings and the Schottel unit position remain as they were before the failure. This meant that *Betty Cuthbert's* starboard engine remained at maximum speed with the Schottel unit vectored for maximum ahead thrust.

**Maintenance** The maintenance of *Betty Cuthbert's* propulsion control system in respect of the flywheel speed transducer is also implicated in the accident. The accumulation of debris which led to its failure probably occurred over a period of time. Although it was tested during normal daily start-up procedures, inspection and testing of the transducer was not included in any periodic maintenance routine at the time of the accident, and had it been inspected/cleaned it is likely that the failure might have been prevented.

Proximity type speed transducers will fail at some time during their service life. Many engine manufacturers, who use electronic engine governing, fit two flywheel pick-ups to provide redundancy with an automatic default to the other transducer in the event of a failure. It is a sensible precaution to include inspection/testing of these components in a periodic maintenance regime where their function is critical.
