FERRY SAFETY INVESTIGATION REPORT

COLLISION OF THE MANLY FERRY *COLLARROY* NUMBER 3 WEST WHARF, CIRCULAR QUAY 4 MARCH 2005

OTSI File Ref: 03545

25 November 2005

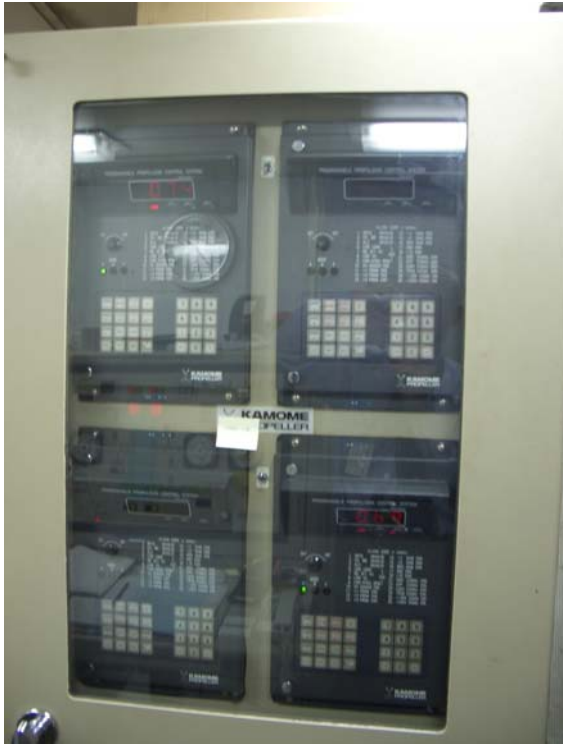
Figure 9: ProCon Cabinet

- 3.14 Eventually, a simulation which fed false inputs into the ProCon system, did replicate the 4 March failure and revealed that ProCon unit 1B had failed. The logic cards, in effect circuit boards, in the ProCon were subsequently replaced with new cards. *Collaroy* was then subjected to a series of sea trials which were completed without fault. Further analysis established that at the time of the malfunction, ProCon units 1B and 2A were being employed by the master, instead of the normally used 1A and 2A units. More significantly, it was also established that ProCon units 1A and 2B were not switched on. This meant that when unit 1B failed, there was no prospect of the master receiving an audible warning alarm, or of a back-up ProCon unit being automatically brought on-line.

3.15 Sydney Ferries advised OTSI that they had been experiencing thermally-induced faults in the ProCon's electronic logic-card circuitry over a period of several months and that Sydney Ferries' technical support staff were aware of the situation. The problem, believed to be caused by the ProCon units being subjected to repeated cycles of heating and cooling after being switched on and off on a daily basis, was usually only apparent during morning start-ups whilst the propulsion control system warmed-up. Loud warning alarms would sound in the vessel's MCR each time a unit malfunctioned. The problem would typically self-correct before vessels left the Balmain Yard. A senior engineer, on his own initiative, issued a Memo to guide fellow engineers in a modified start-up procedure which, amongst other things, was intended to compensate for the problems that were being experienced within the ProCon units during start-up. Part of the instructions read:
