## FERRY SAFETY INVESTIGATION REPORT

# COLLISION OF THE MANLY FERRY *COLLARROY* NUMBER 3 WEST WHARF, CIRCULAR QUAY 4 MARCH 2005

**OTSI File Ref: 03545**

**25 November 2005**

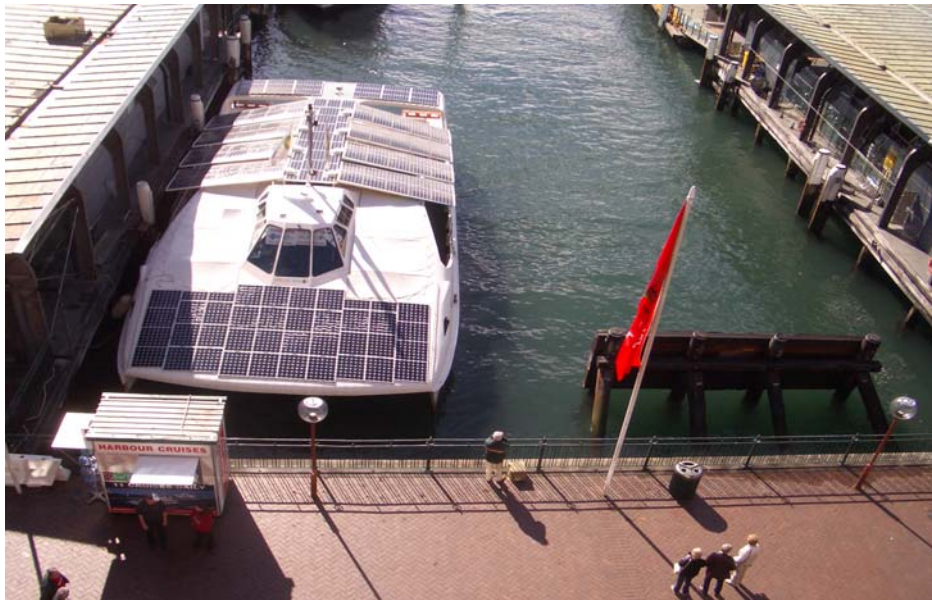
**Figure 11: Absence of Backboards at No. 6 East Wharf**

- 5.3 Whilst the backboard at No. 3 West Wharf arrested the momentum of the *Collaroy*, no such facility exists at the southern end of No. 6 Wharf where large passenger-carrying vessels berth in proximity to a busy pedestrian thoroughfare. This situation is depicted in the photograph at Figure 11.

- i. Review any risk assessment/s undertaken by Sydney Ferries in respect of the *Collaroy*.
- ii. Take action to upgrade safety backboard/buffer arrangements at No.6 Wharf, Circular Quay and at the Southern end of Manly Wharf.
- iii. Take action to ensure the provision of a reliable, high-resolution CCTV video system capable of recording all vessels moving into and out of Sydney Cove from at least two cross-referenced points.
