FERRY SAFETY INVESTIGATION REPORT

COLLISION OF THE MANLY FERRY *COLLARROY* NUMBER 3 WEST WHARF, CIRCULAR QUAY 4 MARCH 2005

OTSI File Ref: 03545

25 November 2005

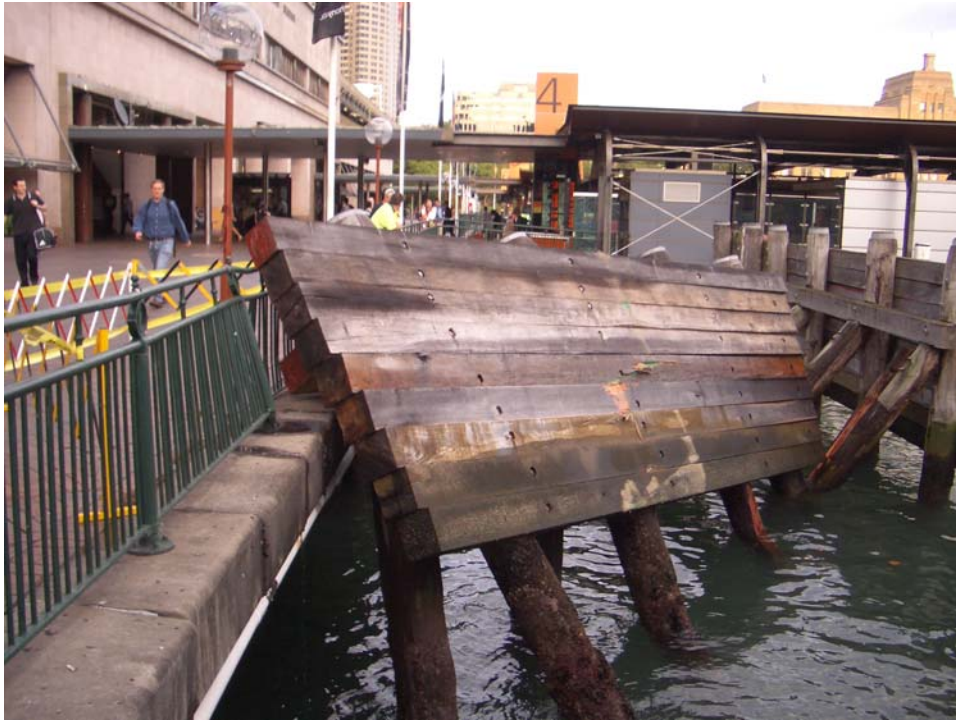
Figure 2: Damage to the Backboard at No. 3 West Wharf

- 2.3 The master reported that he was less than a vessel length (69.5 metres) from his intended berth when he noticed that *Collaroy's* speed was increasing, rather than decreasing, in response to his ordered control setting. He attempted to regain propulsion control by repeating the required setting several times, but the ferry did not respond and subsequently collided with the timber backboards or 'buffers' at the end of the berth. The backboards absorbed the force of the collision before collapsing against the promenade breastwork. Figure 2 shows the impact damage.
- 2.4 According to the master, the primary propulsion control system then spontaneously self-corrected, at which time he regained control and secured the ferry at its berth.

2.7 The *Collaroy* sustained minor scrapings to the above and underwater painted surfaces around its bow area and a zinc anode was torn off. Underwater divers confirmed that there was no visible distortion to the bow propeller or rudderstock. A section of the timber buffer was extensively damaged. Sydney Ferries' operations were affected by the *Collaroy's* withdrawal from service and the closure of No.3 West Wharf for one and three weeks respectively.
