FERRY SAFETY INVESTIGATION REPORT

COLLISION OF THE MANLY FERRY *COLLARROY* NUMBER 3 WEST WHARF, CIRCULAR QUAY 4 MARCH 2005

OTSI File Ref: 03545

25 November 2005

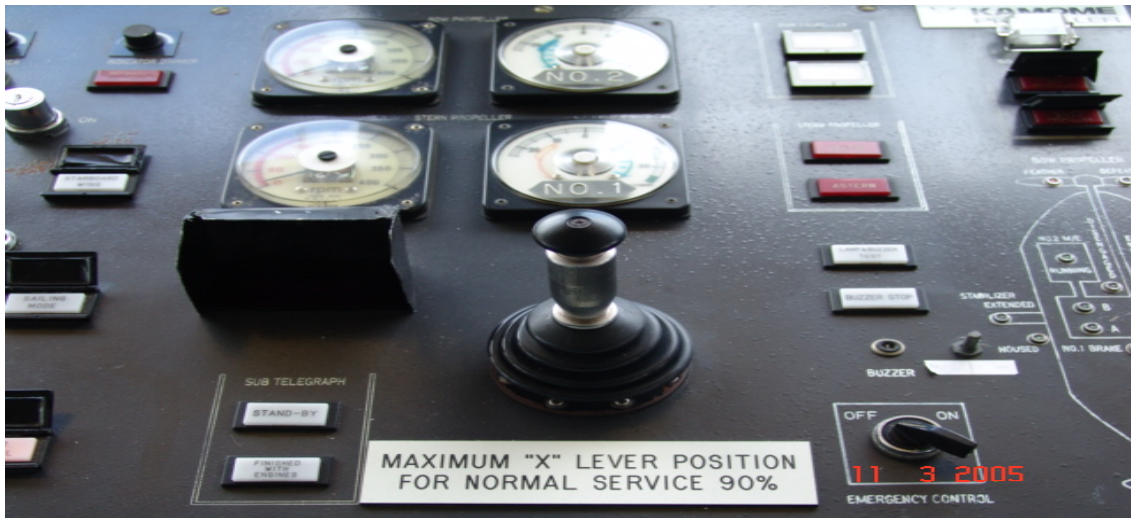
Figure 7: Showing the X-Y lever and Emergency Control Switch

- 3.4 The master advised that, on realising that he was gaining speed rather than slowing, he manipulated the X-Y control lever several times to regain control and obtain full astern propulsion. Approximately one minute elapsed between the onset of the failure he described and the subsequent collision, during which time he did not attempt to communicate with, or effect control through, the engineer located in the MCR. Nor did he attempt to utilise the alternative Emergency Control back-up propulsion system fitted to the vessel, activate a pre-recorded audio warning message or deploy an anchor, on the basis that there was insufficient time to do so. However, he did initiate a prolonged warning blast on the ferry's whistle to alert his crew and personnel ashore.

- 3.17 Confronted by a loss of control, the master responded by repeating his command instructions several times via the X-Y lever. This response action would have been conditioned by previous instances where loss of control had been known to self-correct, and by the fact that he had not been alerted to an alarm which was designed to inform him of a malfunctioning ProCon unit. However, OTSI notes that instrumentation on the control panel would have provided such an indication. The master would also have expected a standby ProCon unit to be automatically available to him. When this didn't happen, the master concluded that there was little he could do, other than to initiate a prolonged warning blast on the ferry's whistle to alert his crew and personnel ashore. The master advised that he did not consider it feasible to deploy an anchor or to use the separate Emergency Control system available to him on the *Collaroy*, believing that there was insufficient time for such manoeuvres to have the desired effect. OTSI notes that the process of deploying an anchor requires both time and space that were not available to the master in this instance.

- 3.18 While the emergency mode comes on-line immediately a master switches the Emergency Control Switch to 'on', the initial effect of such an action is to bring the on-line propulsion engine up to 600 rpm very quickly. However, propeller pitch settings remain as they were immediately prior to the selection of Emergency Control. This option would have had to have been exercised by the master almost immediately after the onset of the failure to have had the desired effect
