FERRY SAFETY INVESTIGATION REPORT

COLLISION OF THE MANLY FERRY *COLLARROY* NUMBER 3 WEST WHARF, CIRCULAR QUAY 4 MARCH 2005

OTSI File Ref: 03545

25 November 2005

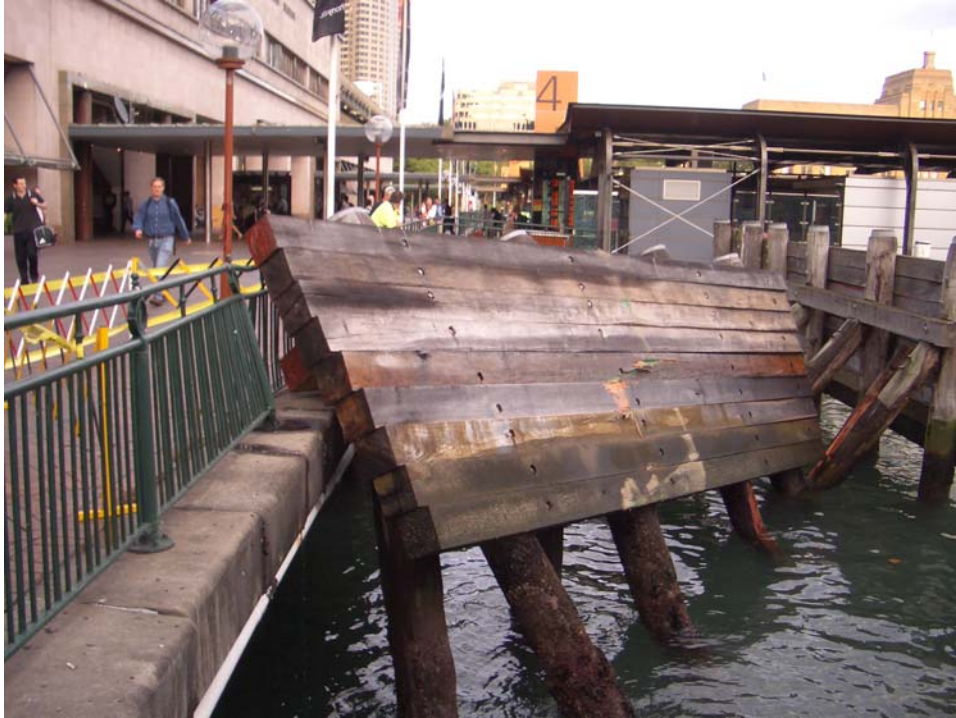
Figure 2: Damage to the Backboard at No. 3 West Wharf

2.7 The *Collaroy* sustained minor scrapings to the above and underwater painted surfaces around its bow area and a zinc anode was torn off. Underwater divers confirmed that there was no visible distortion to the bow propeller or rudderstock. A section of the timber buffer was extensively damaged. Sydney Ferries' operations were affected by the *Collaroy's* withdrawal from service and the closure of No.3 West Wharf for one and three weeks respectively.
