FERRY SAFETY INVESTIGATION REPORT

COLLISION OF THE MANLY FERRY COLLAROY NUMBER 2 WHARF, CIRCULAR QUAY

19 SEPTEMBER 2005

OTSI File Ref: 04202

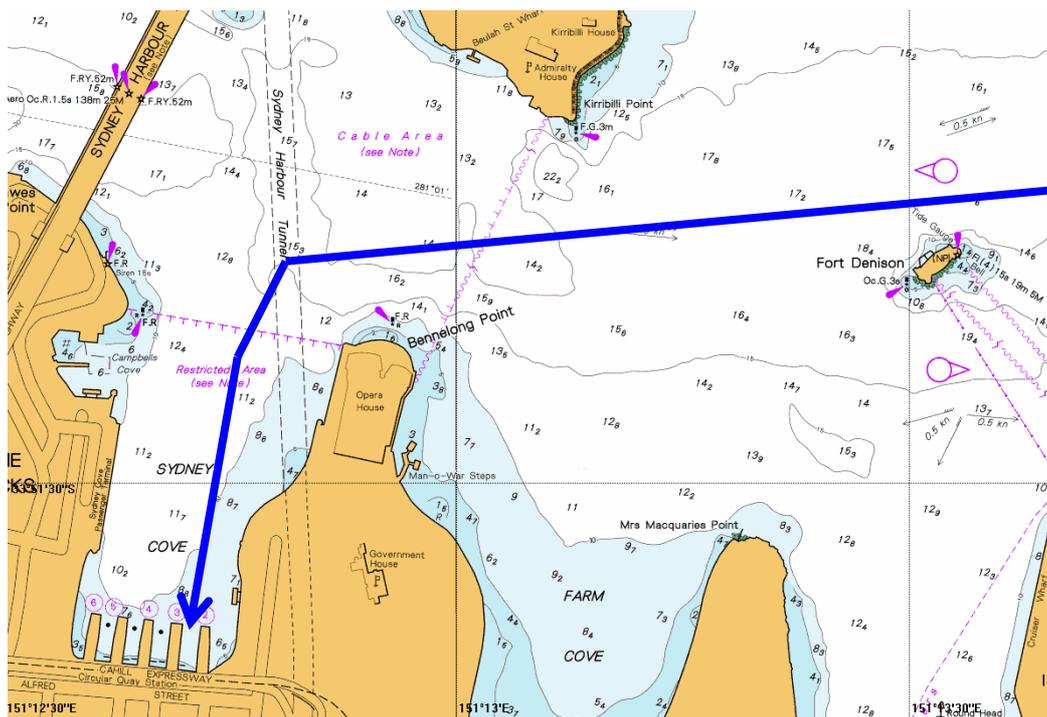
Figure 1 Extract from Chart Aus 202 showing *Collaroy's* approximate track

2.2 *Collaroy's* approximate track into Sydney Cove is as indicated in *Figure 1*

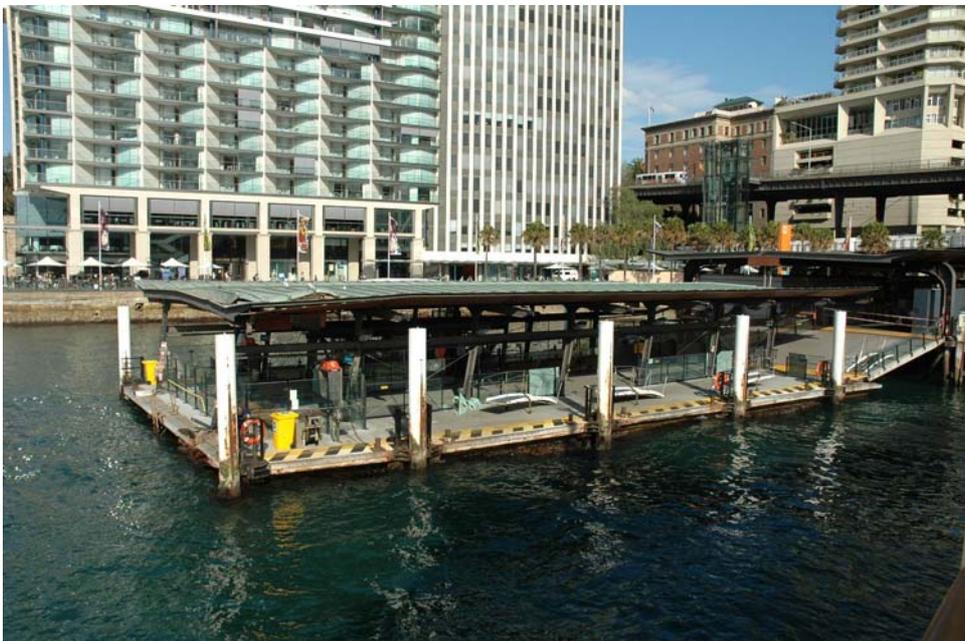
Figure 2 Damage to the Pontoon and Roof at No.2 Wharf

The *Collaroy* was not severely damaged but the pontoon and its roof sustained significant damage and required substantial repair.

2.9 *Collaroy* sustained minor distortion to its skin plating in the bow area above the water line. However, Sydney Ferries' operations were affected for a number of weeks while No.2 Wharf was being repaired. A subsequent decision to withdraw *Collaroy* from service, which remains in force at the time of publishing this report, has had a more significant impact on Manly ferry service operations.

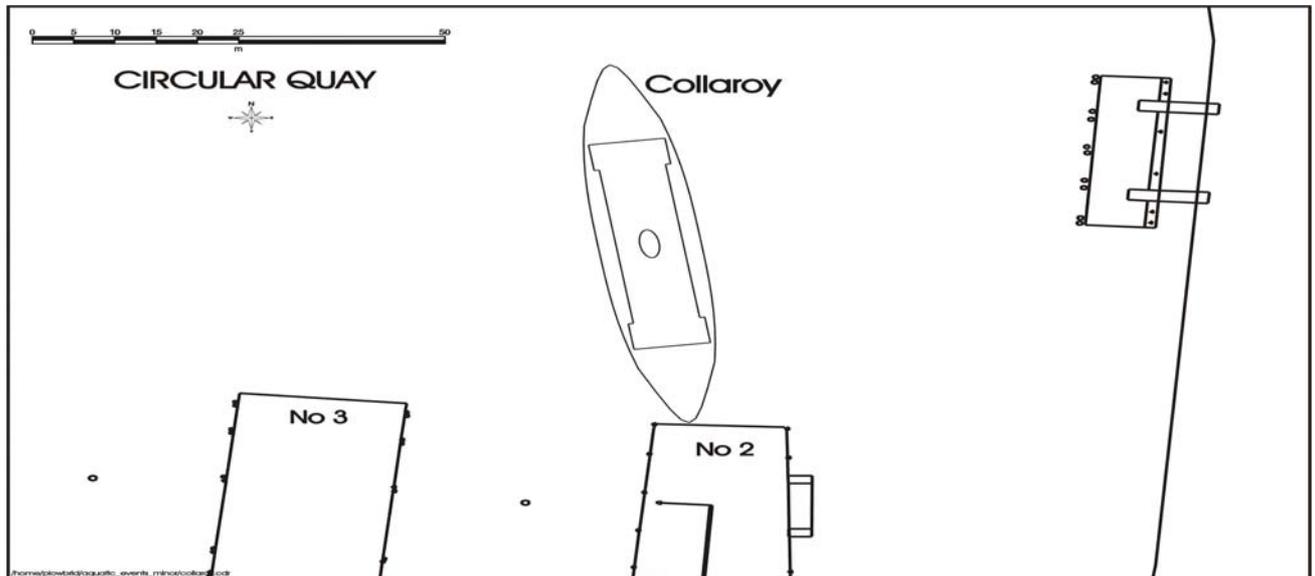
Figure 3 Collision Point of Impact at No 2 Wharf

situations. The point of impact of the collision is shown in diagrammatic representation at *Figure 3*.

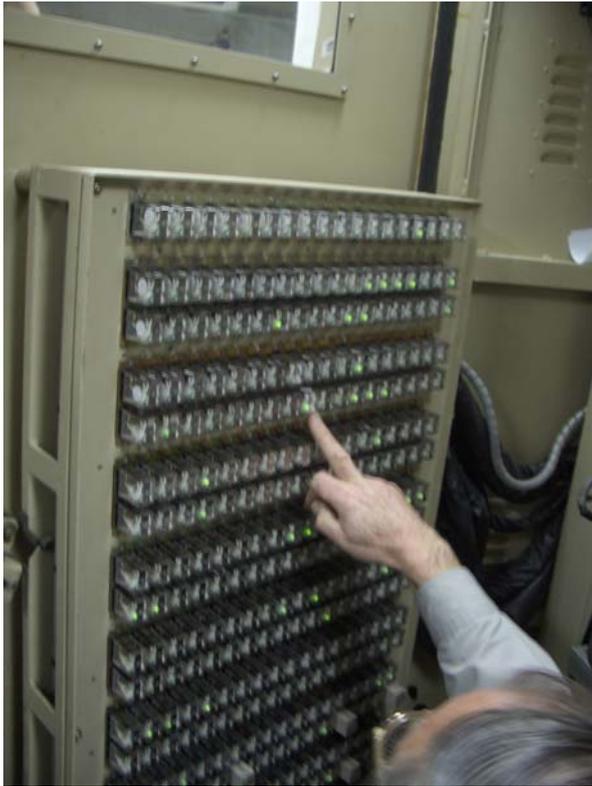
Figure 8 Electrical Relays with Relay # 303 indicated

- 3.8 An examination of electronic components and circuitry in the *Kamome* propulsion control system indicated that an electrical relay failed and that this had the effect of switching off or **Keying Out** of the control system. A high resistance reading was obtained from Relay No 303, a component in the **Key In** circuit, and it was thought that this could have induced such a significant failure. This was confirmed by simulation and when this relay was replaced, the fault did not recur during sea trials. *Figures 8 and 9* show some of the related circuitry, Relay 303 and testing equipment.

- e. Ensure that planned maintenance inspections of safety-critical equipment, such as propulsion control electrical relays and bridge VHF and UHF communications radios, are being completed and that any reported defects are rectified in a timely manner.
