Office of Transport Safety Investigations

FERRY SAFETY INVESTIGATION

**COLLISION BETWEEN SYDNEY FERRIES' *DAWN FRASER*
AND A DINGHY, REGISTERED No. AAP694N
WALSH BAY, SYDNEY**

5 JANUARY 2007

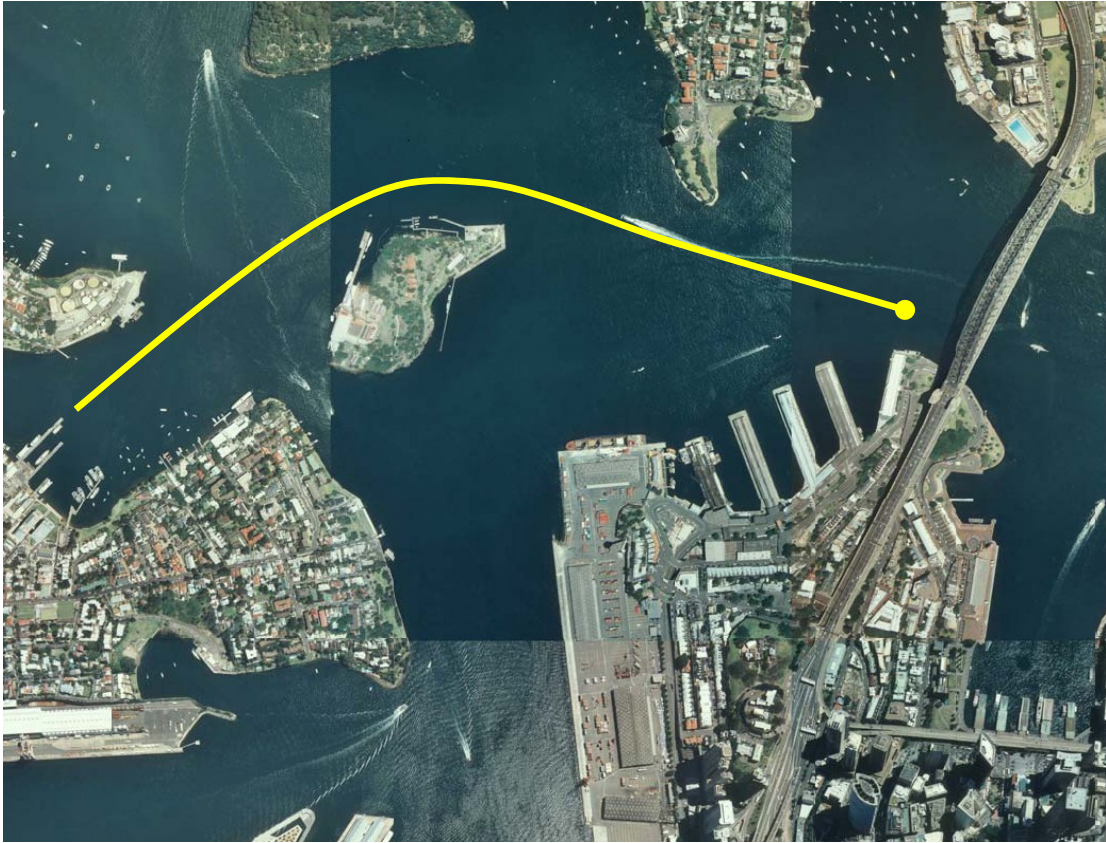
- 2.13 The approximate course of *Dawn Fraser's* usual track to Circular Quay is shown on the Chart at *Figure 1* and in the Aerial Photo at *Photo 1*. The Easternmost point of the track in *Photo 1* indicates the general locality of the collision.

Photo 1: Aerial Photograph showing the approximate course of *Dawn Fraser*'s usual track, with the Eastern extremity indicating the general locality of the collision

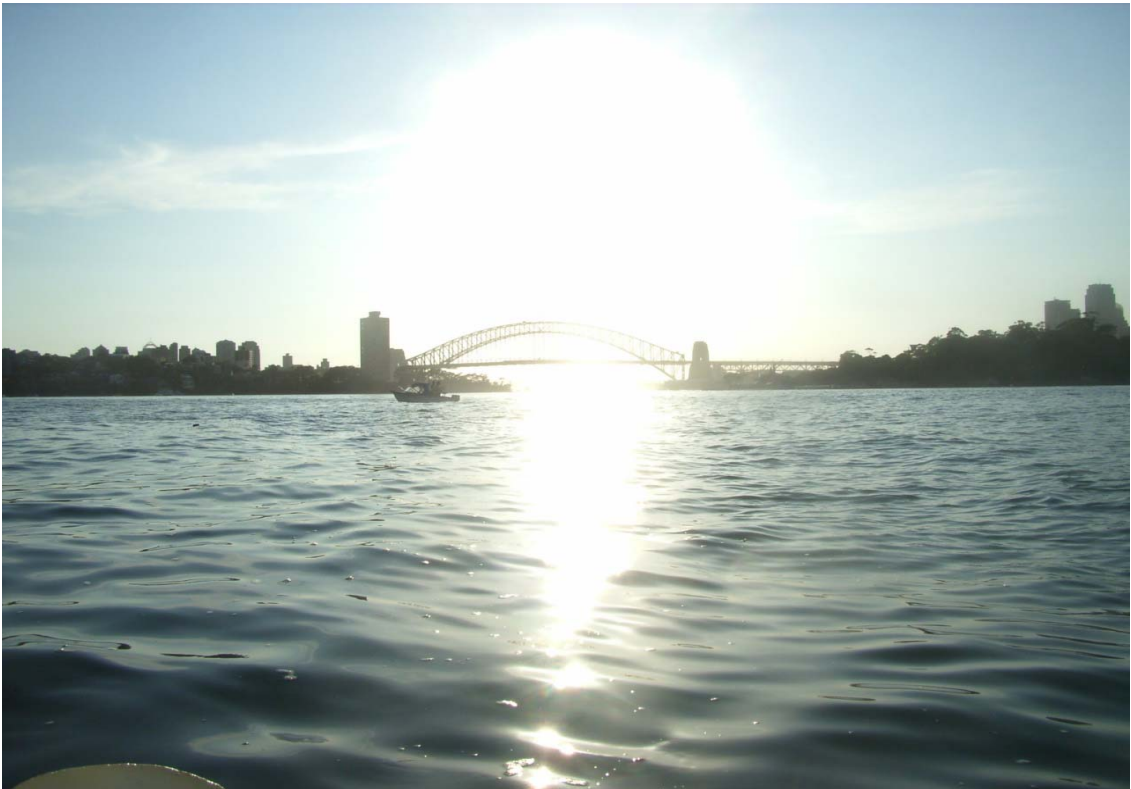
- 2.15 *Photos 2, 3 and 4* were taken by OTSI's IIC from a recreational vessel at 7:00am on 17, 18, and 19 January 2007 respectively. While they do not represent the exact conditions that prevailed on 5 January 2007, and do not make allowance for the fact the Master was wearing polarised sunglasses on the day of the accident, they provide a reasonable indication of the conditions that would have been encountered by the Master as the *Dawn Fraser* headed towards the Harbour Bridge on the day of the accident.

Photo 2: Approaching Sydney Harbour Bridge from the West at 7:00am on 17Jan 07. Indicative of the Glare and Dazzle experienced on *Dawn Fraser* on 5 January 2007

- i. *Dawn Fraser* was operating in conditions of reduced visibility because it was heading directly into the glare of the morning sun and its reflected dazzle off the surface of the water;
- ii. the speed of approximately 22 knots, at which *Dawn Fraser* was being operated immediately before the presence of the dinghy became apparent, was excessive given that the selected course the ferry was taking afforded reduced visibility;
- iii. although ferry operating procedures make provision for a GPH to be utilised as a 'lookout' to assist a master, the GPH on *Dawn Fraser* was

- ii. Review its training and vessel operating instructions to emphasise the requirement for masters to exercise additional caution when operating in environmental conditions where visibility is reduced, and fully describe the techniques required to address such operating conditions;

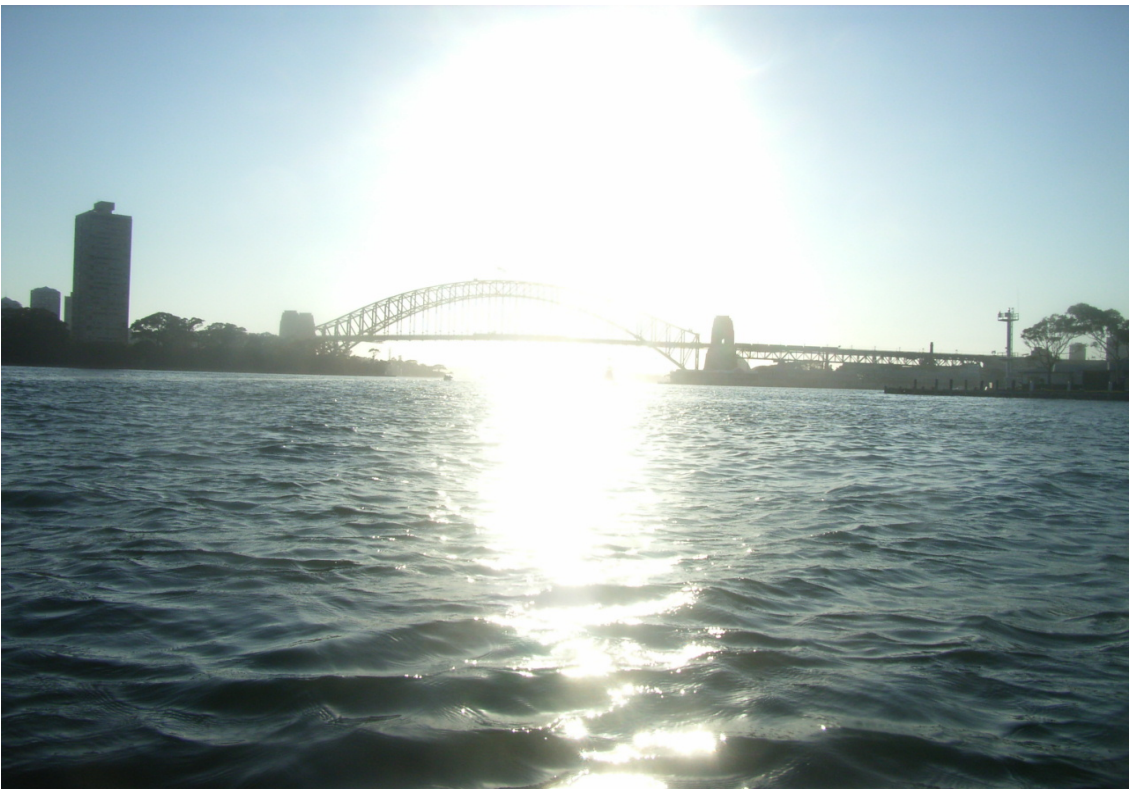
Photo 3: Approaching Sydney Harbour Bridge from the West at 7:00am on 18Jan 07. Indicative of the Glare and Dazzle experienced on *Dawn Fraser* on 5 January 2007

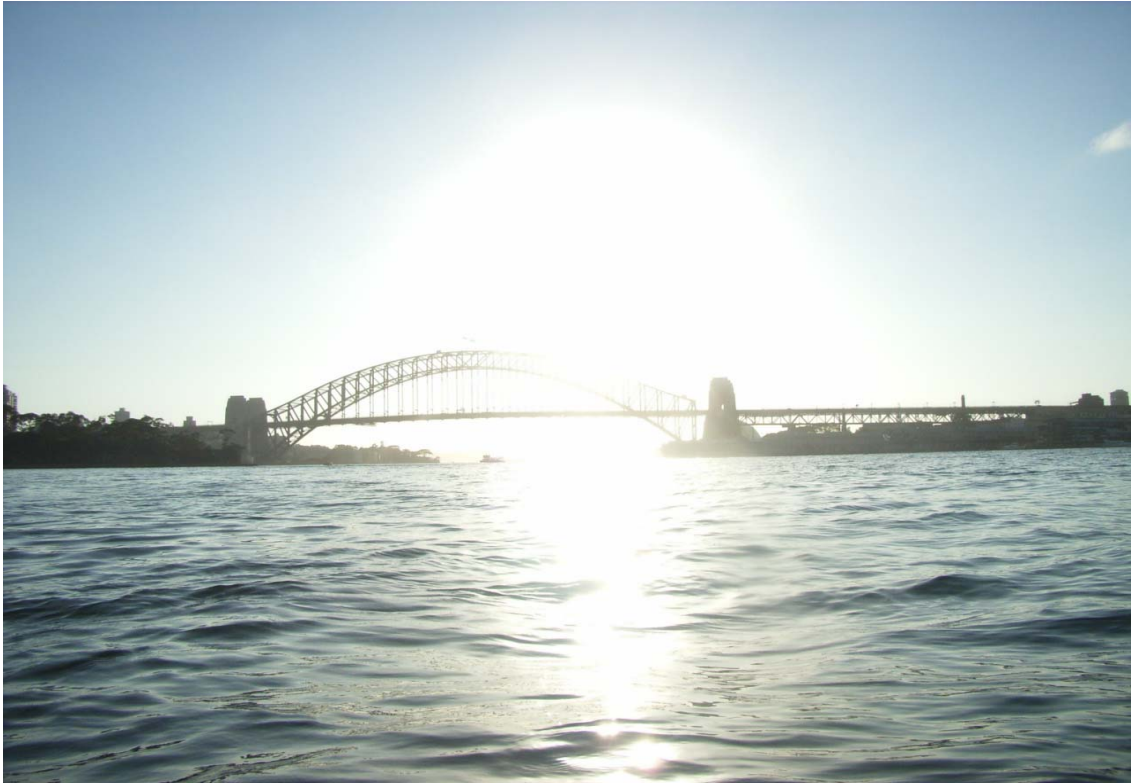
Photo 4: Approaching Sydney Harbour Bridge from the West at 7:00am on 19 Jan 07. Indicative of the Glare and Dazzle experienced on *Dawn Fraser* on 5 January 2007

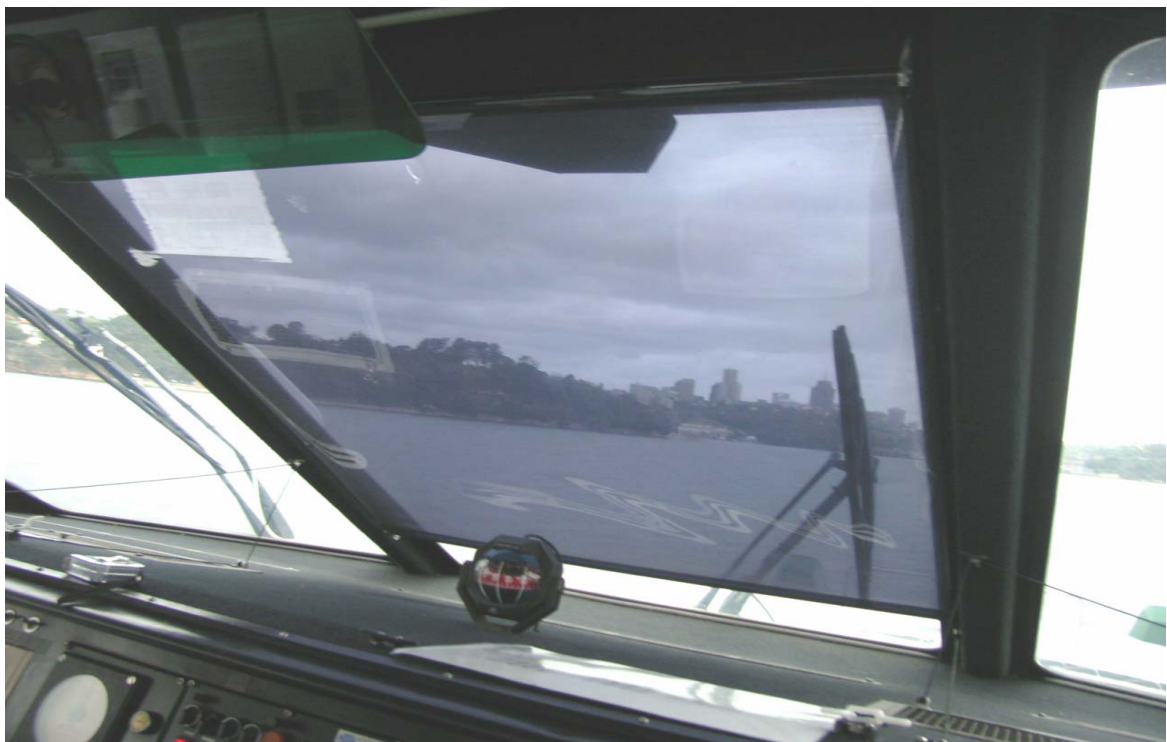
Photo 5: *Dawn Fraser's* centre windscreen panel with the blind fully drawn

- 3.10 Upon inspection of *Dawn Fraser* shortly after the accident, OTSI noted that its windscreen and windows were clean. These glass surfaces were 'raked' back to minimise reflection and augmented by roll-down blinds to filter glare and dazzle. OTSI noted that these blinds had not been drawn

- iv. *Dawn Fraser's* Master was wearing sun glasses, but he did not fully utilise the pull-down tinted blinds on the bridge's windscreen to further reduce the effects of the glare and dazzle;

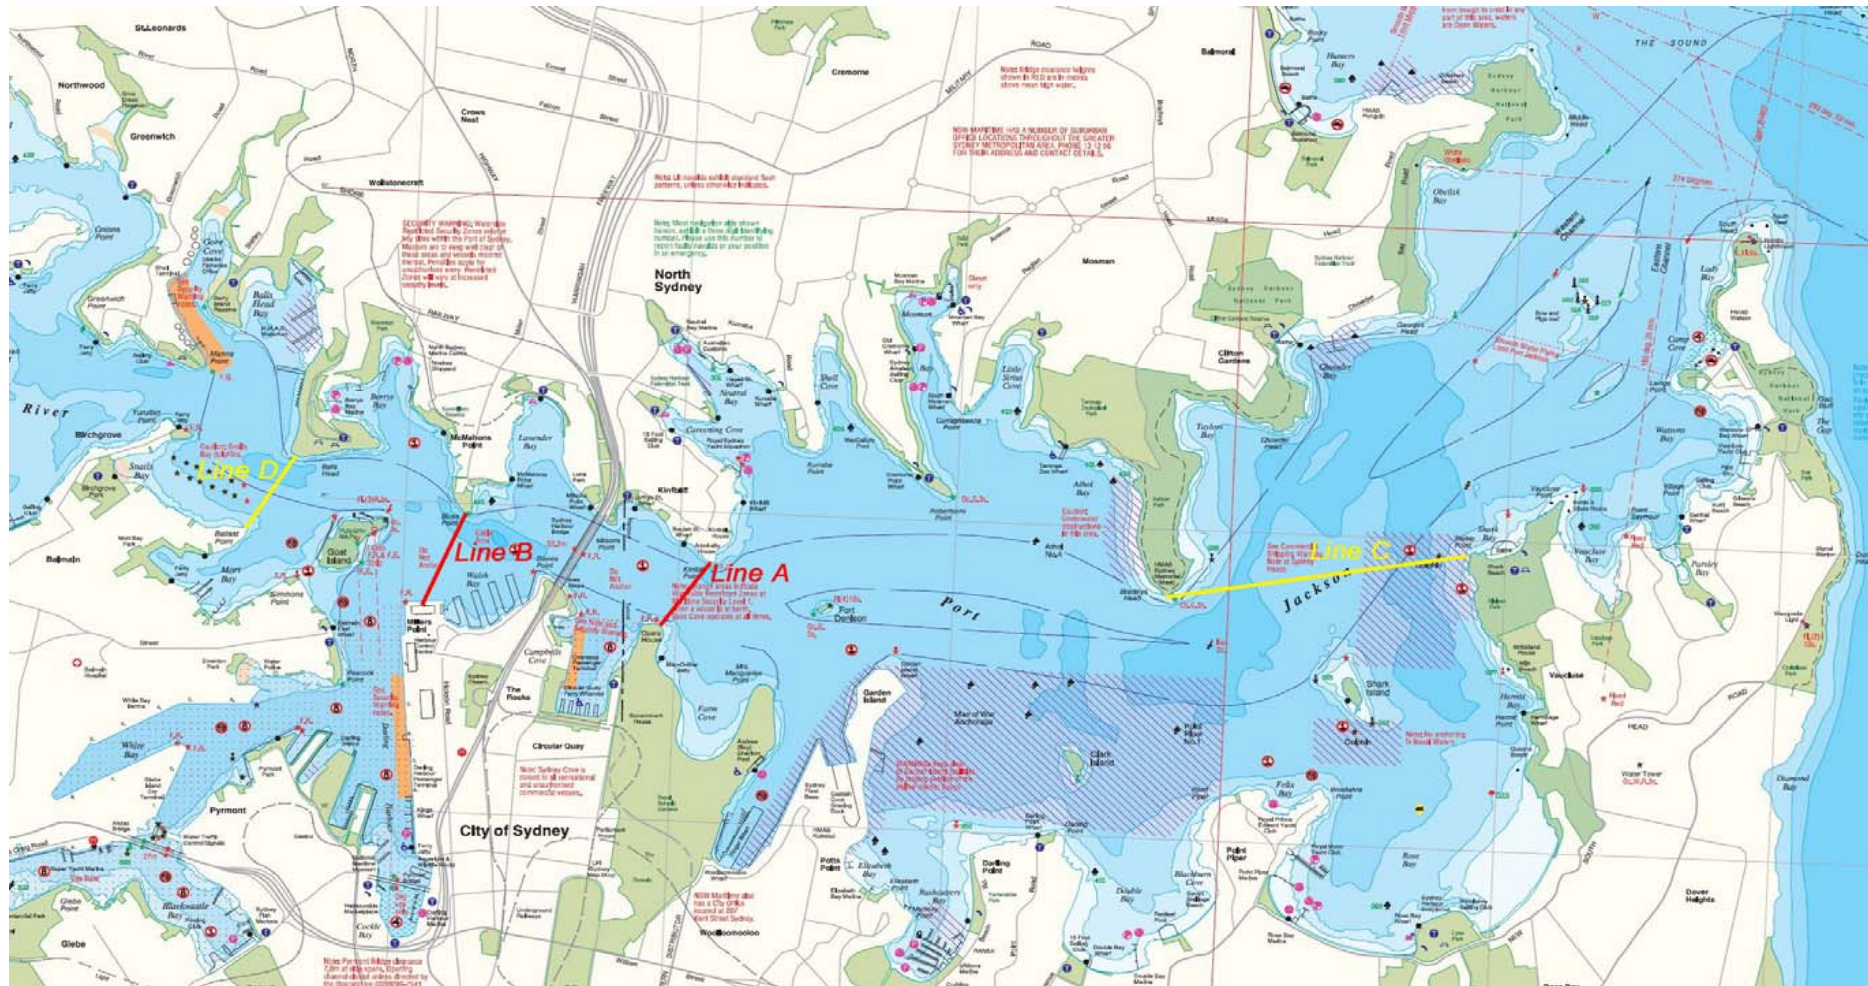
Chart 2: 'Lower' Harbour Environs with recommended and actual restricted speed landmarks indicated by Lines A and B and Lines C and D respectively

- ii. The area in the immediate vicinity of the Harbour Bridge is extremely busy, because of the large number of vessel movements into and out of Walsh Bay and Sydney Cove, and water conditions directly under the Bridge are like nowhere else on the Harbour. While merchant and trading vessels are subject to a speed restriction in this area, other vessels are not unless they are in close proximity to another vessel. Given the unique conditions in the vicinity of the bridge, the circumstances of this accident and a subsequent accident involving a ferry and a recreational vessel which resulted in multiple fatalities, immediate consideration needs to be given to restricting the speed of all vessels in this area.

- 3.37 It is important to note that any speed restriction that NSW Maritime might apply would not obviate the requirement for those operating a vessel to determine what constitutes a safe operating speed at the time. Rather, it would provide them with an 'upper' speed limit. In making this recommendation, OTSI acknowledges that merchant and trading vessels are already restricted to a maximum speed of 10 knots in the area bound by a line drawn between Shark Point and Bradleys Head to the East of the Bridge (Line C on *Chart 2*) and to 8 knots in the area West of the Bridge to a line drawn between Ballast Point and Balls Head (Line D on *Chart 2*). In the event that NSW Maritime applies a speed restriction in the area of the Bridge, OTSI considers that such a restriction should not apply to merchant and trading vessels unless it is lower than the extant limits already imposed on such vessels.
