Ferry Safety Investigation Report

Circular Quay

20 February 2004

***'Lady Herron'* – Collision with wharf**

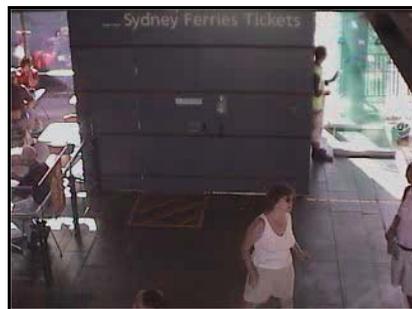
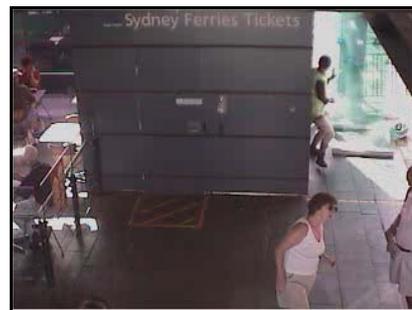
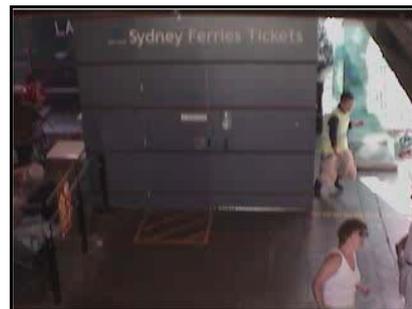
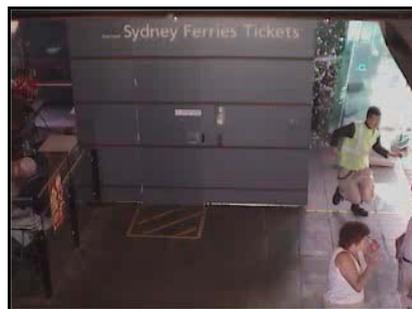
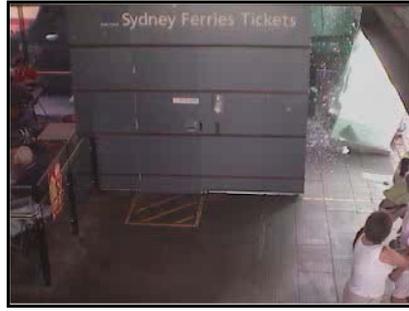
At 0942:58, *Lady Herron* collided with number five wharf near the southern end of the eastern berth and the adjacent timber back board.

Sequence of five frames from a security camera showing *Lady Herron's* impact with number five wharf

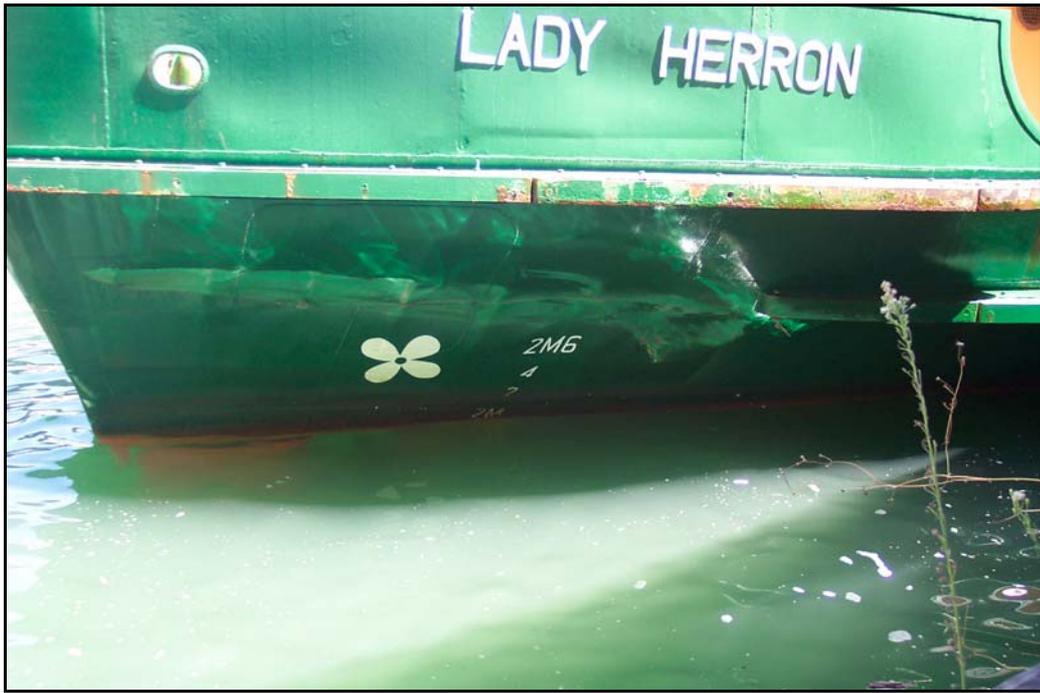
The *Lady Herron* received damage to the shell plate and frames on the port side, estimated at \$80 000.

Damage to Lady Herron's bow

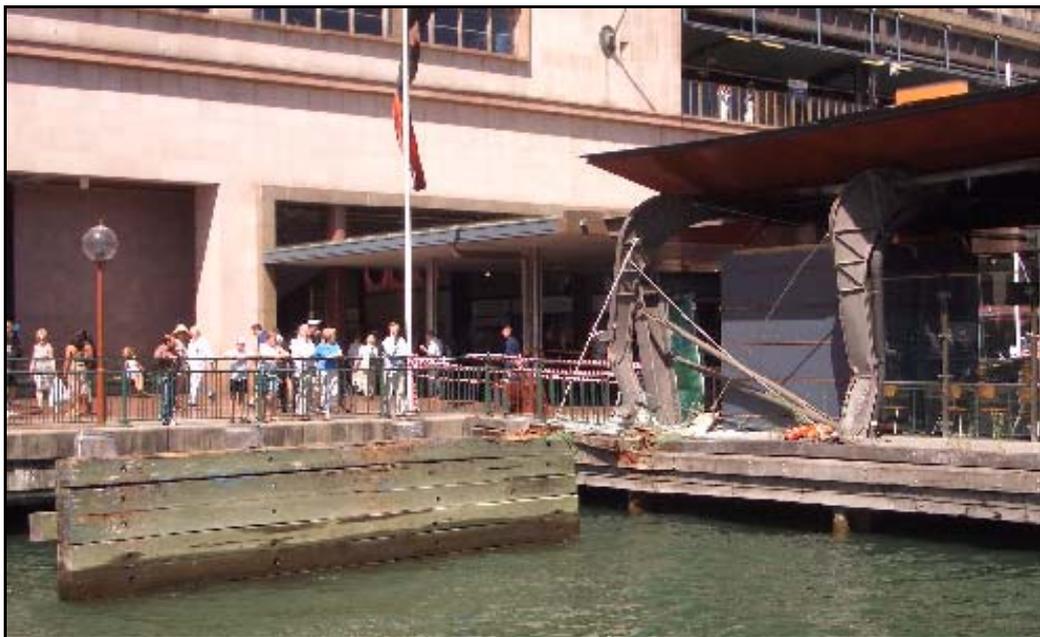
The building on number five wharf in way of the ticket box sustained significant damage in the collision. Two of the steel portal frame columns supporting the roof structure were severely damaged and required replacement. A steel frame over the ticket box and some of its glass security screens and the timber wharf fender, timber back board and piles also sustained damage. Damage to the wharf infrastructure was estimated at \$98 000.

Number five wharf building and back board damage

The height of tide when *Lady Herron* made contact with the wharf was a factor in the amount of damage sustained by the wharf building. The vessel was floating relatively high with respect to the wharf and it appears from the damage to the wharf structures that the bow of the vessel hit the steel portal frames supporting the roof of the wharf building before it made contact with the timber facings of the wharf.

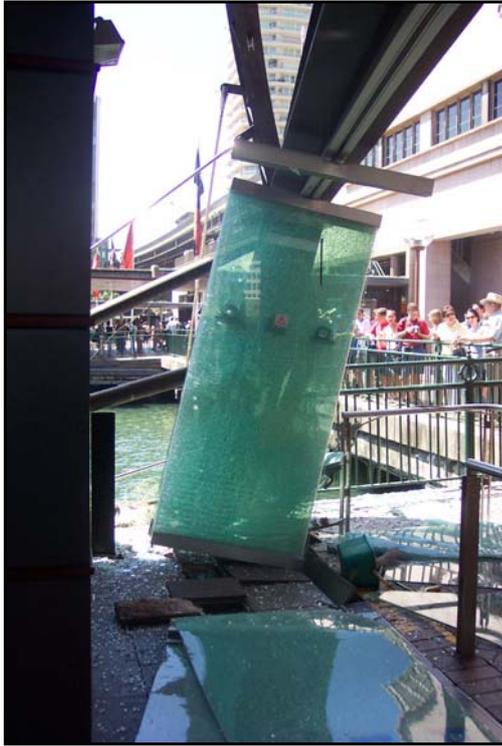
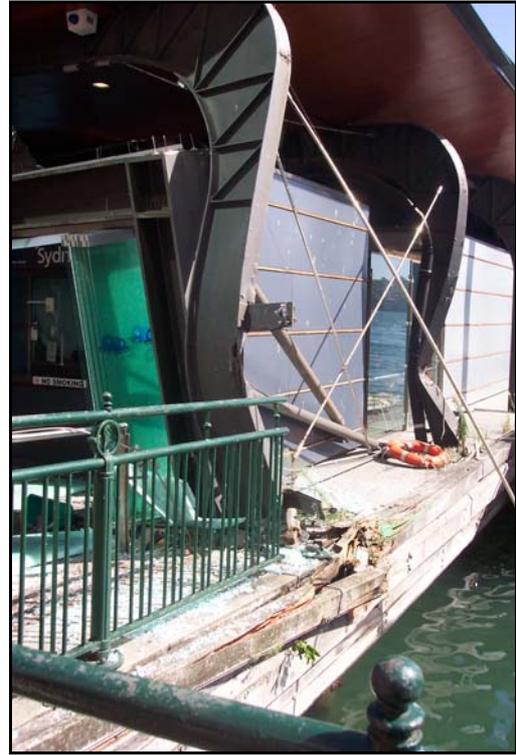
A man was standing beside the glass panels adjacent to the ticket booth at number five wharf when *Lady Herron* hit. The impact resulted in some of the panels shattering and the person ran from the scene to avoid the flying glass.

Number five wharf, damage to ticket booth and roof support structure
