FERRY SAFETY INVESTIGATION REPORT

COLLISION OF THE *LOUISE SAUVAGE* ROSE BAY WHARF

ROSE BAY WHARF

12 MAY 2004

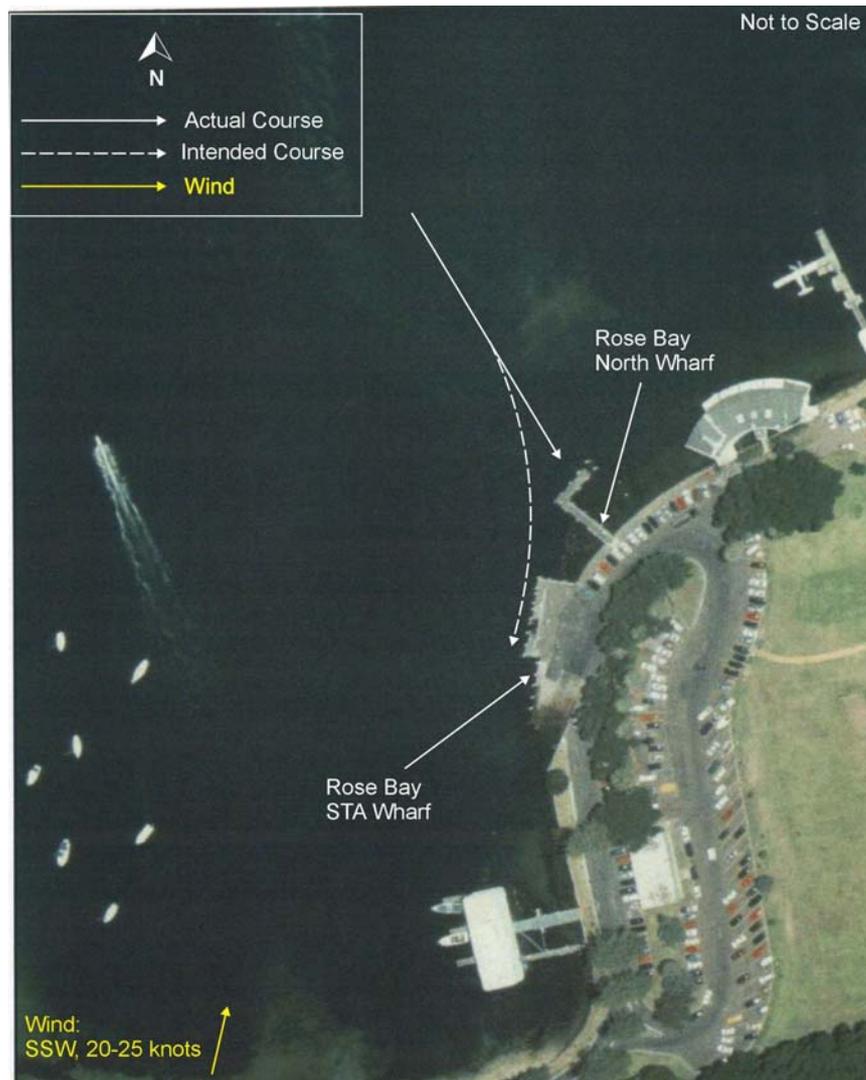
Figure 3 – Aerial View of Rose Bay

2.18 The impact of the collision was buffered by the progressive collapse of the timber structure as well as the climbing angle of the vessel as it rode up the staircase of the wharf. This collision sequence caused the vessel to be held tight by the forward metal sponson structure upon the timber pylons of the wharf.

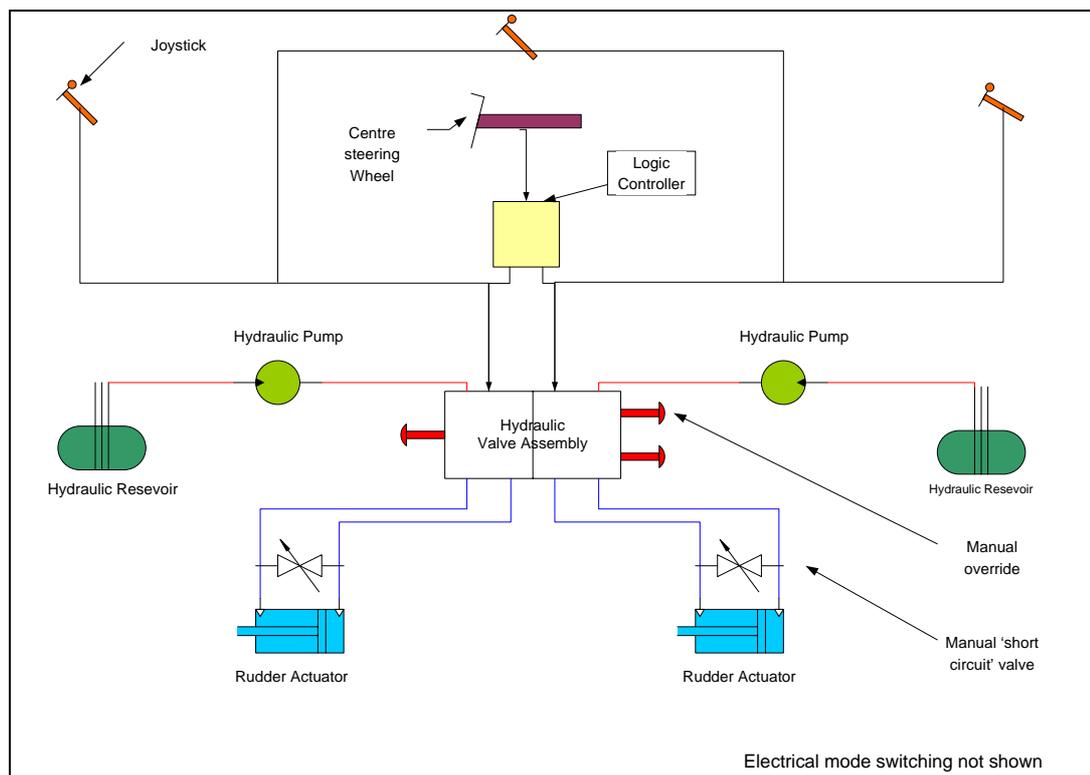
Figure 6 – Simplified rudder system schematic

- 2.55 OTSI witnessed sea trials that were conducted after the accident but prior to the vessel resuming normal services. These trials identified that rudders fitted to the Supercat class regularly creep out of alignment. The long standing nature of this problem was confirmed by comments from Sydney Ferries staff and a review of maintenance records. To correct rudder misalignment, the Emergency Steering (hydraulic failure) configuration is frequently used.

- 2.56 Also identified during the above trials was that when the Emergency Steering (hydraulic failure) mode of the steering system was used, the isolated rudder would lock in the position it was in at the time the Emergency Steering switch was activated. Further testing during sea trials proved that a rudder isolated, when fully displaced, would remain in the fully displaced position. This characteristic reduced the effectiveness of the remaining operational rudder.

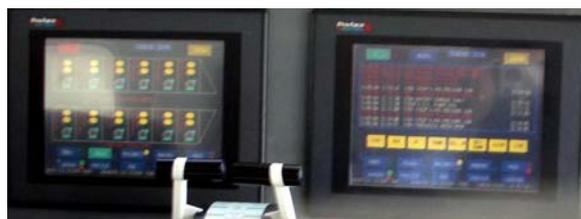
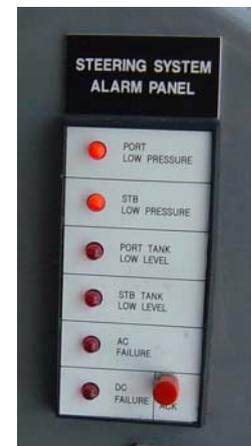
Figure 7 – Steering Monitoring Systems

- 2.61 The MAX system also has the capability to provide data recording for up to one week of vessel operations. Hard copy of the recorded data was provided by Sydney Ferries and was found to contain a number of recordings. The recordings were unable to be reliably interpreted due to the high degree of variability of vessel parameters. The data recording feature of the MAX system was further tested during subsequent sea trials and information retrieved from the system was found to be sporadic and inconclusive.

- 2.62 Due to the Original Equipment Manufacturer of the MAX system no longer trading, combined with Sydney Ferries not holding the required intellectual property for the MAX system, the investigation was unable to conclude if the unreliable recording was due to a limitation of the MAX system's design.
