# FERRY SAFETY INVESTIGATION REPORT

## COLLISION OF THE MANLY FERRY *NARRABEEN* NUMBER 5 WHARF, CIRCULAR QUAY 26 MAY 2005

**OTSI File Ref: 04066**  
**24 March 2006**

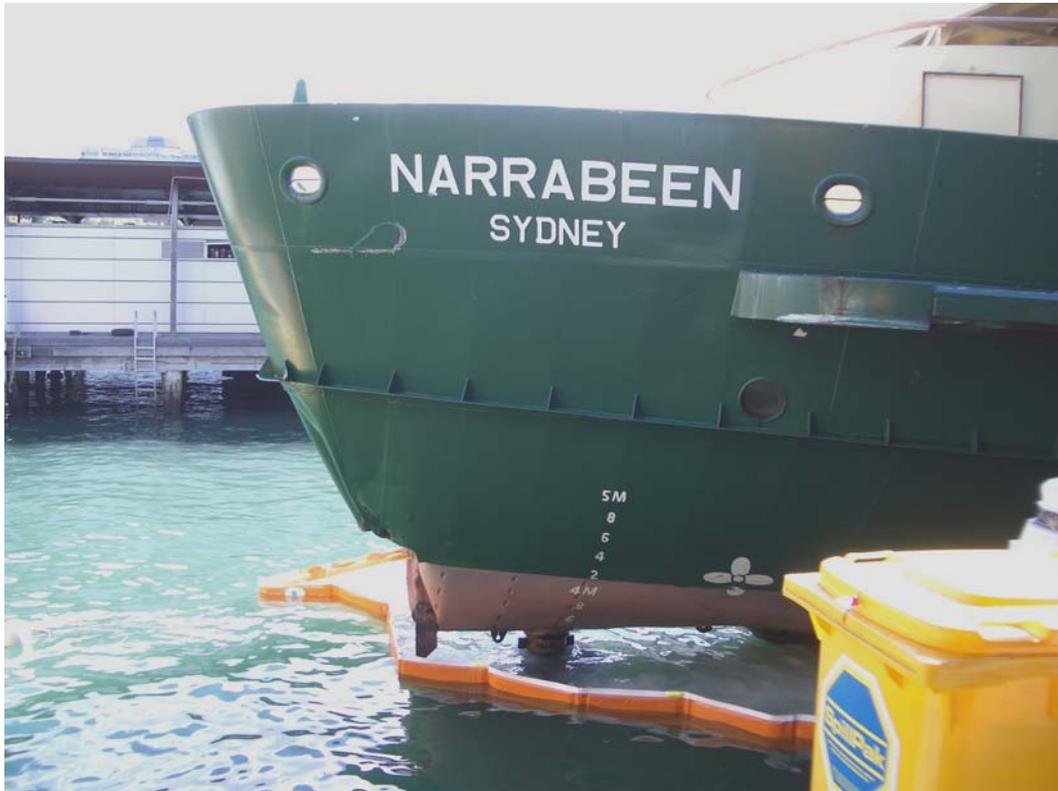
**Figure 1: Hull Damage and Spill Containment**

- 2.9 *Narrabeen* sustained structural damage to the bow section, including a rupture of the fore peak tank which allowed ballast water to escape. The vessel was examined by divers who established that there were no

major breaches of the hull. No.5 Wharf and its floating pontoon were closed to the public to allow a damage assessment, and subsequently repairs, to be conducted. *Figure 1* shows the containment of ballast water around *Narrabeen's* breached hull.

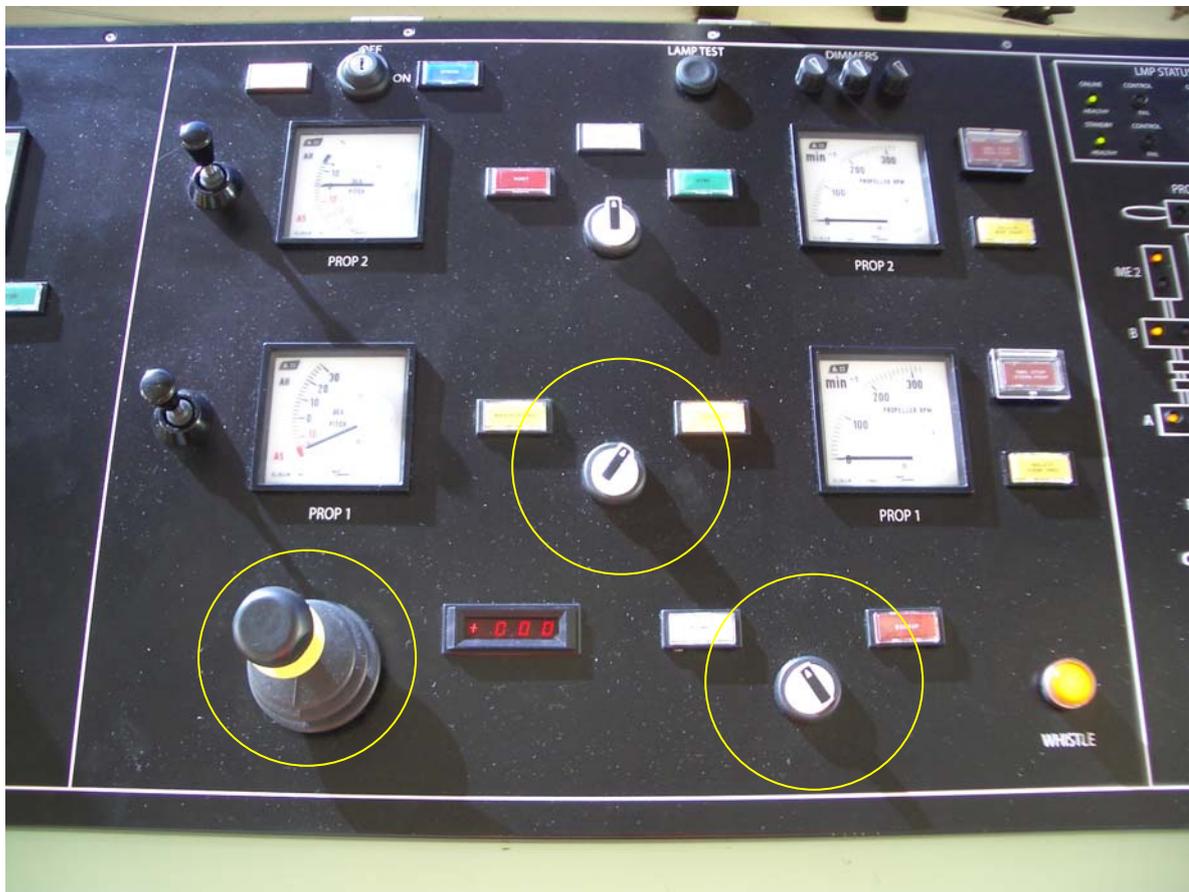
**Figure 5: Centre Control Console - Main Controls**

3.7 Command of *Narrabeen* is normally exercised from either the No. 1 or No. 2 wheel house (or 'bridges'), each of which has, along with a centre control console, a port and starboard wing station for use during berthing. The layout of the centre control console resembles a desk fitted with switches and gauges, angled slightly upwards towards the windscreen. The console runs most of the width of the bridge, with a section either side for floor mounted lookout chairs. *Figure 5* shows a photograph of the main section of the console, comprised of the X-Y lever and mode switches.

3.8 *Figure 6* identifies all of the individual controls and indicators. As can be seen in *Figures 5 and 6*, both the **Sailing – Manoeuvring mode** and **Normal – Backup mode** switches are identical in shape and are located in close proximity (17cm) to each other.

- d. Commission a technical study into the design and layout of the bridge console on the Freshwater class to determine its adequacy, both in physical and cognitive terms, and that any resulting recommendations be considered for their applicability across the remainder of Sydney Ferries' fleet.

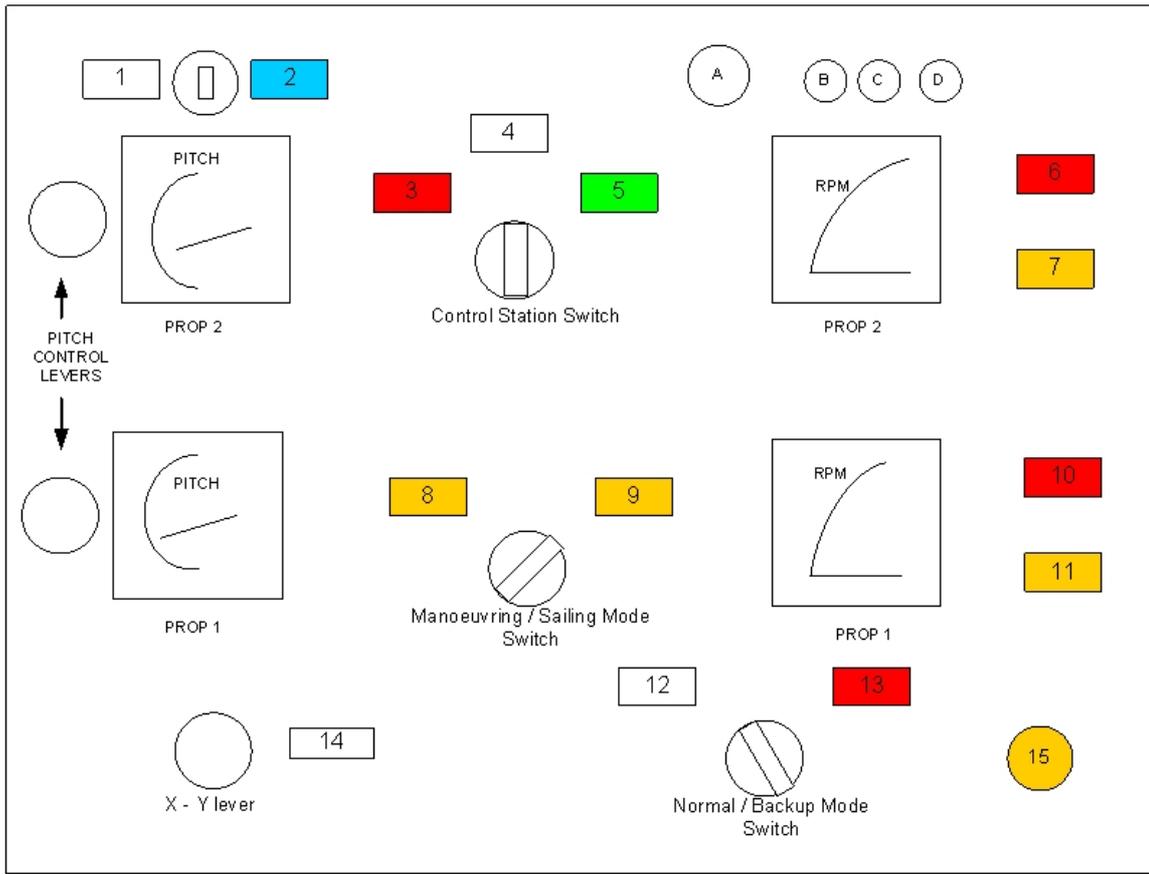
3.21 A limiting factor in any emergency preparedness is the depth of the risk assessment carried out on systems and procedures. Sydney Ferries failed to identify the risk of inadvertent switching when utilising identical and closely positioned mode switches. As a consequence, the emergency situation that presented had not been incorporated into any form of emergency drill.

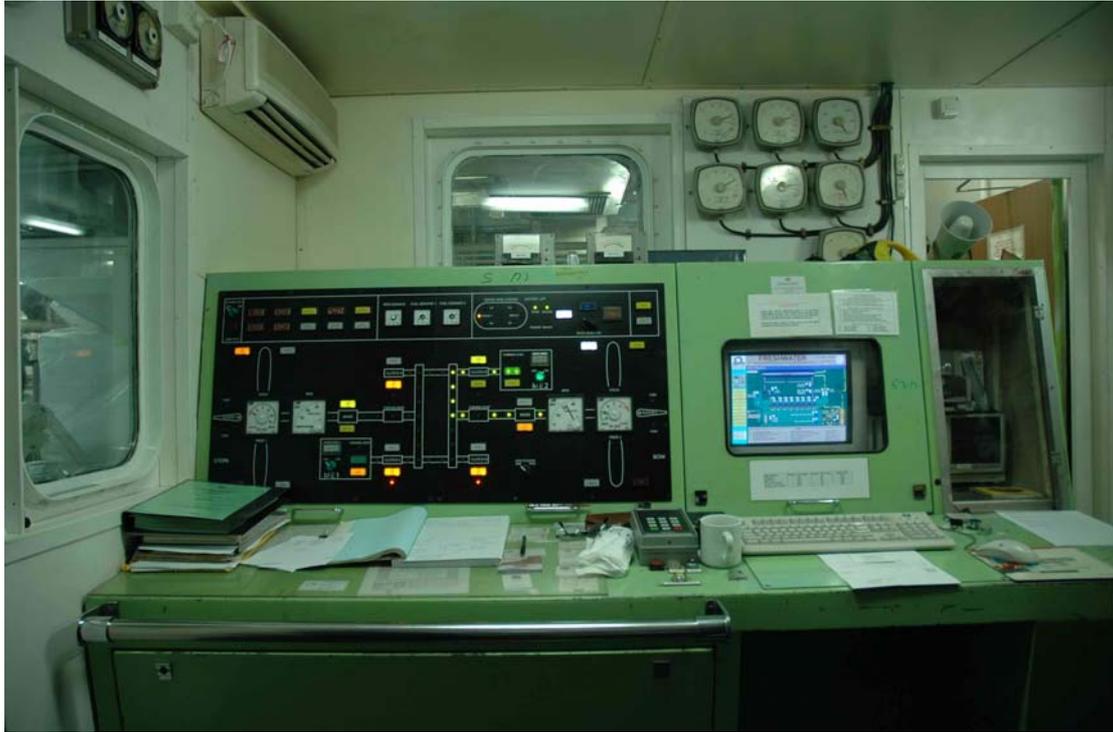
**Figure 7: Engineer's Environment**

3.15 In reviewing the interaction between the Master and the Engineer, OTSI was able to draw parallels with other recent investigations it has conducted into incidents involving Sydney Ferries' vessels. It is clear in this instance that the Master attributed little weight to the advice given by the Engineer. In the other investigations alluded to, there have been instances where there has been no communication between the Master and the Engineer at the onset of, and during, an emergency situation. This is most significant because the Engineer is able to take over control of the propulsion system at its lowest level on the Freshwater class. He/she can directly effect changes to propeller pitch as far down in the propulsion control system as the hydraulic control unit, bypassing all electronic controls and systems. However, the Engineer must be directed by the Master to do so. The Engineer is also heavily reliant upon advice from the Master or Helmsman to maintain his/her situational awareness given that he/she normally operates in the MCR (see *Figure 7*). In this instance, the level of ambient noise within the MCR was such that the Engineer did not even hear the vessel's whistle being sounded. In the limited time available, without knowing *Narrabeen's* exact position and without receiving further communication from the Master, intervention by the Engineer would not have been an option.

- i. Implement and enforce a procedure whereby on approach to a wharf, the Master notifies the Engineer of his/her intention to change mode in preparation for berthing, and the Engineer advises the Master that he/she is ready to take control from the Machinery Control Room (MCR) if directed by the Master.

- ii. Assess the benefits and risks associated with installing a system of closed circuit television cameras with clear views fore and aft of the vessel, combined with a monitor which can be viewed by the Engineer from within the MCR.
