# FERRY SAFETY INVESTIGATION REPORT

FIRE ONBOARD CAPTAIN COOK CRUISES' FERRY *JILLIAN*

SYDNEY HARBOUR

28 APRIL 2010

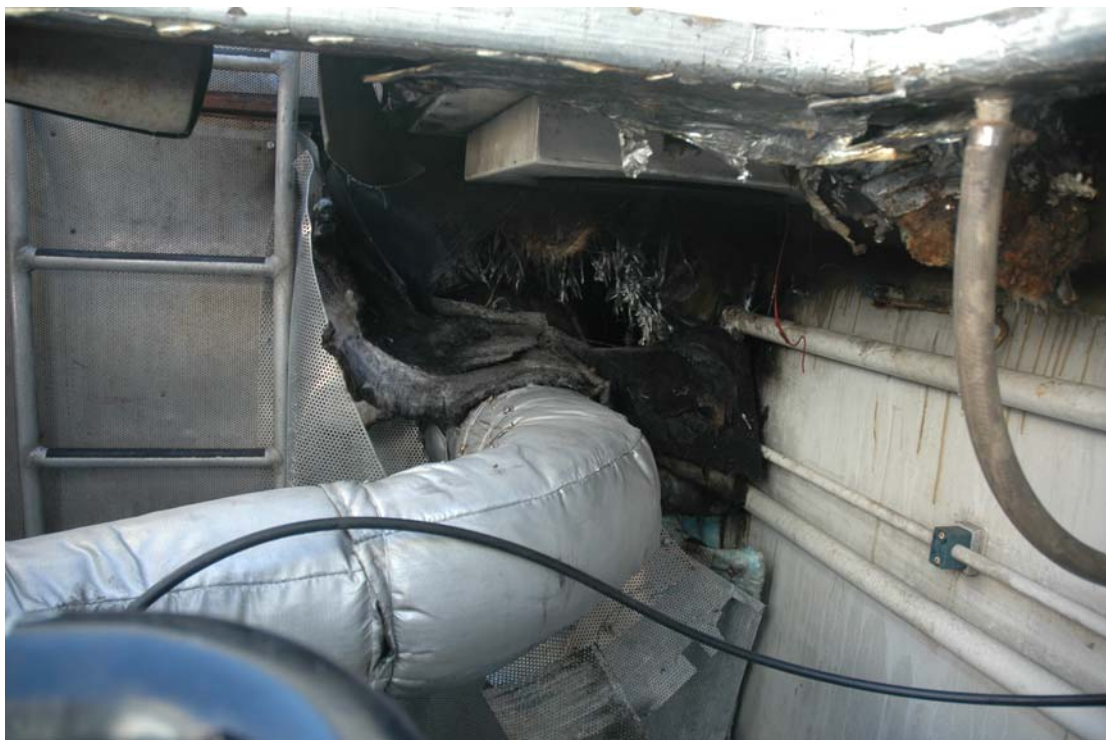
**Photograph 1: Rear port engine room bulkhead damage**

- 1.19 The *Jillian* suffered fire damage to the rear port side from the engine room aft bulkhead to the steering compartment including the main after deck area. The outer port side hull, bulkhead and deck were extensively damaged and all the composite material delaminated (see *Photographs 1 & 2*).

- repaired the structural damage to the ferry by cutting out and replacing the damaged section of deck and bulkheads, replacing wiring and installing a new wet exhaust system;

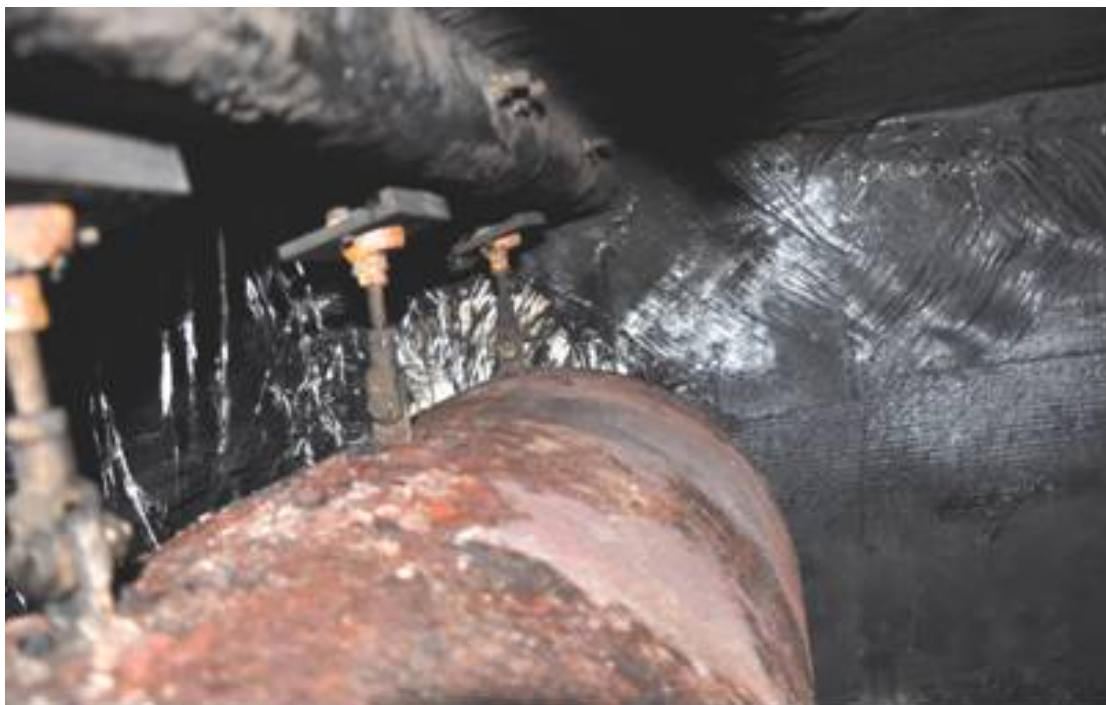
**Photograph 3: Port muffler compartment**

- 1.20 The most extensive fire damage was to the compartment located behind the engine room where the exhaust muffler was mounted from the deck head (see *Photograph 3*). Major fire damage and delamination was sustained by the whole rear port side deck and outboard port side hull of the vessel, from the engine room rear bulkhead to the rear hatch of the steering compartment.

- 1.22 The lagging enclosing the exhaust system was burnt around the area at the front of the muffler and along the top. There was also damage to the lagging at the end near the outlet pipe.

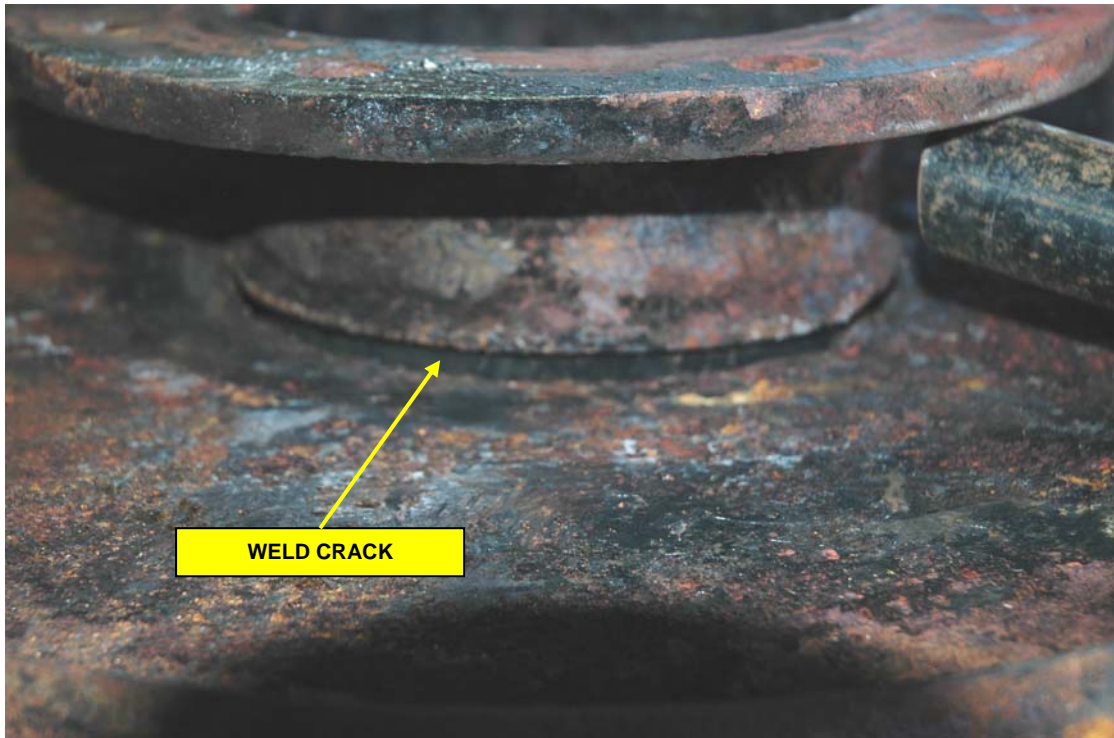
Photograph 4: Crack in port muffler

- 1.23 The seat of the fire was identified as being at the front end of the muffler in the area just after the point where the exhaust pipe passed through the engine room rear bulkhead, in the void where the muffler is housed. From there it spread to the deck, the engine room rear bulkhead and then throughout the muffler compartment.
- 1.24 Having removed the lagging from the rear of the port engine and muffler, an examination of the short 500mm section of pipe between the flange and the front of the muffler revealed a crack at the join where the pipe is attached to the muffler, extending over 75% of the circumference of the pipe where it is welded to the muffler (see *Photograph 4*). This crack allowed the heat from the exhaust to impinge on the deck head and engine room rear bulkhead which eventually caught fire.

vessel as it travels through the water. This lack of flexibility causes stress points within the system, especially where the flange is welded to the muffler.

- 2.1 The fire onboard the *Jillian* on 28 April 2010 was caused by the radiated heat emanating from a crack in the port exhaust pipe located under the rear deck and behind the port engine room rear bulkhead. The heat reached such intensity that it ignited the epoxy resin in the composite fabric used in the hull of the ferry.

- 2.6 The structural damage to the *Jillian* has been repaired and all three Rocket Class ferries have had their dry exhaust systems replaced with wet systems.

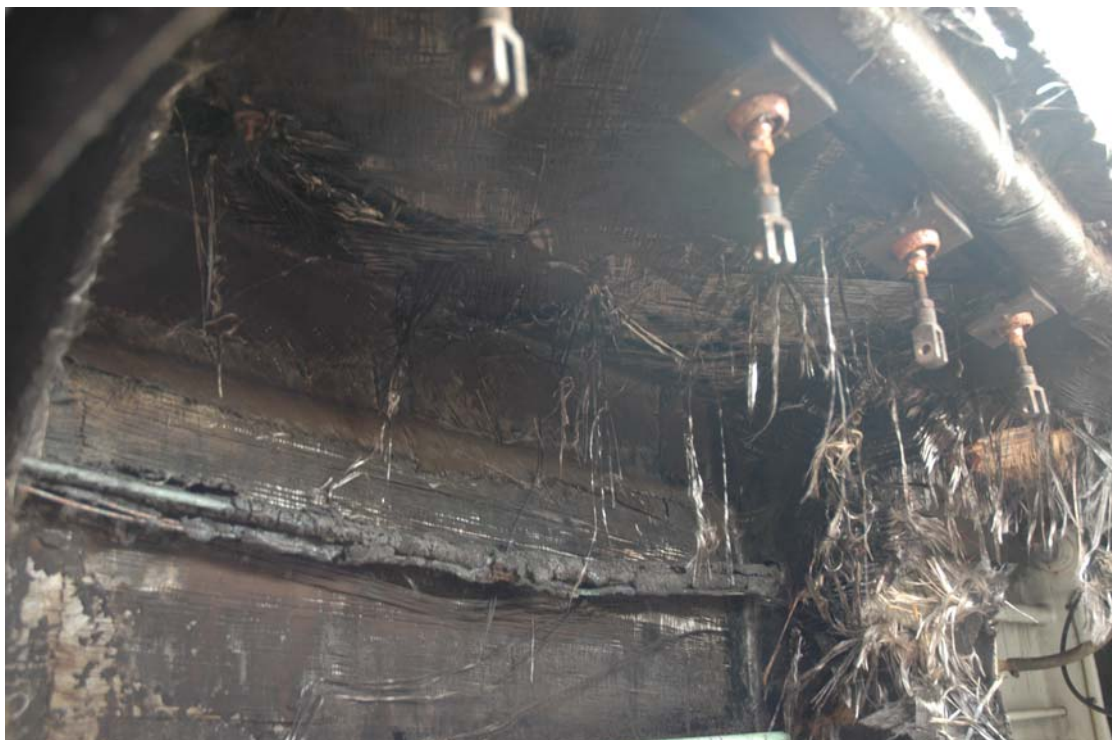
**Photograph 5: Port muffler hanging supports**

- 1.33 CCC's only record of this 23 January 2010 fire onboard the *Jillian* was in an entry in the vessel's log book, but it had no record of any repairs undertaken as a result of the fire, although it subsequently produced an invoice for some work which may have been associated with the repair of fire damaged lagging. After the second fire, during examinations of the vessel on 29 April and 3 May 2010, OTSI ascertained that none of the four bottle screw supports to the muffler had been replaced since the exhaust system was installed originally ( see *Photograph 5* ). Additionally, there was no evidence of an

order being placed for a replacement support bracket, nor were there any maintenance or repair records or invoices located indicating a support bracket was replaced.

- 1.34 In short, there was no evidence of any remedial safety action having been taken to repair the hanging support brackets in the muffler compartment after the 23 January 2010 fire.

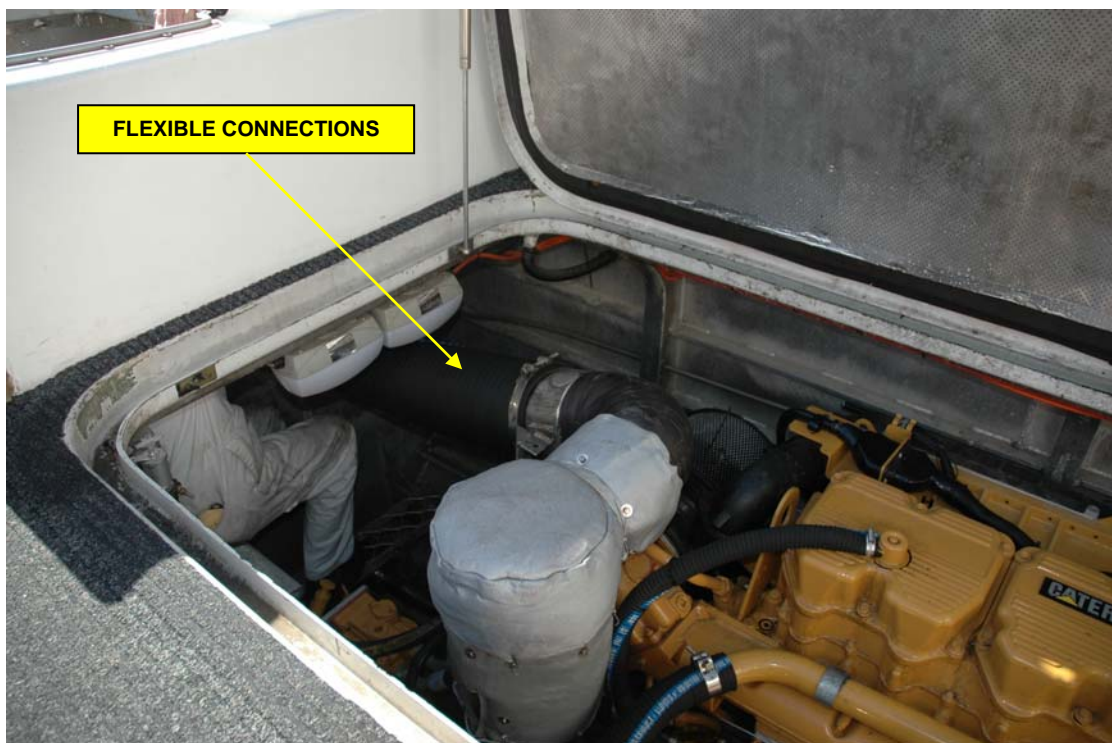
**Photograph 6: Wet muffler system – SF's Pam Burridge**

- 1.36 With a wet exhaust system, the engine exhaust gas is mixed with water pumped into the system. This system operates at a cool temperature such that the exhaust can be touched at any time without inflicting a burn. The system is flexible and so is not adversely affected by engine vibration and the normal flexing of the vessel (see *Photograph 6*). On the HarbourCats, the wet

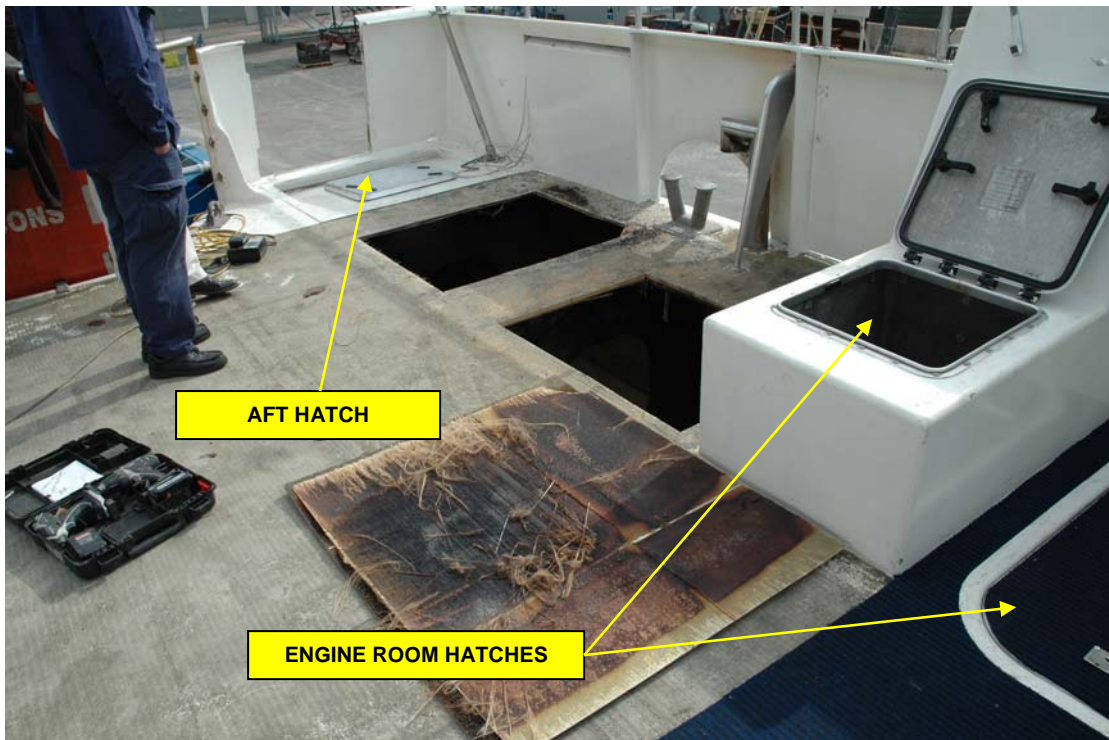
**Photograph 7: Rear deck of *Jillian* after deck sections removed**

The inspection revealed that a large section of plywood had been fibreglassed on to the deck above the muffler void to strengthen the deck (see *Photograph 7*). Inquiries revealed that the deck required additional stiffening in this area to support the weight of the muffler as the deck was flexing excessively. This extra stiffening was not required on the *Megan* and *Alice* as this problem had been identified on the *Jillian* not long after it was launched and had been rectified by the builder during the construction of the *Alice* and the *Megan*.

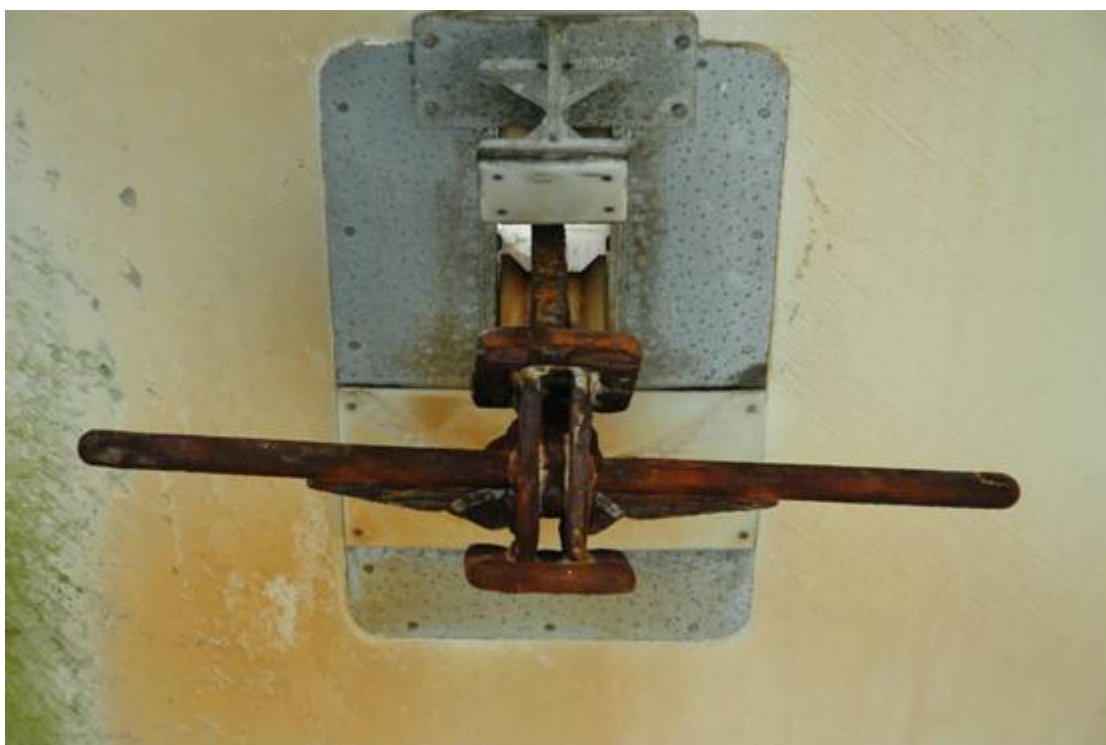
**Photograph 8: *Jillian*'s rusted anchor**

- 1.41 There were cracks in the fibreglass on the main structural deck beams and evidence of other repairs to the beams. The anchor was badly rusted to the extent that it would not have functioned properly (see *Photograph 8*).

- fitted new shafts, rudders and hydraulic steering;
- replaced the anchor;
- replaced the water tight seals to the engine room hatches;
- fitted locking mechanisms to hatches;
- replaced the reflective tape on all life rings and carley floats;
- installed a new hydrostatic release to the carley floats;
- repaired lighting in the tiller flat, exit signs and replaced bulbs in the NUC lights; and
- rectified, and where necessary, replaced the defective life rings, unserviceable gauges and the marking of the horn.

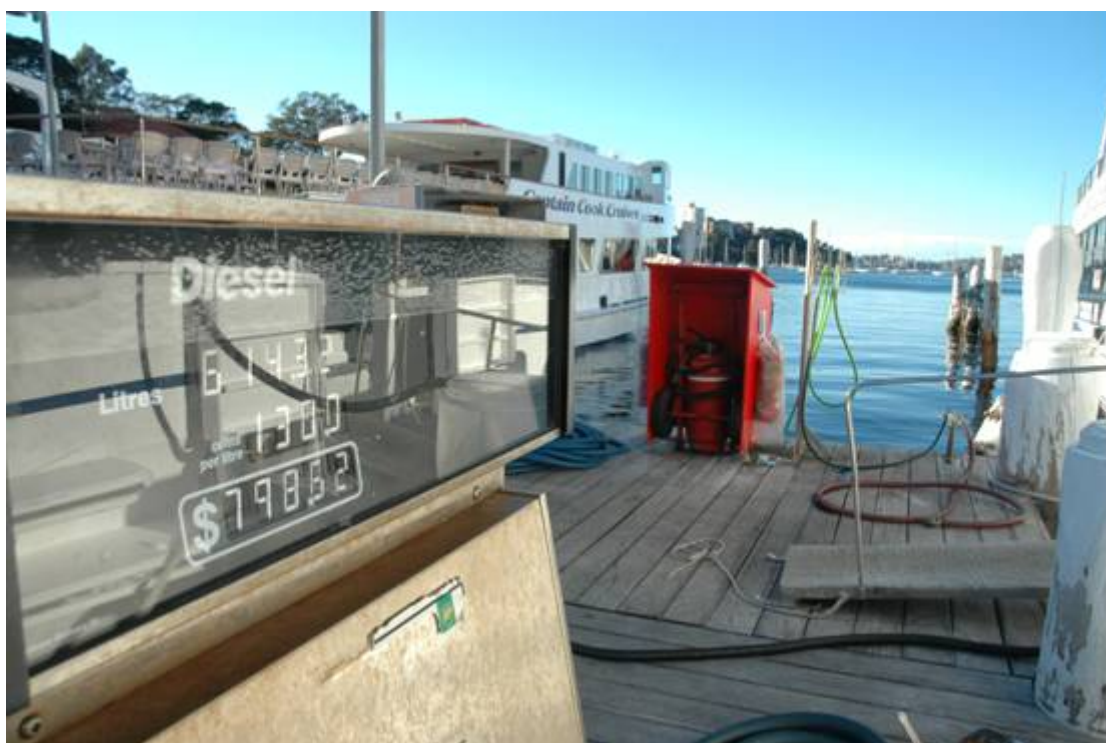
**Photograph 9: View of fuel pump and Neutral Bay Marina**

- 1.46 Taking the ferry to the Neutral Bay Marina introduced an increased risk to other vessels and infrastructure. Circular Quay is readily and more quickly accessible to Water Police, SPC fire emergency vessels and land-based Fire Brigade units, and there is a plentiful supply of fire hydrants and extinguishers. By comparison, access to Neutral Bay is more restricted and the presence of other vessels, some with large gas cylinders onboard, moored in very close proximity to the *Jillian*, together with fuel lines on the marina, increased the complexity and risk of the firefighting operation, and even more so if the fire had spread beyond the ferry (see *Photograph 9*).

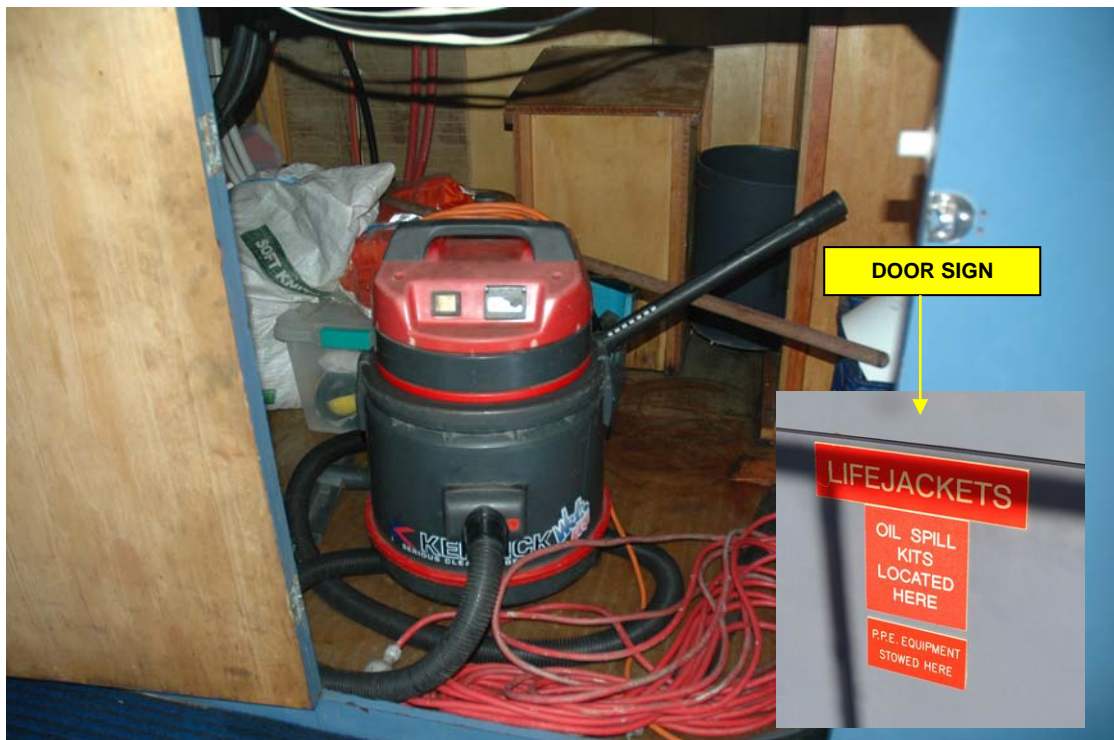
- 1.49 **Stowage of life jackets.** The stowage of lifejackets did not comply with the requirements of NSWMA as they were not readily accessible for emergency usage. Signage for the location of the life jackets was misleading in that they were not located where the signage indicated; they were in an unsigned storage bin in a dead-end passage and sealed in plastic bags (see *Photographs 10 & 11* and *Figure 3*). The unsafe storage of the life jackets had not been identified during survey.

**Photograph 10: Life jacket signed storage below wheel house**

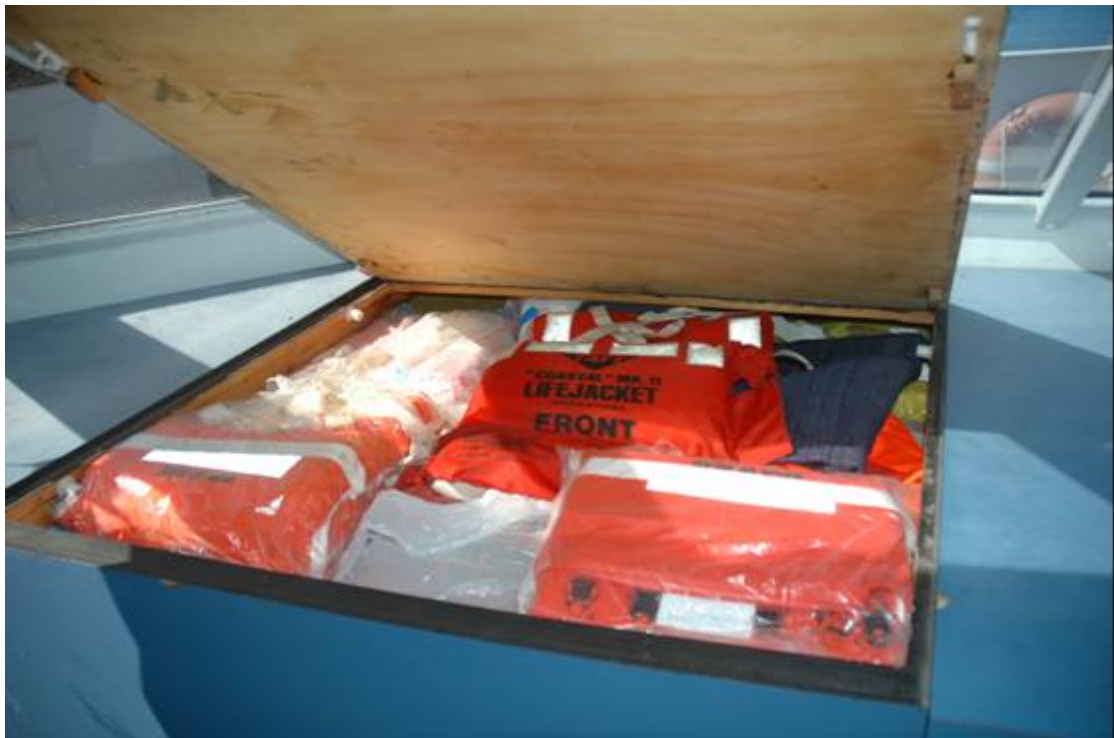
**Photograph 11: Life jackets wrapped in plastic in unsigned storage**

- new wet exhaust systems have been fitted to both the *Megan* and the *Alice*;
- lagging has been checked and replaced where necessary;
- seats with under-seat life jacket storage have been installed;
- bilge and fire valve operations have been re-assessed and adjusted as necessary;
- vessel log, defect reporting and fire drill systems have been reviewed and improved; and
- locking, signing and sealing of all hatches.

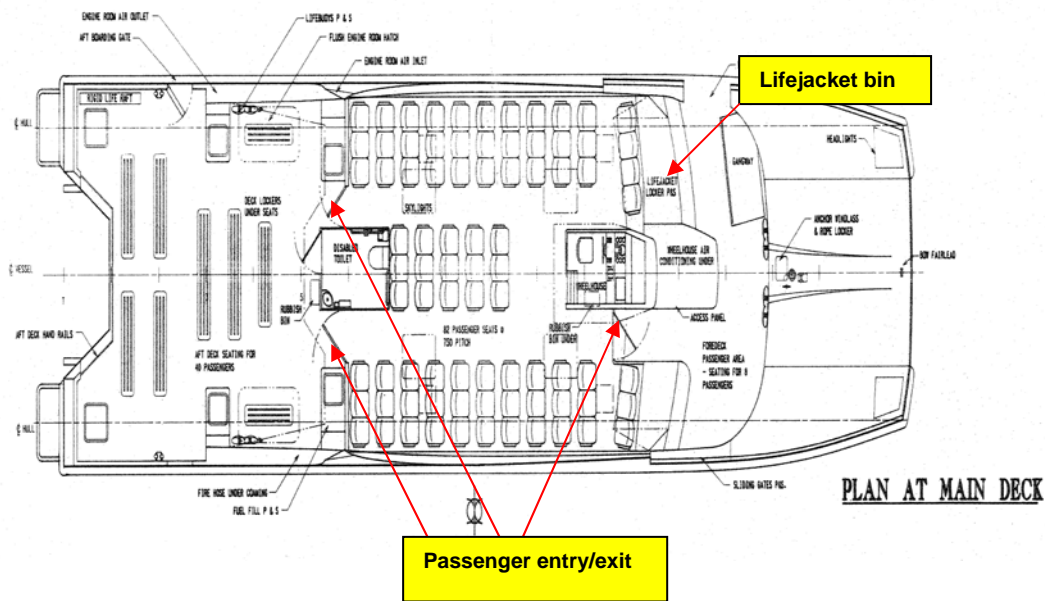
Figure 3: Passenger access to life jackets

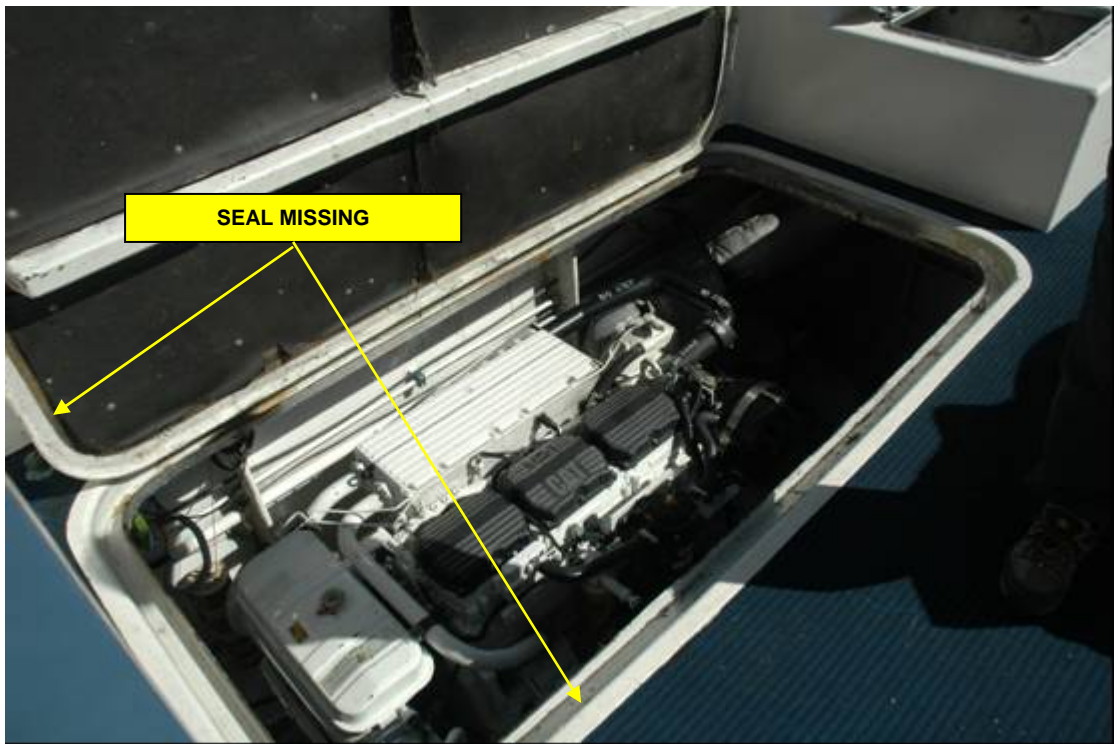
Photograph 12: Engine room hatch without seals
