Office of Transport Safety Investigations

FERRY SAFETY INVESTIGATION REPORT

COLLISION MV *KATIKA*

4 DECEMBER 2010

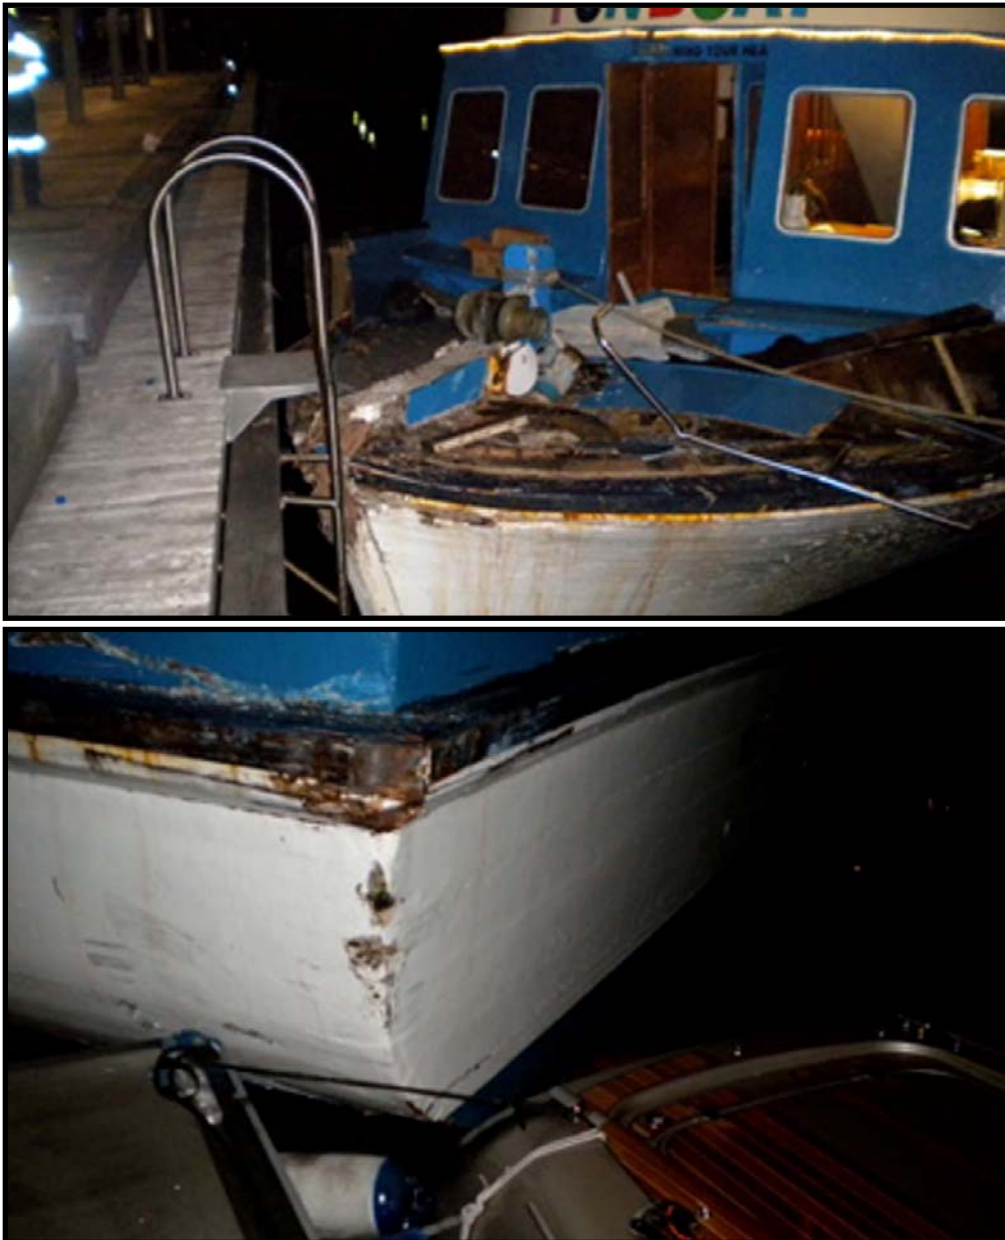
- 1.7 After the initial collision, the *Katika* continued to move forward still in Ahead gear, with the wheel hard to starboard. It travelled in an arc across Pyrmont Bay for approximately 70 metres to the Eastern side of the Bay. The starboard bow then collided with a wharf structure resulting in further damage and additional injuries to passengers. The vessel bumped along the edge of the wharf's boardwalk for a further 48 metres before the bow became stuck on a metal ladder attached to the wharf (see *Photograph 1*).

Photograph 1: Final bow and stern positions

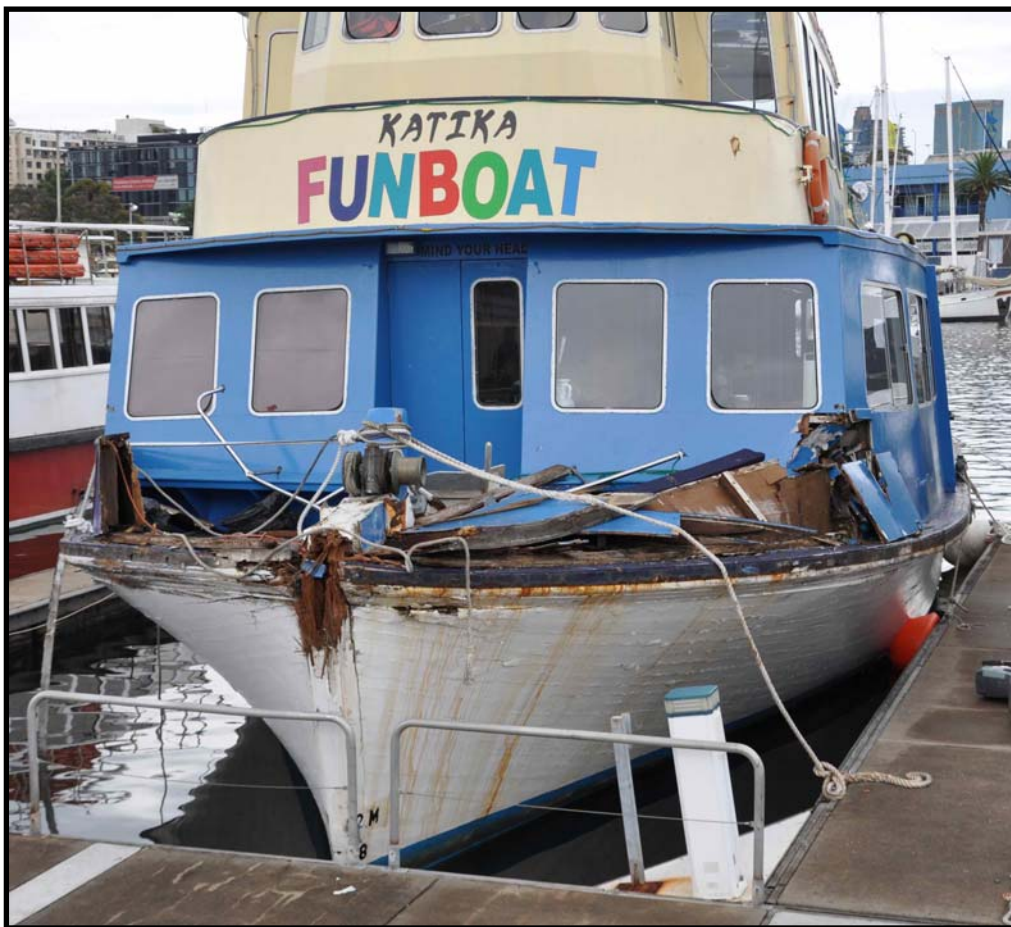
- 1.20 The stem, king plank and forward bulwarks were damaged beyond repair and decking forward of the cabin was torn up (see *Photograph 2*). The hull planking was sprung on both sides of the bow between the waterline and the gunwale. The cabin also sustained minor structural damage.

Photograph 2: View of damage

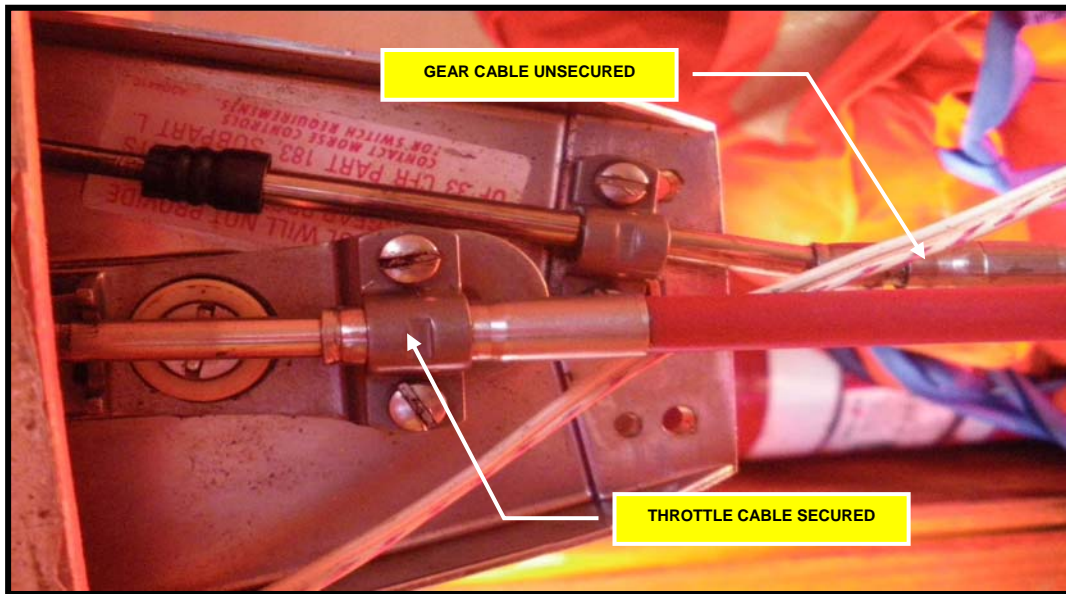
- 1.34 OTSI investigators conducted preliminary inspections of the *Katika* on 6 and 7 December 2010 at Blackwattle Bay Marina where it had been towed after the incident. Further examinations were conducted on 15 December 2010 and again on 13 January 2011 with the Master of the vessel at the time of the collision available to describe his experience of the incident to investigators.
- 1.35 The initial inspection of the *Katika* revealed that the throttle control cable was still connected and would work the throttle in both the Ahead and Astern position. However, the outer Morse/Teleflex[®] gear cable casing was not secured to the control housing under the control lever in the wheelhouse (see *Photograph 3*). As a result, the mechanism did not respond when the Master attempted to change gear from Ahead to Astern.

Photograph 3: View of control cables

- 1.36 The Morse/Teleflex[®] control unit is operated with a single lever. The central lever position is the Neutral position. The first position forward engages Ahead gear and the next position engages the throttle. The reverse applies. If the gear cable is disconnected while in gear, any movement of the lever in either direction only acts on the throttle. This accounts for the increase in speed of the *Katika* just prior to the first collision. In trying to engage Astern gear, but without success, the Master pulled the lever fully backwards which served only to increase the throttle to full engine speed.

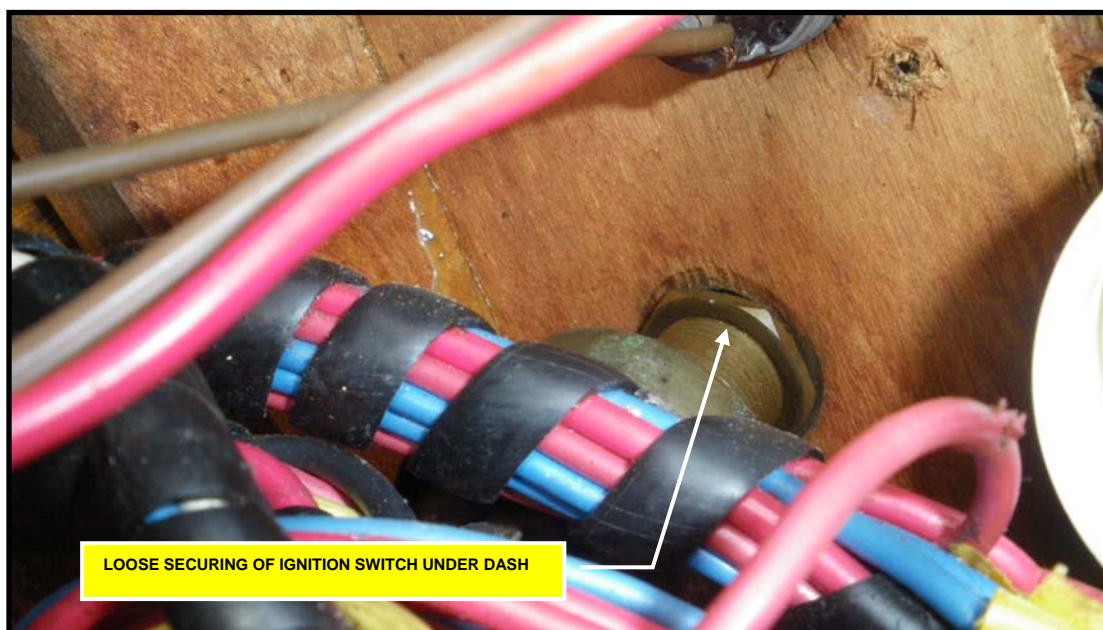
- 1.38 The engine is shut down from the wheelhouse by turning the ignition key anticlockwise to activate the solenoid on the fuel rack. This was tested on the night of the incident by the NSWMA investigator which showed that this function was working correctly so the engine could have been shut down from the wheelhouse. The Master could have done this when he realised impact was imminent, thereby reducing the collision force, or even after the initial

collision thereby probably avoiding subsequent collisions. However, the barrel of the ignition mechanism was not secured to the dashboard and the whole key and barrel rotated unless held firmly in one hand while the key was turned with the other hand (see *Photograph 4*). It was reported as having been like this for some time.

Photograph 4: Loose ignition switch barrel

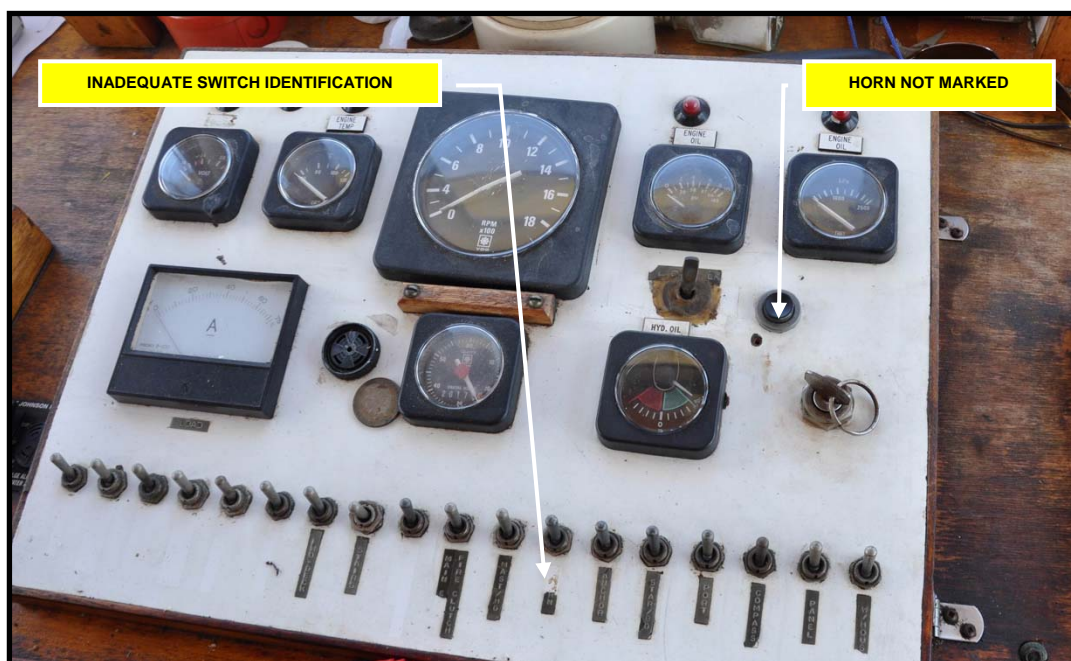
- 1.39 The dashboard in the wheelhouse was not secured properly nor was the single lever control mounting. Some switches on the dashboard showed markings to indicate what the switch operated but much of the labelling was unreadable and other switches were not labelled (see *Photograph 5*). The horn button was not marked and could easily be mistaken for the main engine start or shut down switch.

Photograph 5: Dashboard

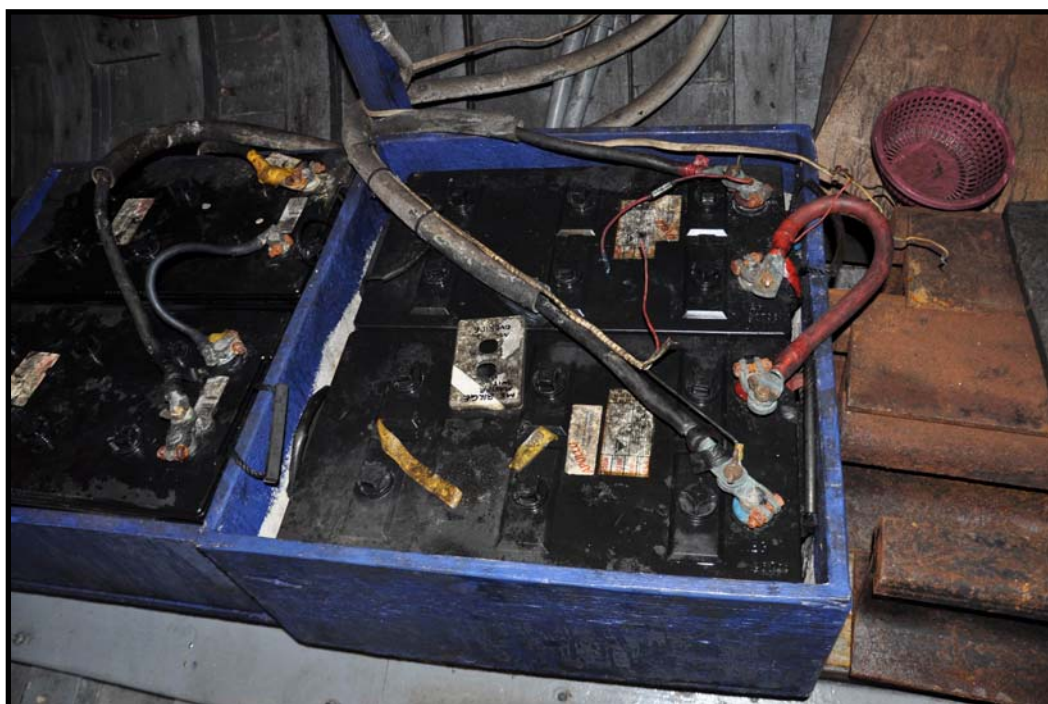
- 1.40 On further examination of the *Katika*, the battery terminals were found to be badly corroded (see *Photograph 6*) and the air intake to the auxiliary diesel generator was almost totally blocked with dust. There were loose wiring connections throughout the 24 volt electrical systems in the wheelhouse and in other areas including the engine room, galley, bar and saloon and upper decks. The whole engine room showed evidence of very poor housekeeping and there were no records to verify that any maintenance had been carried out.

Photograph 6: Battery installation

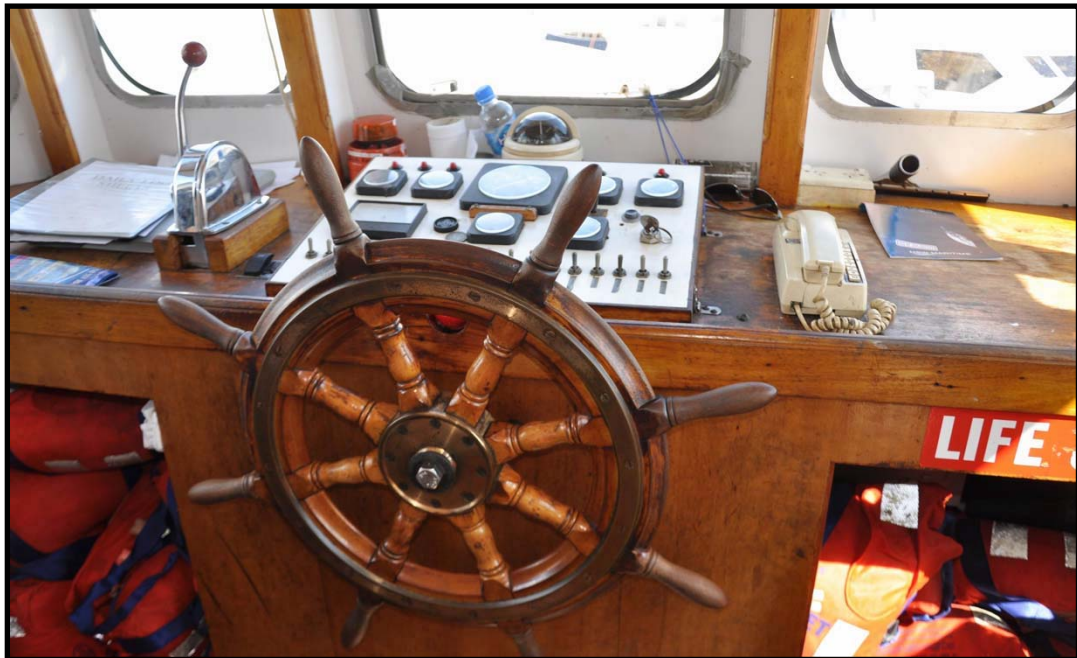
- No passenger safety briefings were given at the commencement of cruises despite scripts being available.⁴
- All upper deck life jackets were crammed under the wheelhouse dashboard where they could interfere with the control cables and wiring. Passenger access to this stowage located in a blind area was hampered by the Master in his position at the wheel (see *Photograph 7*).
- Many of the life jackets on the lower deck were still in their manufacturer's plastic wrapping thus preventing immediate use.

Photograph 7: Lifejackets in wheelhouse

- 3.11 Rectify the safety defects and deficiencies identified in this investigation as applicable on all fleet vessels.

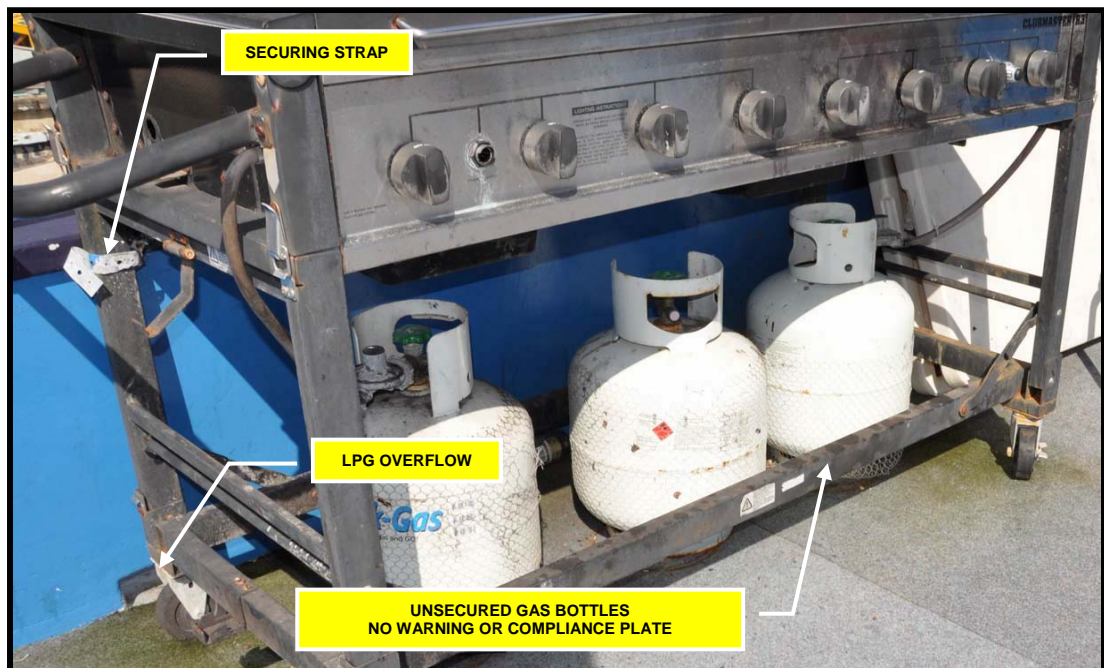
- The location of the gas bottles on the top deck was such that, in the event of a gas leak, LPG gas could enter the engine room as the scuppers were located in close proximity to the engine room air intakes.

- The barbecue was secured with jagged, sharp metal straps which could inflict injury.

Photograph 8: LPG gas barbeque on upper deck

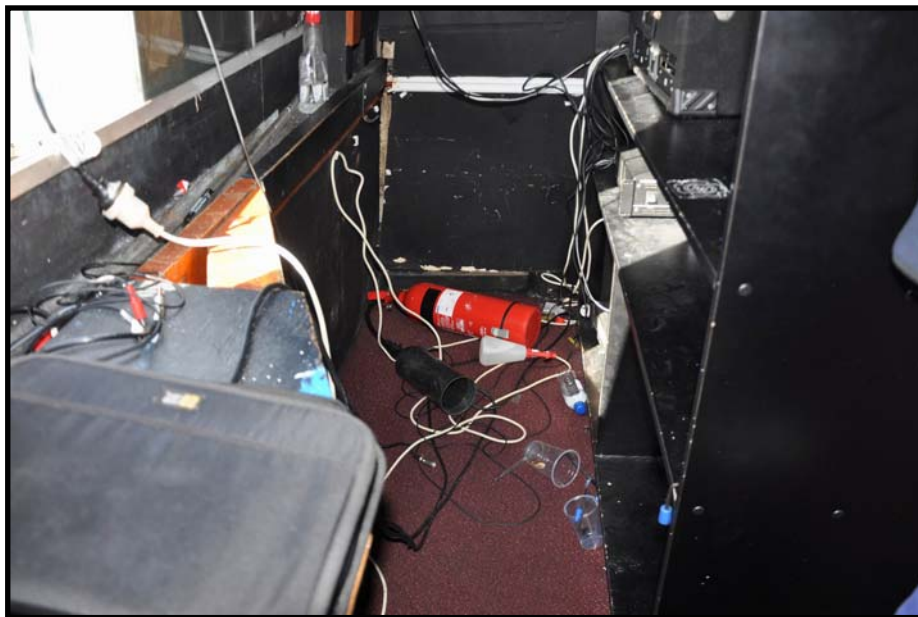
- The strobe light attached to the life ring near the wheelhouse was unserviceable.
- Numerous 240 volt power leads were not tagged as required and speaker cables ran through open windows to the top deck allowing water in inclement conditions to run down the cables into electrical equipment (see *Photograph 9*).
- Fire extinguishers were not secured and so could become missiles in a collision.

Photograph 9: 240 volt cables and unsecured fire extinguisher

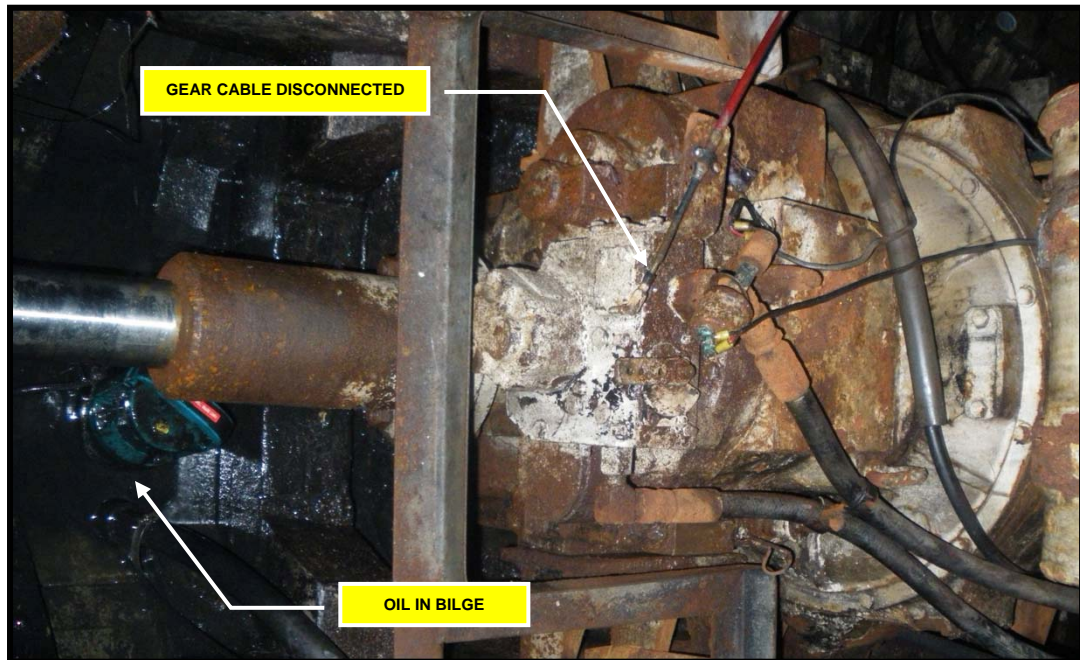
- Large amounts of oil floating on the bilge water in the engine room presented a fire risk (see *Photograph 10*).

Photograph 10: Oil in bilge
