## MARINE SAFETY INVESTIGATION REPORT

**COLLISION BETWEEN SYDNEY FERRIES' HARBOURCAT  
*PAM BURRIDGE* and MOTOR LAUNCH *MERINDA***

**SYDNEY HARBOUR**

**28 MARCH 2007**

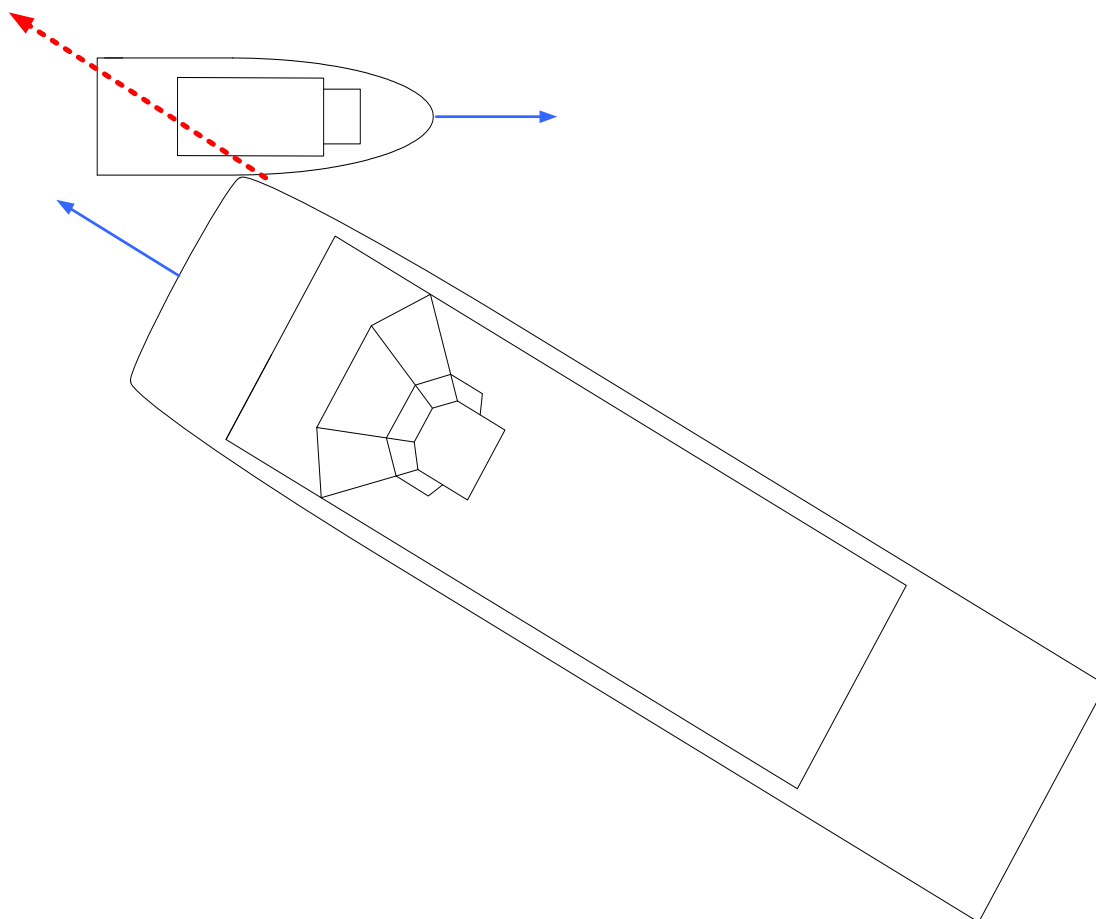
**Diagram 1: Angle and point of impact of the collision**

- 1.9 *Merinda’s* Helmsman advised OTSI that he did not see *Pam Burrige* at all and, upon hearing a series of loud bangs, thought that he had hit either a submerged or a floating object.
- 1.10 The starboard pontoon (hull) of *Pam Burrige* collided with the starboard side of *Merinda* around the midway point and continued through *Merinda*, tearing through the hull, machinery space and decking, and dislodging the transom. *Merinda’s* fly bridge was all but lifted away as a result of the collision. *Diagram 1* shows the angle at which the vessels collided.

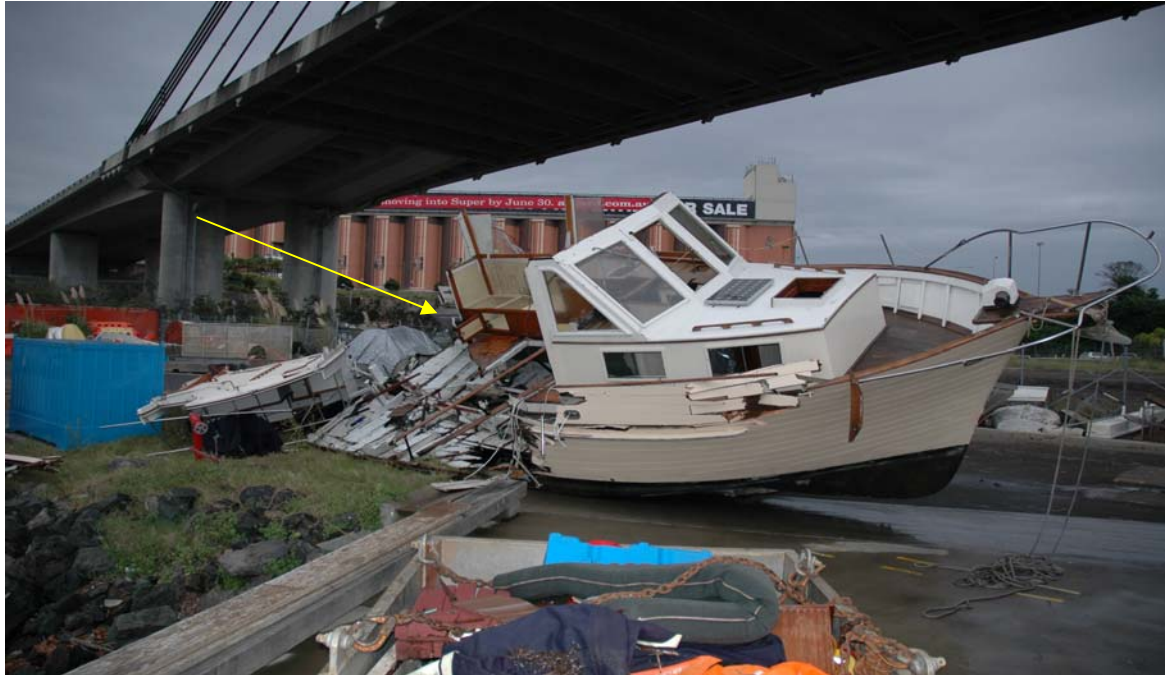
**Photo 3: Depicting the extent of damage to *Merinda***

- 1.11 *Photo 3* shows the extent of the damage to *Merinda*. *Photo 4* depicts an area of *Merinda's* deck over which *Pam Burrige* passed and further indicates the angle of the collision. The specific location of this area of deck is indicated by the yellow arrow in *Photo 3*.

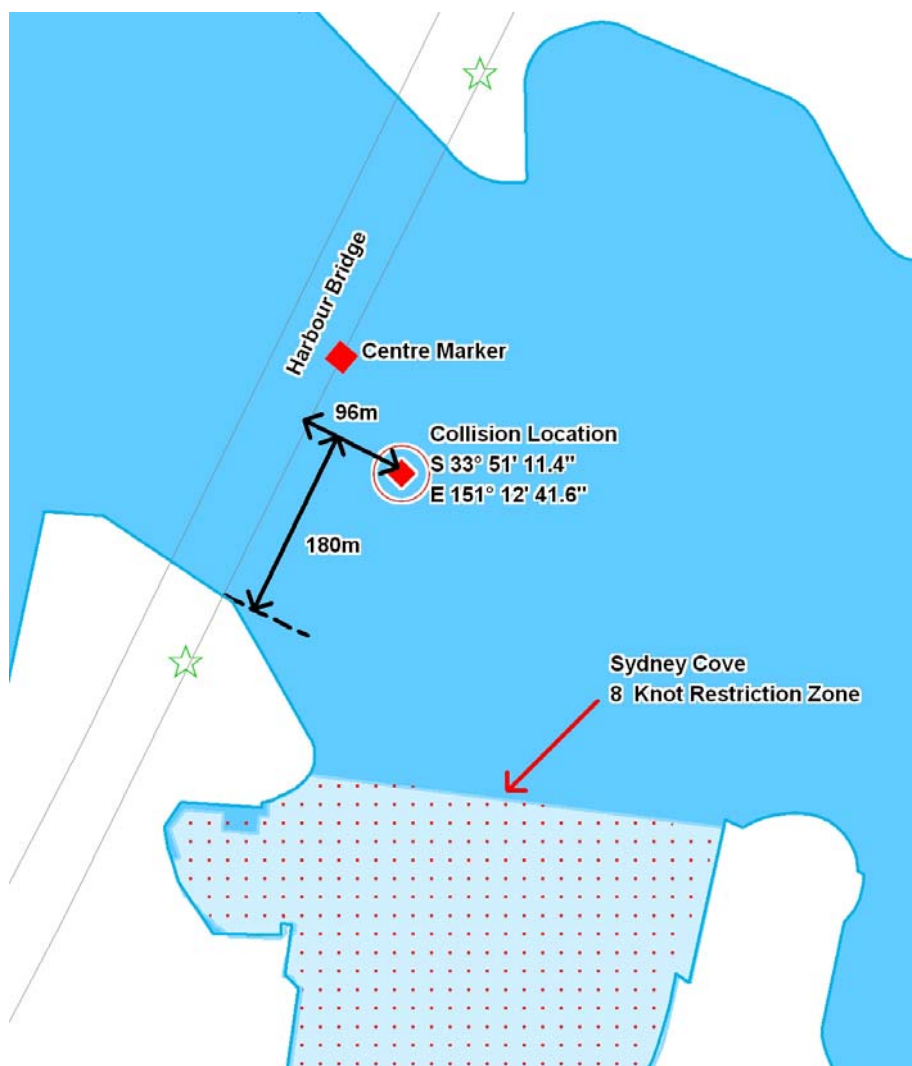
**Diagram 2: Collision Point, Latitude: S 33° 51' 11.4\", Longitude: E 151° 12' 41.6\"**

speed at which they were operated, or the exact location of the collision as neither vessel was fitted with a data logger.<sup>10</sup> Additionally, the actual collision was not captured on radar and although *Pam Burrige* was fitted with a Global Positioning System (GPS), it displayed, rather than recorded, information. Nevertheless, analysis of CCTV footage supplied by the RTA, together with radar records supplied by Harbour Control allowed OTSI to calculate that the collision occurred approximately 96 metres East of the Sydney Harbour Bridge and on a perpendicular to the Bridge 180 metres from the shoreline of Dawes Point, as depicted in *Diagram 2*.

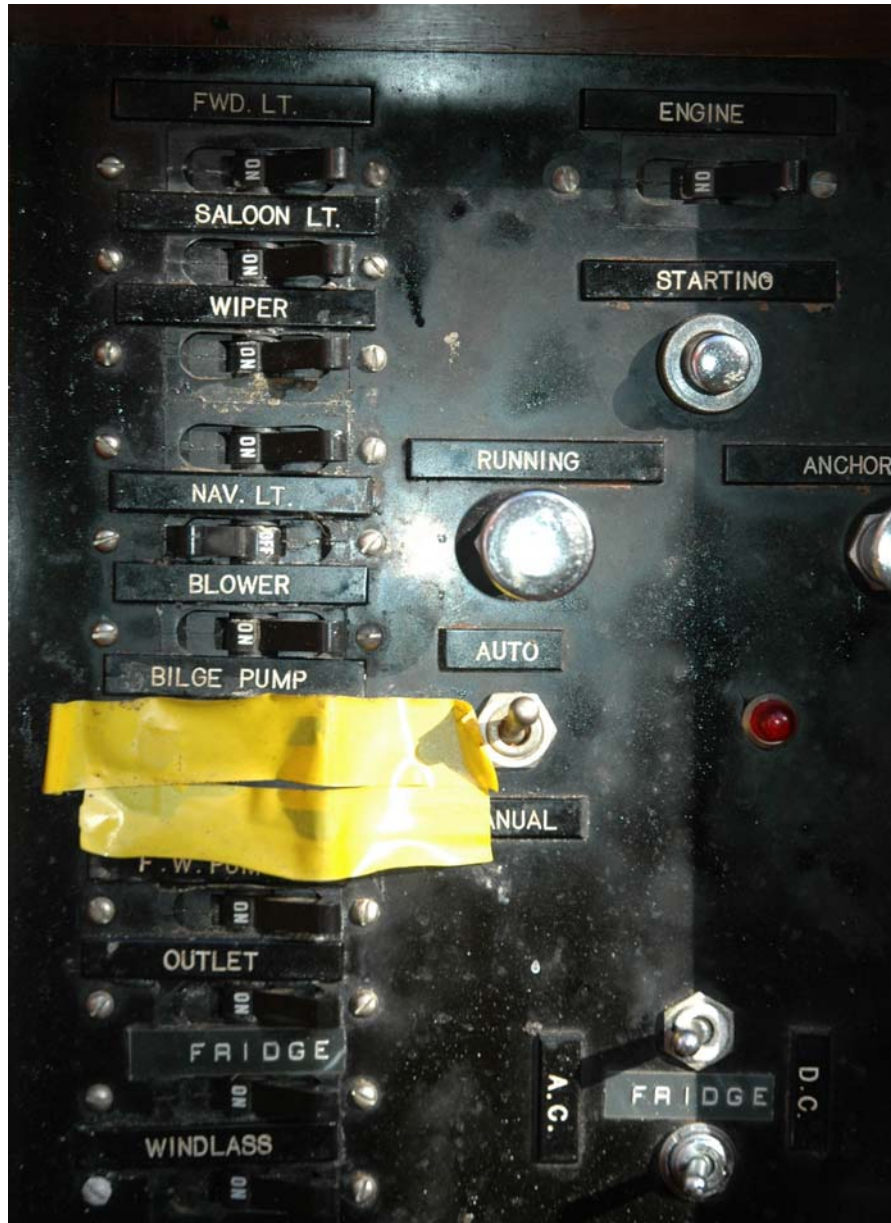
Photo 5: *Merinda*'s circuit and control switches, showing the "NAV. LT." Circuit Breaker in the OFF position

- 2.6 When the wreckage of *Merinda* was inspected by OTSI investigators, the condition of that part of the vessel that had suffered least from the collision indicated that the vessel had been in relatively good condition. Examination of the control panel revealed that two switches were taped over (see *Photo 5*) and one of the owners of the vessel advised that this was to ensure that no-one inadvertently switched off the bilge pumps. It was also noted that while the running light switch was in the 'ON' position, the navigation light circuit breaker switch was in the 'OFF' position. The potential significance of the condition of the circuit breaker switch is addressed later in the report. On the basis of the advice provided to OTSI and its own examination, OTSI determined that there were no grounds to conclude that *Merinda* was other than seaworthy when it commenced its cruise on the night of 28 March 2007.

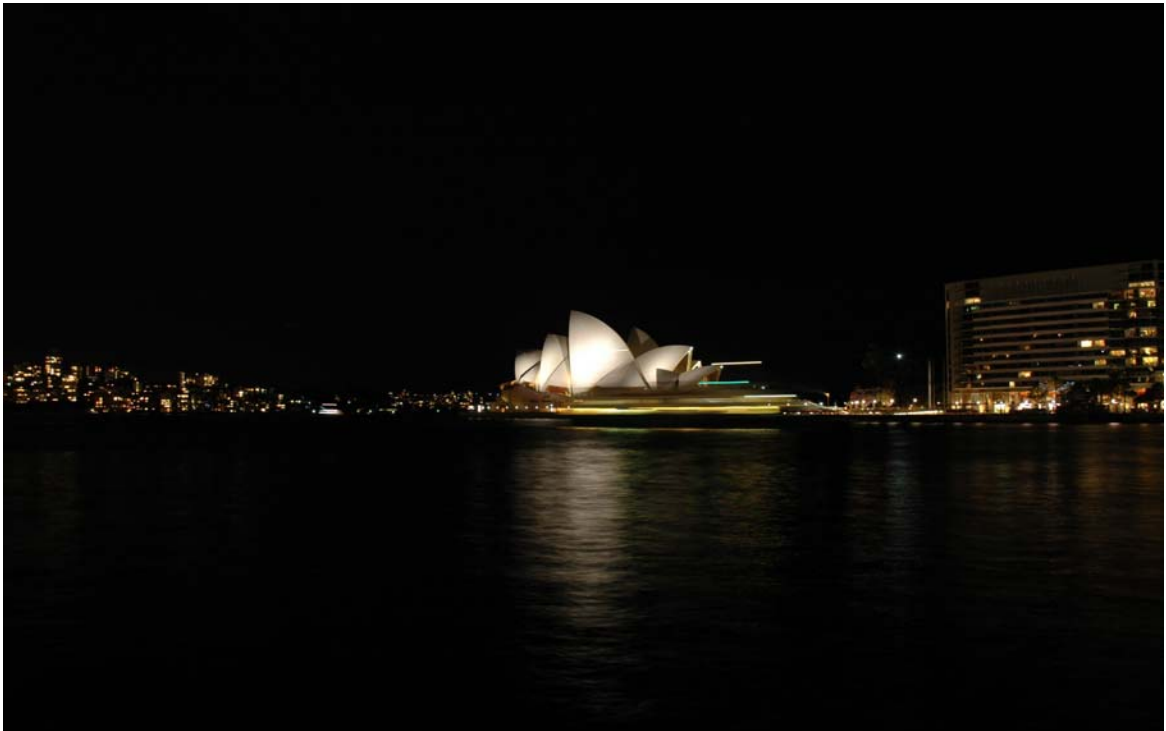
**Photo 11: Lighting conditions looking Eastwards**

<sup>41</sup> *Photo 11* was taken from Dawes Point and the perspective is therefore slightly different to that which would have been seen by the Helmsman. The bright horizontal yellow line in front of the Opera House is emanating from a passing ferry. *Photo 12* was also taken from Dawes Point, so it too provides an approximation only. Nonetheless, the two photographs do illustrate that the lighting to the North was less even than that to the East.

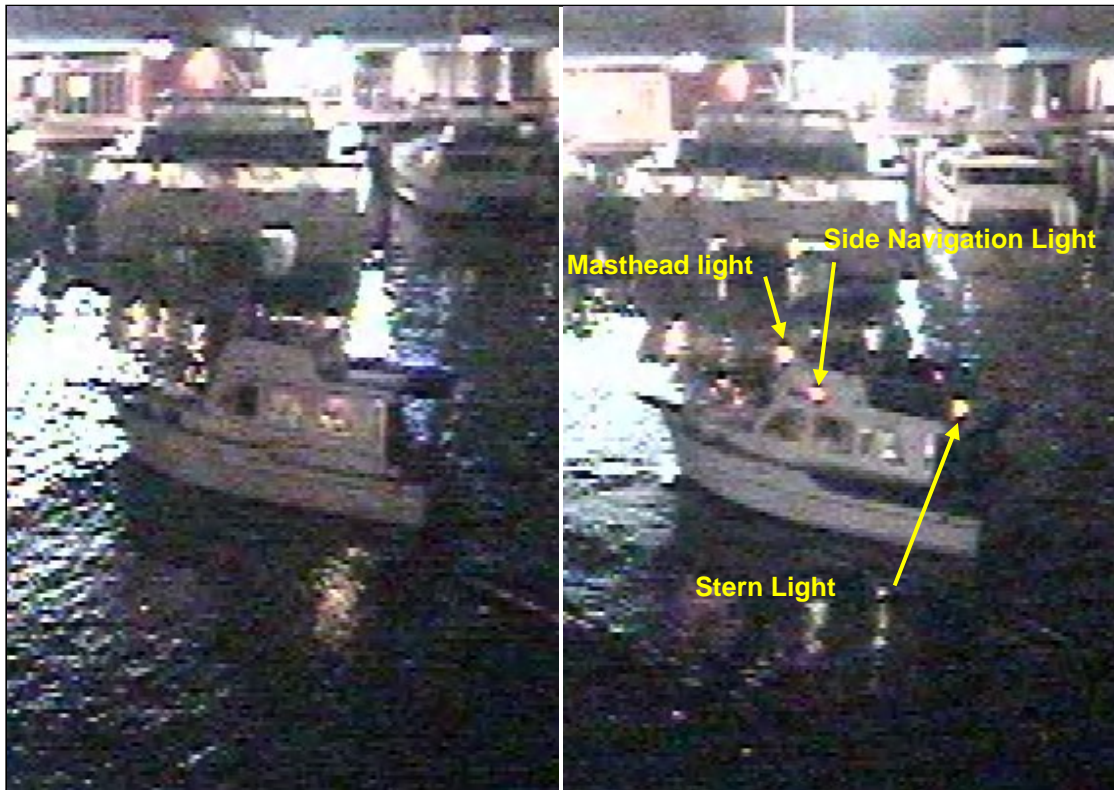
Gypsy's Port side navigation light appears white, as opposed to its actual red, in *Photo 15* is a consequence of the limitations of the CCTV recording, the relative angle of the vessel to that of the camera when the image was captured and the preponderance of other light sources in the immediate vicinity. The significant issue is that *Merinda's* navigation lights are clearly not exhibited.

**Photo 14: *Merinda* departing Walsh Bay, 28 March 2007**

**Photo 15: *Island Gypsy* departing Walsh Bay, 24 July 2007**

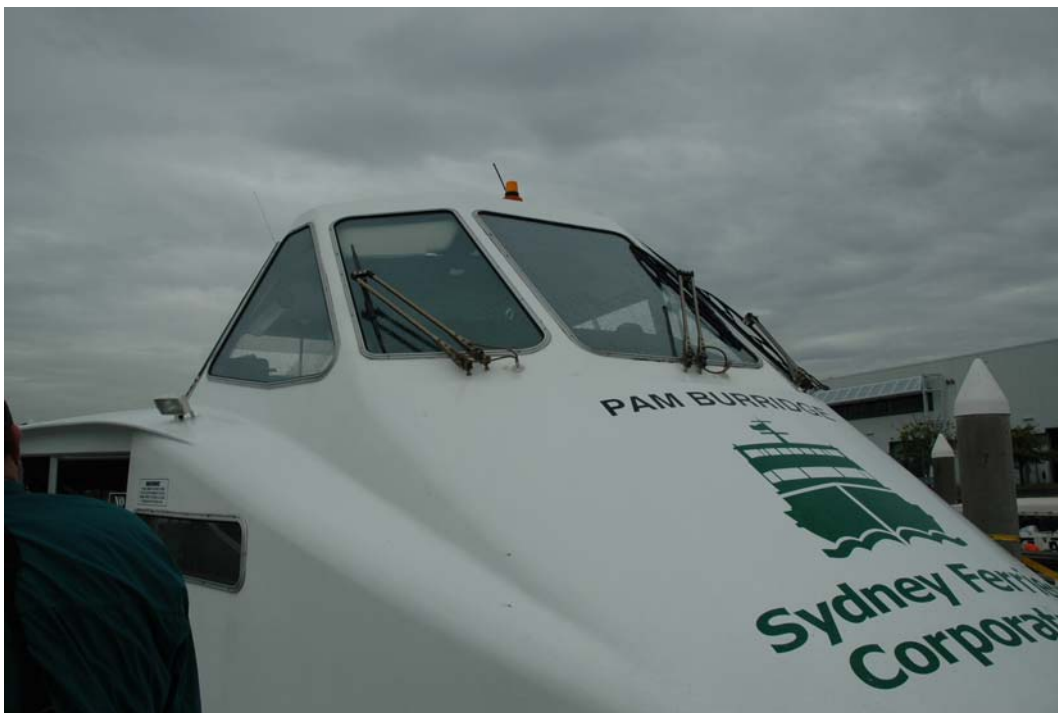
**Photo 16:** *Pam Burridge's* wheelhouse, showing supporting pillars

- b. *Pam Burridge's* wheelhouse elevates the Master's eye height approximately 4 metres above water level. This, in conjunction with the placement of the supporting pillars (see *Photo 16*) provides a

good field of view, albeit one which provides a ‘top-down’ perspective of smaller vessels.

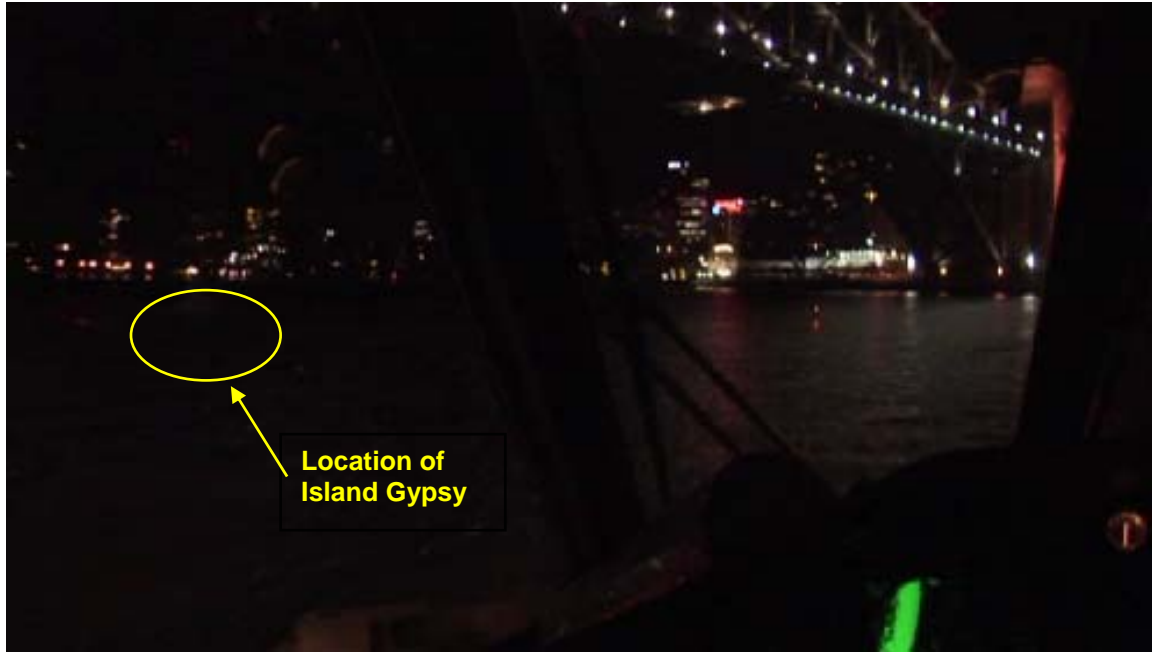
**Photo 18: Island Gypsy, with navigation lights extinguished, as viewed from *Pam Burridge***

the illumination from the two saloon lights was insufficient to make the vessel apparent from the wheelhouse of *Pam Burridge* at other than very close range (see *Photo 18*).

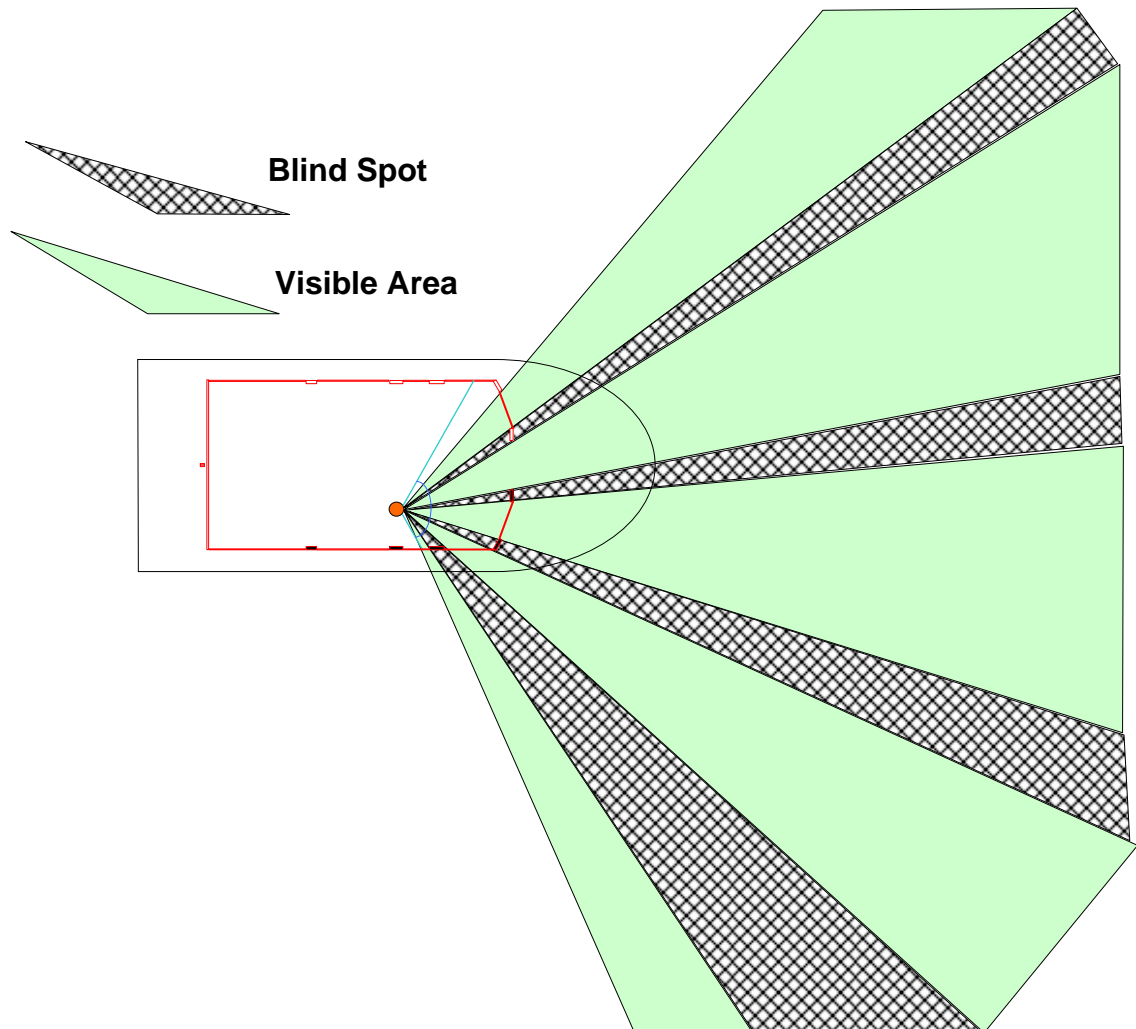
**Diagram 3: Indication of the effect of the Island Gypsy pillar design on visibility**

2.76 *Diagram 3*, a scaled representation which takes into account the height of the Helmsman and the position from which he was controlling *Merinda*, illustrates the extent to which the main saloon's design can restrict visibility if a helmsman remains in a relatively static position.

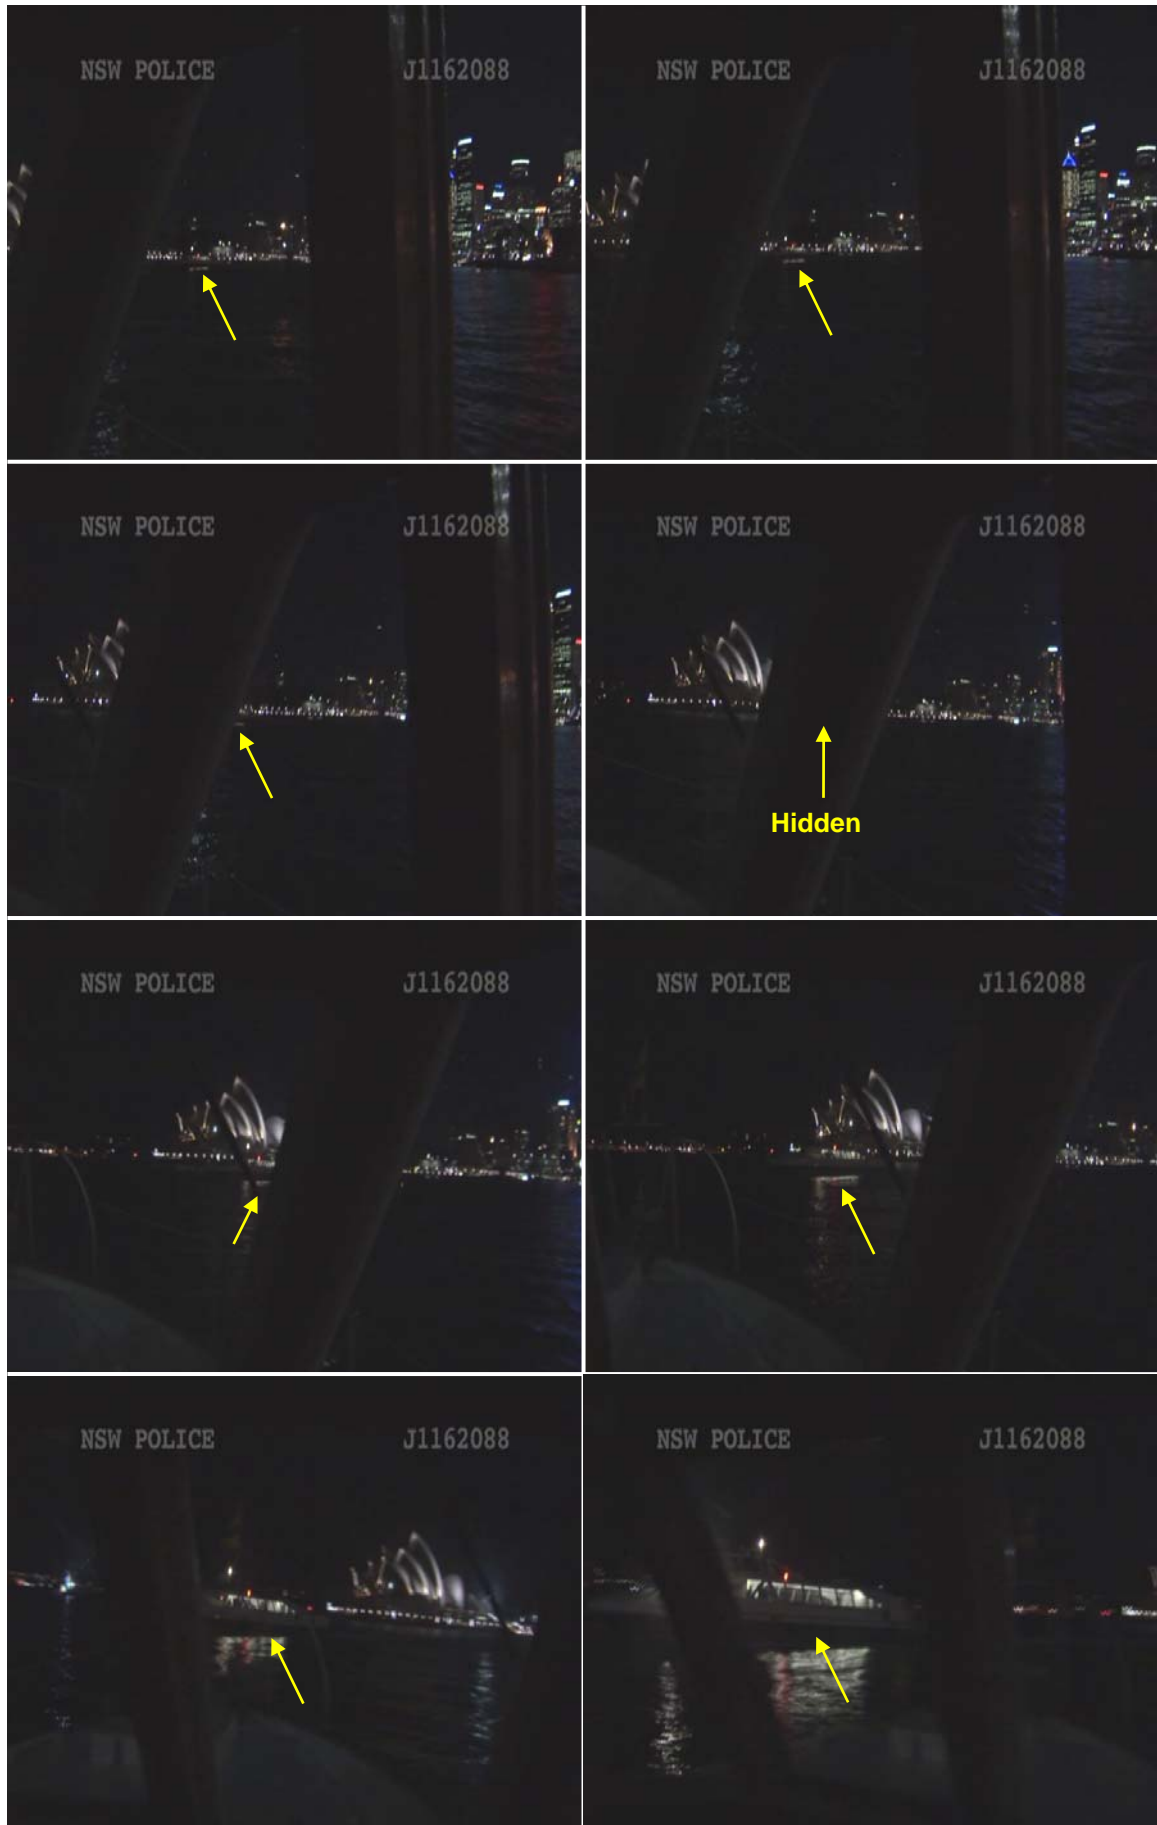
**Photo 21: Series of eight frames showing *Pam Burrige* moving out of Sydney Cove, as viewed from within the *Island Gypsy*'s saloon**

2.77 The eight frames in *Photo 21*, appearing on page 45, were obtained from video footage taken during the re-enactment. The frames depict a period of *Pam Burrridge's* movement out of Circular Quay as filmed from within the saloon of the *Island Gypsy* from the same driving position as the Helmsman would have operated on *Merinda*. The consecutive frames are separated by approximately two seconds in time and the significance of each frame, as viewed from left to right and top to bottom, is described on page 46 following the *Photos*:

- a. in frames 1 and 2, *Pam Burrridge*'s mast head light, cabin lights and Port navigation light (indicated by the yellow arrow) are visible;
- b. in frame 3, *Pam Burrridge* is disappearing from view behind the cabin pillar on the left;
- c. in frame 4, *Pam Burrridge* has disappeared from view;
- d. in frames 5-7, *Pam Burrridge* commences to re-appear and its masthead light, cabin lights and Port navigation light are visible, and
- e. in frame 8, *Pam Burrridge*'s masthead light, cabin lights and Port navigation light are visible, as is the vessel's bow.

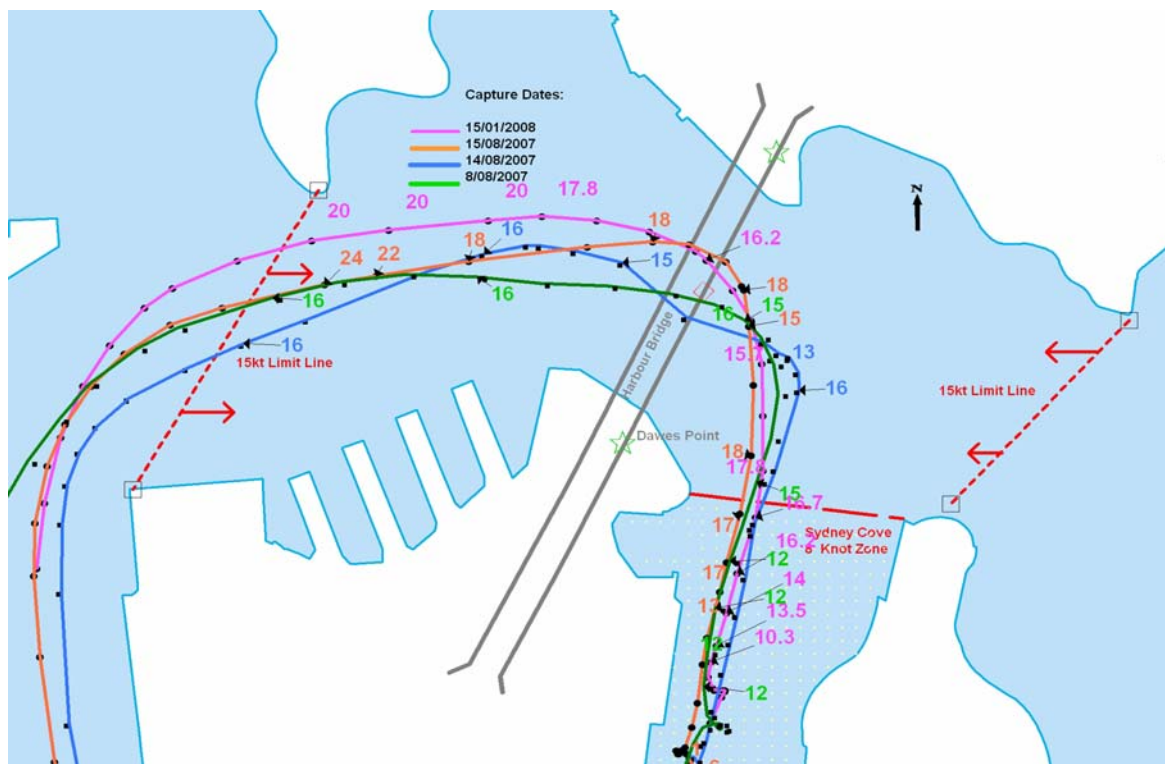
**Diagram 4: HarbourCat tracks and speeds recorded on 8, 14 and 15 August 2007 and 15 January 2008**

earlier than before he/she should have and virtually passed underneath the red diamond. The blue track, recorded on 14 August 2007, shows that the master accelerated slightly before reaching the limit line, turned before his/her vessel was abeam of the red diamond and crossed to the South rather than the North of the channel, but otherwise operated at an appropriate speed. The red trace, recorded on 15 August 2007, indicates that the master operated in excess of the speed limit virtually from the time he/she left Circular Quay and was travelling at twice the permissible speed as he/she approached the limit line, commenced to turn well before the red diamond, but did pass to the North of the channel.

2.84 OTSI repeated the above exercise on 15 January 2008. The purple track indicates that the master exceeded the 8 knot limit within the Cove and the 15 knot limit within the immediate vicinity of the Bridge and commenced to turn toward the Bridge before he was abeam of the red diamond. However

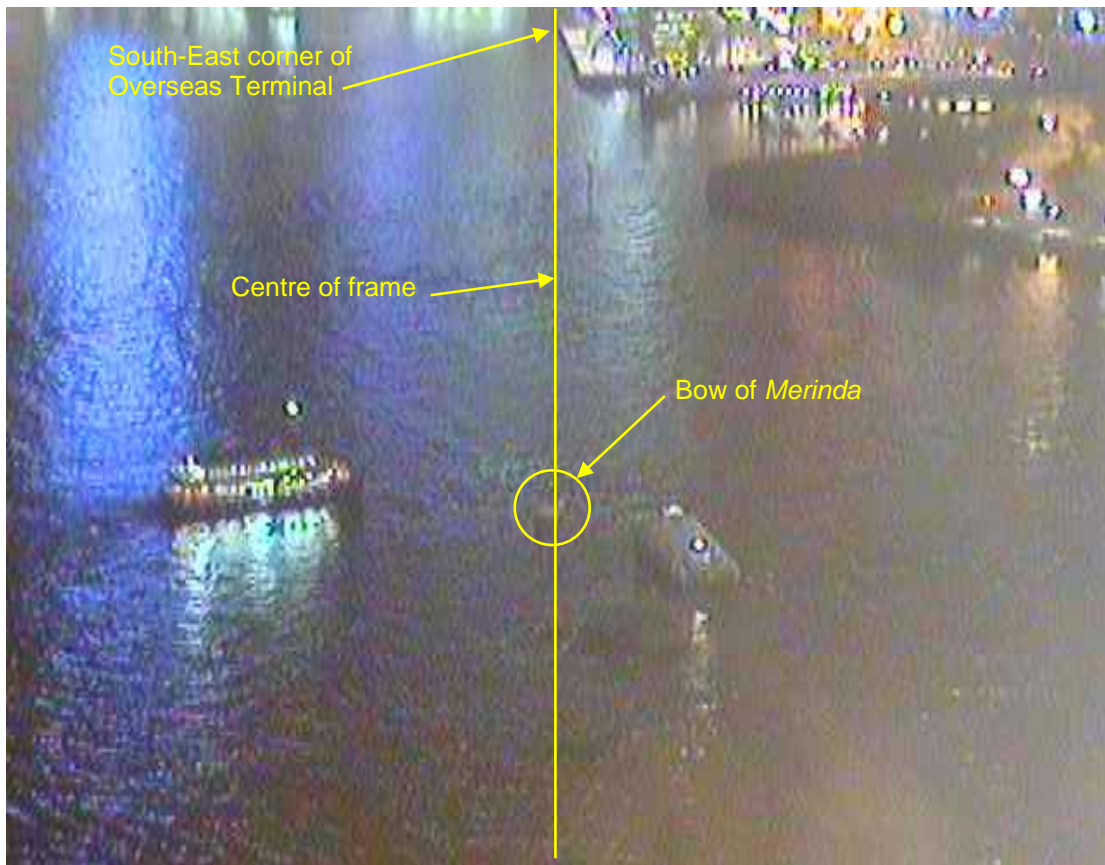
**Photo 22: Location of bow of *Merinda* as recorded by Camera 1**

Camera 1 was re-oriented within a minute of the collision onto the wreckage of the *Merinda* and subsequently captured the response effort. A short, early sequence clearly shows in centre frame the bow of *Merinda* surfacing after having been submerged. Fortuitously, the South-Eastern corner of the Overseas Passenger Terminal is also in centre frame in the background, indicating that the bow of the *Merinda* surfaced on a line from the camera to the corner of the Overseas Passenger Terminal, as shown in *Photo 22*.

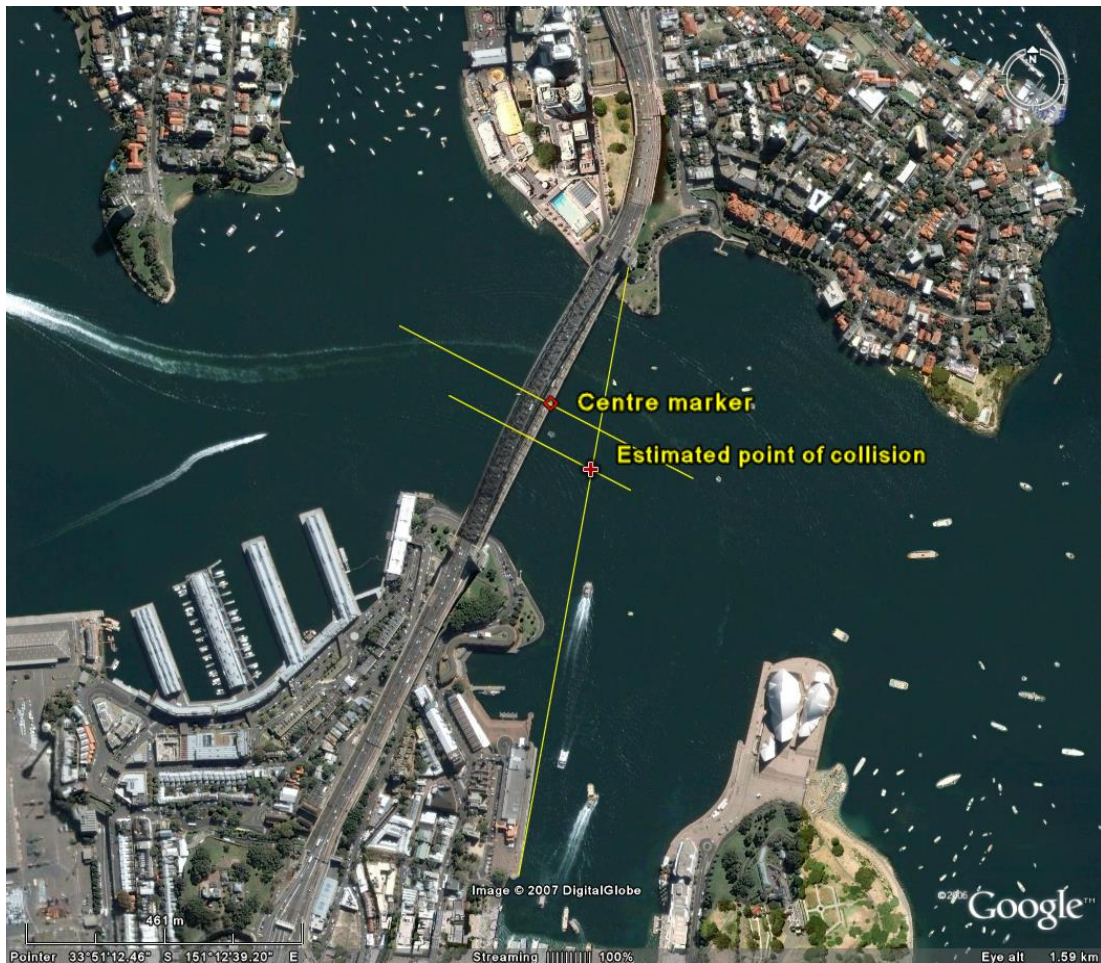
**Image 2: Indicating the estimated point of collision**

Camera 2, mounted above the central walkway between the tops of the East and West arches of the Harbour Bridge and looking down and to the East, also shows the *Fishburn* arriving on scene after the collision. Although no other vessels can be seen and the wreckage of the *Merinda* cannot be discerned on this footage, a comparison of the images captured by this camera with those showing the position of the *Fishburn* at the same times from Camera 1, together with *Fishburn*'s known length, allows an estimation to be made of the distance from a perpendicular to the centre of the Bridge to the position where the bow of the *Merinda* surfaced. The intersection of the lines determined by these two CCTV records gives the location at which the *Merinda* surfaced after the collision, as shown in *Image 2*, as South 33°51'11.4", East 151°12'41.6".

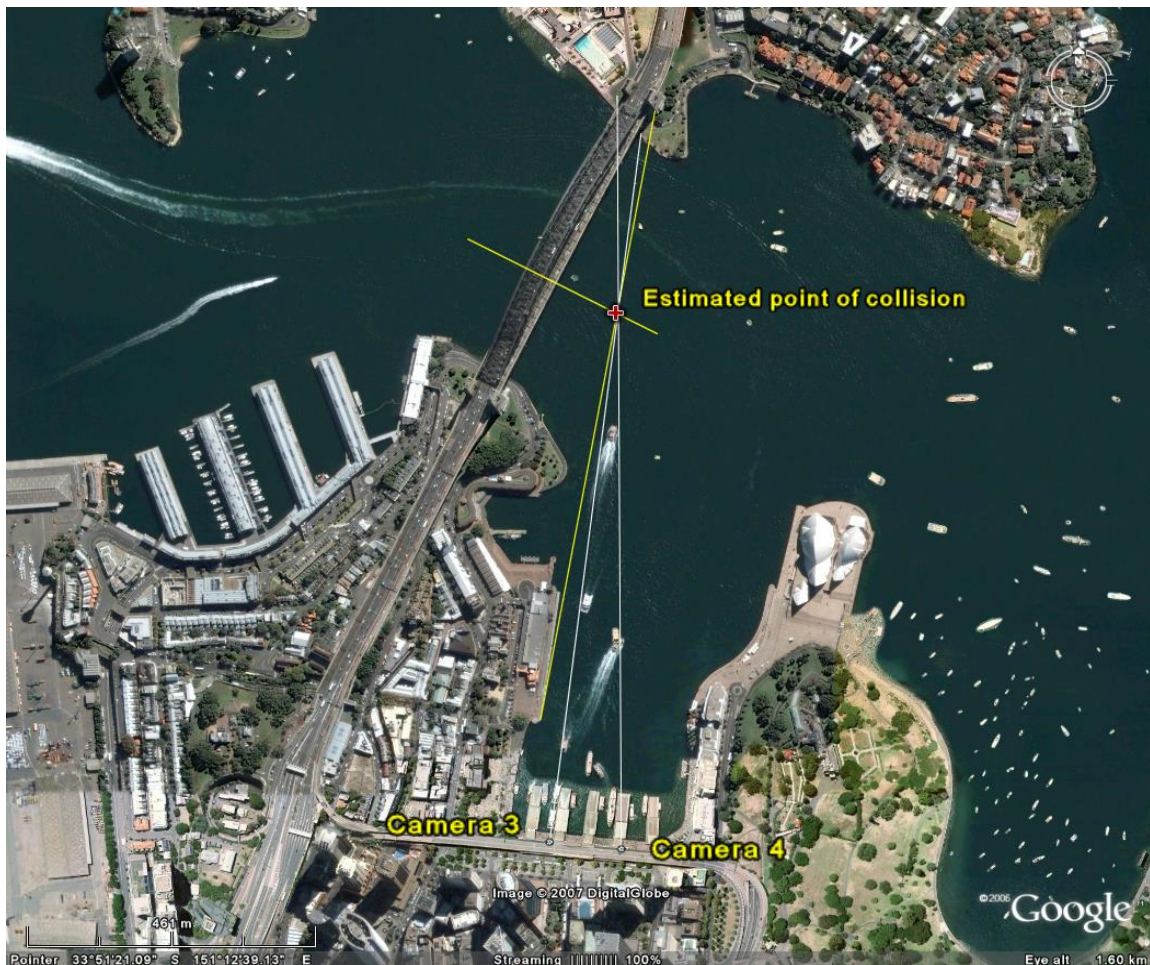
**Image 3: Lines of sight from Circular Quay cameras to area of the collision**

*Image 3*, these lines of sight are superimposed on an image showing the location determined from the RTA camera records as seen in *Image 2*. As can be seen, there is close agreement between the locations determined by these two independent methods, indicating that the wreckage of the *Merinda* surfaced very close to the location of the collision.
