FERRY SAFETY INVESTIGATION REPORT

COLLISION INVOLVING SYDNEY FERRIES' *SIRIUS* WITH THE AQUARIUM WHARF, *OCEAN DREAMING* AND THE PYRMONT BRIDGE

22 MARCH 2007

Investigation Reference 04359

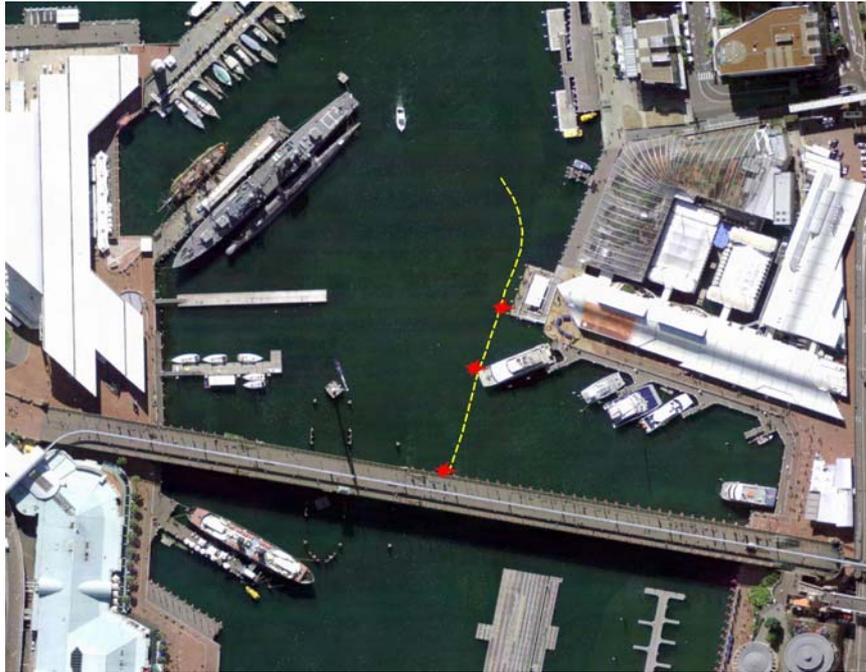
Photograph 1: Approximated points of collision, Darling Harbour

- 1.5 The three incidents of collision occurred in quick succession and at low speed and as a consequence there were no injuries and the resulting damage was largely superficial. *Photograph 1* depicts the approximate points at which the collisions occurred.

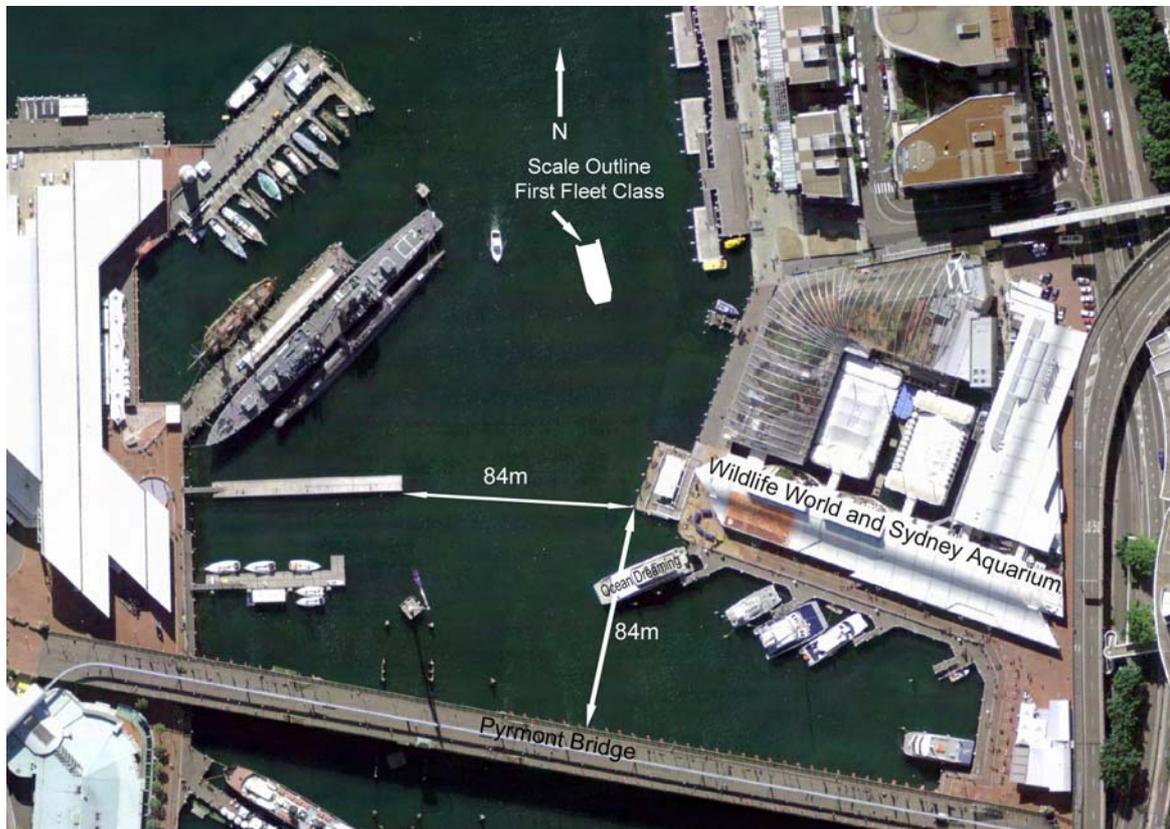
Photograph 2: Overview of Accident Site

- 1.7 The Aquarium Wharf is situated approximately 84m North of Pyrmont Bridge. The wharf services vessels and passengers on the Eastern side of Darling Harbour's entertainment area and is located in the immediate vicinity of the Australia Zoo and the Sydney Aquarium. Significantly, the presence of a

pontoon opposite the wharf and the fact that there is limited clearance under Pymont Bridge restricts the manoeuvre of large vessels in this area. These major features and the extent to which they limit manoeuvre are depicted in *Photograph 2*.

Sydney Ferries' masters are required to adopt certain vessel-specific practices when berthing at dead-end wharves. Aquarium Wharf is not defined as a dead-end wharf but there is very limited room in which to manoeuvre in the event of a problem during berthing. OTSI considers that Sydney Ferries' masters should be required to approach this wharf in the same manner as they would a dead-end wharf.

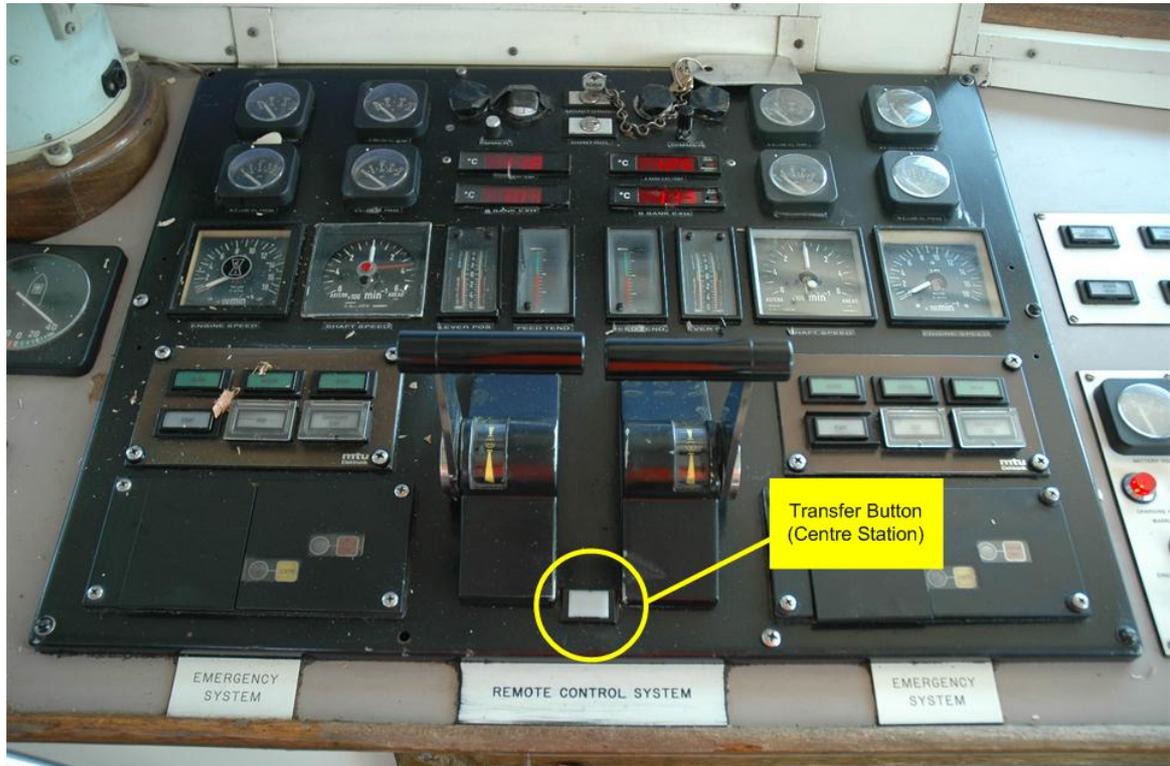
Photograph 3: Transfer Button

- 2.4 To switch control between stations, the master presses a button (*Photo 3*) to initiate transfer to another station and once in position at the new station, moves the controls until they are synchronised with the controls at the station

from which the transfer was initiated. Once the controls have been synchronised, the transfer process is complete.

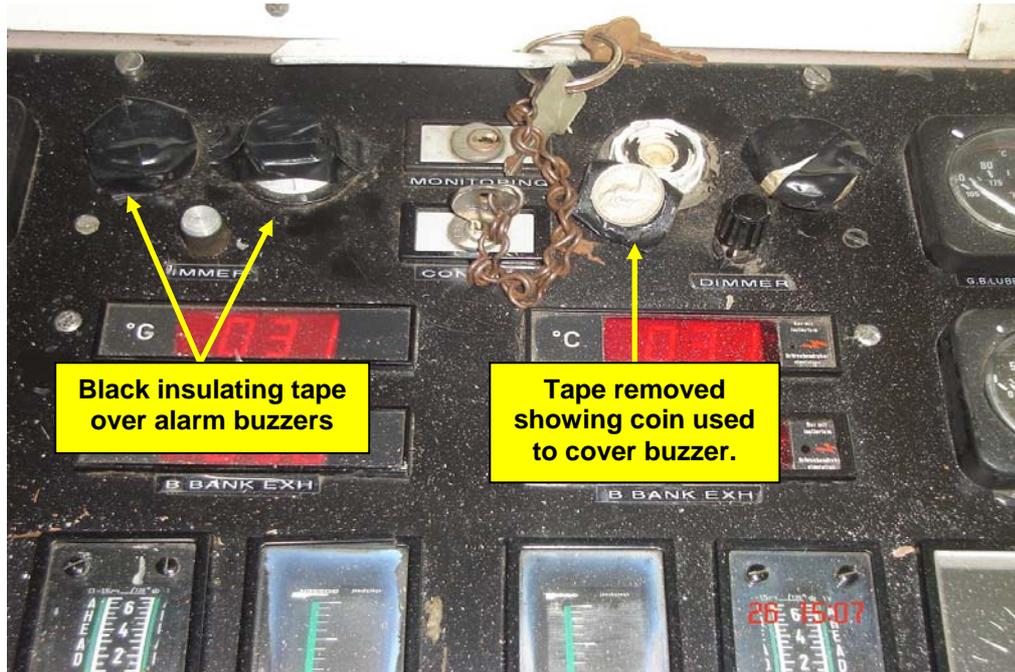
Photograph 4: Control Station

- 2.5 When the request for transfer is initiated, an audible alarm is activated and this continues to sound until the transfer process is completed. When OTSI examined *Sirius*, it noted that the alarm's buzzer had been stuffed with paper and that coins had been taped over it with insulating tape, as can be seen in *Photograph 4*. Based on the appearance of the tape, this modification did not appear recent and it was clearly intended to dampen the intensity of the associated audio output which, at unmuffled full pitch, may have acted as a distraction to the crew. Subsequent to this incident, the audio alarm mechanisms have been rendered redundant through the installation of an automatic return to slow ahead after an incomplete change of stations.

- ii. In addition to the control system being designed in such a way that prevents the inadvertent transfer of control from one station to another, the system also incorporated an alarm that was activated when a request for transfer was initiated and terminated when the transfer was completed. This alarm was operational but had been interfered with to dampen its audio output; as a consequence, the alarm may not have been sufficiently loud for the Master to have heard it if he had not completed the control transfer process.

- 2.15 Upon being made aware that the audio alarm on *Sirius* had been subjected to unauthorised modification, Sydney Ferries issued *Fleet Marine Circular 75* which instructed that masters should specifically check for and report such indications. While OTSI considers this to have been an appropriate action, the fact that it should have been necessary for Sydney Ferries to have issued such an instruction is disappointing given that its masters know that they are under a fundamental obligation to report any matter that impacts, or could impact on, a ferry's safety systems.

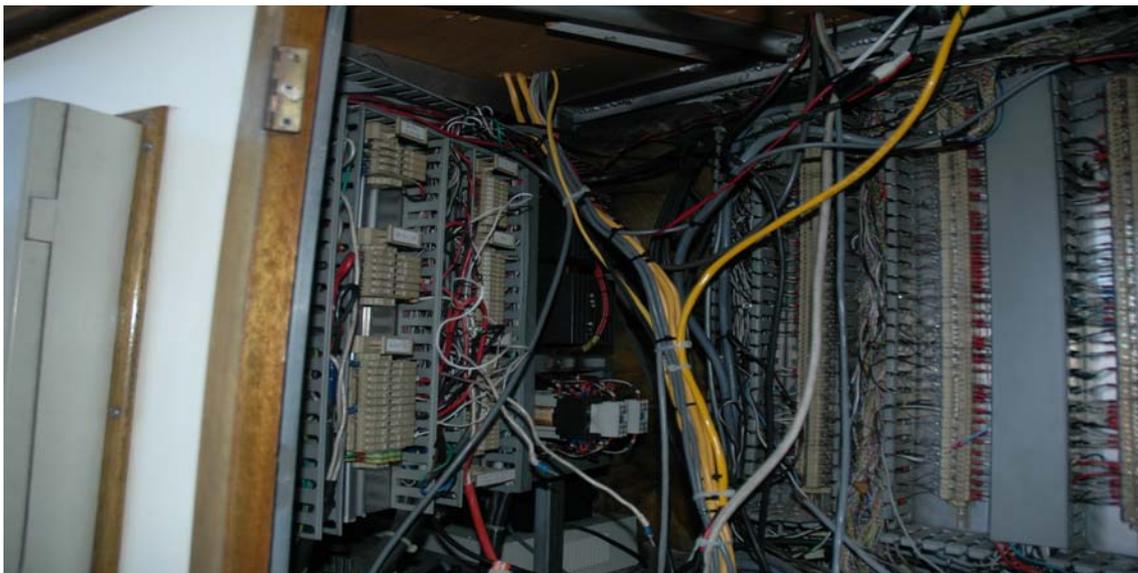
Photograph 5: Wiring underneath control console

- 2.7 An examination of the locker spaces below the control console revealed that the general state of the vessel's wiring was sub-optimal. A variety of cables ran side-by-side, as can be seen in *Photograph 5*, carrying a variety of voltages and currents. The implications of running control system wiring among other potential sources of electromagnetic interference are that a false or interrupted signal which could affect the vessel's controls may be generated. In addition, much of the ferry's wiring is made of copper which is prone to metal fatigue if not properly secured. Unsupported lengths of cable also place stress on connectors and terminals and it was apparent that a

- ii. The state of the control wiring onboard *Sirius*, particularly its routing, was sub-optimal. This raised the possibility that electromagnetic interference (EMI) could have contributed to a false control signal and a loss of control. However, exhaustive testing of the ferry's control electronics failed to replicate the fault condition described by the Master. Accordingly, OTSI considers that it is unlikely that the loss of control was a consequence of an electrical fault.

- 2.16 While the upgrade of First Fleet ferries was not in response to the Darling Harbour incident, it has significantly enhanced arrangements within the wheelhouse and revised wiring arrangements should reduce the possibility of electromagnetic interference to and within the control system. Replacement of the buzzer alarm with an automatic return to slow ahead after an incomplete change of stations provides an additional layer of defence.

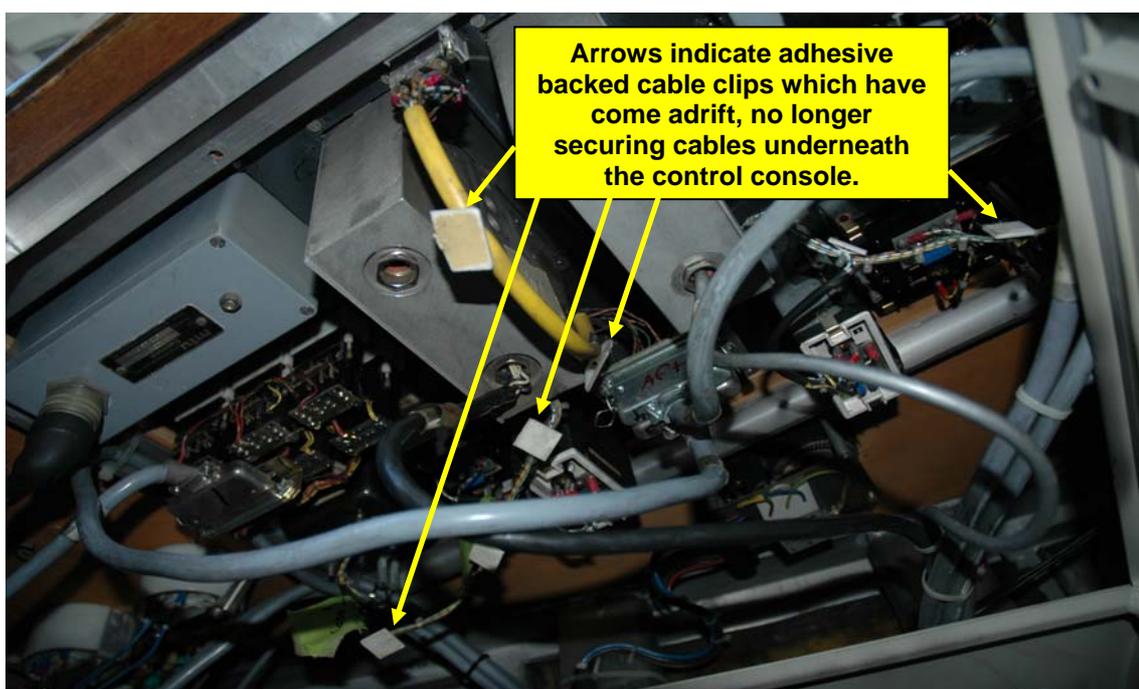
Photograph 6: Poorly secured wiring

number of cable saddles, which are intended to reduce conductor fatigue and terminal stresses, had become detached from their mounting surfaces, as is shown in *Photograph 6*.
