# FERRY SAFETY INVESTIGATION REPORT

**SINKING OF MV *VENTURE***

**CABARITA, PORT JACKSON**

**1 MARCH 2015**

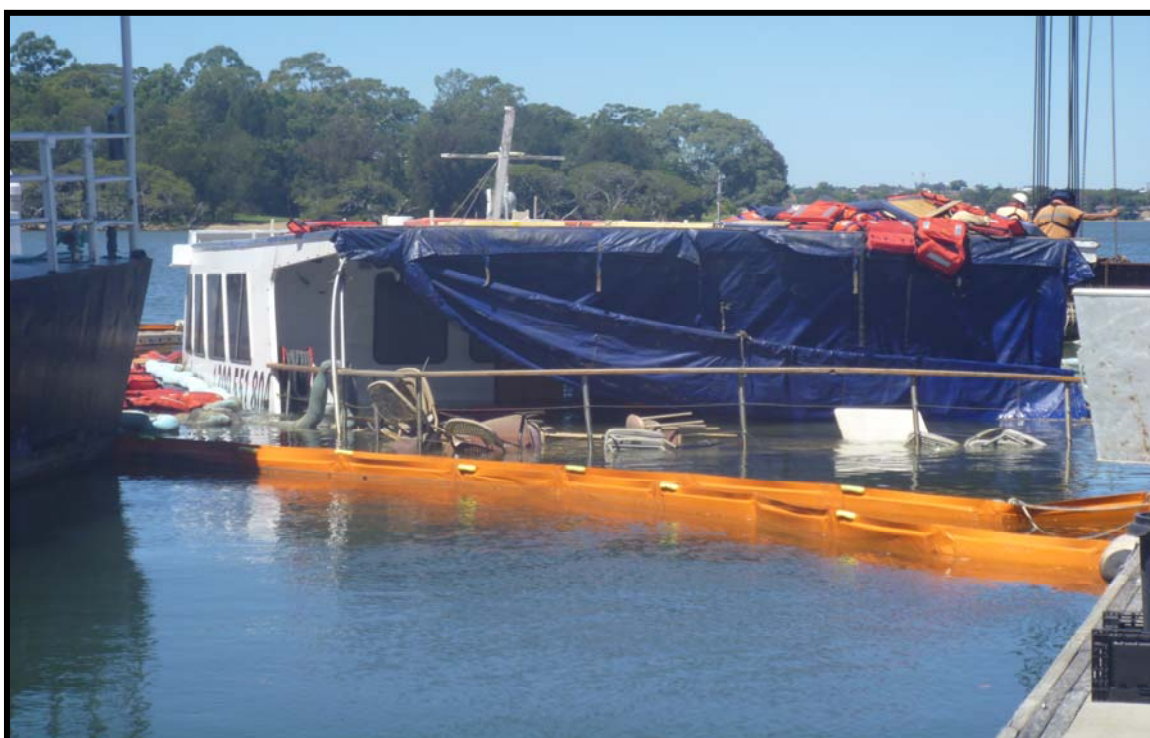
- 1.1. At 0050<sup>1</sup> on 1 March 2015, the Cruise Sydney Harbour Cruises' (CSH) charter ferry *Venture* returning to its berth after completion of a charter collided stern first with a concrete finger pontoon at Cabarita Marina. Because of the collision, *Venture* sustained a breach in the planked timber transom and sank in six metres of water. At the time there were four crew on board none of whom sustained any injury.

Photograph 1: *Venture* sunk at berth

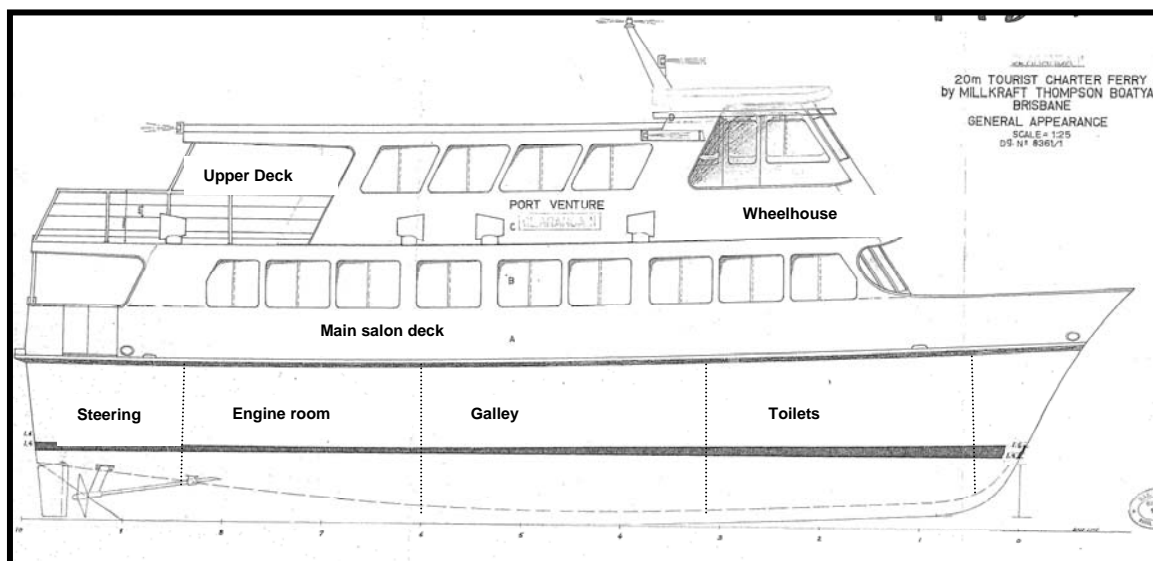
**Diagram 1: Layout of *Venture***

- 1.8. The hull was divided into five watertight sections by bulkheads. Two bulkheads were fitted with watertight hatches with open door warning lights on the dashboard in the wheelhouse, but no audible alarms. These were a

collision bulkhead forward and another aft of the engine room separating the steering and engine compartments (see *Diagram 1*).

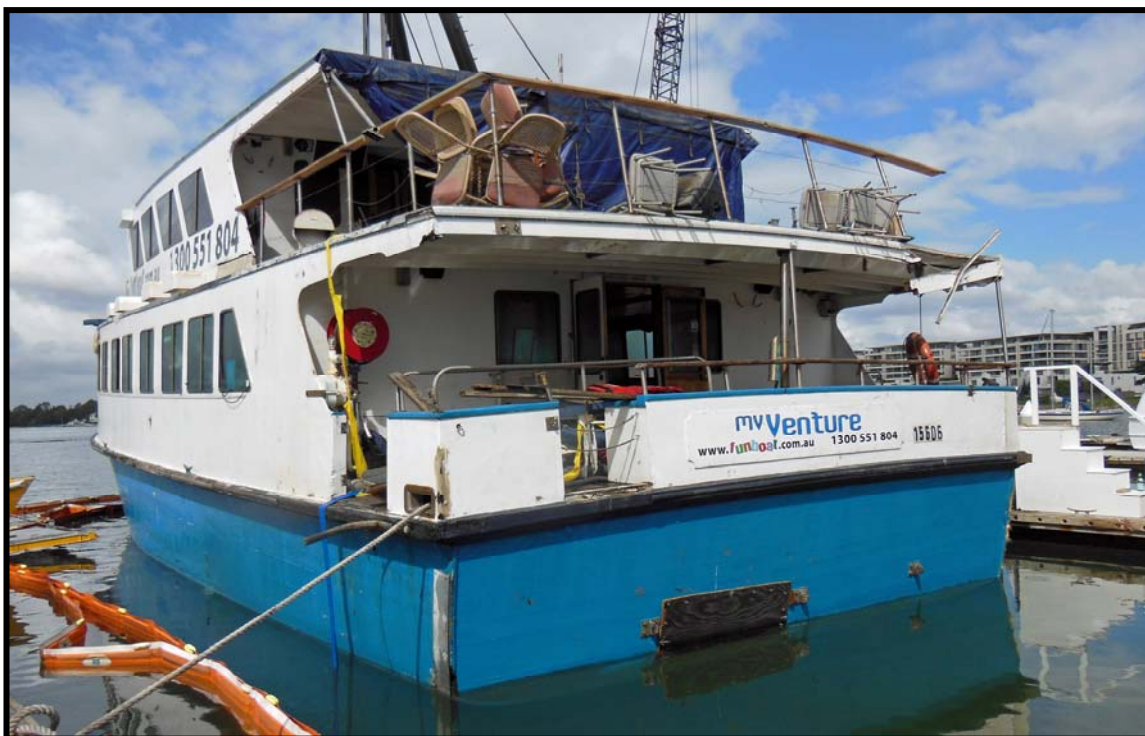
- 1.20. An initial inspection of *Venture* was made by OTSI Investigator's on 6 March 2015 after being notified of the incident by RMS. *Venture* was resting on the bottom at its berth with only a portion of the upper deck and wheelhouse above the surface.
- 1.21. Salvage of *Venture* only commenced on 6 March 2015 after negotiations with insurers. Salvage divers secured a plywood patch over the hole in the transom and attached airbags around the stern. A large sheer leg crane with a 50 ton capacity provided a sling around the hull forward. At 1400 the hull was raised to gunwale height. Large pumps were then used to re float the ferry which was achieved at 1700 (see *Photograph 3*). Salvage crews maintained a watch overnight as there was still some water ingress into the hull. Portable pumps were used to hold the water ingress.

Photograph 3: *Venture* after salvage

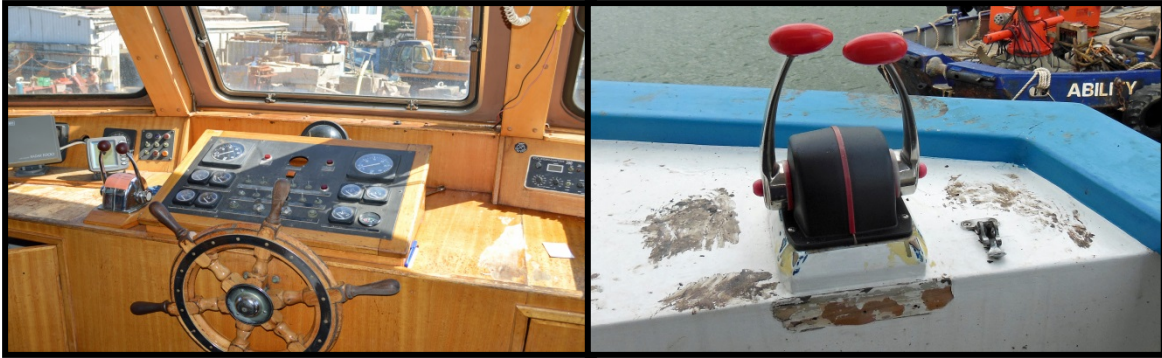
**Photograph 4: Wheelhouse and starboard wing controls**

- 1.29. The wheelhouse starboard control lever was placed in the astern position and the wing control was tested. The starboard engine gearbox remained in the astern position. However, the wing starboard control lever could be moved through both ahead and astern positions without changing the astern position at the gearbox. The operation of the starboard wing lever while the gearbox position was in astern was stiff, and firm resistance was noticeable. Full movement in both directions was accomplished. The movement of both levers in astern and ahead positions advanced the throttle the same amount. Although the levers on the wing position were longer than the levers in the wheelhouse, advancement of throttles was the same at the engine.

- 1.30. The examination determined that, providing there was no gear selected from the alternate position, both the wheelhouse and wing positions in both astern and ahead selections operated the gear selection at the gear box correctly. Also, the throttle advancement functions were functioning as intended.

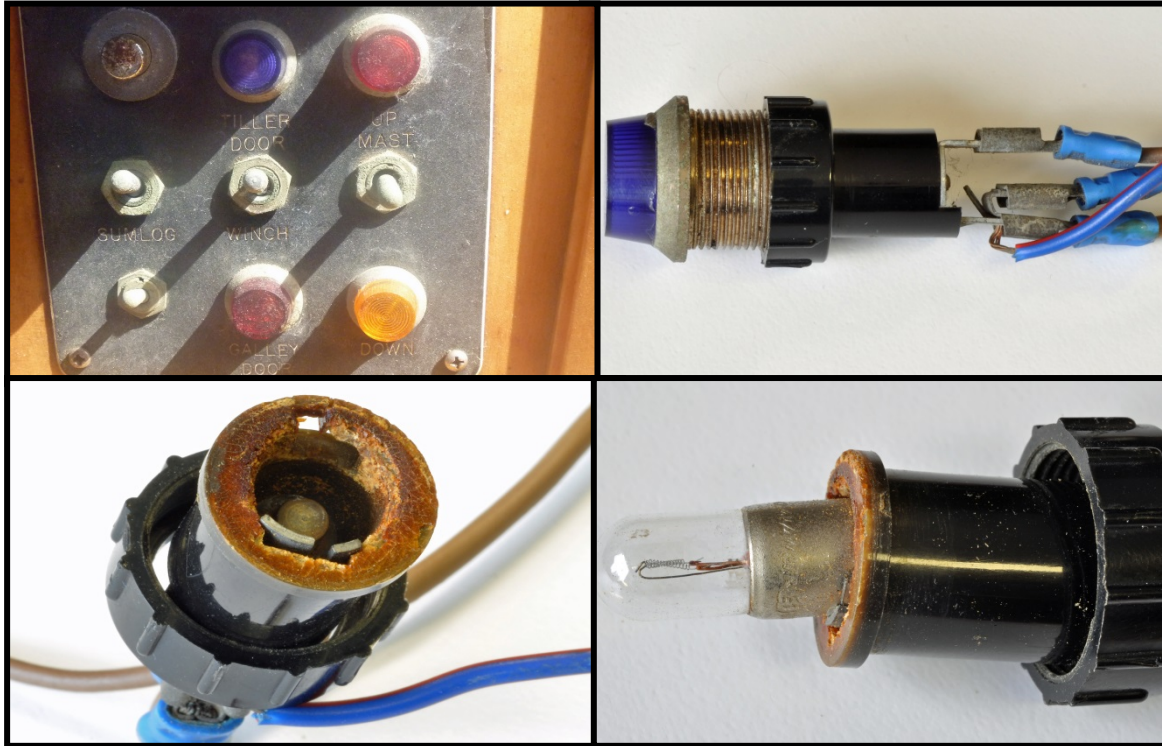
- 1.31. The warning light indicating the aft watertight bulkhead door being open was removed from the wheelhouse dashboard panel for examination. The bulb and its housing were photographed and tested. The impedance across the supply wires with the bulb in place was measured at 18.4 ohms, while the impedance of the bulb alone was 17.9 ohms. The inscription on the bulb indicated it to be a 24 volt, 4 watt bulb, branded Tungsram (a Hungarian company, now a GE subsidiary). The bulb socket appeared to be made from a phenolic resin such as "Bakelite", and had a metal insert on one side. The side without the insert was badly worn, causing the bulb to sit at an angle, (see *Photograph 5*). Due to the wear in the socket it was possible to

momentarily break circuit continuity by gently moving the bulb. However, with the bulb in its natural position circuit continuity appeared secure.

Photograph 5: Open aft bulkhead door pilot light

- 1.32. Because the wiring harness and circuits supplying electrical power to the *Venture* had been immersed in water, they could not be tested. Therefore, it was not possible to determine if the watertight bulkhead door open warning pilot light was functional at the time of sinking.

- 3.3. The dashboard open door warning light indicating when the rear watertight bulkhead door was open was not working. Thus, the Master and GPH did not have the benefit of the visual alert to the potential hazard. Though the light had been unserviceable for a considerable time it had not been reported as defective and had not been tested.

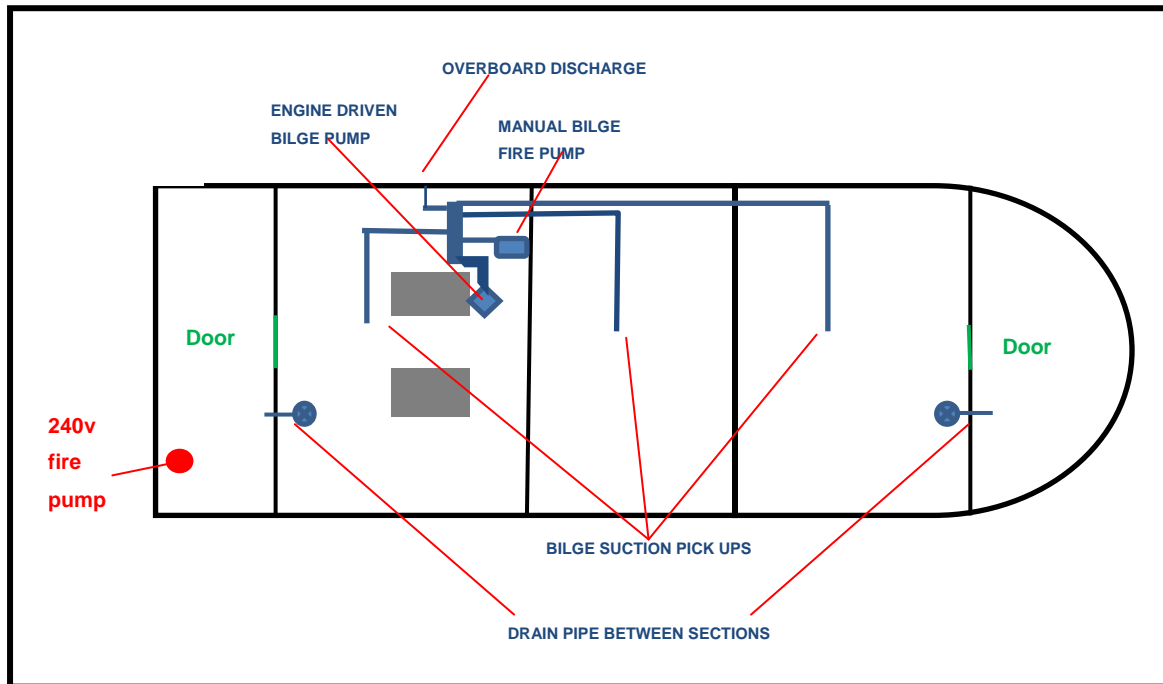
Diagram 2: Bilge pumping system

- 1.33. Accumulation of water in the bilges of the five sections of *Venture* was pumped out by a Jabsco® pump driven off the port engine (see *Diagram 2*). The bilge pump was connected to a valve chest and overboard discharge. The forward and aft voids bilges were not connected directly to the bilge system. They were connected by drain pipe fitted with a shut off gate valve. This allowed accumulated water to be drained into the adjacent compartment where bilge pickups were located.
- 1.34. An additional 240 volt electric fire pump located at the stern on the port side supplied water direct from outside the hull through the pump to the fire hydrants on the rear and upper deck. The pump plumbing did not allow

immediate conversion for use as a bilge pump without shutting off the intake valve, removing the line from the through hull fitting to the pump and placing the line into the bilge.

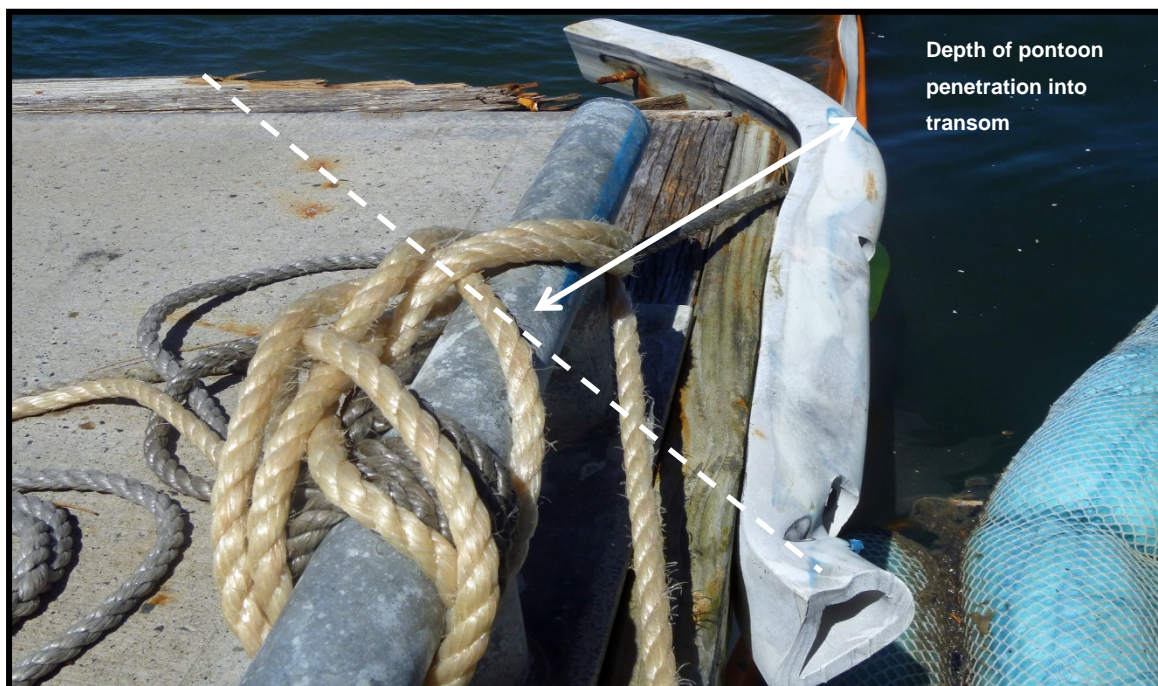
- 2.7. At interview, the GPH and Cruise Director indicated that, on arrival at Cabarita, they had positioned themselves on the rear deck in readiness to pick up the berthing lines. The GPH was on the starboard side and the Cruise Director on the port side. They both described the ferry becoming stationary at about a 45° angle to the east west line of pontoons on the southern side of the marina with the stern about 60 metres from the berth. When *Venture* then went straight astern on both motors increasing in speed, they both yelled a warning to the Master. However, the transom collided with the corner of a pontoon near the centre line of *Venture* (see *Photograph 7*). The GPH described the ferry *"as hung on the pontoon for a short time"* then forward off

the pontoon. The Cruise Director described the ferry as being “*impaled on the end of the pontoon for a short time*” then possibly driven forward before becoming stationary.

**Photograph 7: Pontoon damage from collision**
