FERRY SAFETY INVESTIGATION REPORT

CLOSE QUARTERS INCIDENT INVOLVING

MV NARRABEEN AND BARQUENTINE *SOUTHERN SWAN*

17 MAY 2013

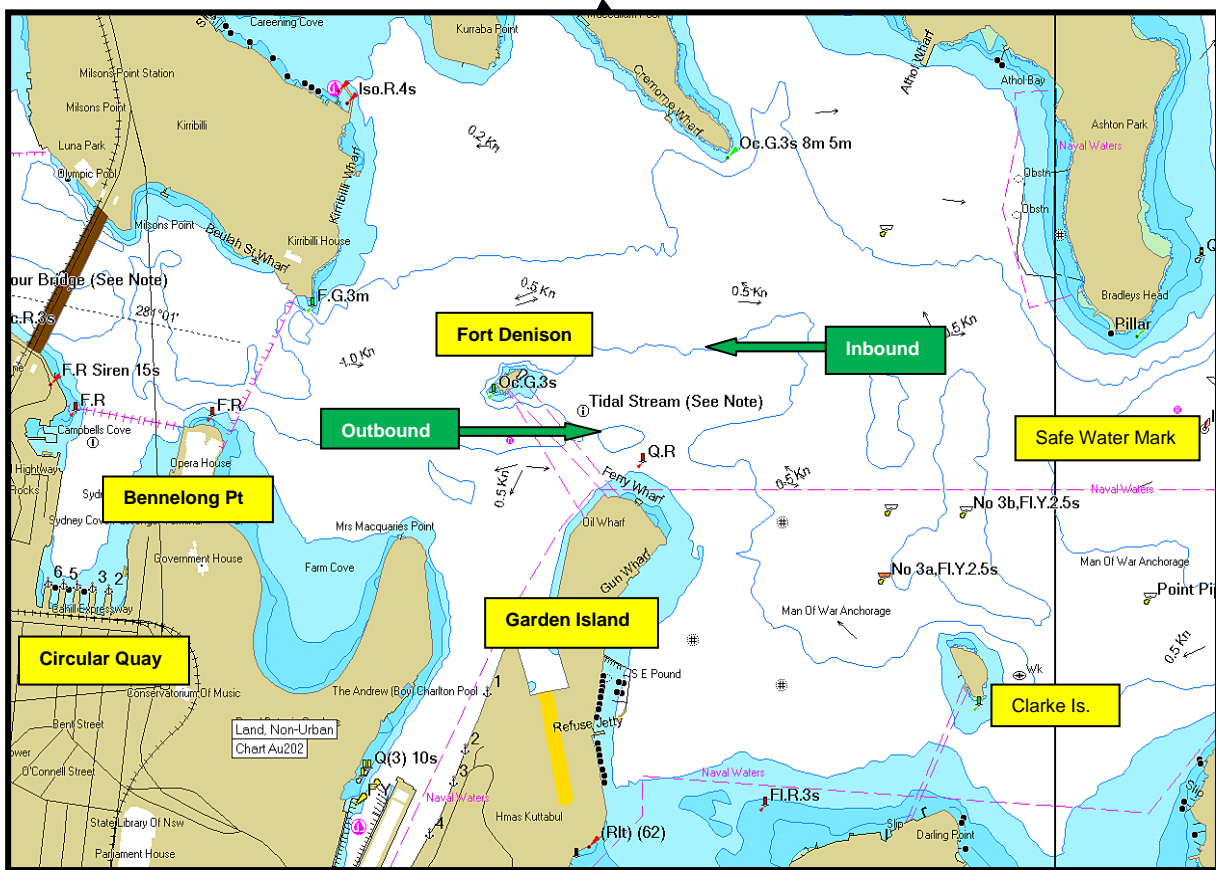
Figure 1: Chart Extract 1 - Incident location

- 1.11 The incident occurred west-south-west of Fort Denison, which lies 450 metres to the north-west of the most northerly tip of Garden Island and 870 metres east of Bennelong Point (*Figure 1*).

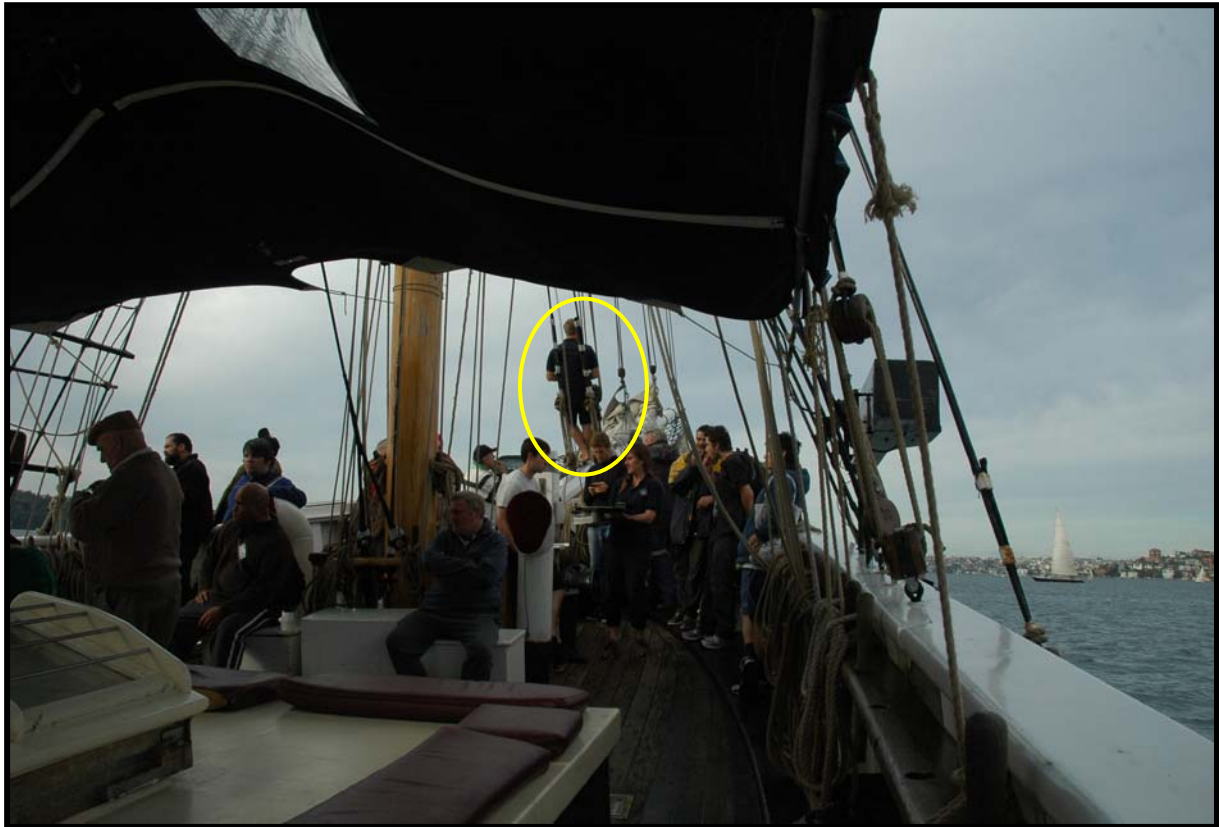
Photograph 3: Lookout position *Southern Swan*

- 2.21 In his Vessel Incident Report, the Master of *Southern Swan* reported his position at approximately 19:25 as being 'approximately 5 metres south of the starboard lateral mark off Fort Denison' and, shortly thereafter, as 'now only a few metres SE of the starboard lateral mark'. At the time he was helming from the starboard side of the wheel and was not able to see any part of the Fort due to the obstructions to his view forward and to port.

- 2.22 At interview, the Master indicated that his report of distance off the Fort was based on information received after the incident from his crew. He suggested the crew determined the distances based on their knowledge of the length or beam of the *Southern Swan* as a guide. However, this was not confirmed by the crew members who were interviewed.
- 2.23 The lookout at the time of the incident was an unqualified crew member who had joined *Southern Swan* in August 2012. This member did not possess basic knowledge of vessel lights or navigation marks and had limited experience onboard any vessel. Another crew member who

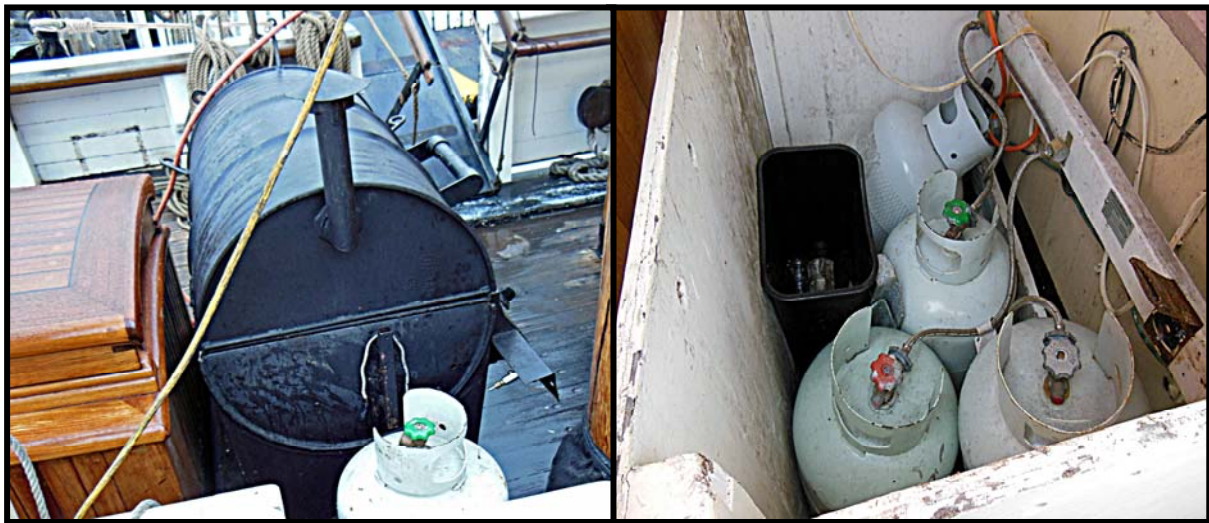
Photograph 4: Barbeque and LPG bottles

- 2.51 LPG bottles were housed unsecured in a storage bin with one bottle lying on its side. On the aft deck there was another single unsecured LPG bottle next to a barbeque made from a 44 gallon drum which did not have a compliance plate attached (see *Photograph 4*).

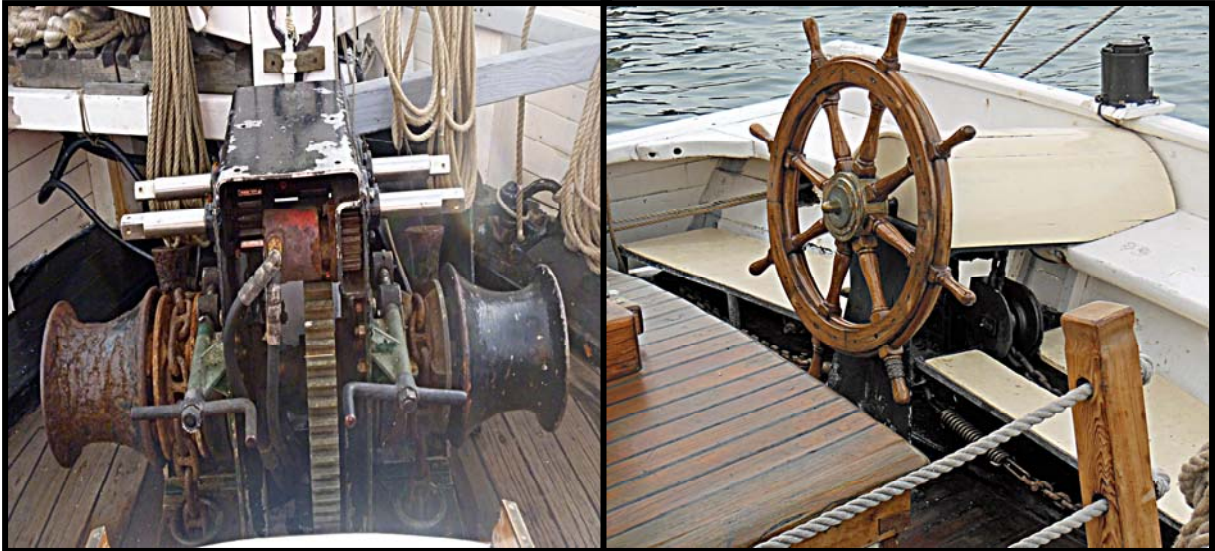
Photograph 5: Unprotected anchor winch and steering chain

- 2.52 The anchor winch on the foredeck was not barricaded off from the public thereby allowing unauthorised access with the possible consequence of the anchor being accidentally released (see *Photograph 5*). Similarly, in the area on either side of the steering wheel at the stern, the chain was exposed and represented a hazard in which a passenger could become entangled. This area should also be isolated from public access. There was no sign on the entrance hatch to the engine room advising that access was restricted and this hatch remained open while underway on a charter.

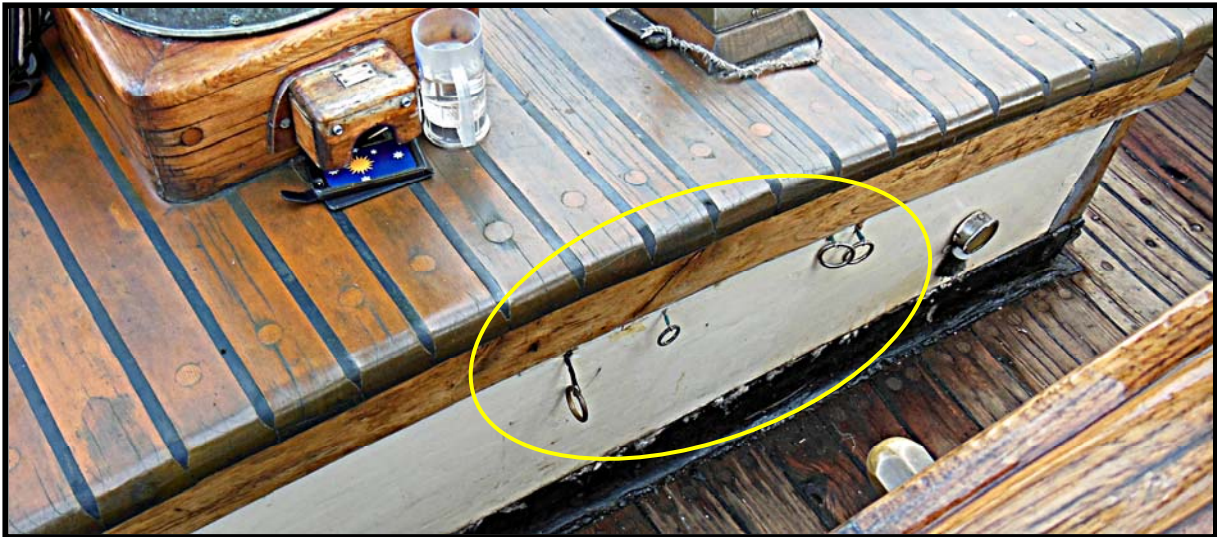
Photograph 6: Fuel shut-off cables

2.57 The fuel shut-off valve positions were not labelled (see *Photograph 6*). In an emergency situation requiring the fuel supply to be shut-off and where the Master was either incapacitated or absent, it is highly likely that an inexperienced crew member required to perform the task would experience difficulty in identifying these shut-off cables.
