FERRY SAFETY INVESTIGATION REPORT

STEERING LOSS *OCEAN RIDER*

SYDNEY HARBOUR

5 MAY 2016

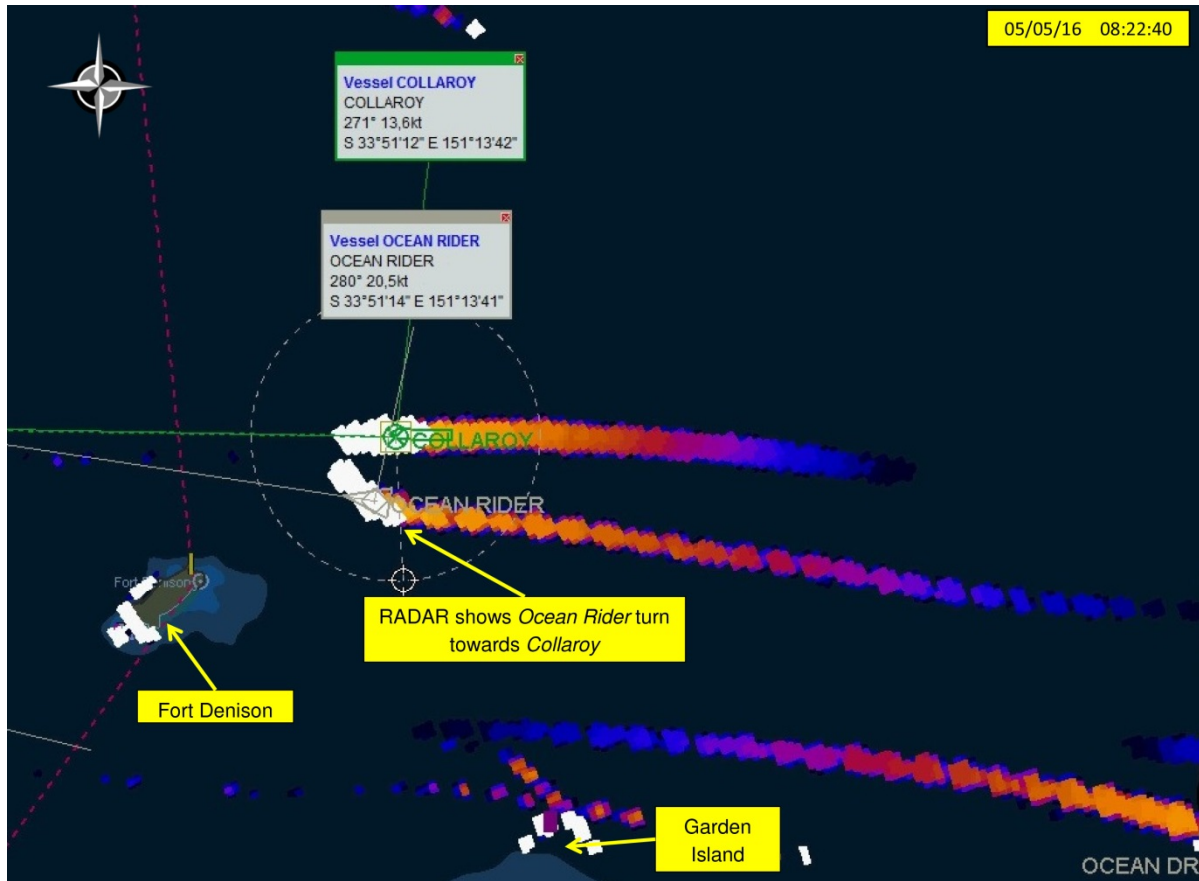
Figure 3: Ocean Rider turning abruptly to starboard

- 1.4 *Ocean Rider* was overtaking on *Collaroy*'s port³ side as both vessels approached Fort Denison. As *Ocean Rider* drew level with *Collaroy*'s bow, a loss of control resulted in the ferry turning abruptly to starboard⁴ (see *Figure 3*) and towards the *Collaroy*.

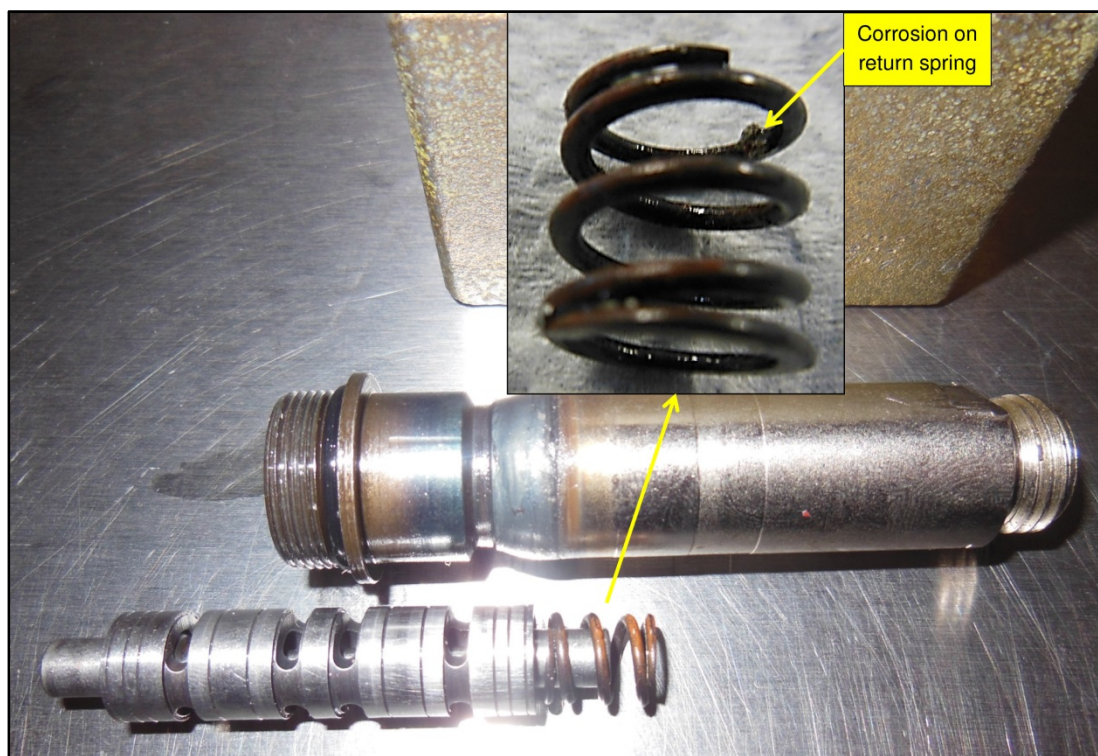
Figure 10: Corroded return spring and spool valve

- 2.14 Inspection and testing of the hydraulic system was conducted on 6 May 2016 and no faults were identified. On 11 May 2016 the hydraulic system was dismantled by a contractor for a further inspection to identify the cause of the control failure.
- 2.15 The contractor replaced the solenoids and directional control valve for both AC and DC systems. The removed directional control valve was then stripped and inspected, revealing a corroded return spring (see *Figure 10*). The contractor reported that the valve in this state would not have performed at an optimal level.

- 2.16 The contractor stated that contaminants from the rusty spring could temporarily block a valve, interfering with the operation of the hydraulic ram. A blocked valve would continue to circulate the hydraulic oil within the system, until the blockage was displaced.

- 2.17 Corrosion of the return spring, which was immersed in hydraulic oil, was likely attributed to water ingress into the hydraulic oil. Water could be present either through condensation accumulating in the hydraulic system, or from an external source allowing water into the hydraulic lines.

- 2.19 The use of a hose to clean the compartment created a damp environment in the tiller flat. The cleaning and resultant damp environment offers a possible explanation for water ingress into the hydraulic oil and the subsequent corrosion of the spring.

- 2.35 In the days following the loss of control, MFF replaced all the electrical relays and switches in the steering system including the wing positions. The hydraulic system lines were purged, cleaned and refilled and operating solenoids replaced. The ferry's electrical generation system was modified to improve reliability.

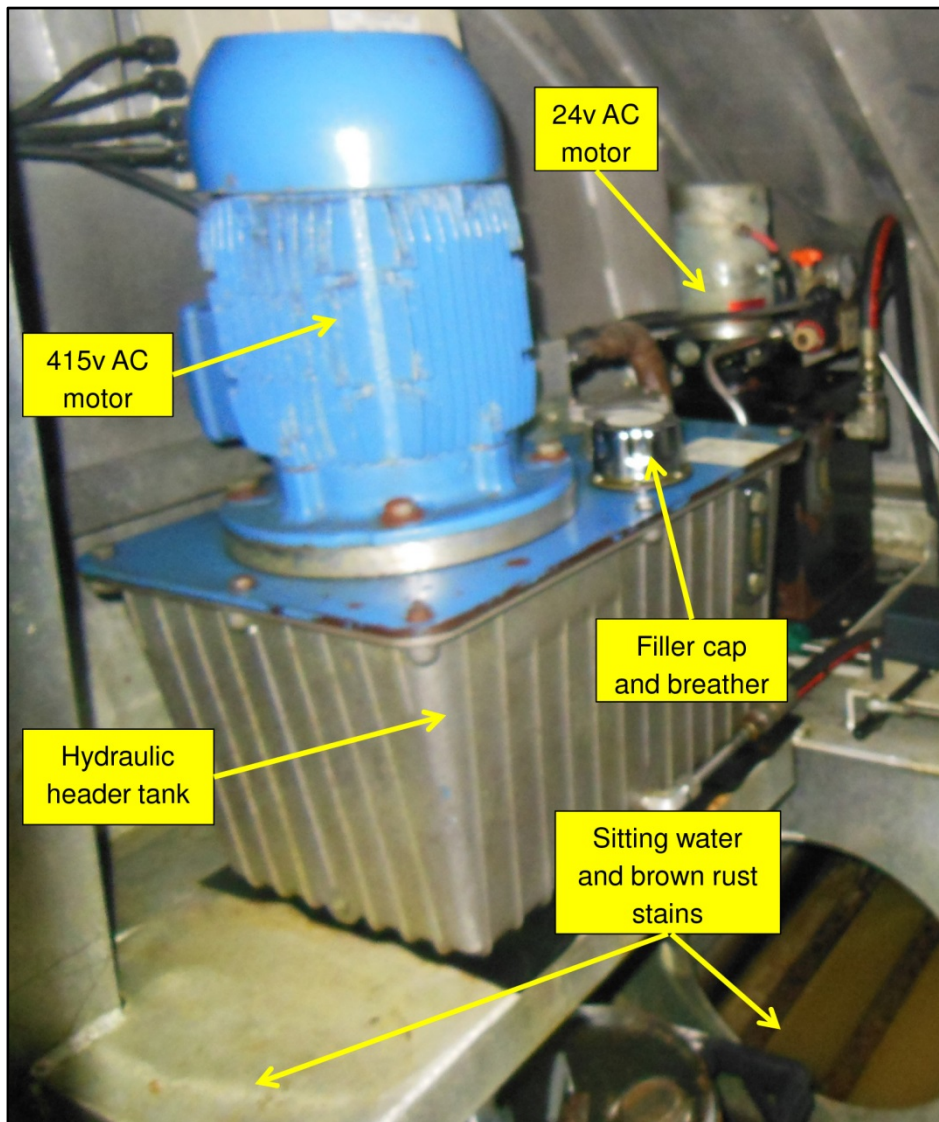
Figure 11: Corroded steering components

2.20 There was evidence of contaminant marks and corrosion on metal components on surfaces within the tiller flat (see *Figure 11*).

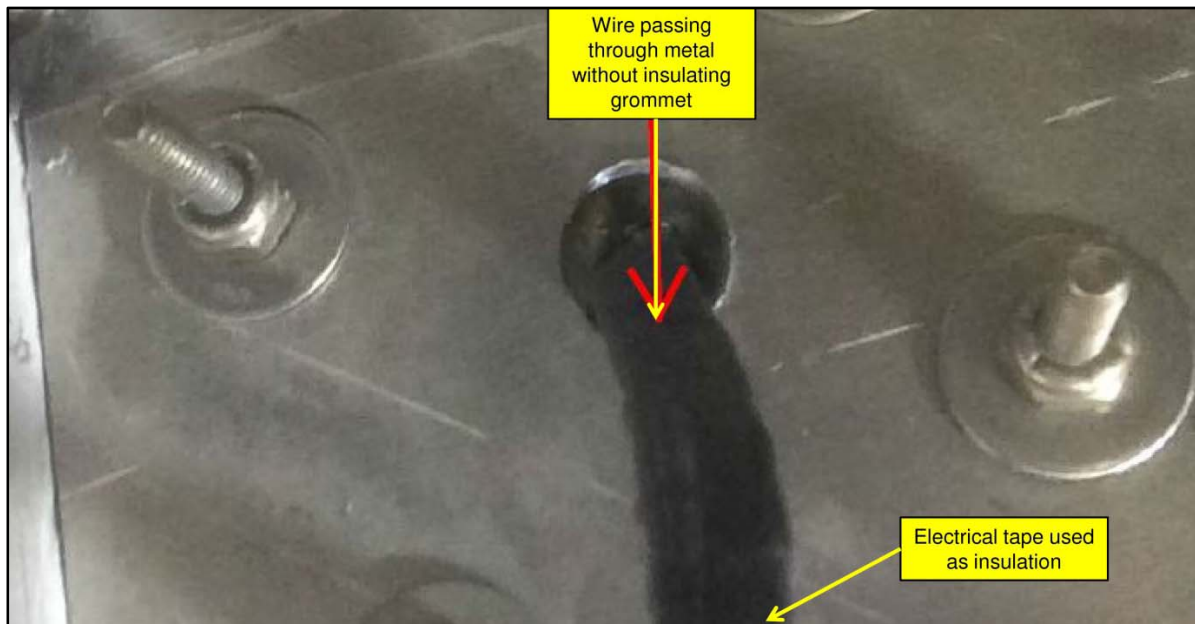
Figure 12: B-Joystick wire passing through chair base without insulating grommet

- 2.22 The NSCV utilises the Australian wiring standards when providing guidelines for electrical installations. A failure to adhere to these requirements and / or poor maintenance can significantly increase the likelihood of electrical faults occurring.
- 2.23 The electrical system associated with the steering was visually examined and a number of issues were noted. Each of these issues increased the likelihood of a fault being introduced in the electrical system.
- 2.24 The B-Joystick steering controller electrical wiring passed through the helmsman's aluminium chair base without any insulating grommet. The lack of a grommet exposed the wire to an increased risk of mechanical damage from vibration or movement against the sharp metal edge (see *Figure 12*).

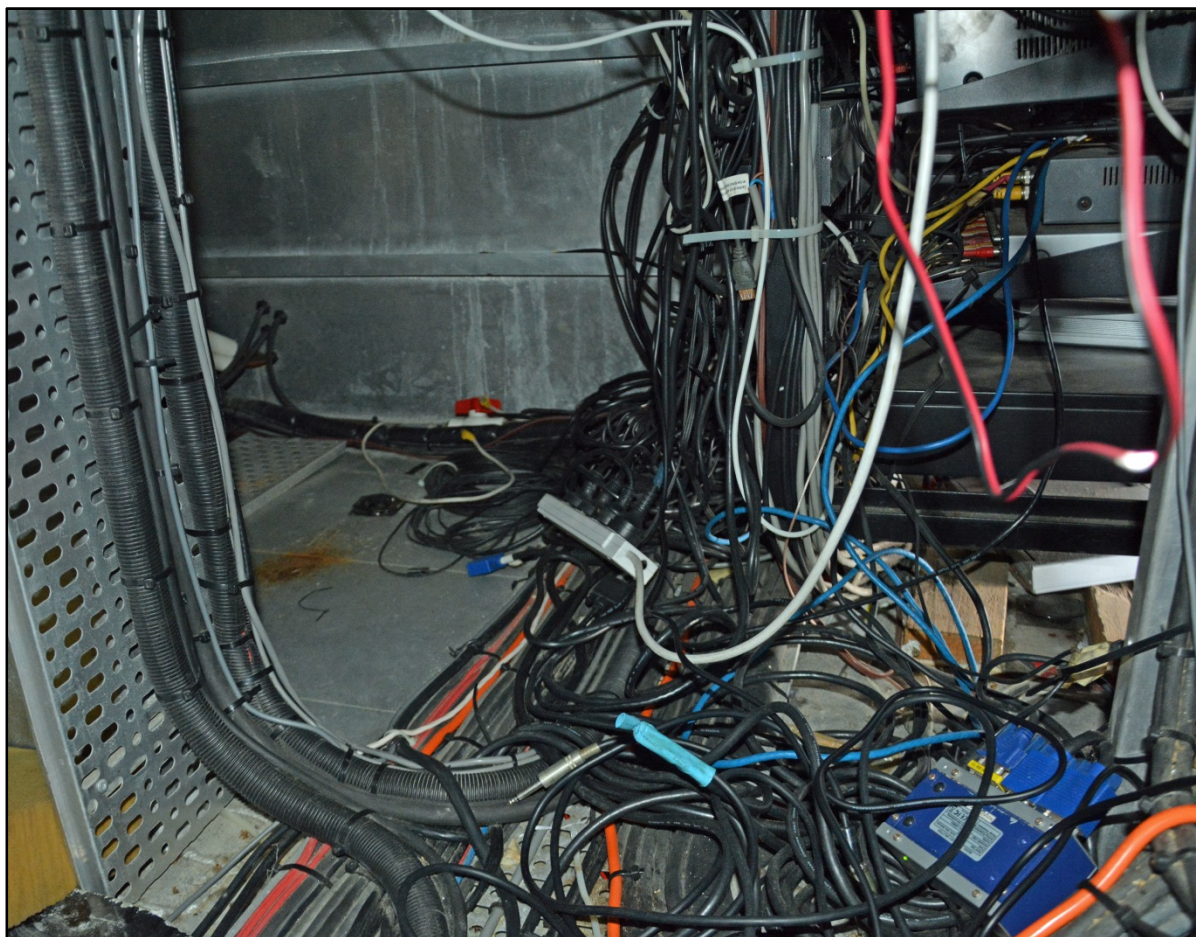
Figure 13: Unsecured wires under dash board

- 2.25 The vessel's electrical wiring under the dashboard was found intermixed with power supply cables, audio visual cables and unsecured stored items (see *Figures 13 and 14*).

- 2.26 The code of practice for electrical wiring¹¹ states that electrical leads should be arranged so they will not be damaged. So far as is reasonably practicable, avoid running leads across the floor or ground, through doorways and over sharp edges, and use lead stands or insulated cable hangers to keep leads off the ground.

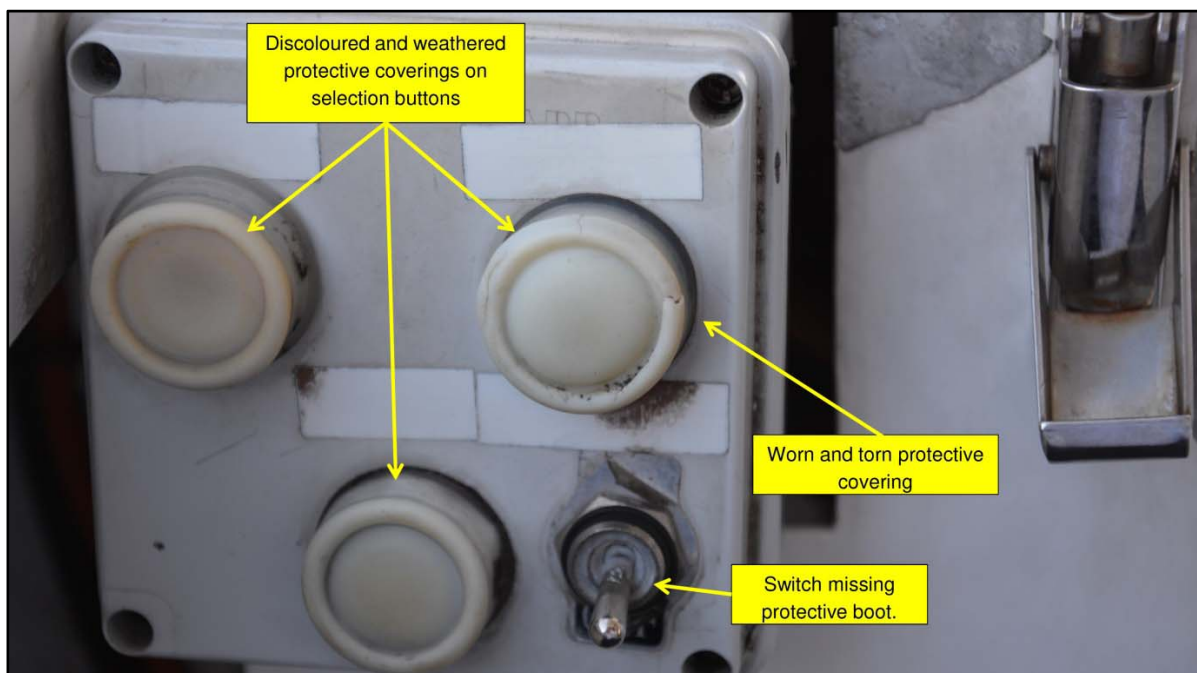
Figure 15: Port wing controls 6 May 2016

2.27 The steering controls, situated at both external wing positions and exposed to the elements, were heavily weathered. The labelling identifying the controls was faded and illegible. The protective rubber waterproof covering over the selection buttons was torn or missing, exposing the buttons to the ingress of water (see *Figures 15 + 16*).

- 2.41 The company replaced the wing steering controls with new heavy duty weather proof steering joysticks. MFF also renewed the electrical controllers and related cabling components of the hydraulic steering system.

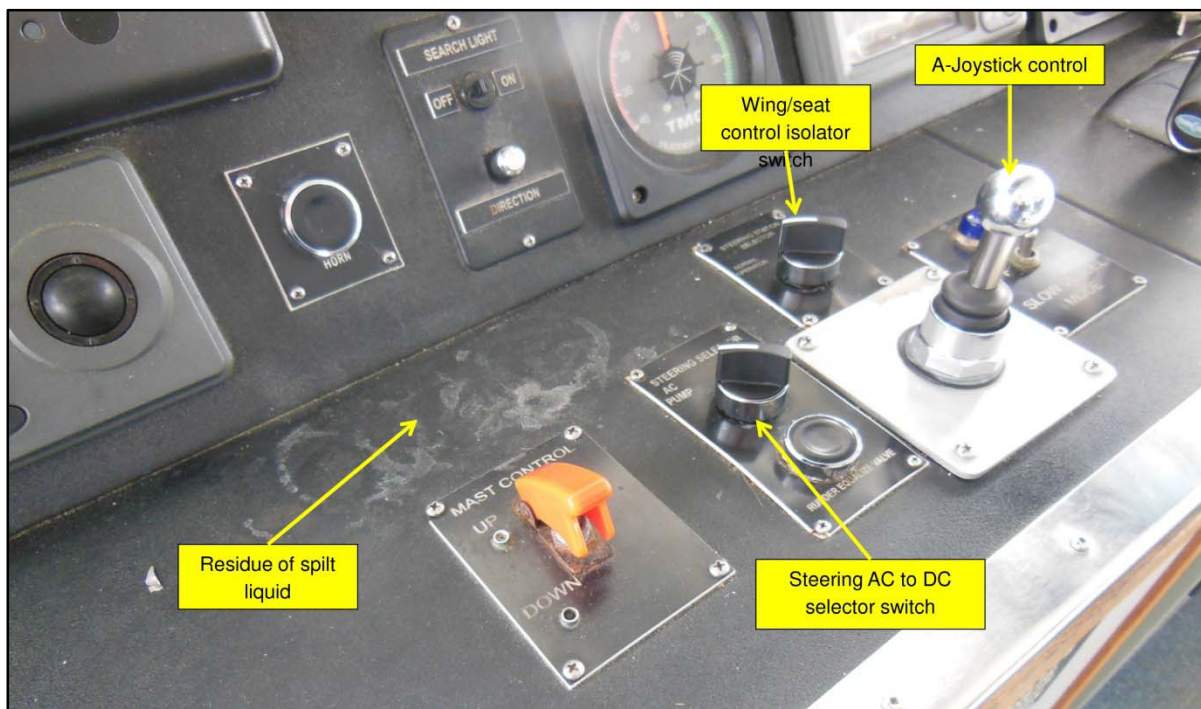
Figure 17: Liquid residue near main steering controls

2.28 In the wheel house there was evidence of a spilt liquid on the dashboard in close proximity to the ferry's main steering controls (see *Figure 17*). The stains on the dash revealed that liquid had spilt from containers placed in close proximity to the steering controls.

- 2.29 The spilling of liquid so close to electrical controls increased the likelihood of liquid draining through holes in the dash and on to the switch internals. Investigation of the dash underside revealed liquid stain or water mark on the under surface.

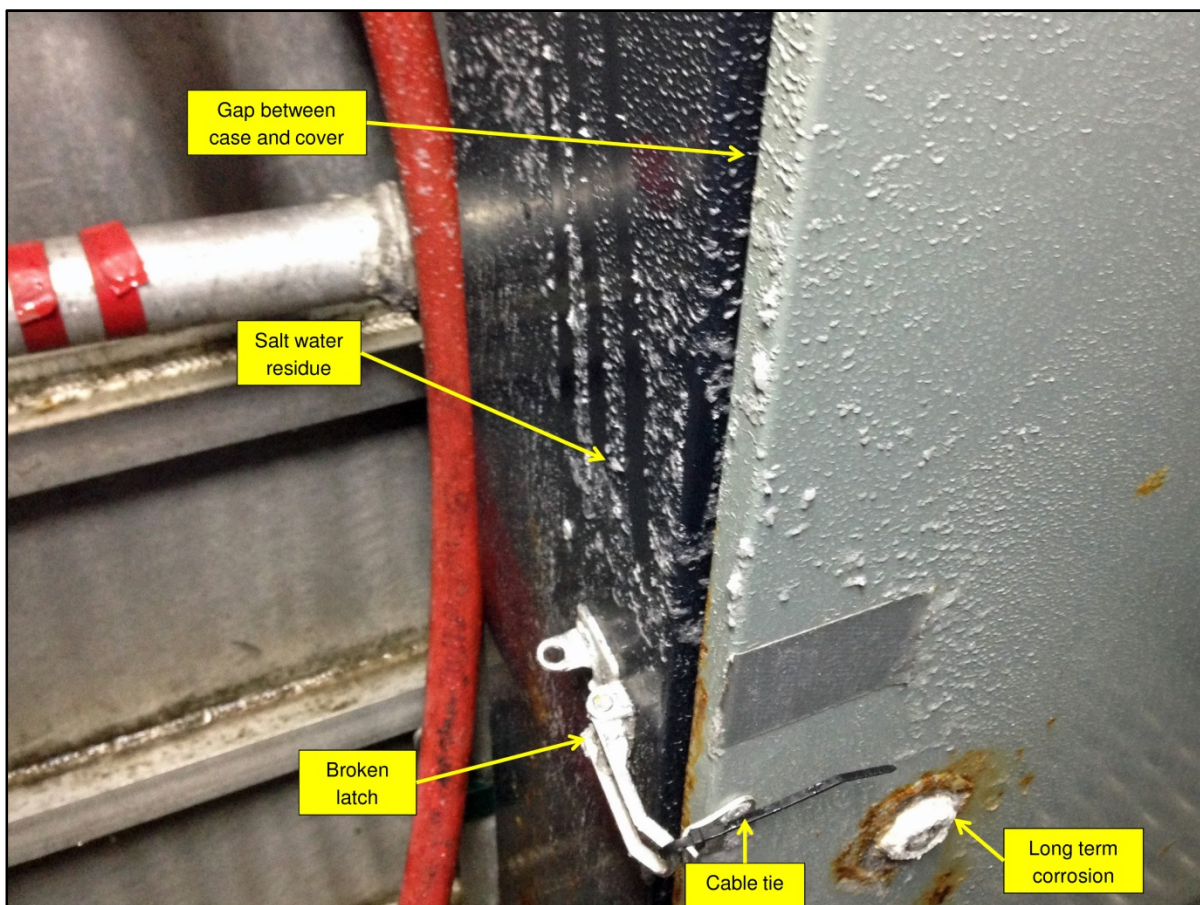
Figure 18: Salt encrusted DC distribution board

- 2.30 Inspection of the port side engine room revealed that the main 24v DC distribution board had a heavy covering of crusted salt residue. This residue was a result of sea water in the bilge spraying off the rotating propeller shaft. Ocean Rider's wheel house controls systems are supplied power from this distribution panel.

- 2.31 The distribution board is housed in a protective case, the cover of which was ajar due to the failure of the retaining latch through corrosion. A loose cable tie was being utilised to restrain the cover, however, the cover was adrift from the case which exposed the internal electrics to the salt water spray (see *Figure 18*).

- 2.39 The starboard generator was refurbished and an additional permanent generator installed in the port engine room.
- 2.40 The company replaced the EC300 controllers with new units and replaced associated wiring to the engines. The 24v DC distribution board has been replaced and relocated away from the port engine room.
