**Office of Transport Safety Investigations**

## **FERRY OCCURRENCE: FACTUAL STATEMENT**

***OCEAN WAVE* LOSS OF CONTROL**

**9 JUNE 2016**

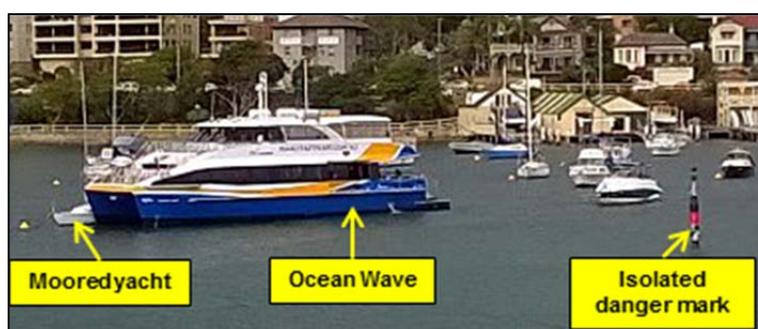
However, initial attempts to berth at Manly East Jetty were unsuccessful. The prevailing wind conditions caused the now unsecured vessel to drift towards a number of moored vessels within an area of moorings<sup>2</sup> at the eastern side of Manly Cove. Shortly after, the *Ocean Wave* came to rest against a small moored recreational yacht (refer to *Photographs 1 and 2*)<sup>3</sup>.

**Photograph 1: Positions of yacht, *Ocean Wave* and isolated danger mark**

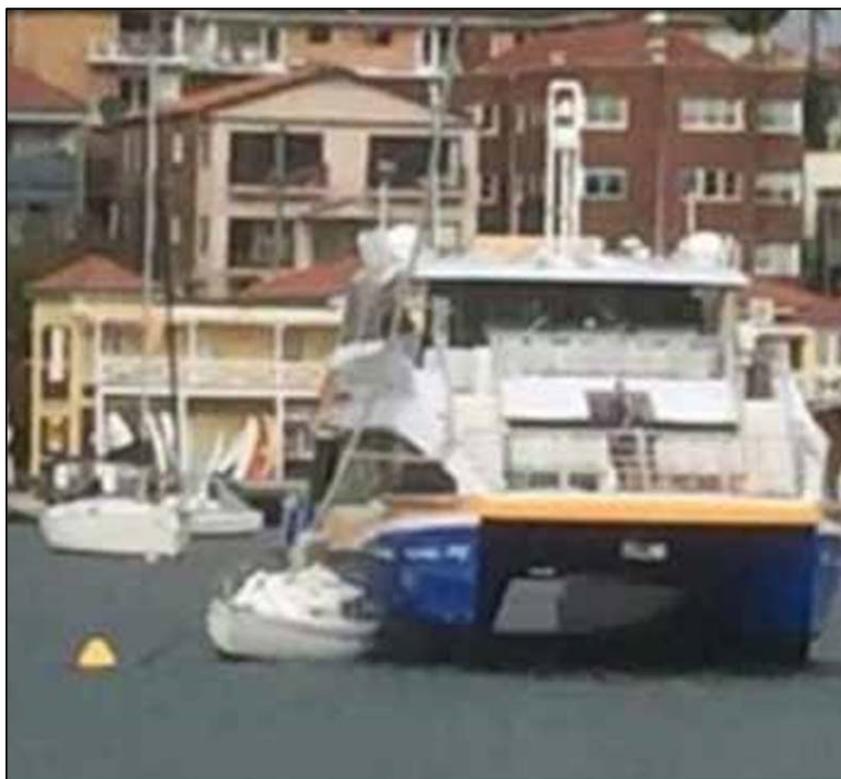
**Photograph 2: Final positions of the moored yacht and *Ocean Wave***

The Master directed the crew to secure the vessel to the mast of the yacht to prevent the vessel from drifting further into shallower water and other vessels. The MFF vessel *Ocean Surfer*<sup>4</sup> arrived shortly after and provided assistance to the *Ocean Wave* in manoeuvring away the yacht and berthing at Manly East Jetty.

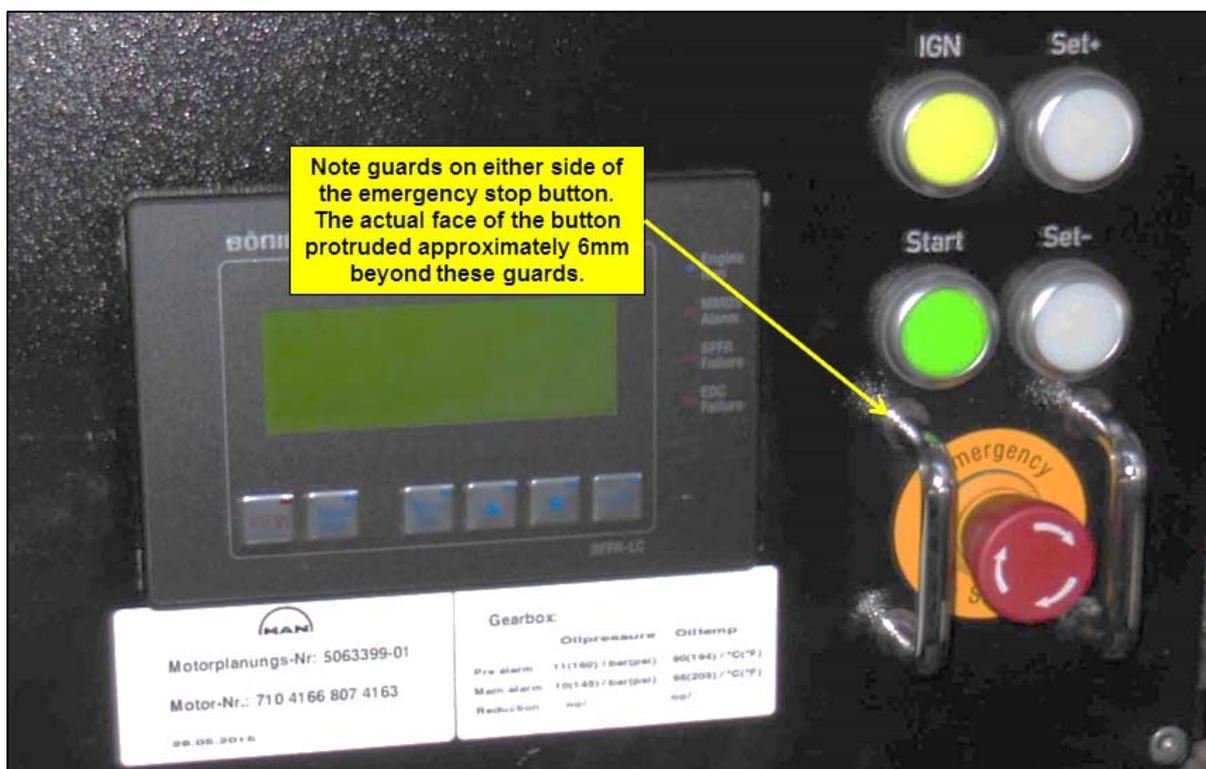
The diagnostic report revealed that the engine fault alarm for the starboard engine had activated when an emergency stop button was triggered (refer to *Photograph 3*).

**Photograph 3: Emergency stop button for the starboard engine**

When the emergency stop button was fully activated by being depressed, the starboard engine would stop. However in this case, partial activation by partial depression triggered the engine management system to raise an alarm and reduce the rpm of the starboard engine. As a precaution, the system automatically reduced the rpm of the port engine as well. The reason for this was twofold:

Examination of this emergency stop button mounting revealed that it was fitted with two guards on either side. The guards were designed to protect the button itself and act as a defence against unintentional operation. However, in its normal position the top of button protruded approximately 6mm beyond the guards. The button could therefore be inadvertently damaged or partially activated, despite the presence of the guards, by something coming in close proximity to the button.

Further examination was undertaken of the movements of crewmembers within the engine room around the time of the alarm activation. A crewmember said that they were undertaking a routine inspection of the engine room around the time that the engine fault alarm activated. This account was confirmed by an examination of the vessel's internal CCTV footage. The footage revealed that a crewmember was moving around the starboard engine room and was observed passing the emergency stop button at a time which coincided with alarm activation time from the data logger. It is therefore highly likely that it was this crewmember inadvertently activated that emergency stop button when passing that location.

The design of the emergency button and guards were such that the outer face of the button in its normal position protruded approximately 6mm higher than the guards. This meant that the guards were an ineffective defence, as the button could still be inadvertently damaged or partially activated by anything moving in close proximity.

Appropriate remedial action is in hand to mitigate the risk of similar loss of control in Manly Fast Ferry's fleet. MFF has issued instructions to ensure the location, operation and effect of the emergency stop button is fully understood by all personnel required to operate the *Ocean Wave*. MFF has also considered strengthening their crewmember training framework around loss of control scenarios to incorporate:

- Identifying when (in the journey) would be the appropriate time to initiate routine engine room entry, checks and maintenance;
- how best to safely move around the engine room and avoid unintentional contact with emergency stop buttons and critical equipment more generally;
- training drills which incorporate similar 'loss of control' scenarios, especially recognising the fault, understanding the reaction of the engines and decision making on the optimal process to rectify the fault, reset the engine/s after failure and regain control of the vessel; and
- how best to secure a vessel with reduced manoeuvrability in the prevailing conditions.
