FERRY SAFETY INVESTIGATION REPORT

**COLLISION INVOLVING SYDNEY FERRIES VESSEL
MARJORIE JACKSON**

BALMAIN SHIPYARD

2 AUGUST 2010

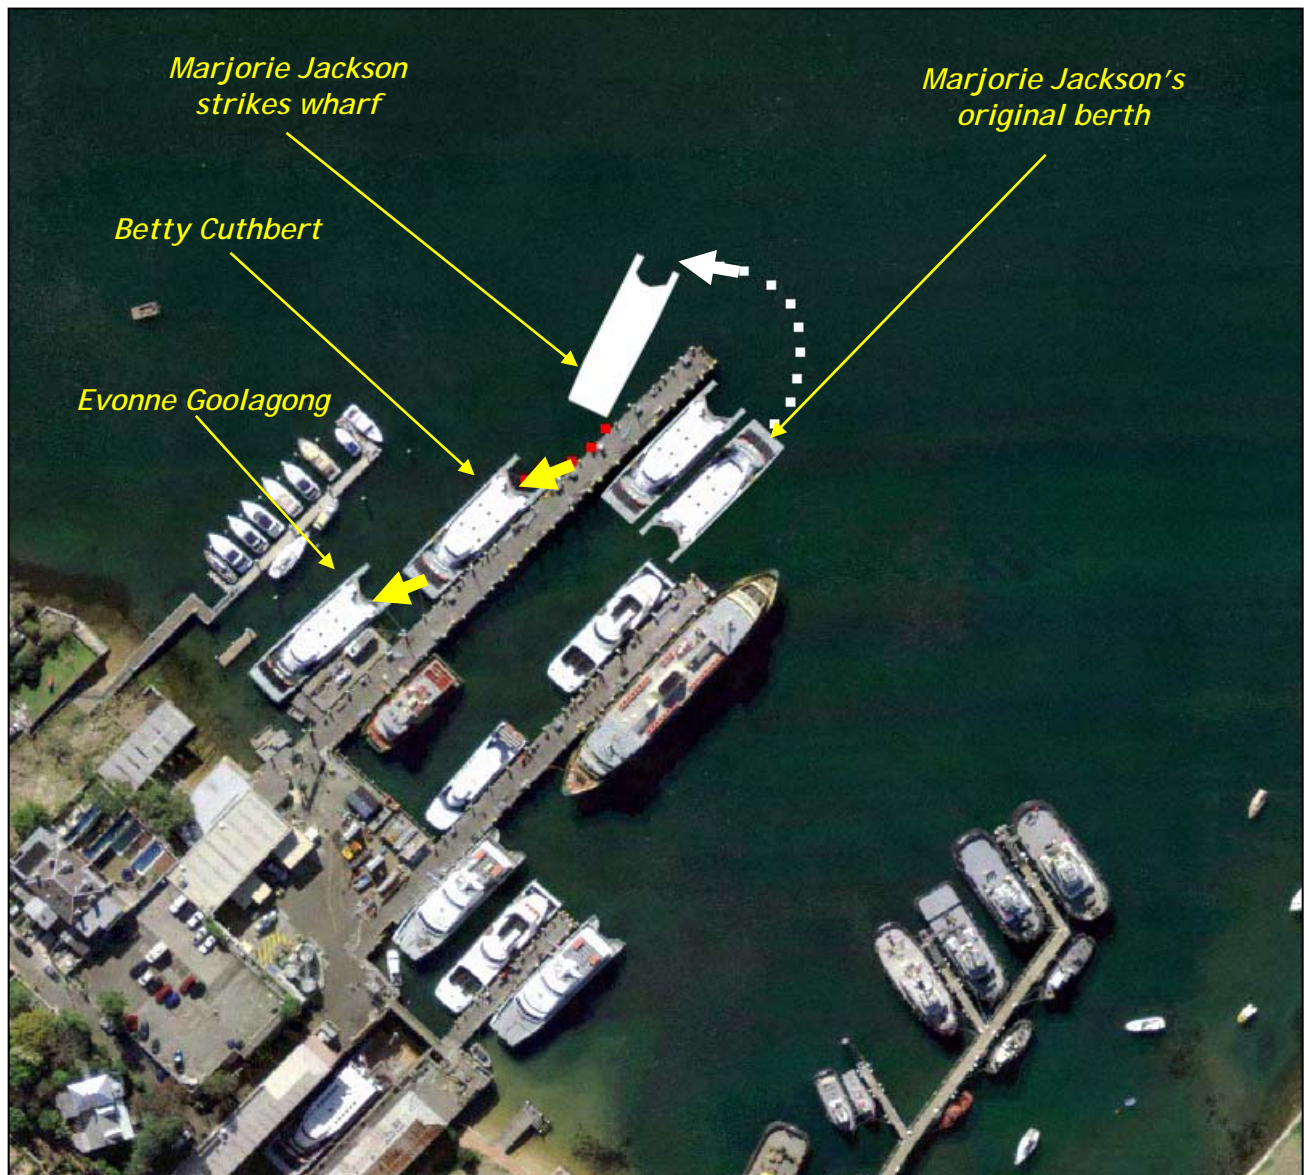
- 1.3 After he had turned to Port around the end of the wharf, the Master heard what he described as a steering failure alarm and then noticed that the vessel was continuing on its port turn towards the wharf. He attempted to go astern by turning both controllers and increasing the throttle, but this action did not arrest the vessel's movement and it continued forward. He did not immediately realise that the starboard Schottel steerable rudder propeller (SRP) was still in the ahead position, with any power commands effectively driving the vessel forward from the starboard unit despite any alteration to the position of the controllers.

- 1.4 The Master was able to alert the General Purpose Hand (GPH) of a steering failure and an attempt was made to throw a line from the vessel to a wharf pile. However, this was unsuccessful due to the speed of the vessel. The port bow of the vessel collided with the wharf twice at a speed of 2.8 knots as it kept moving ahead. It then accelerated reaching a maximum speed of 6 knots before colliding with the stern of the *Betty Cuthbert* at a speed of 5.8

Photograph 1: Aerial view of Balmain Shipyard showing vessel path

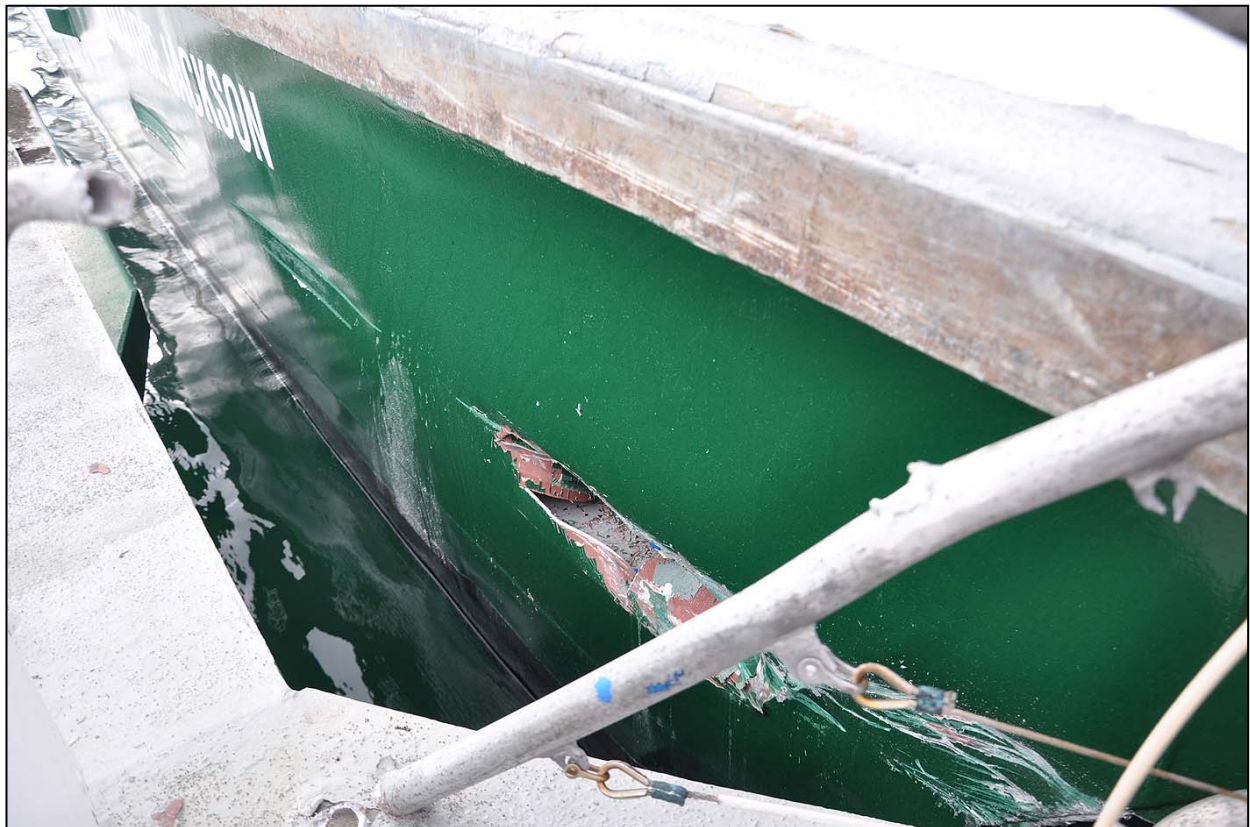
- 1.6 The wharf piles sustained only minor damage during the collision and the structural integrity of the wharf was not affected.
- 1.7 The damage to the *Betty Cuthbert* and the *Marjorie Jackson* was the most significant, yet was confined to structural damage above the waterline. The *Marjorie Jackson* had to be dry-docked for repair to impact damage from penetration of the aluminium skin of the starboard pontoon (see *Photograph 2*). The stern railings and other fittings on the *Betty Cuthbert* were repaired at the Balmain Shipyard.

Photograph 2: Damage to the *Marjorie Jackson*'s starboard pontoon

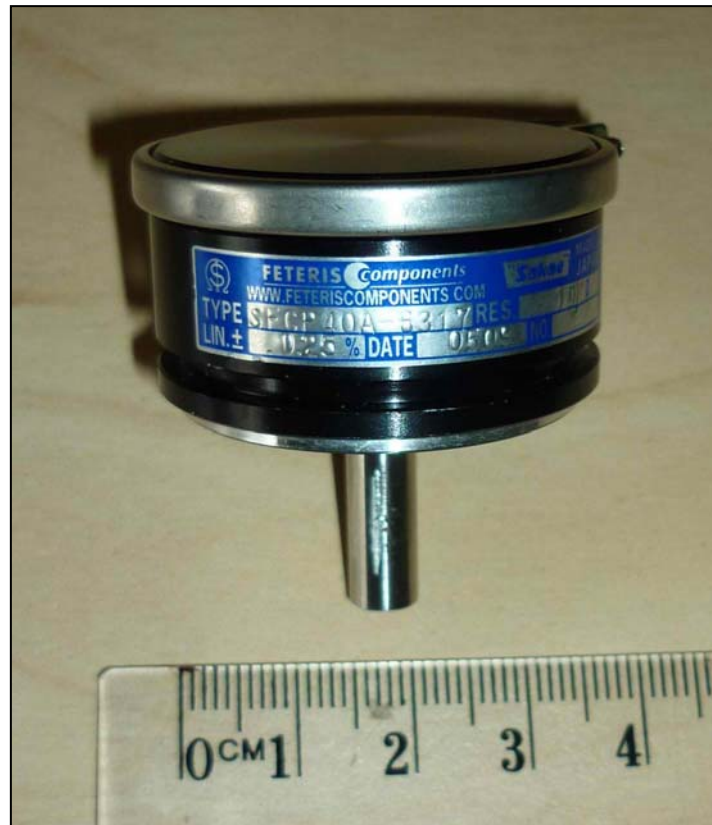
- 1.20 In order for the electronically controlled vessels to emulate the operation of the mechanically linked controllers, a complex series of potentiometers and servomotors are incorporated in the Kwant control heads. These potentiometers are manufactured by Feteris Components, an industrial electronics company based in the Netherlands (see *Photograph 6*).

Photograph 6: Potentiometer removed from head unit

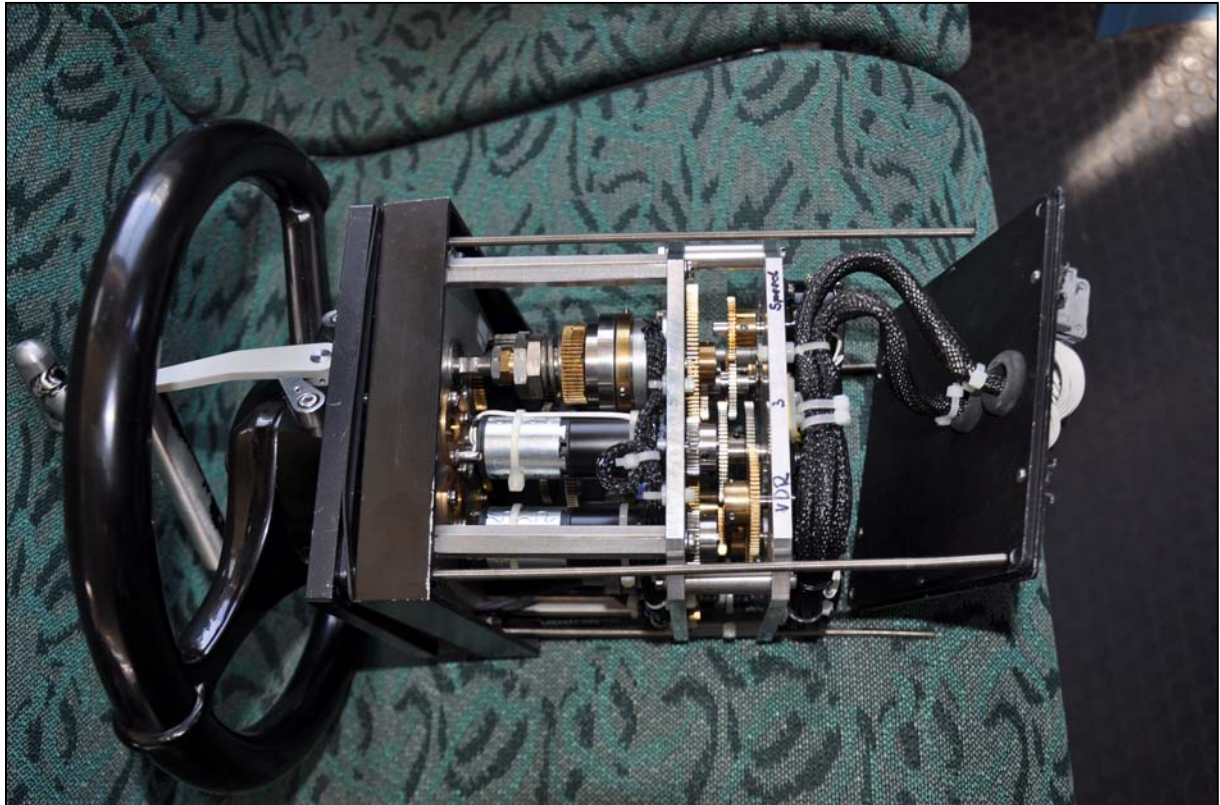
fault, where the link between master and slave controllers is interrupted or one component of either controller becomes out of calibration. This triggers a misalignment alarm and it can present as one controller moving backwards and forwards in an attempt to synchronise with its master controller, a condition referred to as 'ratchetting'. Steering remains unaffected as the potentiometer for steering is separate from the other communicating potentiometers.

Photograph 7: Kwant control head removed for service

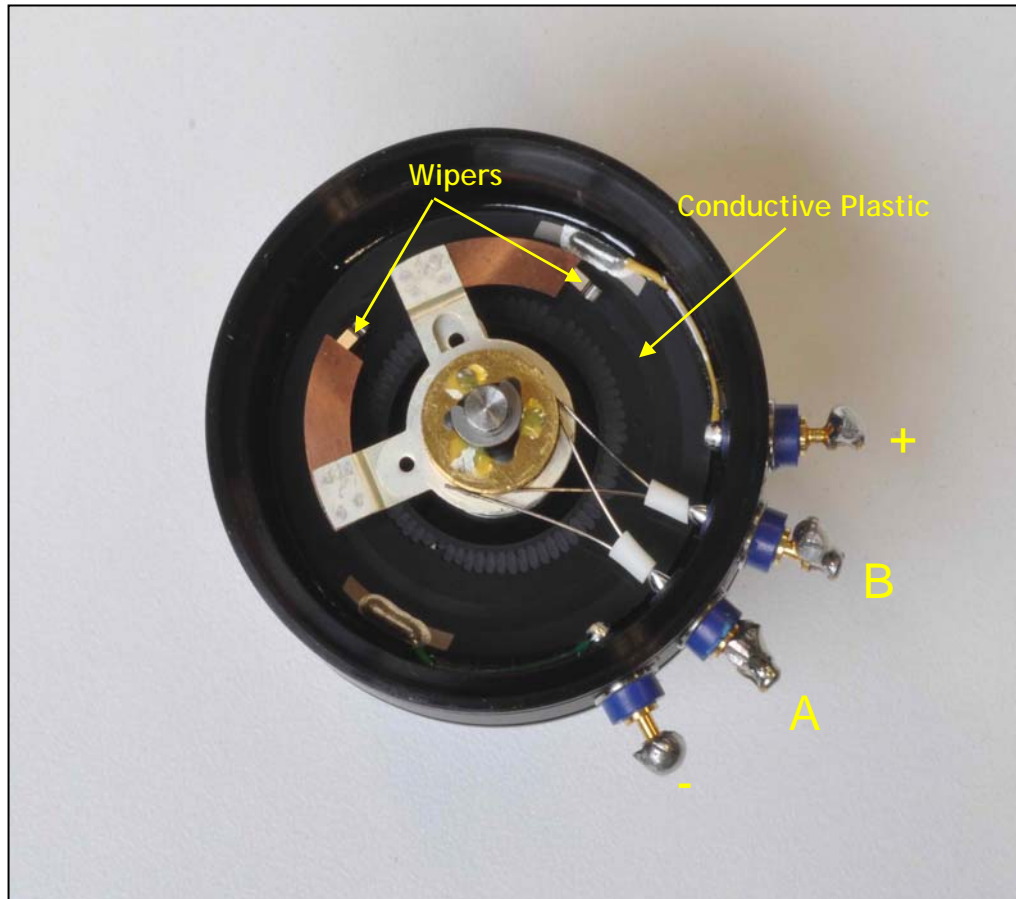
Photograph 8: Partially disassembled steering potentiometer

- 1.34 Within the potentiometer is a disc-shaped conductive plastic resistance component (see *Photograph 8*). A pair of contact wipers offset at 90° travel around the surface of the disc, and the distance of the wiper away from the conductor tap varies the amount of output voltage at the wiper terminal. For example, if five volts is the input voltage when the wiper is closest to the input tap on the resistance disc, the output voltage will be close to five volts. However, as the wiper travels around the disc away from the input, the output voltage lowers linearly. The reason for the second wiper offset is to provide a differential voltage which enables the Schottel controller to determine steering direction, left or right. *Photograph 9* shows the shaft and wiper assembly removed from the potentiometer housing.

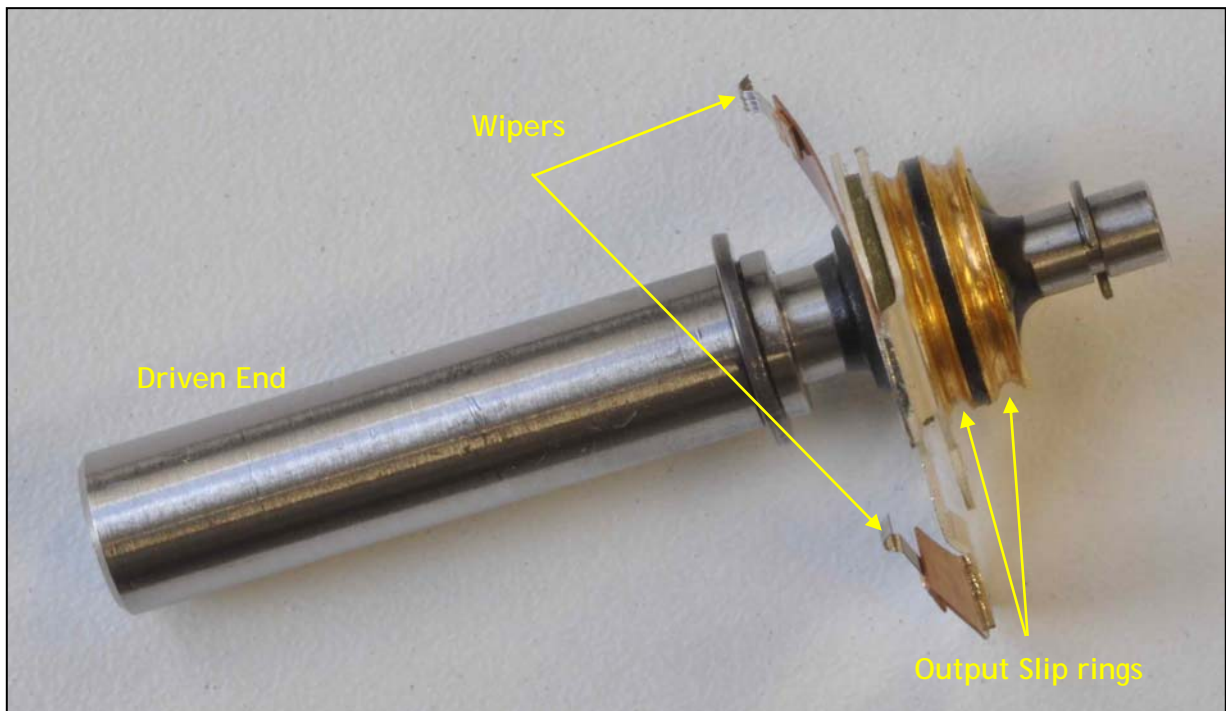
Photograph 9: Potentiometer shaft and wipers

- 1.35 No clear evidence of degradation of the conductive plastic surfaces was found which would suggest that the potentiometers were worn out. However, one theory held by Sydney Ferries' staff was that a build-up of resistance element material worn off through movement was causing the wipers to momentarily lift from the track during rotation, returning an open circuit signal to the Schottel control unit.

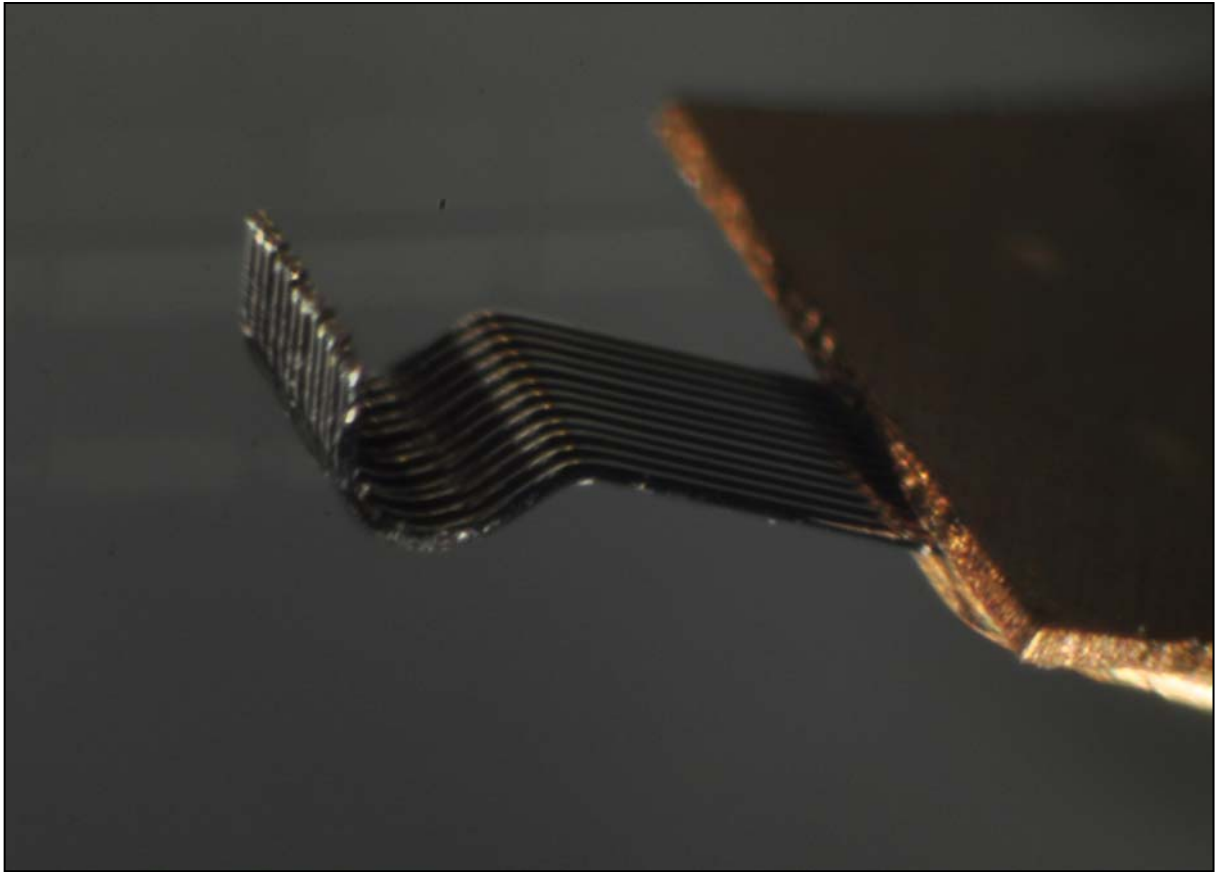
- 1.36 An examination of a potentiometer under a stereo microscope found that the wipers are made up of a group of individual wire wipers fixed to the wiper arm. *Photograph 10* is a photomicrograph of one of the wipers.

- 1.37 For an open circuit to occur, essentially all twelve of the wiper wires must lose contact with the resistive element. Furthermore, if the loss of contact is due to the wiper riding over a build-up of material worn from the resistive element, only an irregular voltage output should be returned because the material would be conductive to the same degree as its parent material.

Photograph 10: Photomicrograph of wiper contacts

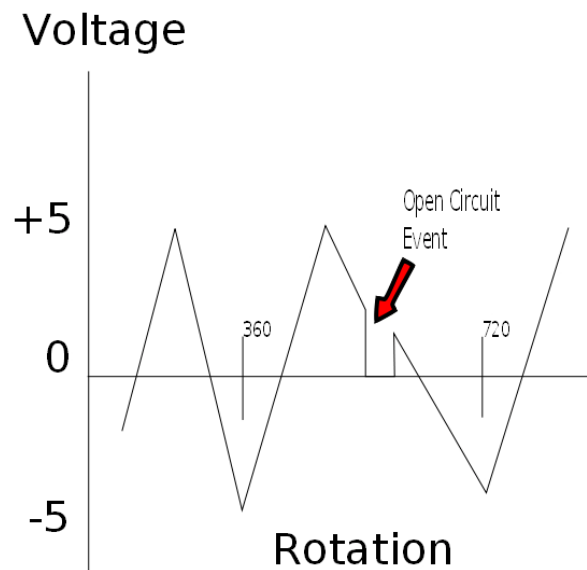
- 1.39 The testing of potentiometers through the use of a digital multimeter and rotation of the shaft by hand is an unreliable means of testing. The only definitive test for whether or not a potentiometer is operating within the design parameters would be to run the potentiometer on a jig fitted with an event logger. Such a rig would need to spin the potentiometer through varying speeds and directions of rotation, while at the same time recording output

Figure 3: Graphical representation of how an open circuit would appear

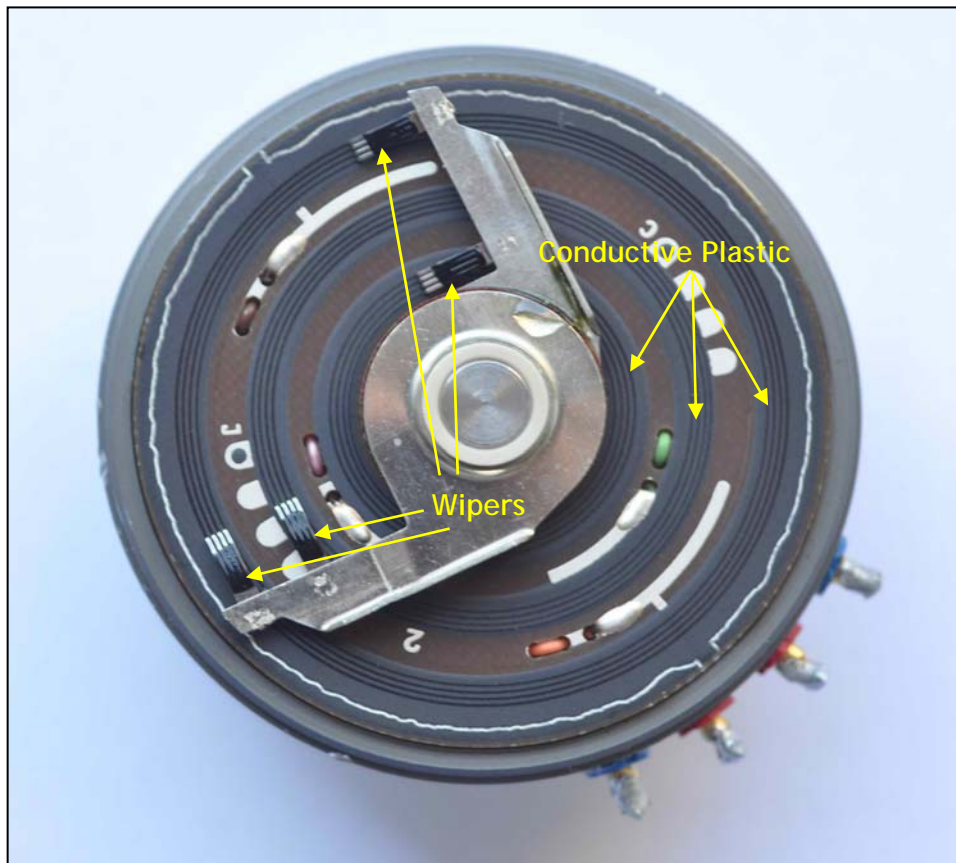
Photograph 11: Replacement SRP steering potentiometer

- instituted a program of tracking individual potentiometers by numbering each unit and automatically replacing them after 12 months of use;
- replaced the potentiometer on the Schottel unit with a larger and more robust unit having a double conductive plastic surface allowing a constant connection (see *Photograph 11*);
- instigated a maintenance plan to replace the control board every four years;
- replaced the wiring connection for the control units with a pin connection in place of the screw terminal to ensure better connection and prevention of damage to wires during inspections;

1.60 The Kwant coded error display panels have been moved from a previous position under the main console to a position on the front of the console readily visible to the Master. However, in this position, the display can be bumped which can easily result in the settings being changed. A protective see-through guard or similar protection should be fitted to these units.
