Office of Transport Safety Investigations

RAIL SAFETY INVESTIGATION REPORT

NEAR MISS WITH TRACK CLEANING CONTRACTORS BANKSTOWN

29 OCTOBER 2010

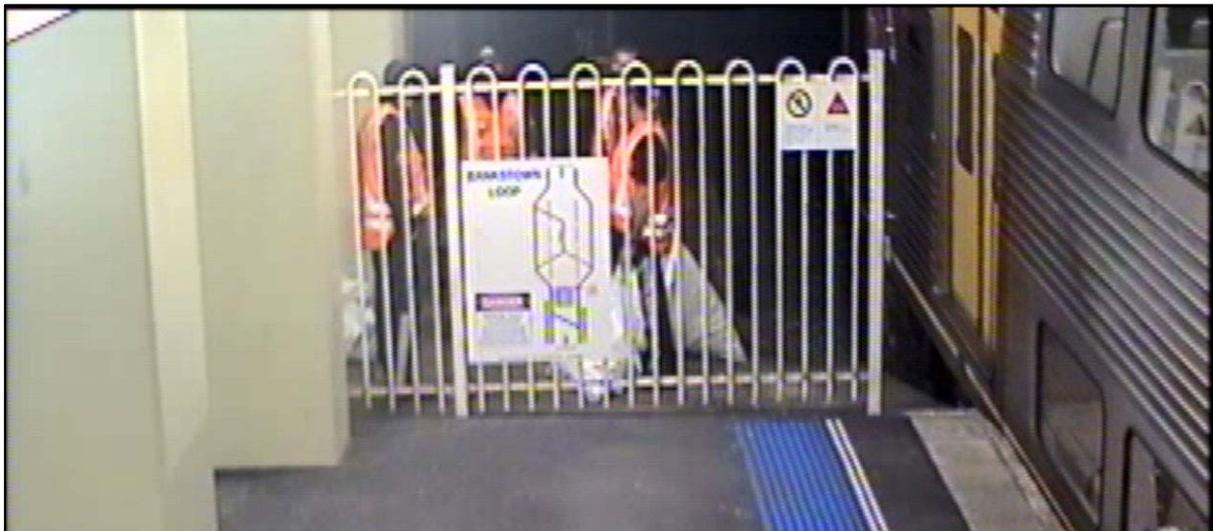
Photograph 2: Cleaners awaiting departure of 42-W

- 1.33 When the four workers reached the Up side a train, later identified as Circular Quay to Bankstown via Regents Park service 42-W, was standing at Platform 1 (see *Photograph 2*). As the workers waited for this train to depart, their Protection Officer completed his work on Platform 2 and was following them across to Platform 1.
- 1.34 Shortly after 12:51am the train departed in the Down direction to enter the Bankstown loop in order to cross over to the Down line and continue on.

- 1.35 At 12:51:56am, immediately after departure of the train, the four workers moved towards the Up track and by 12:52:09 they were all on the track commencing litter removal with the Protection Officer not yet in sight. No Protection was in place. At 12:52:10 the Protection Officer came into view at the end of Platform 1 and walked up onto and along the platform beside where the other four were working. He stated in interview that his phone was not responding and he turned to see the workers in the Danger Zone and immediately reminded them of the Safe Place, using the words “*There’s your Safe Place*”. He then resumed his attempts to contact the Area Controller, impeded by poor phone signal strength. He stated that his intention had been for the workers to move to the nominated Safe Place until he had established CSB.

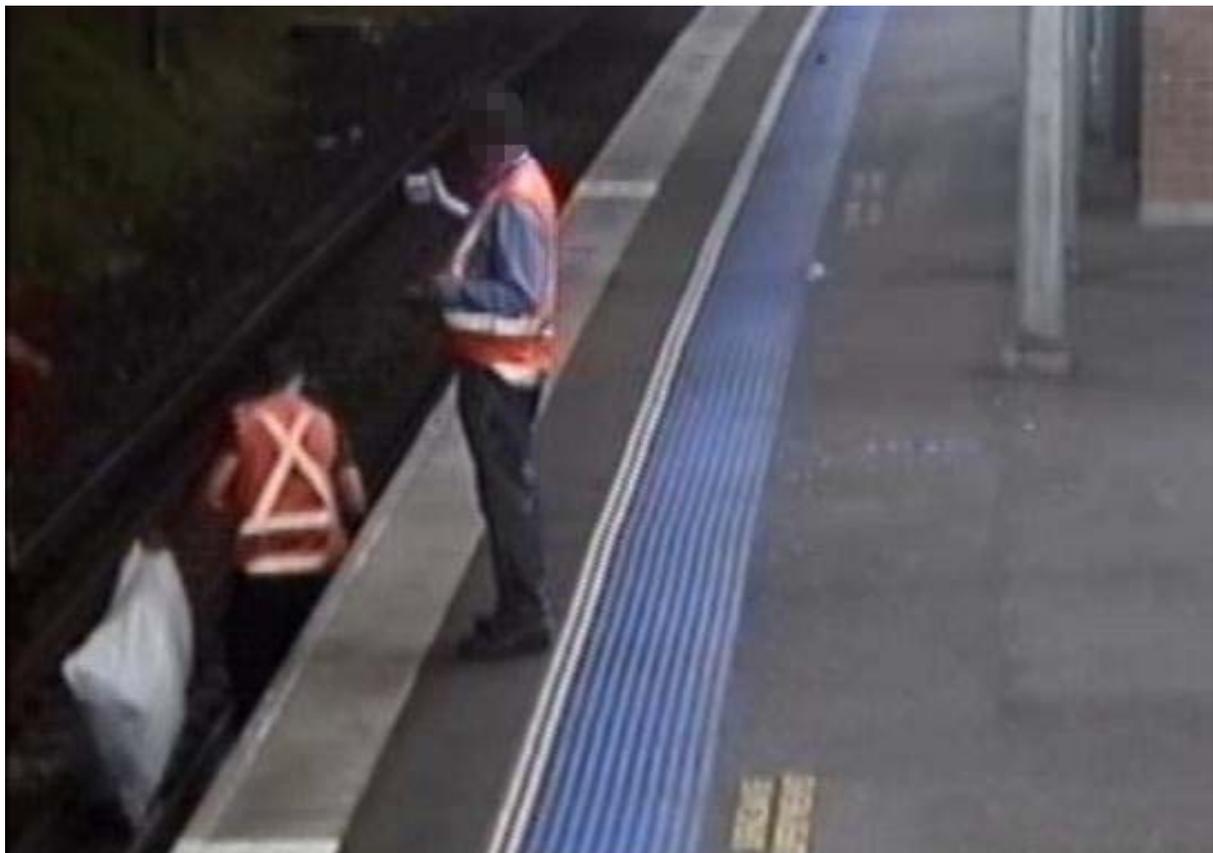
Photograph 3: Protection Officer photographs the track

- 1.36 The workers stated in interview that they thought the Protection Officer had simply reminded them of the location of the designated Safe Place, and that CSB was already in place.
- 1.37 As CSB on the Down had not yet been fulfilled, the Area Controller would not have been aware that the workers had moved from the Down track and were now working on the Up.
- 1.38 At 12:52:45am the Protection Officer, who was now level with the workers picking up litter on and adjacent to the Up track, can be seen to stop and face the track and to take a photograph looking in the Up direction (see *Photograph 3*). He appeared again to be preoccupied with this task, and to give no attention to the workers despite them being directly in his field of view. He then turned and continued walking along the platform behind the workers.

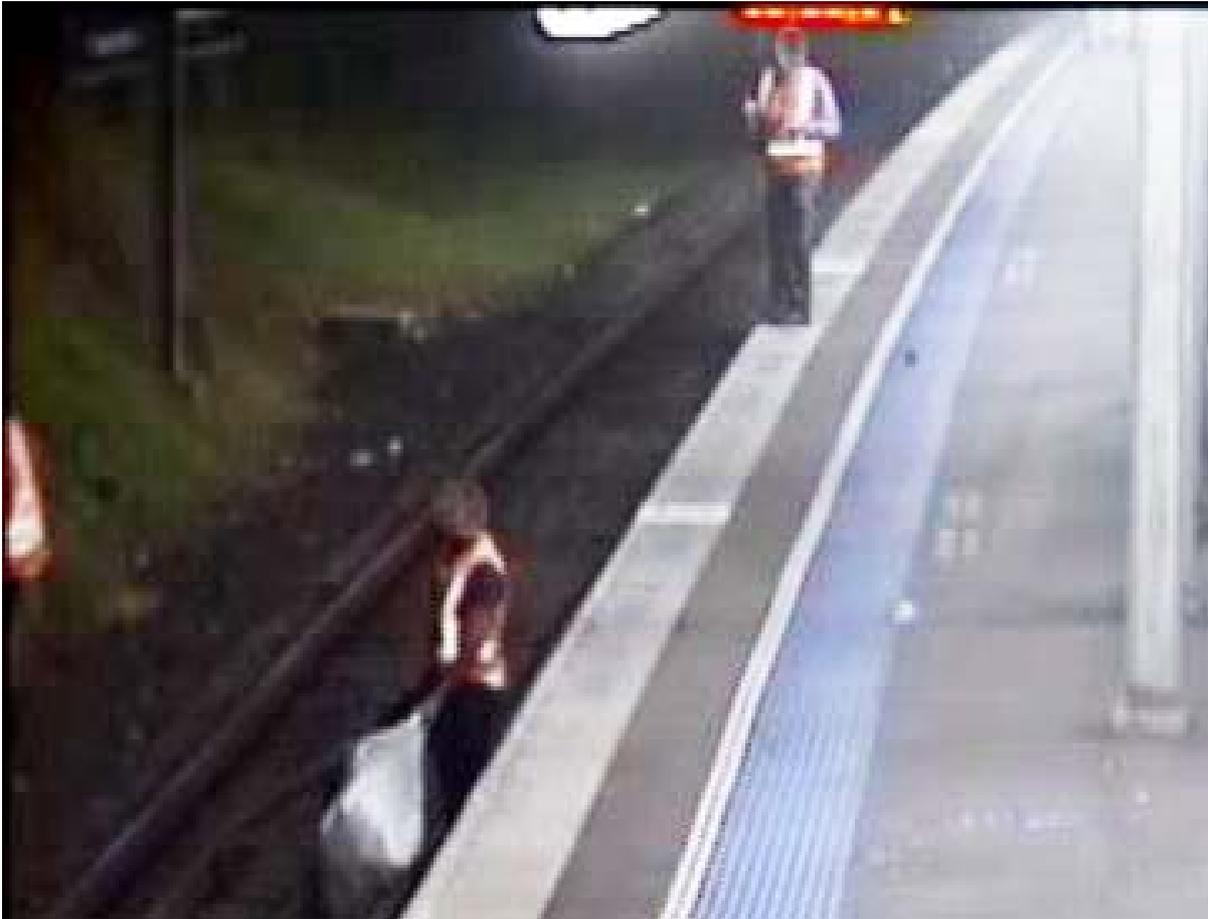
Photograph 4: Protection Officer photographs the track again

- 1.39 At 12:53:15am, having by then walked well past the workers, the Protection Officer turned around to face them and appeared to again take a photograph

using a camera held in his right hand (see *Photograph 4*) before looking down at his mobile phone in his left hand.

- 1.40 He then turned away from the track and continued along the platform in the Up direction, walking away from the edge of the platform. He continued to appear preoccupied, and to show no awareness of the fact that the workers were on the track with no protection arrangement in place.
- 1.41 At the same time empty CityRail passenger train 31-Y, travelling from Regents Park to Sydenham after having been used for points cleaning, was approaching Bankstown Platform 1 in the Up direction. The train was reported by the driver to have been travelling at approximately 55km/h.
- 1.42 At 12:53:38am the driver of 31-Y saw the workers on the track at a distance estimated at approximately 200 metres, sounded the train's whistle, and commenced emergency braking.

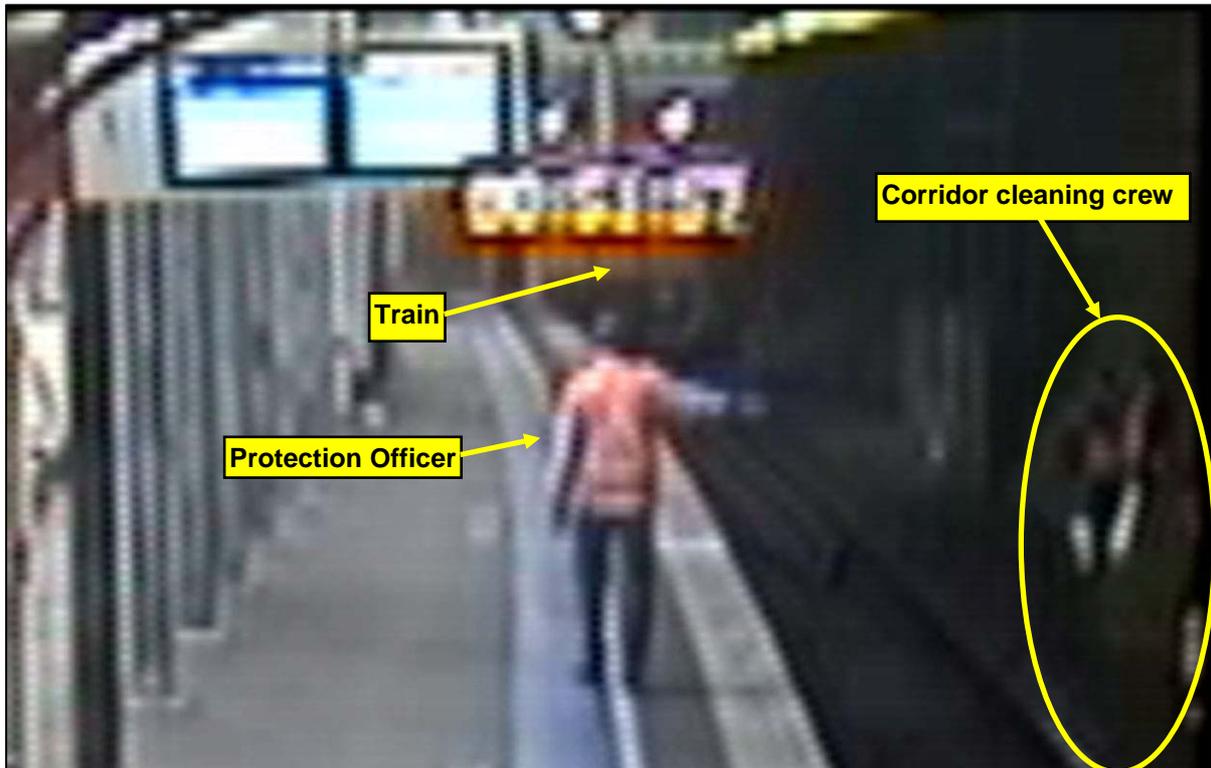
Photograph 5: 31-Y comes to a stand in view of cleaners

- 1.43 On hearing the train whistle, the Protection Officer immediately moved back to the edge of the platform to warn his team while the workers, having also heard the train whistle, moved quickly off the track to a safe location in the Up cess.
- 1.44 Train 31-Y came to a stand just before reaching Platform 1 at 12:53:55am, approximately 60 metres from the workers⁴, and was subsequently signalled by the Protection Officer to proceed, which it did at 12:54:20am (see *Photograph 5*).
