RAIL SAFETY INVESTIGATION REPORT

UNCONTROLLED MOVEMENT OF EL ZORRO GRAIN SERVICE 3996

UNANDERRA

7 FEBRUARY 2011

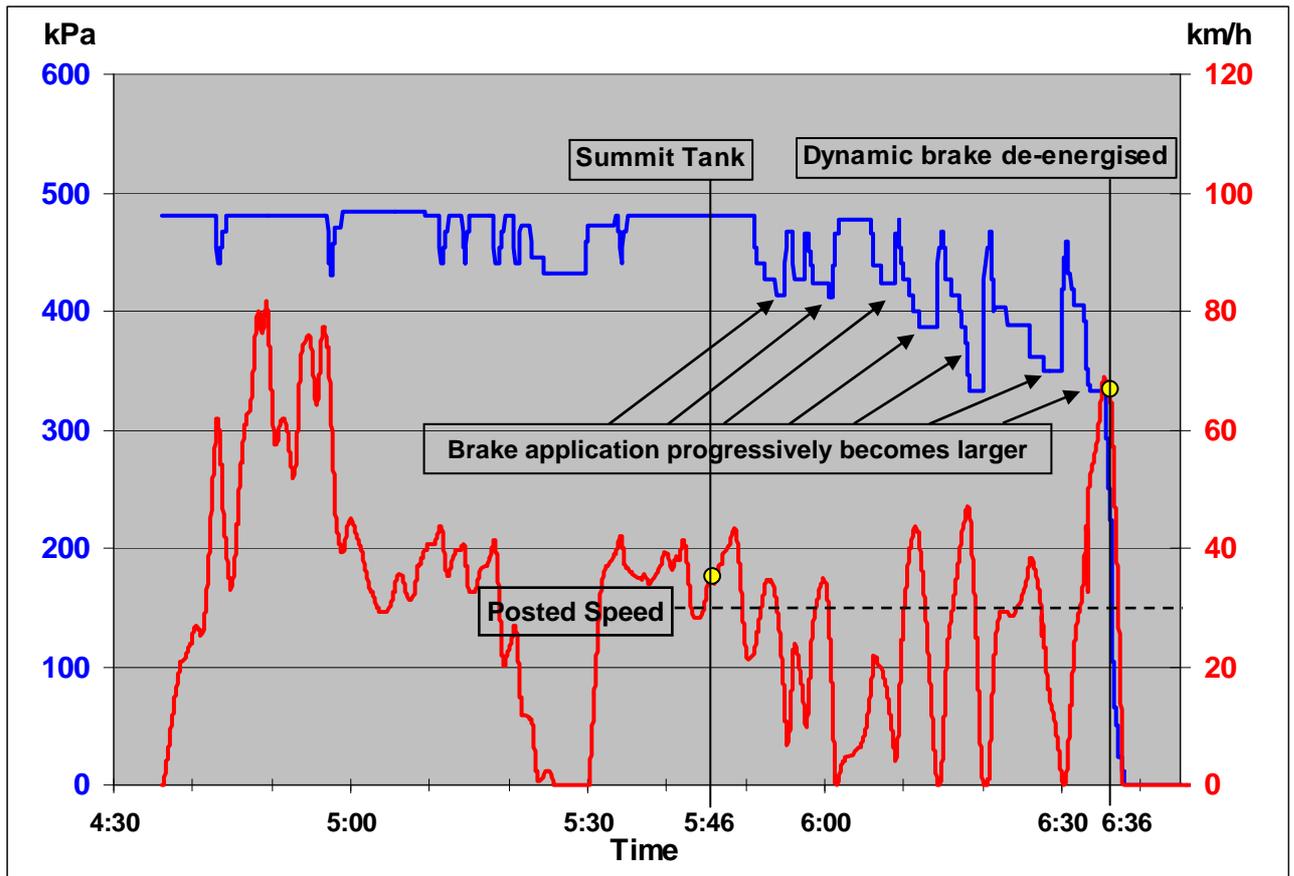
Figure 4: Brake pipe pressure, time and speed chart from Moss Vale to Unanderra

- 2.7 The crew claimed their maximum speed at the bottom of the Illawarra Mountain was 63 km/h as noted on the train’s speedometer and not 73 km/h as recorded by the data logger. CFCLA was asked to have the data logger from EL57 checked and it was found the data logger was calibrated for a wheel diameter of 971 mm instead of 956 mm, indicating the true speed was lower than recorded. On recalculation, the true speed in the case of a data logger reading of 73 km/h was determined to be 68.9 km/h. All speed data was then corrected to take into account the calibration error (see *Figure 4*).

2.8 Passing through Summit Tank, the train was travelling at approximately 35 km/h, some 10 km/h over the prescribed speed limit. The section from Summit Tank to Dombarton was then covered in 34 minutes whereas the sectional running time for a train of similar weight and configuration is designated as 38 minutes.

2.9 After Summit Tank, the train exceeded the speed of 25 km/h for single pipe trains and the posted speed of 30 km/h on seven occasions. On the last occasion, it reached a maximum of 68.9 km/h before passing signal WG 1014 at STOP and coming to a stand 527 metres beyond.

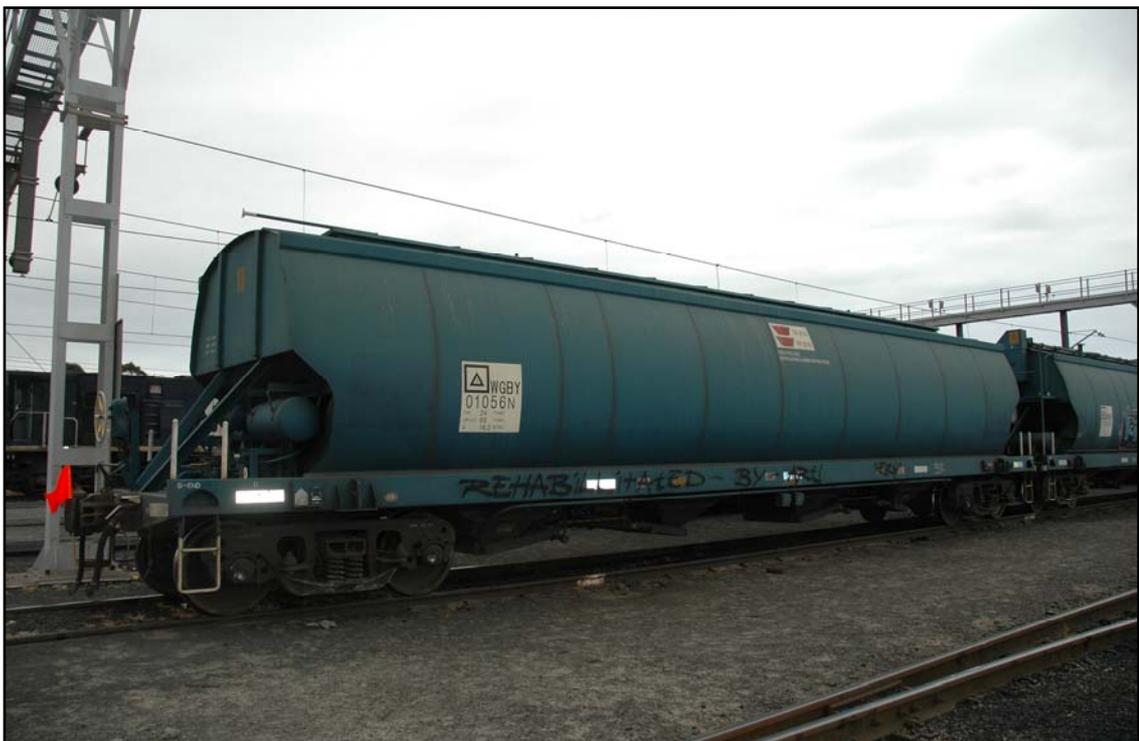
Photograph 1: WGBY Wagon

2.22 The WGBY type wagons making up the train were built by Qiqihar Railway Rolling Stock Co., Ltd. (QRRS), located in the northern city of Qiqihar in Heilongjiang Province of the People's Republic of China. They were sourced from QRRS with the assistance of China International Marine Containers Rolling Stock Australia Pty Ltd (CARS) which was contracted by the AWB to assist in the design, manufacture, purchase, importation and commissioning of the wagons. The first of the wagons arrived in Australia in February 2009 (see *Photograph 1*).

2.23 The WGBY wagons are fitted with a dual pipe braking arrangement consisting of two continuous air pipes along the train. The basic train braking functions are operated by air supplied through the standard continuous single 'brake pipe' arrangement direct to each wheel. A separate second pipe, the 'main reservoir pipe', feeds air to supplementary reservoirs on each wagon directly from the locomotive main air reservoir. The supplementary reservoirs provide air to assist in the recharging of the brake pipe system which increases the air recharge rates thus providing a more responsive

- 2.25 Before entering service, the wagons were modified with a 6 mm pipe connection from the main reservoir pipe to the wagon's supplementary reservoir to supply a trickle air flow and permit dual pipe operations. The specifications for this were devised by CARS's engineers. However, the modified arrangement was not subjected to feed or flow rate tests on the basis that testing was not required because the purpose of the 6 mm pipe was only to deliver a trickle flow as per Rail Corp and ARTC guidelines.
