## **RAIL SAFETY INVESTIGATION REPORT**

**SHUNTING FATALITY  
LACHLAN VALLEY RAILWAY SOCIETY (LVRS)  
HERITAGE STEAM TRAIN SS84  
ARIAH PARK**

**15 APRIL 2006**

**Date: 30 April 2007**

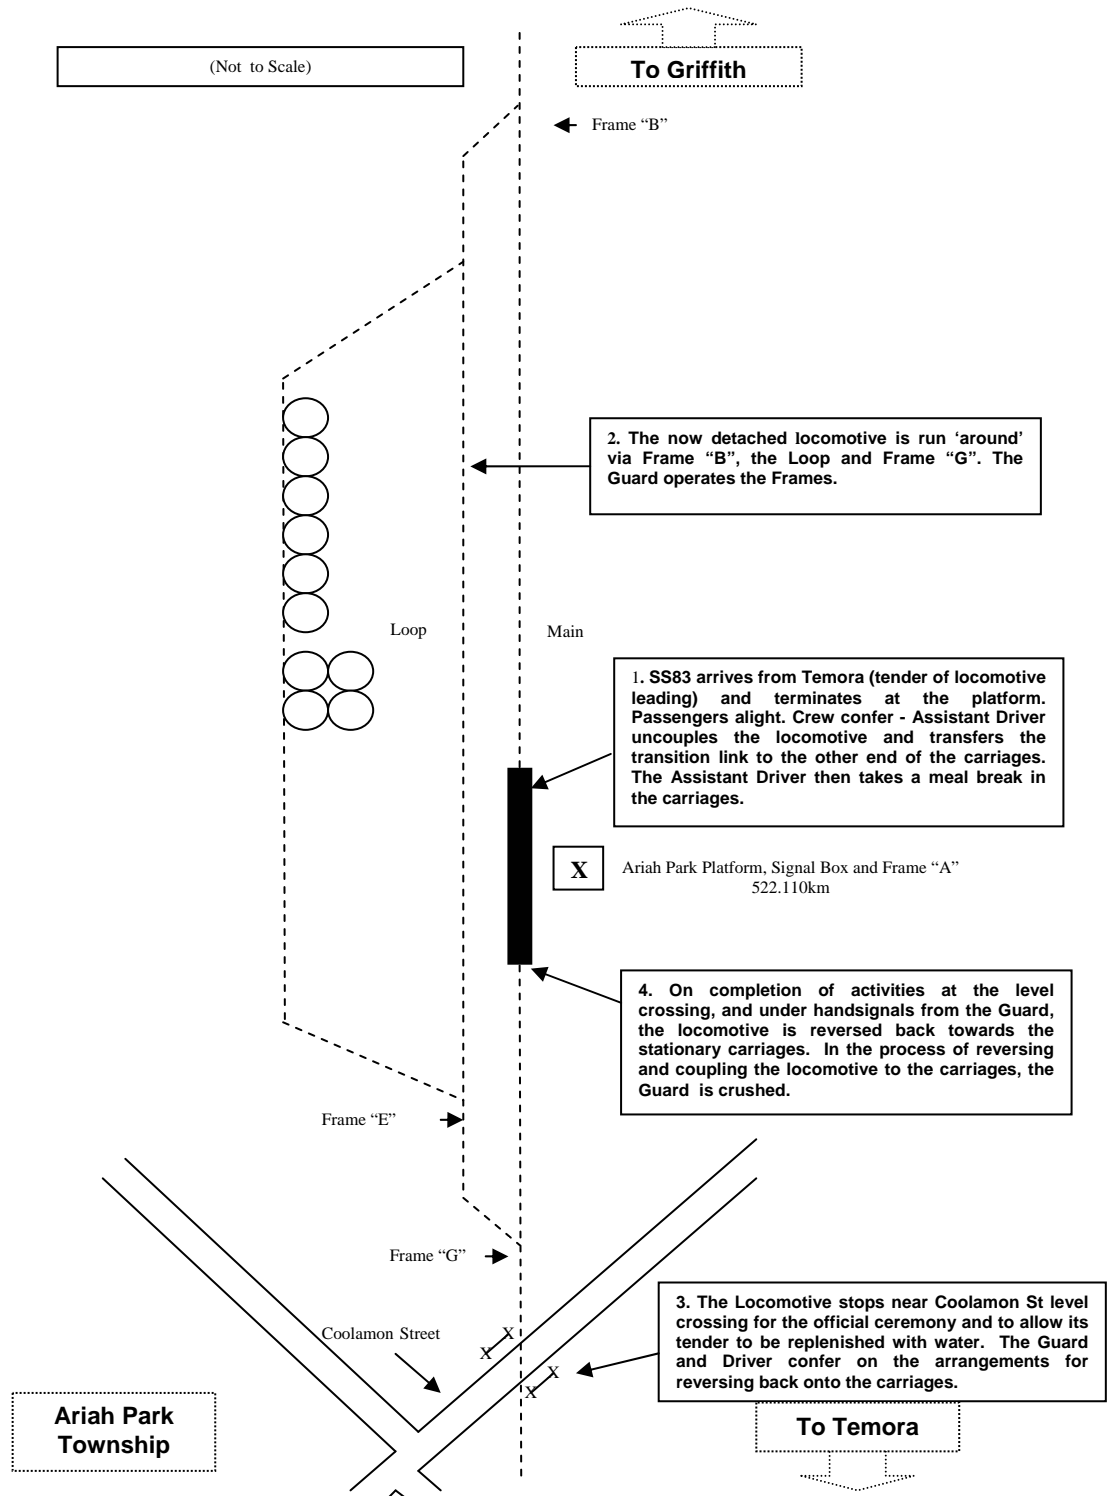
Figure 4: Key Incident Points

- 2.6 On arrival at the Aria Park platform at 10:30am, the passengers alighted from the train and walked to the official celebrations in the township. Meanwhile, the crew members conferred regarding the movements that were required to detach the locomotive from the train and to position it at a nearby level crossing in readiness for a ribbon-cutting ceremony. The discussions specifically addressed the requirement for the Guard to operate the various ground-frames and for the Assistant Driver to transfer the transition link<sup>8</sup> to the other end of SS83 in preparation for the return journey to Temora. The sequence of movements up until the point at which the Guard was crushed is depicted in *Figure 4*.

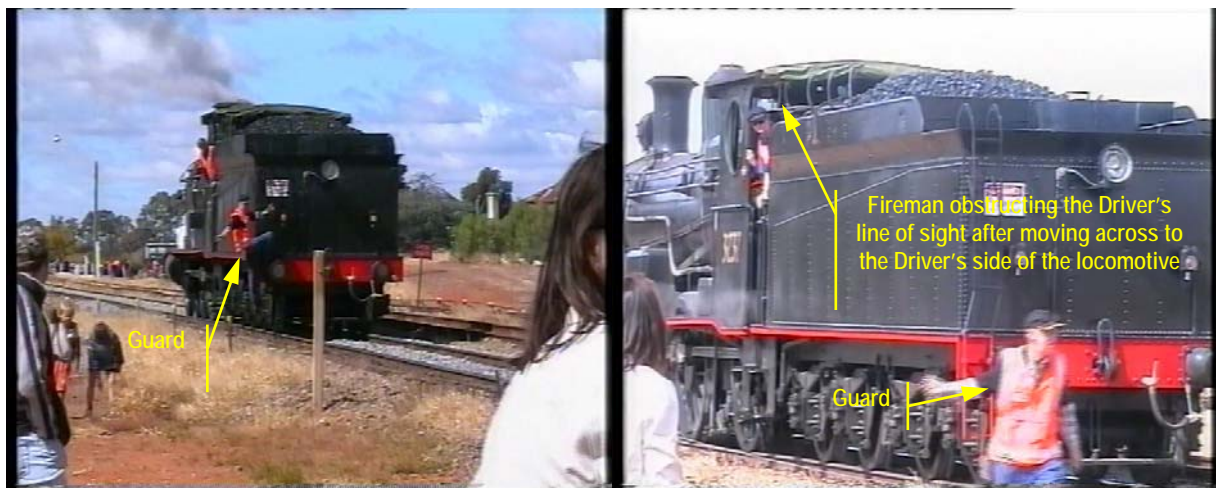
- 2.7 At the completion of the official ceremony at approximately 11:40am, the Guard arranged with the remaining crew<sup>9</sup> to reverse, or propel<sup>10</sup> the locomotive back towards the carriages which were standing at the platform. He climbed onto a ladder on the locomotive's tender to direct the reversing movement (see *Photo 1*).
- 2.8 The sequence of events that follows was captured on video by witnesses at the event. As the locomotive reversed, the Guard directed the crew by hand signals. At a point approximately 20m from the carriage FS 2133, and whilst the locomotive was still moving at what appeared to be walking pace, the Guard stepped off the tender's ladder and onto the ground and continued to provide hand signals to the Driver (see *Photo 2*).

Photo 1: Guard hanging onto ladder on tender of 3237

Photo 2: Guard hand signalling to the Driver to continue reversing

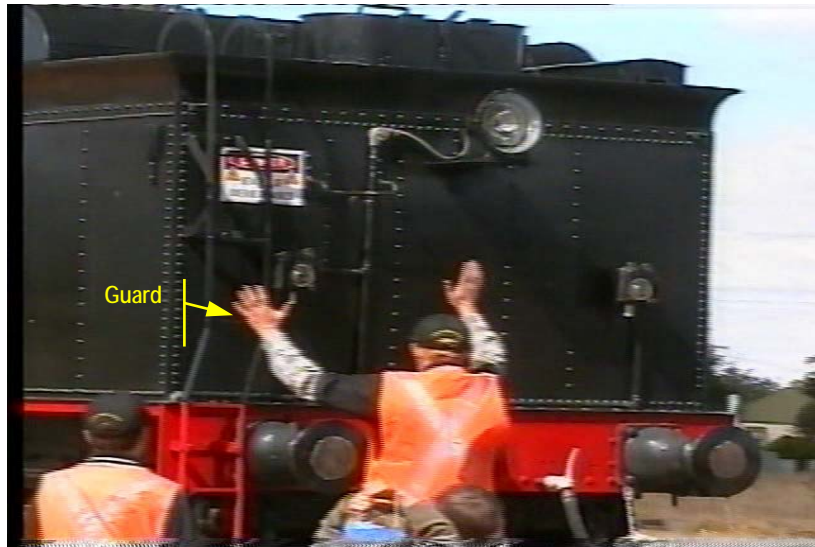
- 2.9 At a point approximately eight metres from the train, the Guard gave a “stop” hand signal and the Driver stopped the locomotive approximately five metres short of the rest of the train (see *Photo 3*).

Photo 3: Guard hand signalling to the Driver to stop, moments before he stepped into the danger zone

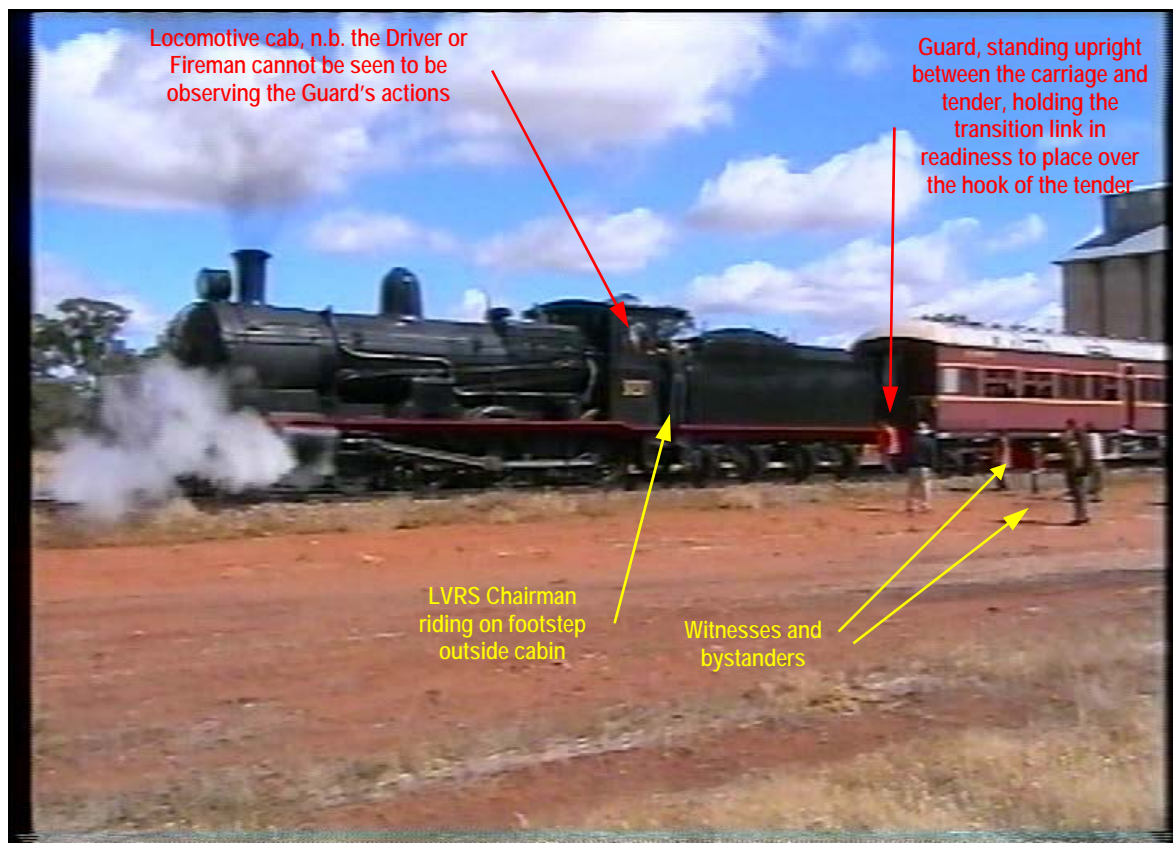
Photo 4: Incident scene at Ariah Park moments before impact

2.10 At this point, LVRS's Chairman boarded the footsteps on the Driver's side of the locomotive, an action that is discussed later in paragraph 3.23. The Guard then stepped into the gap between the tender and the carriage and aligned the transition link in readiness for coupling. He then stepped out of the gap between the tender and the carriage and gave the Driver a "caution hand signal", indicating he could continue to move the locomotive towards the carriage but should do so with caution<sup>11</sup>. As the locomotive commenced to move, the Guard again stepped into the gap between the tender and the carriage in order to complete the coupling process (see *Photo 4*, taken moments before the impact).

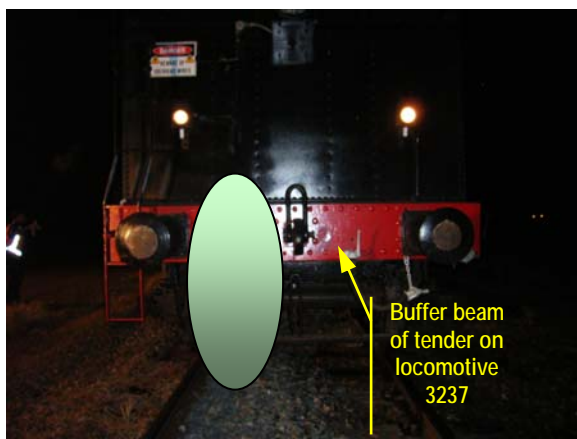
2.11 Moments later, and in accordance with normal practice, the Driver applied the locomotive's brakes when he felt the impact between the tender and carriage. Almost immediately, a nearby spectator observed that the Guard was trapped between the tender and the carriage and tried to alert the Driver to the situation. The green shaded areas in *Photos 5* and *6* indicate the area where the Guard was trapped. The photos also show the buffers on the tender and their absence on the carriage. The photos also show the buffers on the tender and their absence on the carriage.

Photo 5: Shaded area indicates area of the tender's buffer beam where the Guard was crushed

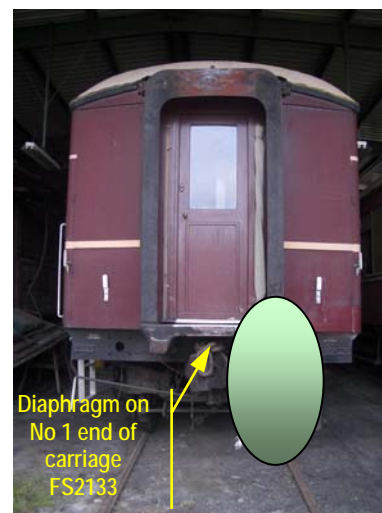
Photo 6: Shaded area indicates the area of carriage's diaphragm where the Guard was crushed

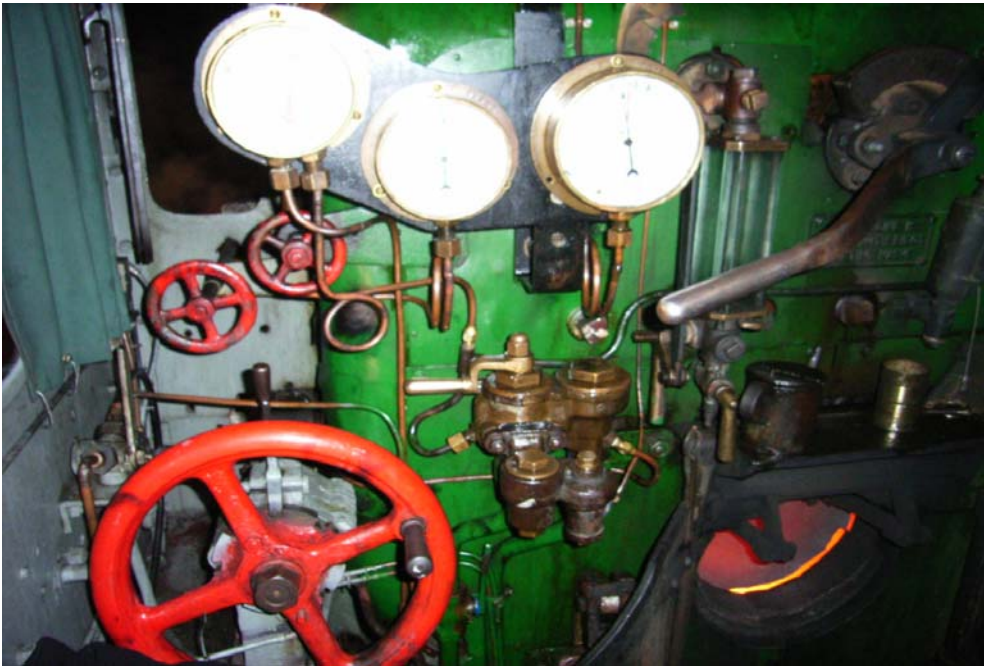
7), it took approximately 20 seconds before the locomotive responded to the Driver's control inputs. When the locomotive did move, the Guard slumped onto the track.

Photo 7: The locomotive's controls

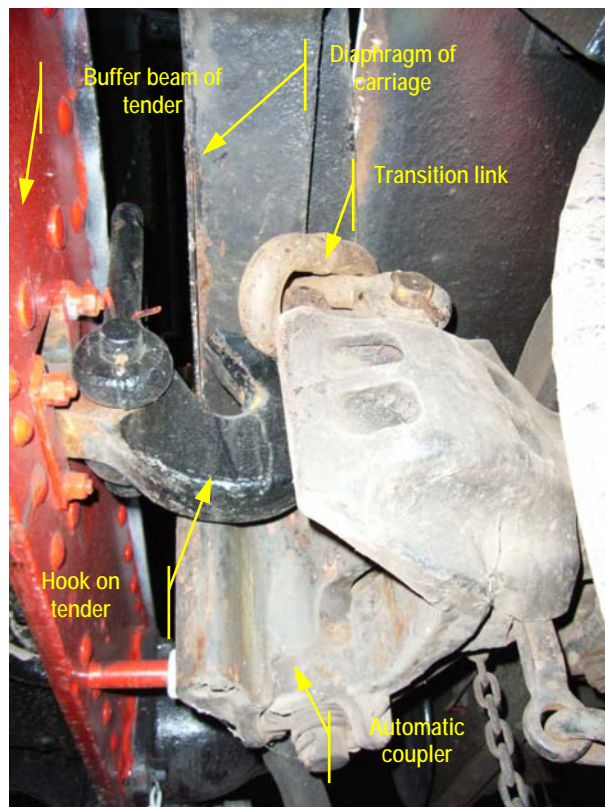
- 3.2 Coupling Practices. Modern rolling stock is fitted with 'auto couplers' which automatically engage when two pieces of rolling stock are brought in direct contact during a shunting operation. Older rolling stock, unless it has been retrofitted, must be manually coupled by means of mechanical linkages called transition links (see *Photo 8*). These transition links are used to couple vehicles fitted with automatic couplers (such as that on the FS type carriages) to vehicles fitted with hooks (such

Photo 8: Tender and carriage coupling components (bottom view)

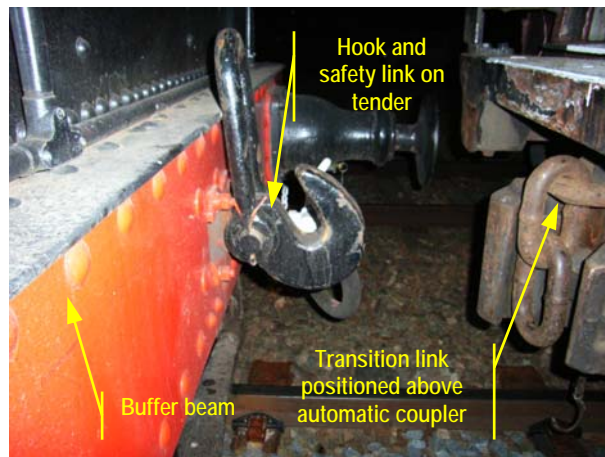
- 3.3 During coupling, the forces at the moment of impact are lessened by buffers which protrude from the end of the rolling stock. At the low speeds at which shunting operations should be conducted, the buffers compress slightly but the actual bodies of the rolling stock remain separated.
- 3.4 OTSI noted that the carriage was not fitted with buffers and had a narrow diaphragm. The sole purpose of a narrow diaphragm is to allow passengers to cross between passenger vehicles, whereas wider diaphragms can also act as a buffer. The only safe way to have coupled the pieces of rolling stock in this instance would have been for the Guard to have remained outside the wagon outline until the locomotive had come to rest in very close proximity to the locomotive and then crawled underneath the locomotive's buffers to place the link over the hook (see *Photos 9 to 11*).

Photo 9: Uncoupled hook and transition link

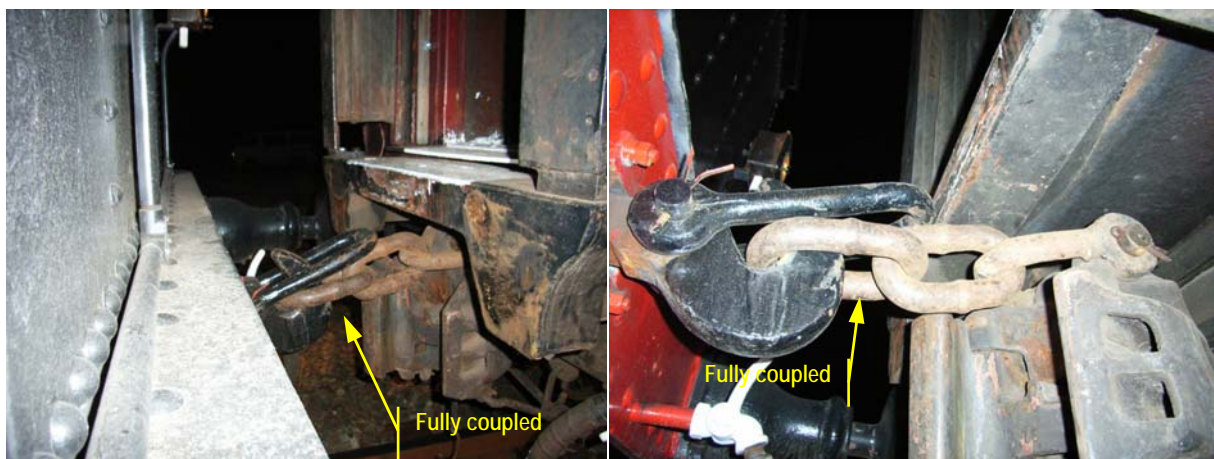
Photo 10: Tender fully coupled to carriage (side view)

Photo 11: Tender fully coupled to carriage (bottom view)

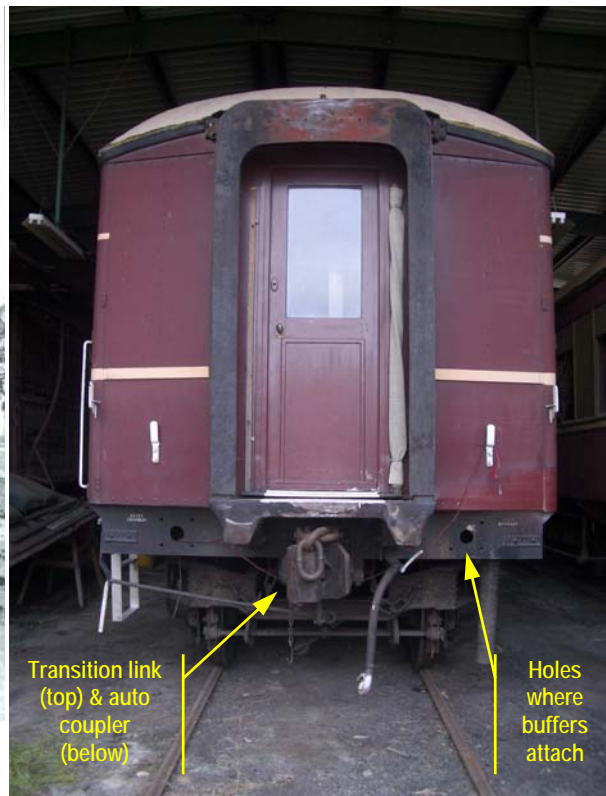
- 3.22 LVOP 16 states that crews must *"Ensure that vehicles with buffers are only coupled to other vehicles fitted with buffers or diaphragms"*. This instruction was clearly deficient in that it should have prohibited the coupling of non-buffered vehicles or one non-buffered vehicle to one that was buffered. Alternatively, if provision was to be made for the coupling of non-buffered vehicles in certain circumstances, then the procedure should have specified how this was to be safely accomplished.

Photo 13: No 1 end of FS 2133 as configured on the day of the accident, n.b., the absence of buffers
