Railway Safety Investigation Report

Baan Baa

4 May 2004

Road Motor Vehicle Struck by Countrylink Xplorer Service NP23a on Baranbah Street Level Crossing (530.780kms).

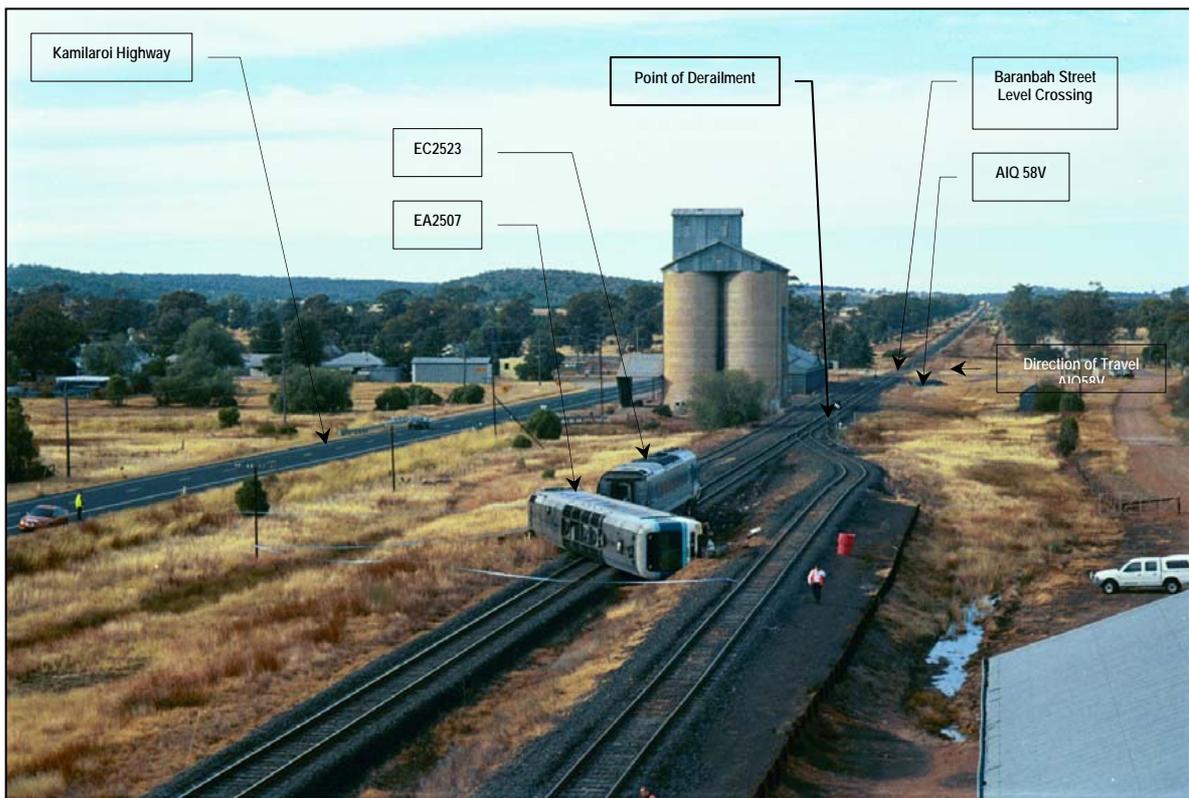
- a. NP23a remained on the rails initially with the wreckage of AIQ 58V entangled around the front of train. Approximately 15m beyond the point of impact, the wreckage of AIQ 58V struck a points indicator³ and was disentangled, coming to rest approximately 65 metres north of the crossing and seven metres west of the track.

- d. EA2507 then continued to plough up and to the left into a gravity hump⁷ of the Silo Road embankment. All remaining bogies, i.e., the second bogie on EA2507 and the two bogies on EC2523 remained on the track. The rapid deceleration when the first bogie of EA2507 mounted the embankment caused the front-end of EA2507 to be pushed further to the left and the rear-end pivot counter-clockwise, i.e., out to the right. The couplings linking EA2507 and EC2523 parted and EA 2507 toppled onto its right side approximately 420m from the point of impact. EC 2523 remained upright and did not derail.

Photo 1: Incident scene on 5 May 2004

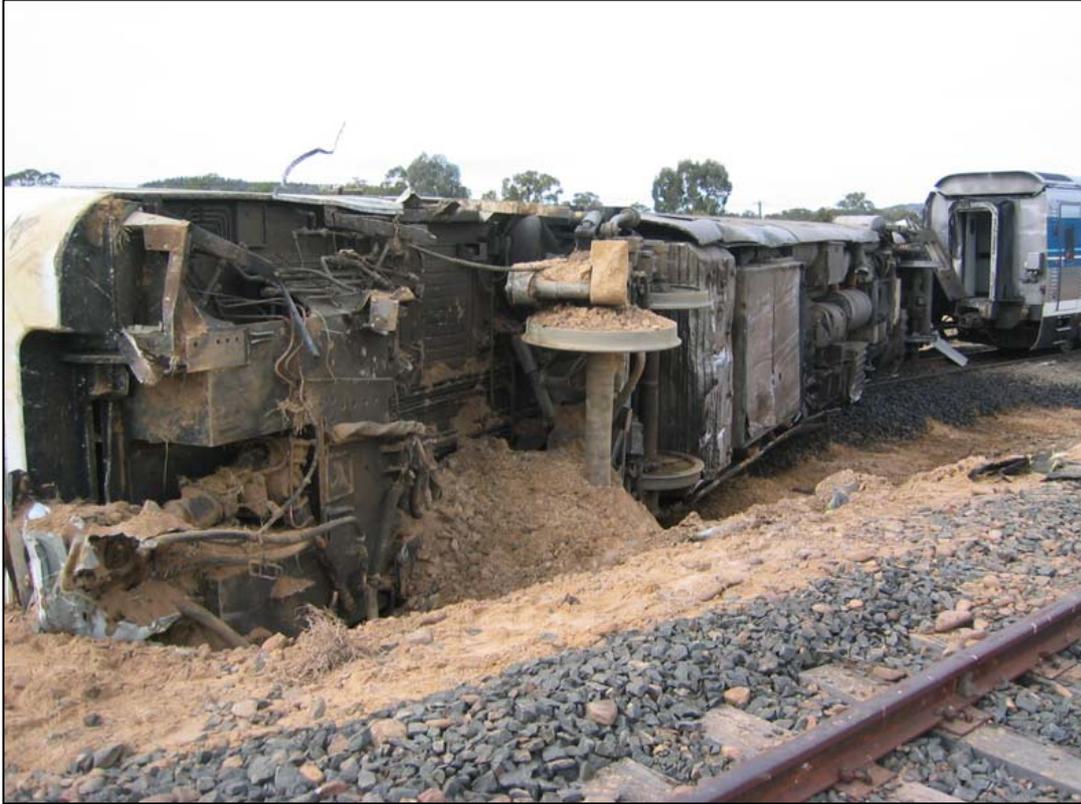
- 4.7 In addition to the injuries described in paragraph 4.1.2, the following damage was occasioned:
- 4.8 EA2507 suffered (see Photo 2):
- a. severe impact and derailment damage to the headstock, underside of the driver's cab, leading bogie, traction/suspension control equipment for both bogies, fuel tank, auxiliary generator set, traction engine and access skirts;

- b. a shattered front windscreen;
 - c. horns dislodged from mountings;
 - d. shattered passenger windows;
 - e. extensive buckling to various carriage body panels on all sides, and

- f. extensive damage to electrical couplings and inter-carriage connections.
- 4.9 EC2523 suffered (see Photo 3):
- a. moderate damage on the "A" end⁹ and left side of the body pillar, and

- b. extensive damage to electrical and inter-carriage connections.
- 4.10 AIQ 58V was destroyed in the collision (see Photo 4).
- 4.11 The fuel tank on EA2507 ruptured as it came in contact with damaged signalling equipment and approximately 1100 litres of diesel fuel spilt onto the ground. Fortunately, this fuel did not ignite.

Photo 2: Damage to EA2507

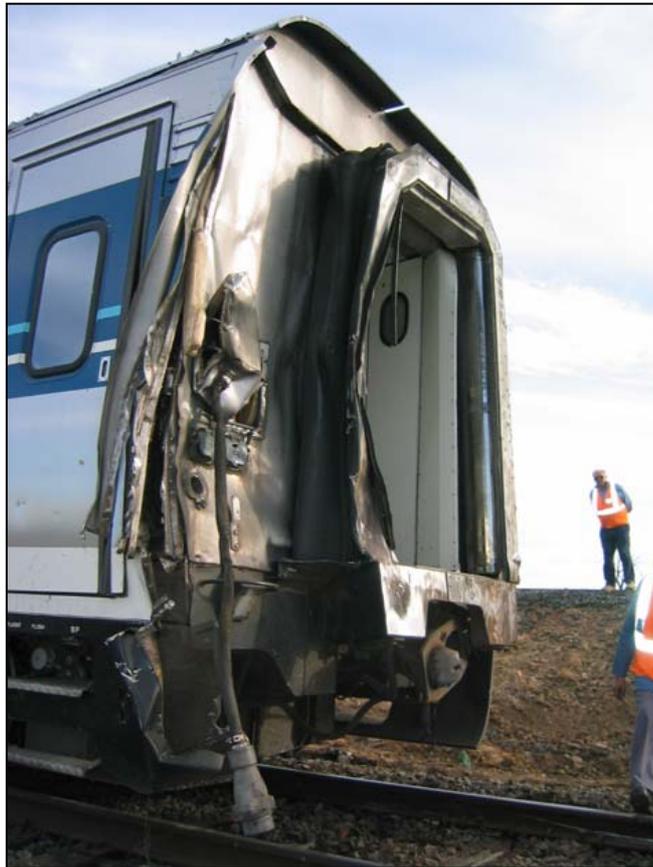
Photo 3: Damage to EC2523

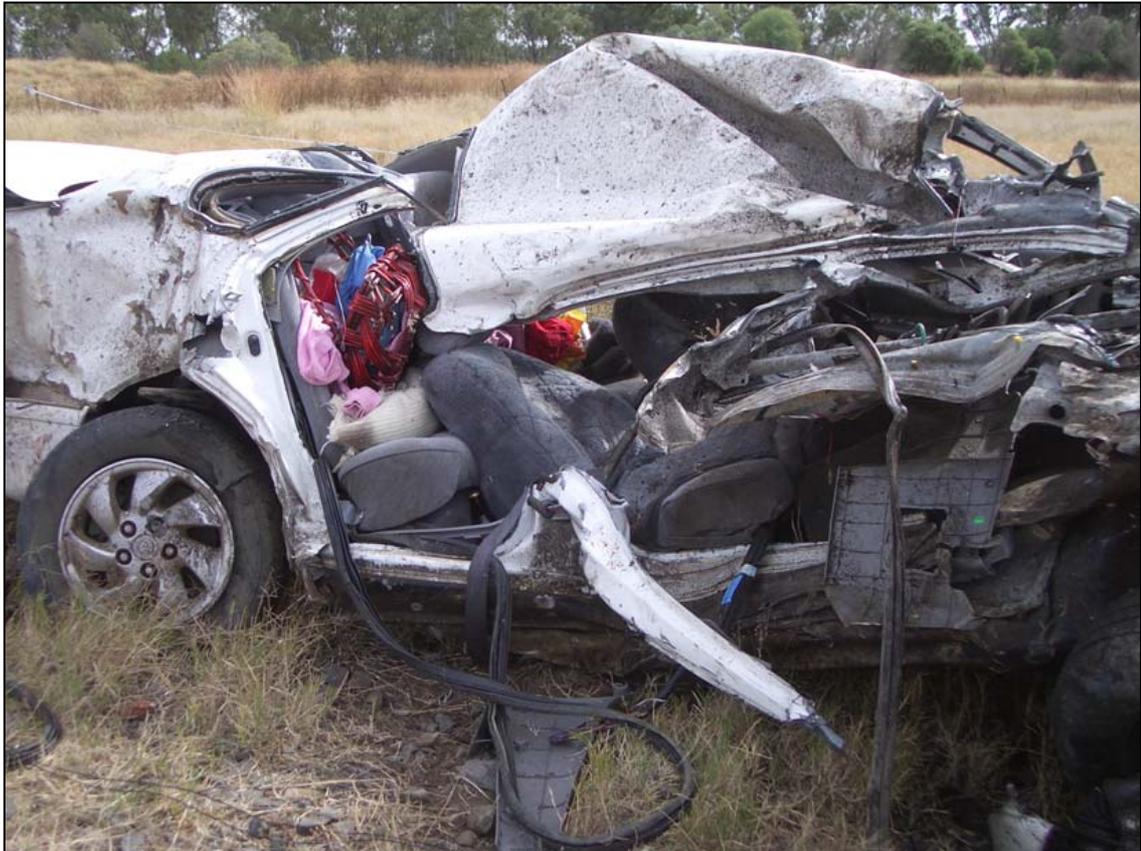
Photo 4: Damage to AIQ 58V

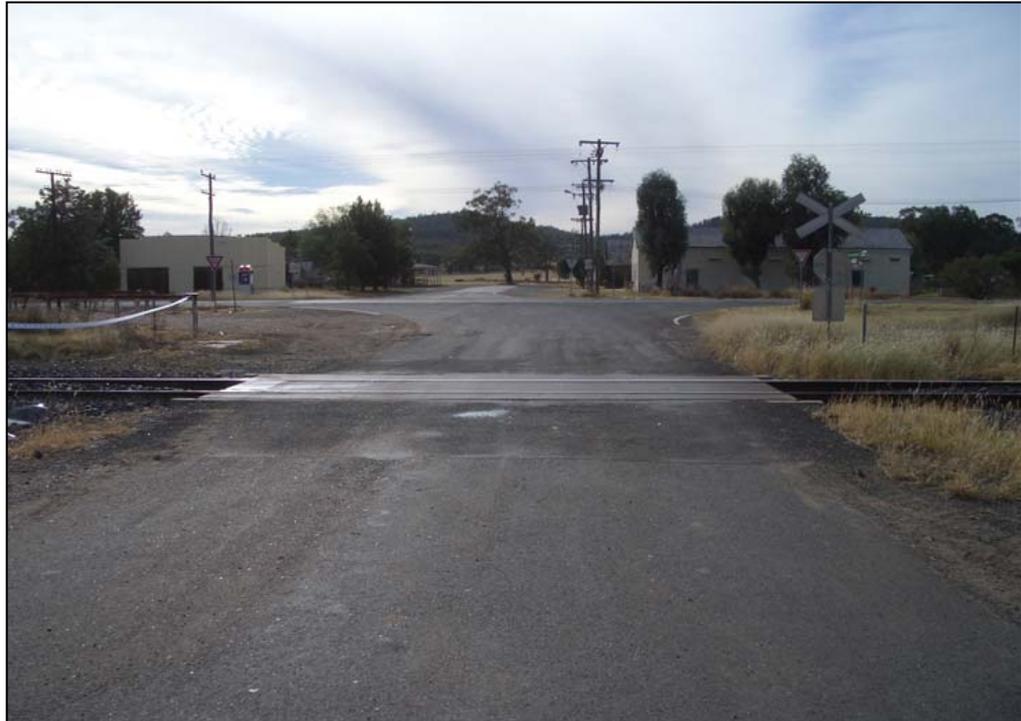
Photo 5: Baranbah Street Level Crossing (530.780kms) looking in direction of travel of AIQ 58V

- a. The level crossing is located at the point 530.780kms from Sydney, by rail, with the approaches running in an east-west direction and perpendicular to the line (see photo 5).
- b. The crossing is 'passive', i.e., there are no traffic lights or boom gates.
- c. While the crossing was signposted with "Stop" signs, signage did not conform to the minimum standards as specified in AS 1742.7 (1993)¹¹. There were no painted markings on the roadway, on either side of the crossing, to indicate stopping points. There was only one advance warning sign, posted 38m prior to the crossing on the western approach, and this sign was only .7m above the ground.¹²
- d. A "T" intersection exists just prior to the crossing on the western side, with the side road running in a southerly direction, i.e., parallel to the track.

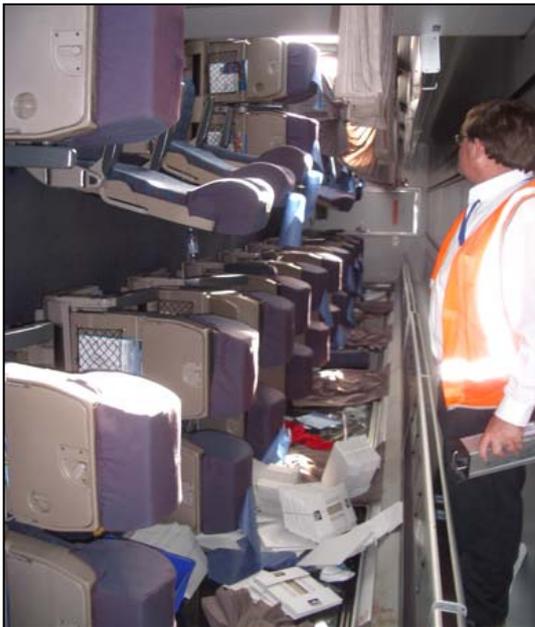
Photo 9: Inside saloon of EA2507 lying on its side

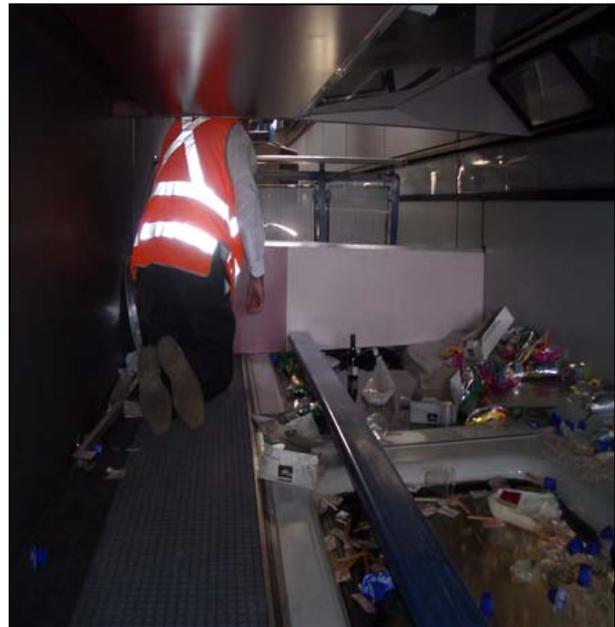
Photo 10: Access along buffet corridor while EA2507 was on its side

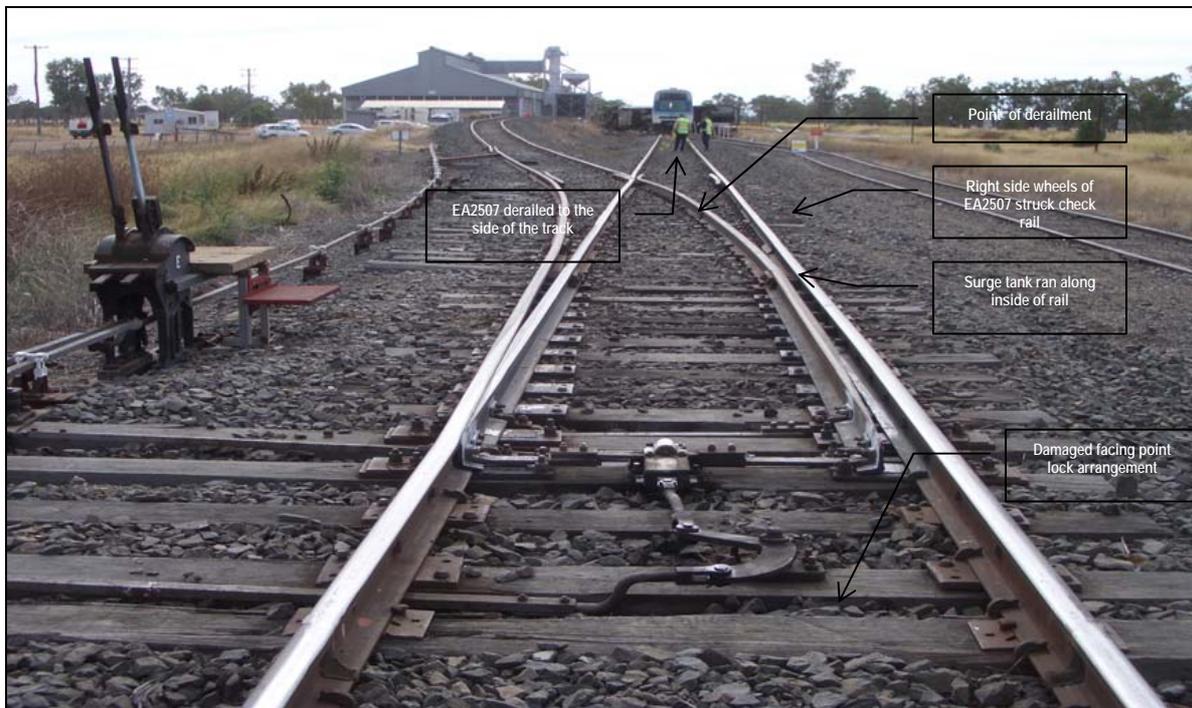
- 5.21 The leading carriage of NP23a derailed when the left-hand leading wheels rode up and over the left rail. The derailment sequence appears to have been as follows:
- a. The front-facing No. 2 Siding points-lock assembly was struck by either part of the wreckage of NP23a, a part of the points indicator that was struck by the wreckage of AIQ 58V or one of the surge tanks¹⁶ that was dislodged from underneath NP23a.
 - b. One of the surge tanks then came in contact with the inside of the right rail leading into a siding and followed the rail towards the siding (see Photo 10). This created lateral forces on the leading wheels of NP23a, resulting in the left front wheel being pushed onto and subsequently over the left rail.

Photo 11: Track layout at the point of derailment.

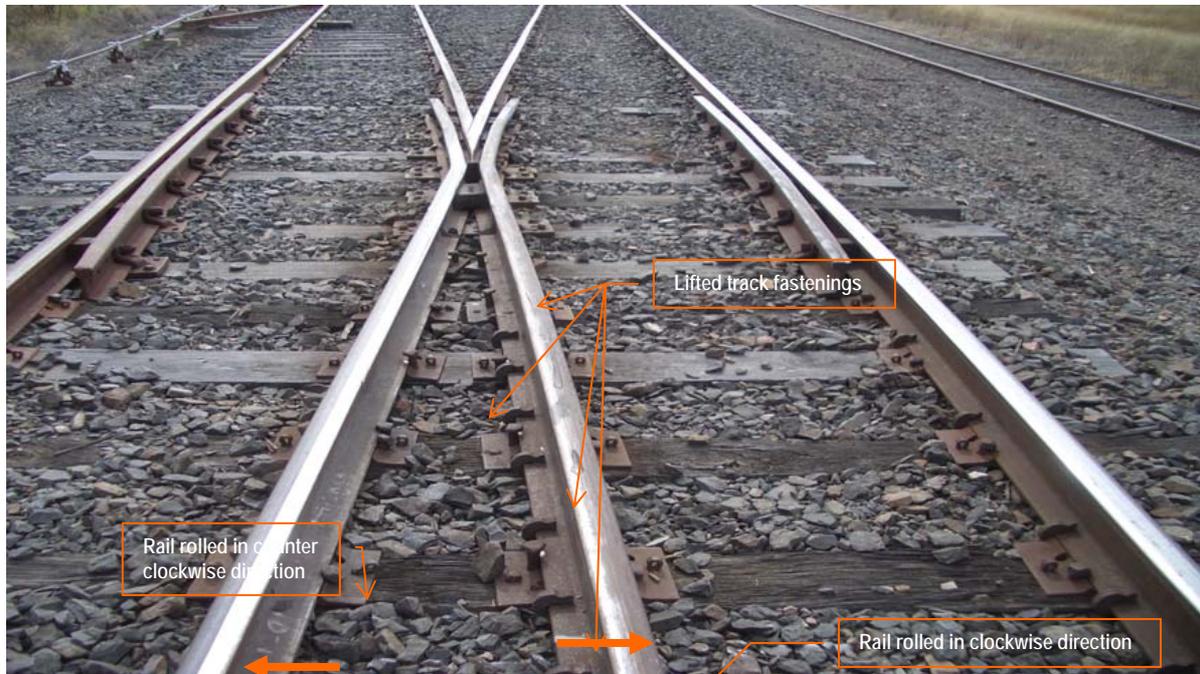
5.22 The above assessment is reinforced by the fact that both of the inside rails were rotated outwards (see Photo 12).

Photo 12: Photo showing rolled rails & lifted fastenings

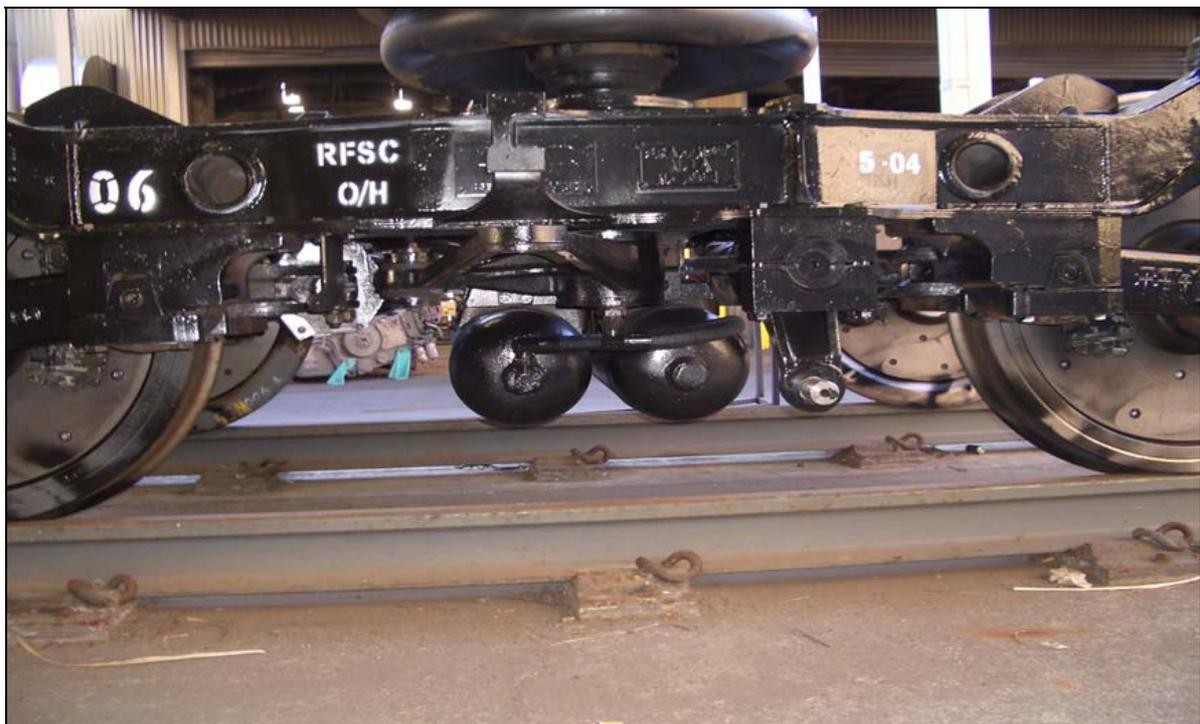
- c. EA 2507 then struck the points indicator and interlocking timbers for "E" Frame⁵ and, as a consequence, the pilot⁶, air-surge tanks for the secondary suspension and remaining pieces of AIQ 58V were ripped from under the train. The fuel tank of EA2507 also ruptured when it struck the remnants of the points indicator.

Photo 13: Location of the surge tanks on an Xplorer car bogie.
