# **OFFICE OF TRANSPORT SAFETY INVESTIGATIONS**

# Rail Safety Investigation Interim Factual Statement

Track Working Fatality Ballast Train 5M23 Vicinity of Baan Baa

22 May 2006

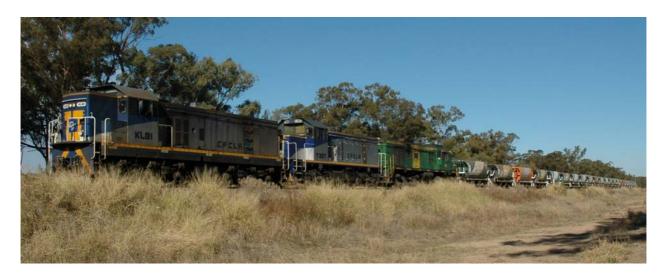
Figure 1: Ballast Train near Baan Baa

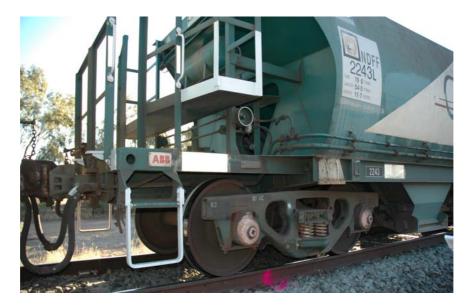
The ballasting operation was continuous, i.e., the three track workers were required to step off the empty wagons and step onto the next loaded wagon while the ballast train was in motion. The ballast wagon walkway and steps are shown in *Figure 2*.

Figure 2: Ballast Wagon Walkway and Steps
