## RAIL SAFETY INVESTIGATION REPORT

# DERAILMENT OF FREIGHT AUSTRALIA LIMITED CEMENT SERVICE 4VM9 BETHUNGRA

22 DECEMBER 2004

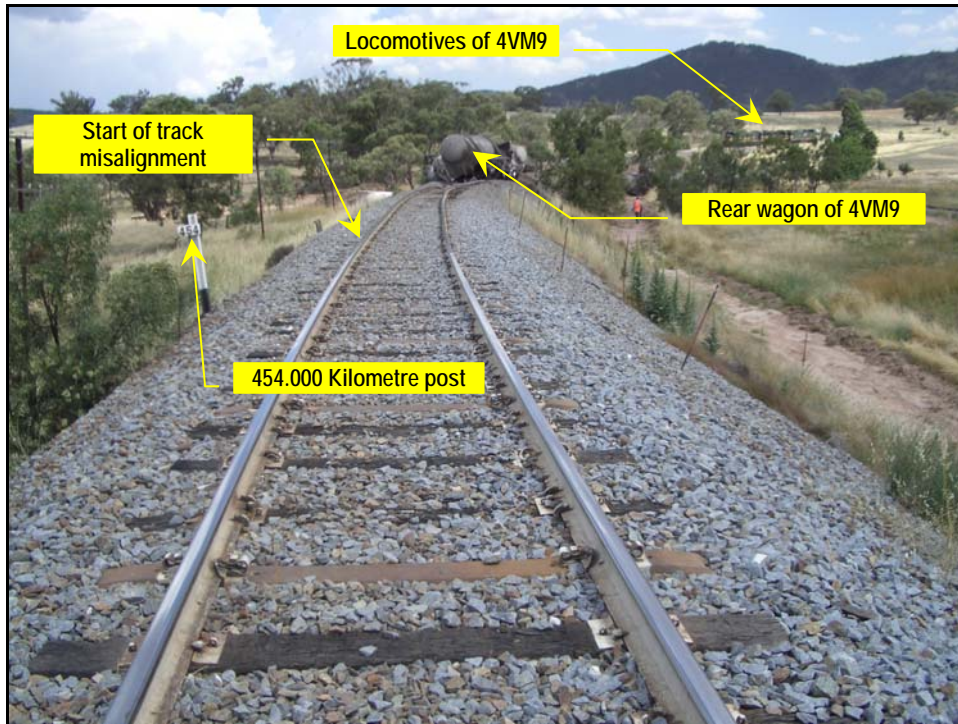
- 2.6 At approximately 8:05pm, 4VM9 rounded a left-hand curve and came onto a straight track section immediately prior to the incident site (See *Photo 1*). Both crew members stated that they then observed a track misalignment of approximately 250mm-300mm, towards the Down or Eastern side of the track just past the 454 kilometre post, whereupon the driver immediately applied the emergency brakes. All four locomotives rode over the misalignment and remained on the track. However, the rest of the train derailed, with eight of the wagons toppling down the embankments on either side of the track. The leading locomotive came to a stand at approximately 454.400kms with the rear of the fourth locomotive standing at 454.324kms.

Photo 1: Looking towards the derailment site from the probable point at which the driver applied the emergency brakes.

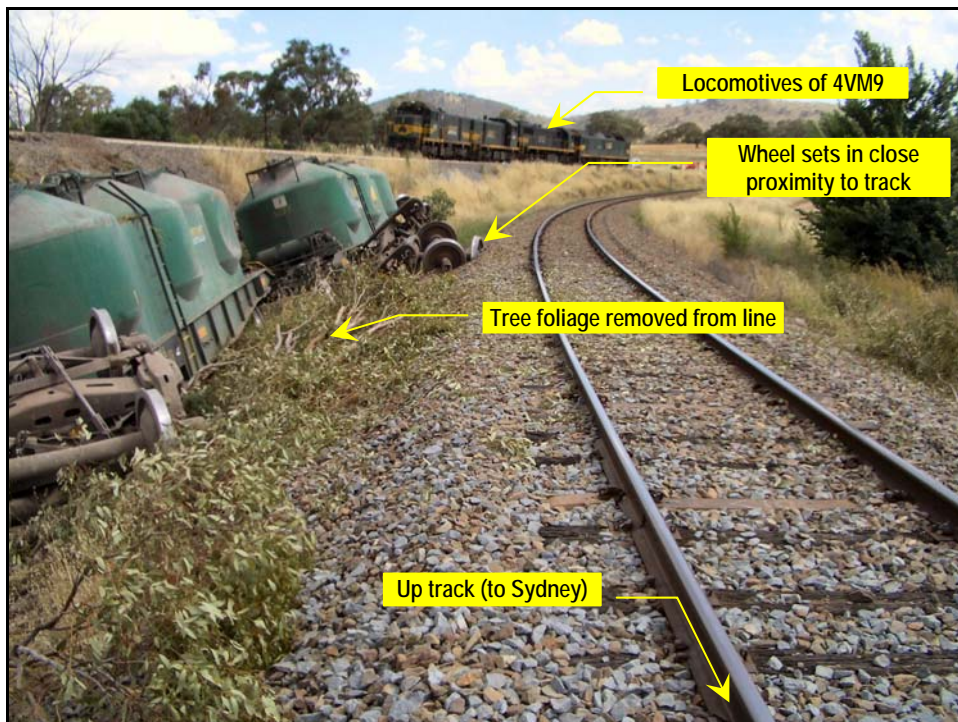
Photo 2: Incident site indicating proximity of derailed wagons and debris to the Up line.

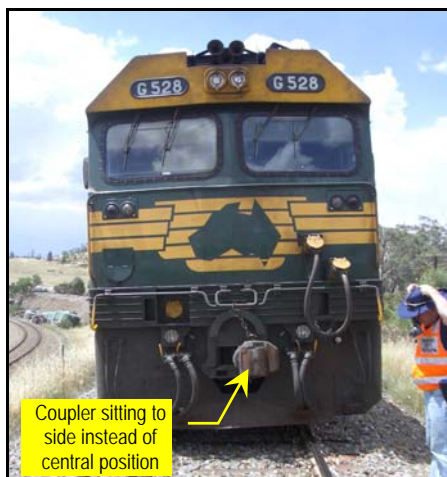
- 2.22 Unlike the wagons, the locomotives remained on the track, suffering only superficial damage to the coupler regions and left side underfloor equipment (See *Photos 3, 4 and 5*). Liquids collected in engine waste tanks had also splashed the underneath of each unit. The most noticeable damage occurred on the third and the fourth locomotives (T388 and T409) where various impact marks were apparent on their bogie frames and sanding valves. T409 also sustained damage to the air piping on its independent braking system.

Photo 3: Position of front automatic coupler indicating the extent of lateral forces.

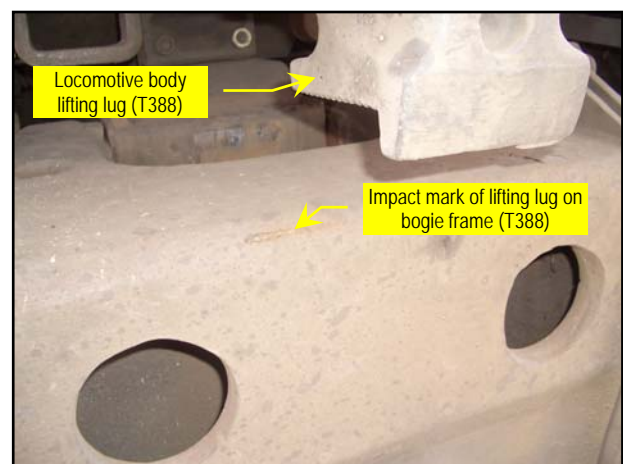
Photo 4: Impact marks on leading bogie of T388 indicating degree of bogie/body movement

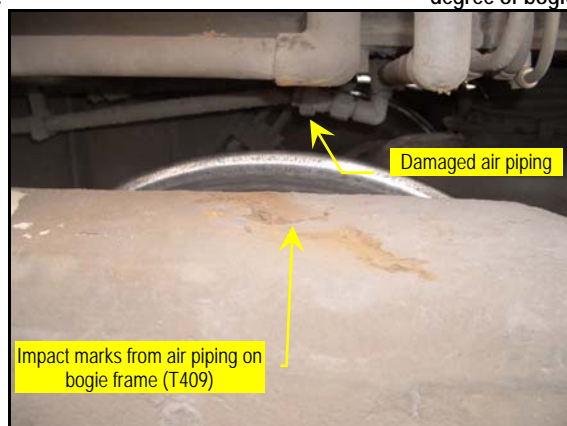
Photo 5: Impact marks on leading bogie and damage to piping of air brake system of T409

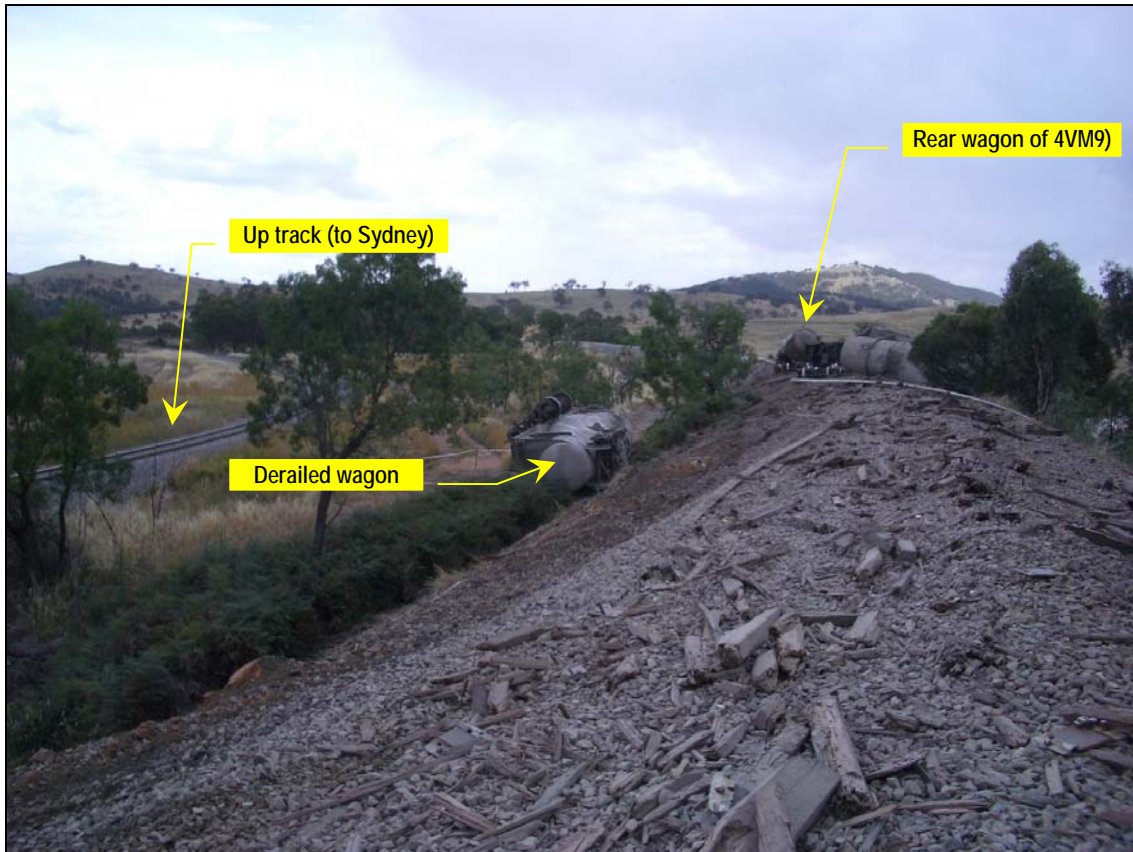
- 3.9 The derailment destroyed 288 metres of track (See *Photo 6*). OTSI spent a considerable amount of time examining track sections between 453.000kms to 453.500kms, and 453.600kms to 454.500kms, i.e., either side of the derailment to establish what the general condition of the track might have been at the derailment site prior to the accident. It noted:

- b. The rails in the damaged section had completely separated from all sleeper ties and all steel sleepers in this area were severely damaged or bent. The placement of steel sleepers was also irregular, varying from 1:3 to 1:12.

- c. All timber sleepers damaged in the incident had shattered or splintered, indicating that the sleepers were aged and in a deteriorated condition. The condition of sleepers that were not damaged by the derailment generally varied from ‘fair’ to ‘poor’ as defined in ARTC Engineering Standard TMS 06, and there was no evidence of recent sleeper marking or renewal.

Photo 6: Incident site looking towards Sydney showing extent of track damage.

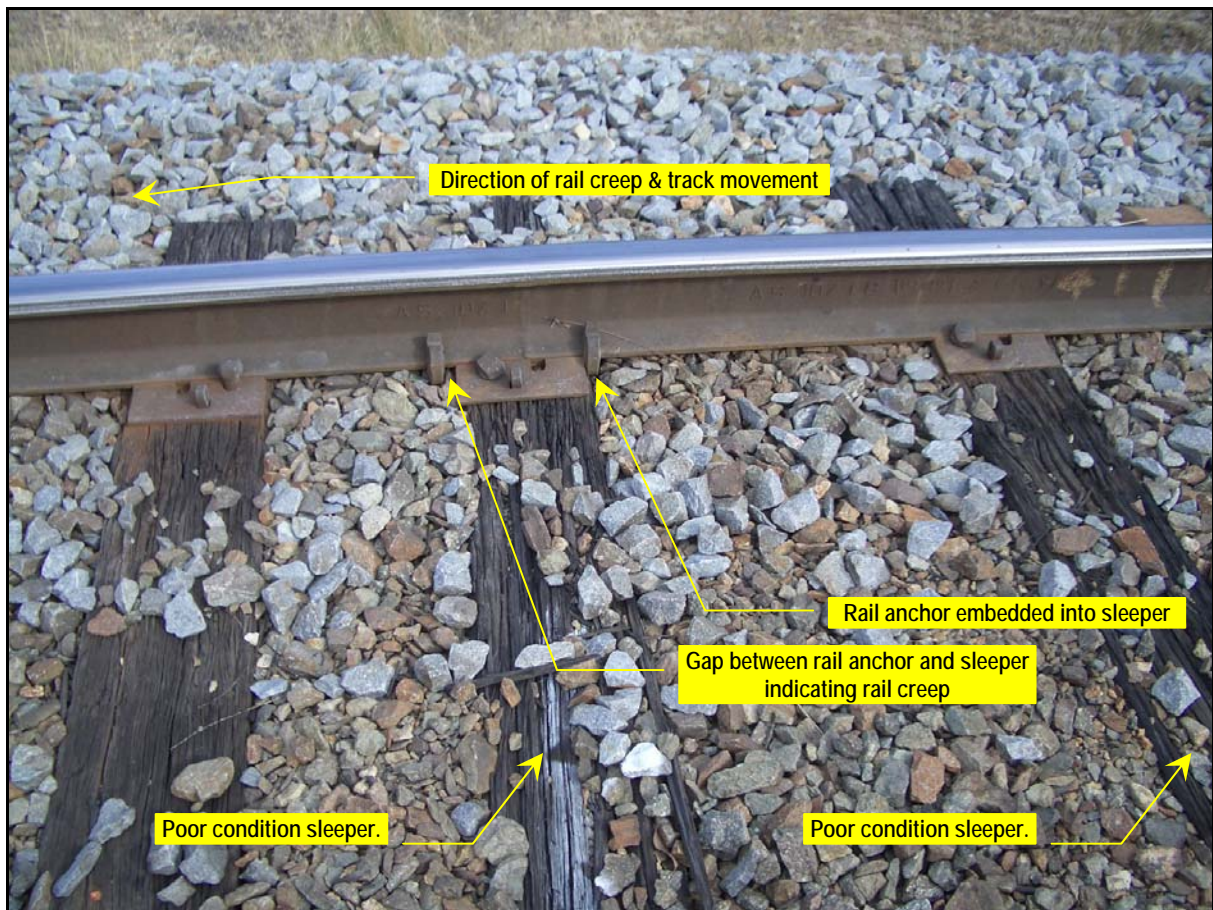
- e. The anchorage pattern on the rails conformed to ARTC Engineering Standard TMP8. However, excessive clearance between the lower side anchor and the sleeper indicated prolonged or long-term creep of the rails down the grade (See *Photo 7*). In addition, there were instances where rail anchors had embedded into the high side of a number of timber sleepers, indicating that the anchorage of the rails was ineffective and that the track had crept downhill.

Photo 7: Indications of rail creep at 453.490kms.

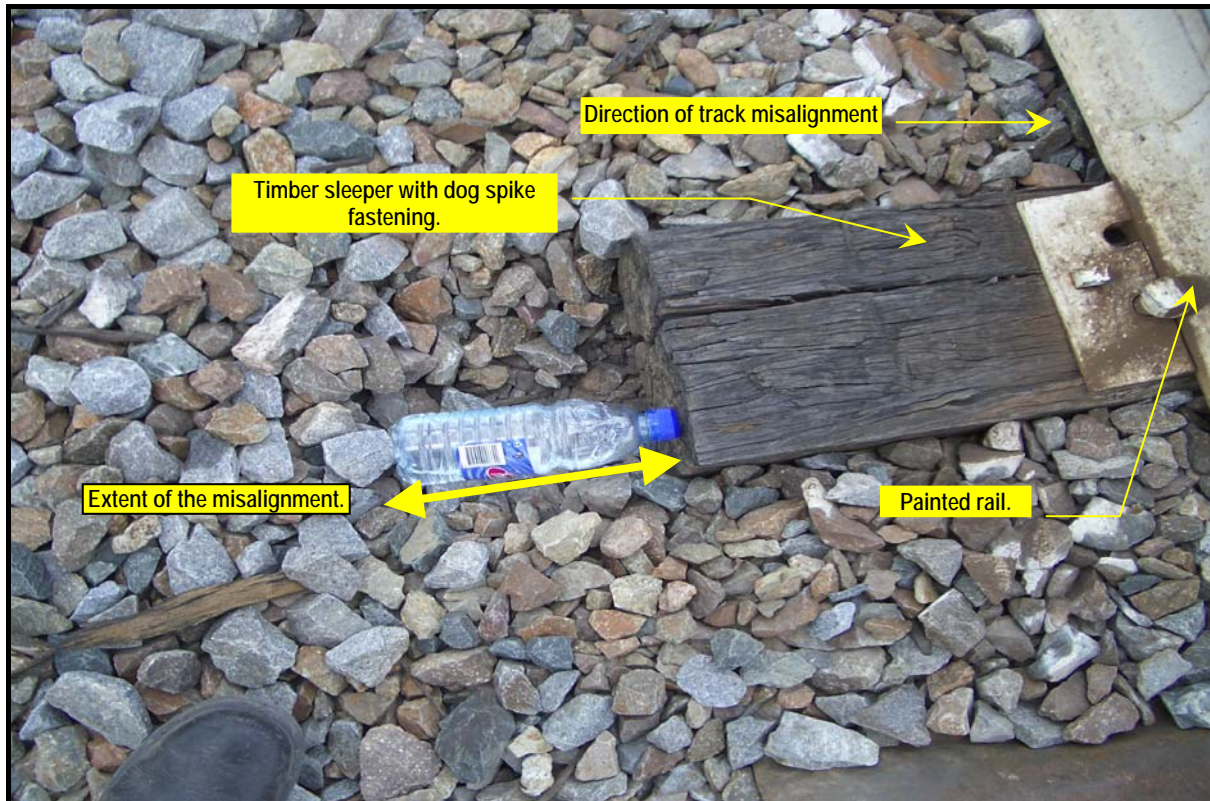
- h. The track had misaligned, to the East, at 454.010kms (See *Photo 8*).
- i. There was a section of timber sleepers, with dog spike fastenings, immediately before the misalignment point. These sleepers were in a 'fair' condition but the rail was not effectively fastened to them.

Photo 8: Apex point of misalignment found after the incident.

- a. There had been a misalignment at the same point in the summer of 2002-2003. The cause of the misalignment was attributed to the operations of a train similar in type to that which preceded 4VM9 through the section, however no evidence was provided to substantiate this. OTSI noted that the train in question did not appear to be overloaded; had been marshalled in accordance with normal practises, and that train management records indicated there was nothing unusual in its maintenance.
- b. Anchoring in the area was described as being "good". OTSI noted that, whilst the anchoring pattern was consistent with the requirements of Engineering Standard TMP 08, which requires single anchoring on every second sleeper (or every sleeper if necessary) on a falling gradient steeper than 1:80 in the direction of traffic, the anchoring itself was poor and would not have prevented rail creep.
