## RAIL SAFETY INVESTIGATION REPORT

### DERAILMENT OF FREIGHT AUSTRALIA LIMITED CEMENT SERVICE 4VM9 BETHUNGRA

22 DECEMBER 2004

**OTSI File Ref:** 03262

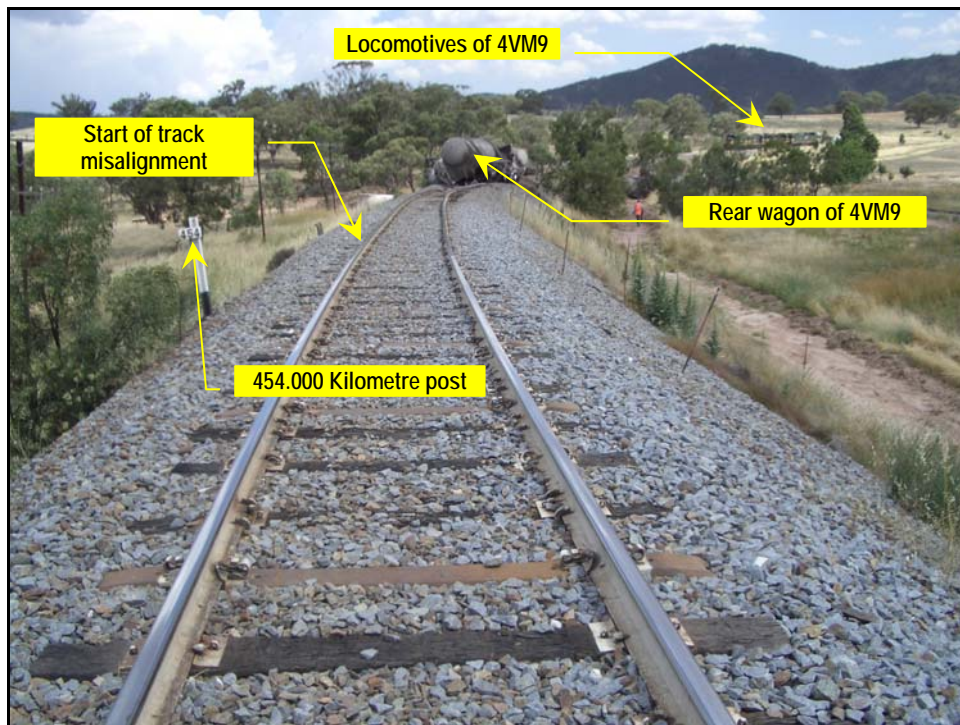
- 2.6 At approximately 8:05pm, 4VM9 rounded a left-hand curve and came onto a straight track section immediately prior to the incident site (See *Photo 1*). Both crew members stated that they then observed a track misalignment of approximately 250mm-300mm, towards the Down or Eastern side of the track just past the 454 kilometre post, whereupon the driver immediately applied the emergency brakes. All four locomotives rode over the misalignment and remained on the track. However, the rest of the train derailed, with eight of the wagons toppling down the embankments on either side of the track. The leading locomotive came to a stand at approximately 454.400kms with the rear of the fourth locomotive standing at 454.324kms.

Photo 1: Looking towards the derailment site from the probable point at which the driver applied the emergency brakes.

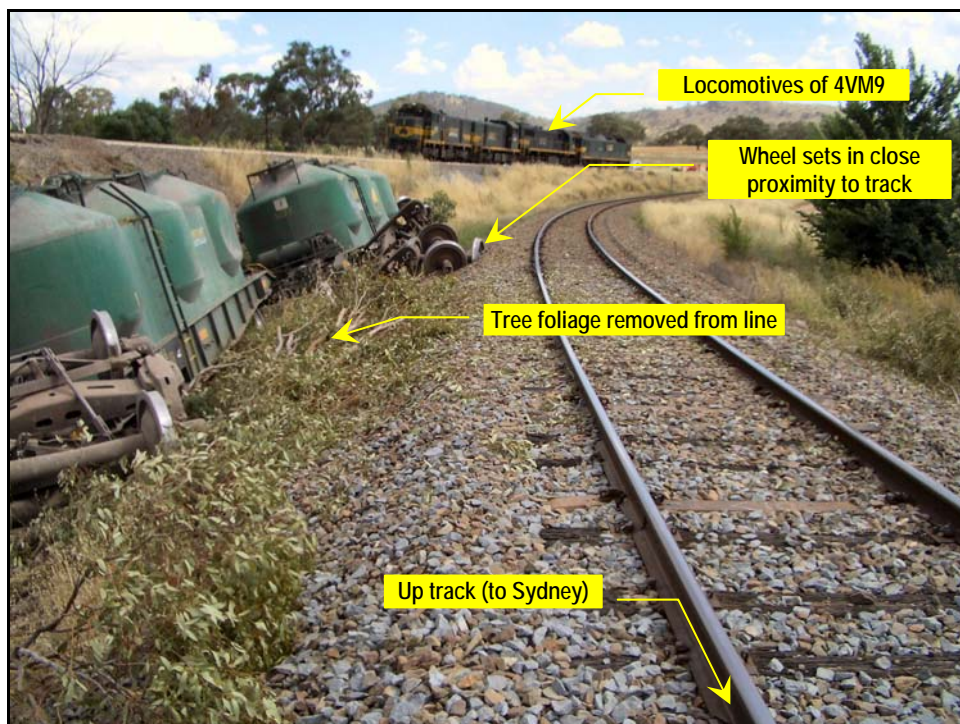
Photo 2: Incident site indicating proximity of derailed wagons and debris to the Up line.

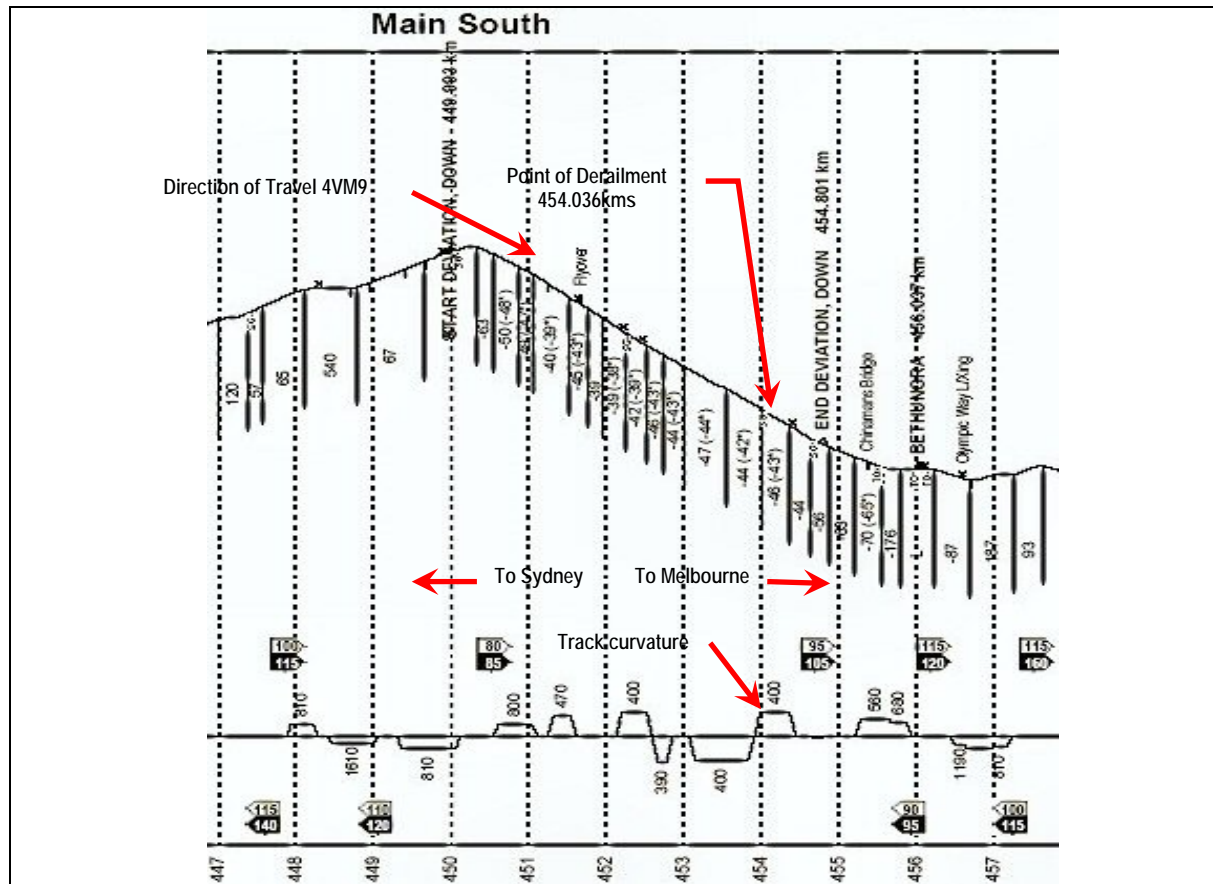
Figure 2: Curve and Gradient Diagram of Down Track.

2.14 The derailment occurred on the Down track at kilometrage 454.036, at a point of transition into a 400m radius curve on a 1:44 falling gradient (See Figure 2).

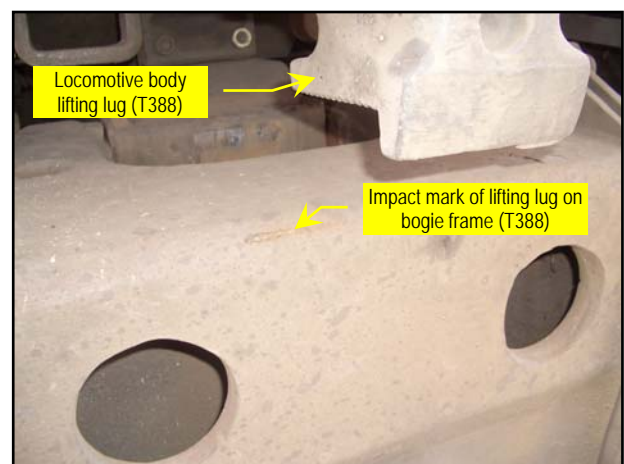
- 2.22 Unlike the wagons, the locomotives remained on the track, suffering only superficial damage to the coupler regions and left side underfloor equipment (See *Photos 3, 4 and 5*). Liquids collected in engine waste tanks had also splashed the underneath of each unit. The most noticeable damage occurred on the third and the fourth locomotives (T388 and T409) where various impact marks were apparent on their bogie frames and sanding valves. T409 also sustained damage to the air piping on its independent braking system.

Photo 4: Impact marks on leading bogie of T388 indicating degree of bogie/body movement

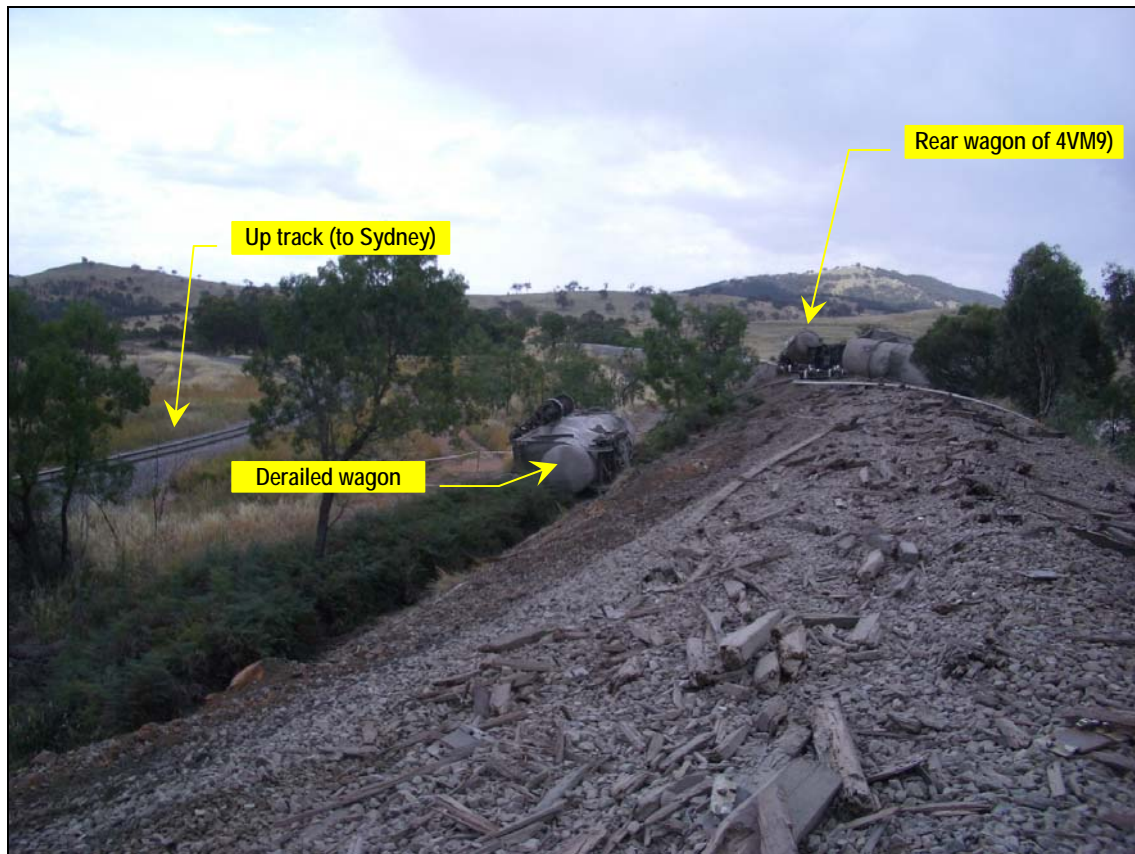
- 3.9 The derailment destroyed 288 metres of track (See *Photo 6*). OTSI spent a considerable amount of time examining track sections between 453.000kms to 453.500kms, and 453.600kms to 454.500kms, i.e., either side of the derailment to establish what the general condition of the track might have been at the derailment site prior to the accident. It noted:

- b. The rails in the damaged section had completely separated from all sleeper ties and all steel sleepers in this area were severely damaged or bent. The placement of steel sleepers was also irregular, varying from 1:3 to 1:12.

- c. All timber sleepers damaged in the incident had shattered or splintered, indicating that the sleepers were aged and in a deteriorated condition. The condition of sleepers that were not damaged by the derailment generally varied from ‘fair’ to ‘poor’ as defined in ARTC Engineering Standard TMS 06, and there was no evidence of recent sleeper marking or renewal.

- d. Most dog spikes examined were loose within the sleeper and easily moved by hand. This indicated that any longitudinal movement of the rails was only restrained by the steel sleepers or timber sleepers fitted with Pandrol clips.

Photo 6: Incident site looking towards Sydney showing extent of track damage.
