RAIL SAFETY INVESTIGATION REPORT

DERAILMENT OF FREIGHT AUSTRALIA LIMITED CEMENT SERVICE 4VM9 BETHUNGRA

22 DECEMBER 2004

OTSI File Ref: 03262

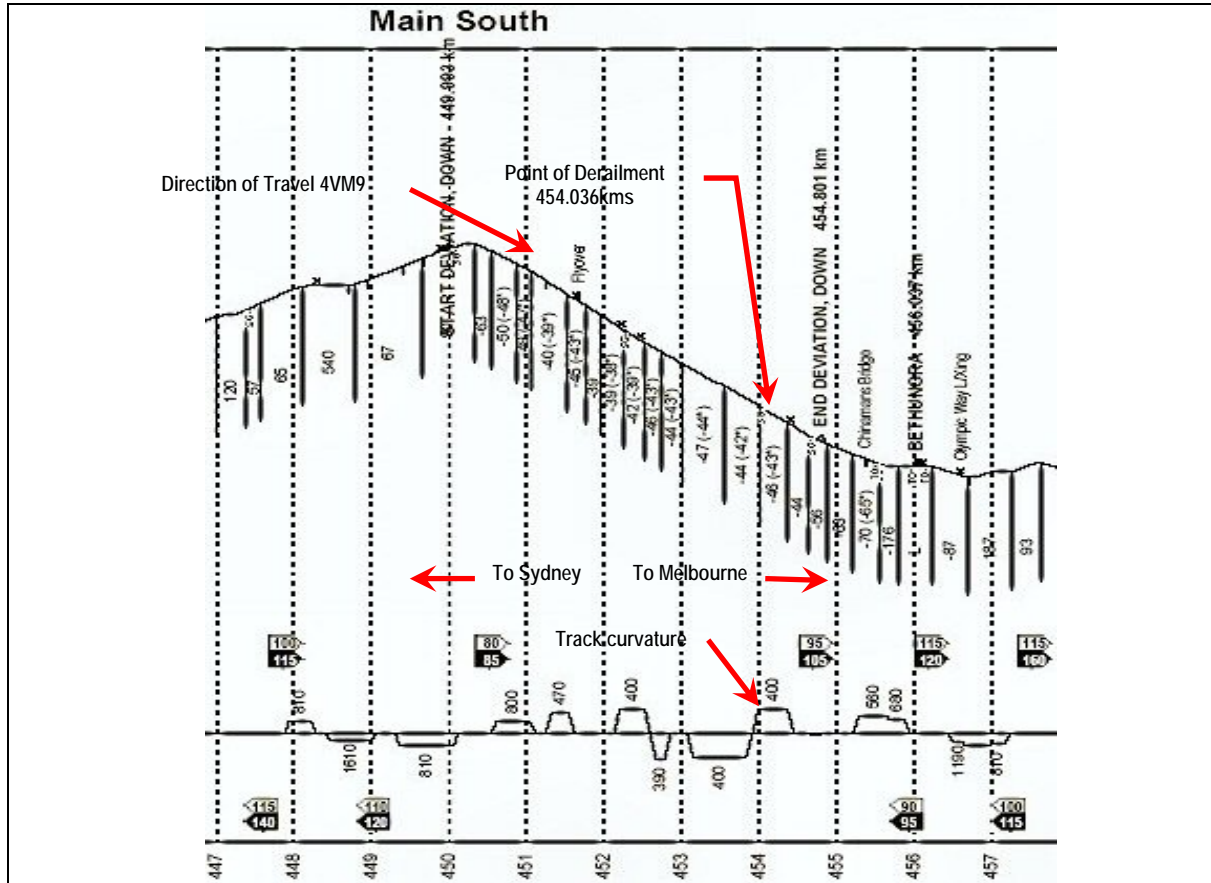
Figure 2: Curve and Gradient Diagram of Down Track.

2.14 The derailment occurred on the Down track at kilometrage 454.036, at a point of transition into a 400m radius curve on a 1:44 falling gradient (See Figure 2).
