RAIL SAFETY INVESTIGATION REPORT

DERAILMENT OF FREIGHT AUSTRALIA LIMITED CEMENT SERVICE 4VM9 BETHUNGRA

22 DECEMBER 2004

OTSI File Ref: 03262

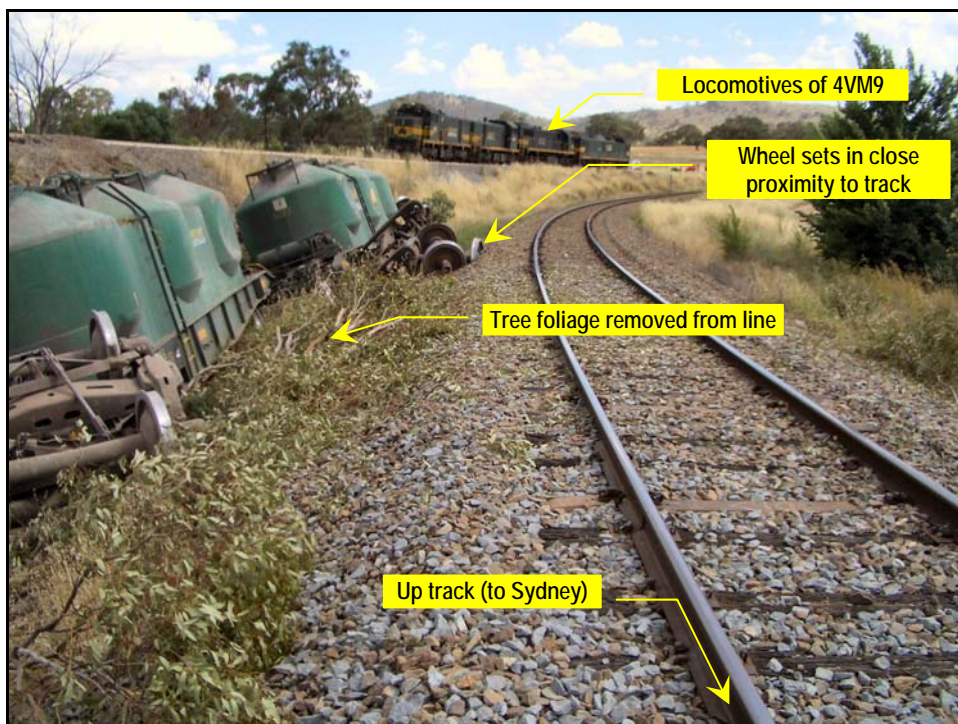
Photo 2: Incident site indicating proximity of derailed wagons and debris to the Up line.

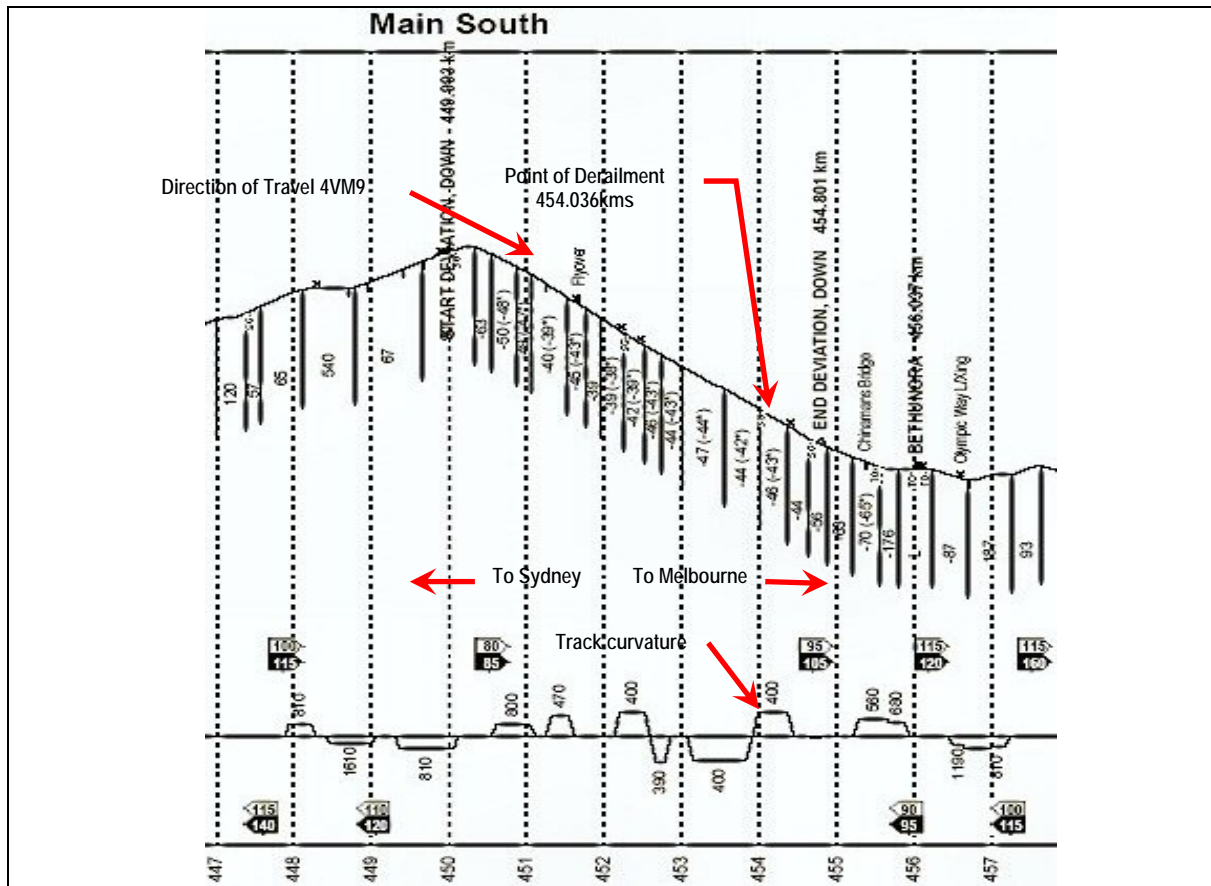
2.14 The derailment occurred on the Down track at kilometrage 454.036, at a point of transition into a 400m radius curve on a 1:44 falling gradient (See Figure 2).

Figure 2: Curve and Gradient Diagram of Down Track.

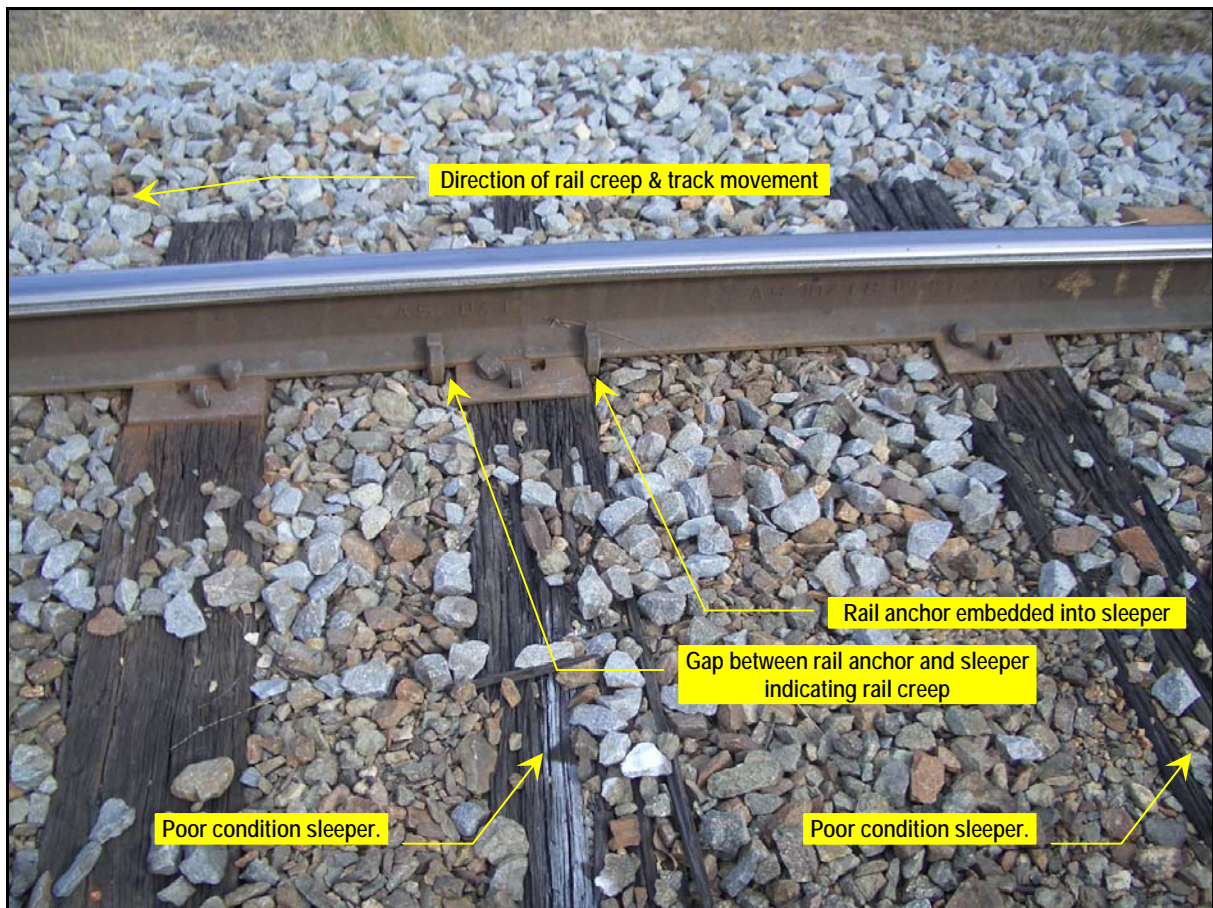
- e. The anchorage pattern on the rails conformed to ARTC Engineering Standard TMP8. However, excessive clearance between the lower side anchor and the sleeper indicated prolonged or long-term creep of the rails down the grade (See *Photo 7*). In addition, there were instances where rail anchors had embedded into the high side of a number of timber sleepers, indicating that the anchorage of the rails was ineffective and that the track had crept downhill.

Photo 7: Indications of rail creep at 453.490kms.
