Office of Transport Safety Investigations

RAIL SAFETY INVESTIGATION REPORT

OPPOSING MOVEMENT BETWEEN COAL TRAINS BLOOMFIELD

20 AUGUST 2005

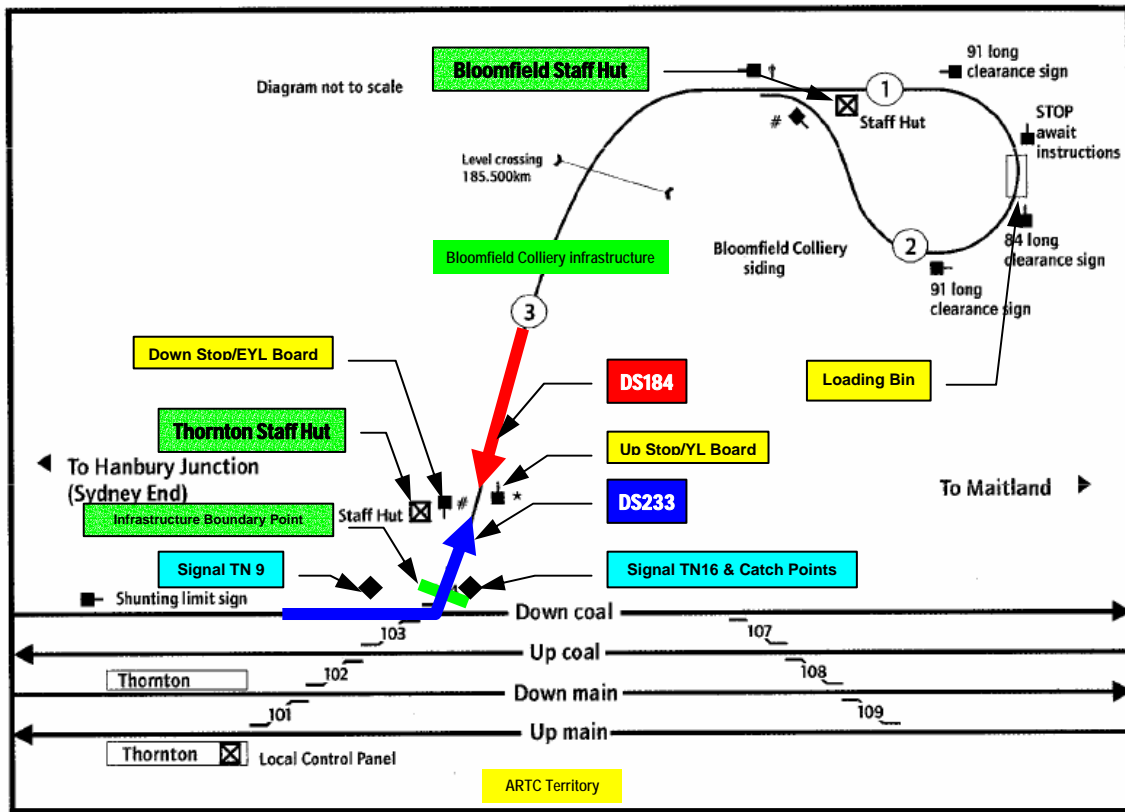
Figure 1: Layout of Bloomfield Colliery Line and Interlocking.

2.2 An empty PNL coal service, DS183, arrived at the Thornton staff hut at 07.45am having departed Kooragang Coal Handling Facilities at 7.05am. At the Thornton staff hut, its crew contacted the Train Controller at Hunter Train Control Centre (HTCC) at Broadmeadow, using the Train Control telephone in the staff hut, to advise their arrival. The crew then took possession of the staff⁸ for the Thornton/ Bloomfield section, as required by ARTC's Network Rules, before proceeding to the staff hut at Bloomfield. At the Bloomfield staff hut, the earlier process of contacting the Train Controller was repeated, albeit it in reverse order, before the empty DS183 proceeded, under Bloomfield Collieries' Procedures, into the coal loading point. DS183 was loaded by 10.10am and was redesignated DS184 on completion of the loading. DS184 then returned to the Bloomfield staff hut. The layout of the Bloomfield Colliery Line and DS183/184's route is indicated in *Figure 1*.

- 2.10 The Bloomfield Colliery line is a single line branch measuring approximately eight kilometres in length with a ‘balloon’ loop at its outer extent (as shown in Figure 1). While there has been rail access into different parts of the site since the 1930’s when mining operations were commenced, the current track configuration was not commissioned until 1991.

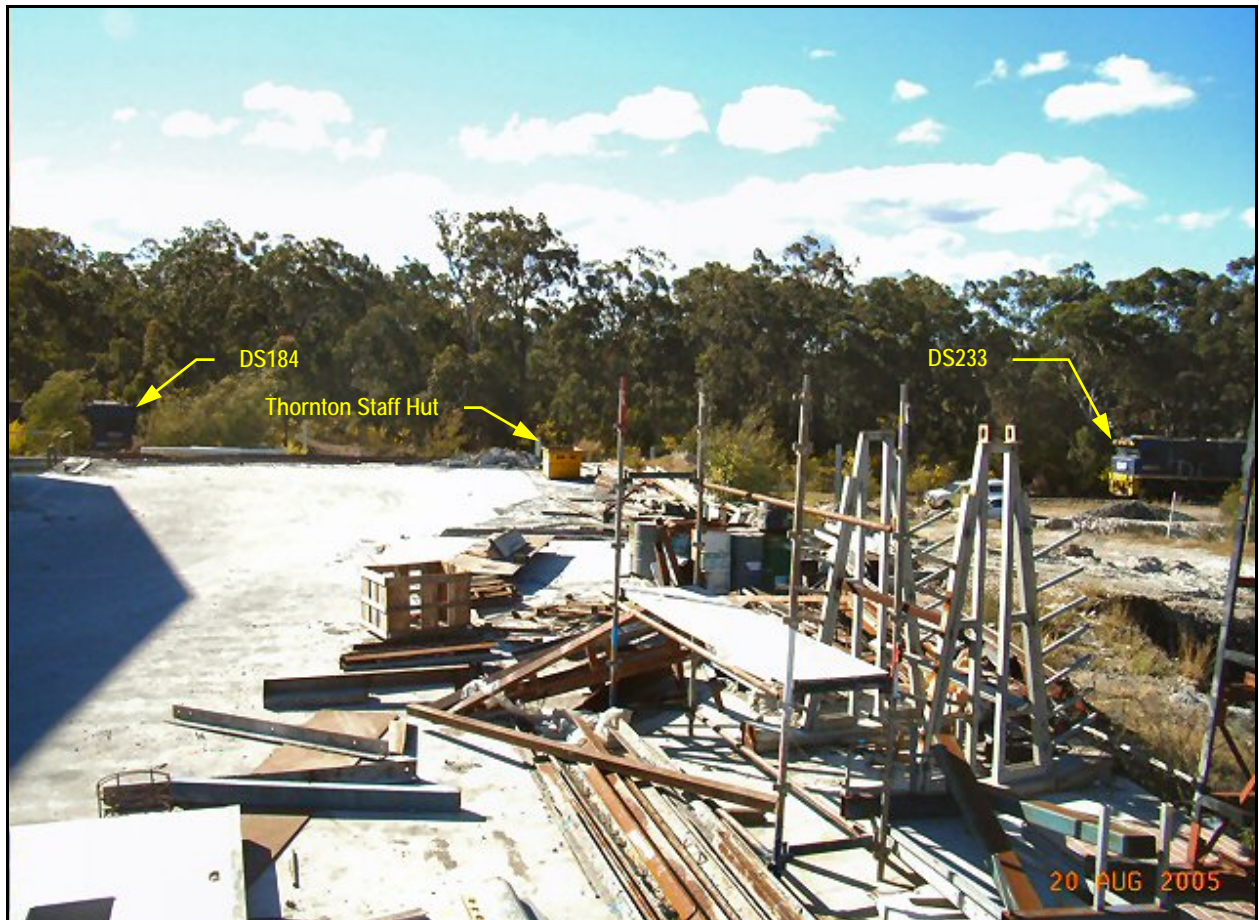
Photograph 1: Relative Positions of DS233 to DS184 after the Incident (Photo supplied by ARTC)

stop, the crew of DS233 observed DS184 standing stationary at the yard limit board⁹. The Driver of DS233 immediately applied the train's brakes, bringing the train to a stand 64 metres from DS184 (see *Photograph 1*).

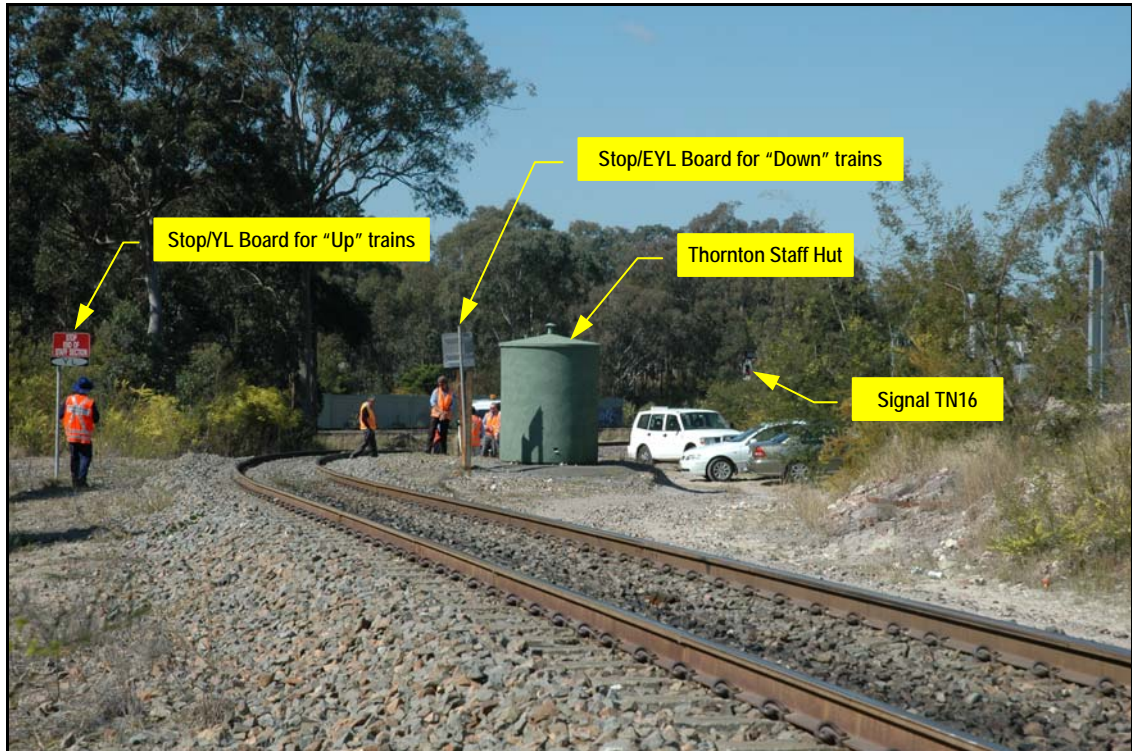
Photograph 2: Looking in a Northerly direction, from the Thornton staff hut, towards the main lines.

- 2.14 The track in the immediate vicinity of the Thornton staff hut and leading to the main line falls at a gradient of 1:60. Stop boards and yard limit (YL & EYL¹¹) signs, indicating the boundaries of Thornton Yard, are located on either side of the staff hut in both the Up and Down directions (as shown in *Photograph 2*). The boards and yard limit signs provide a six metre area of separation between the section limits.

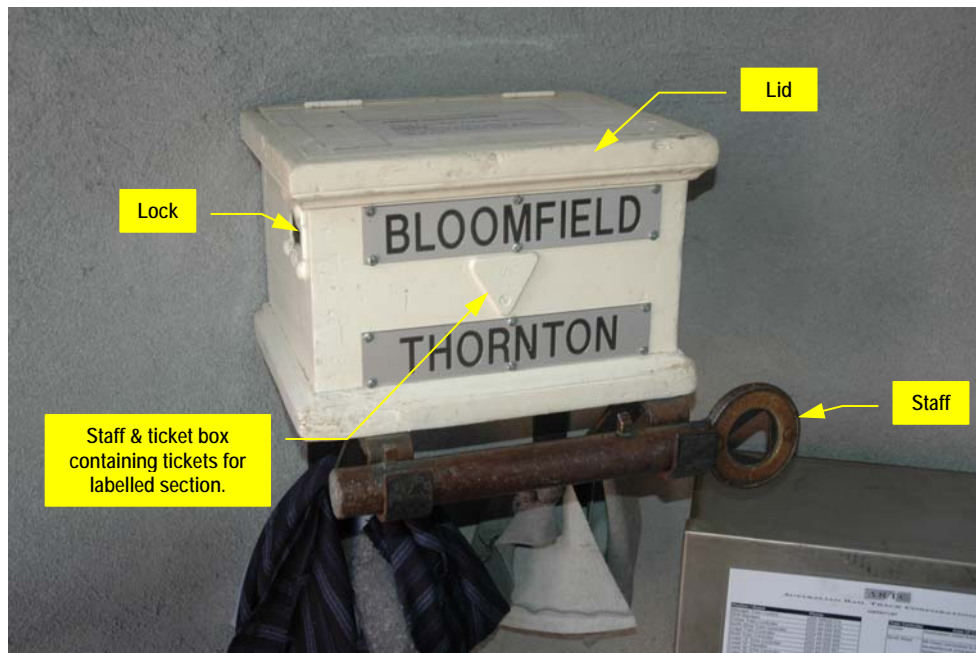
Photograph 3: Staff and Ticket Box with Staff in place

- 3.2 As DS184 arrived at the Thornton staff hut, the crew deposited the staff for the Thornton/Bloomfield section (see *Photograph 3*), as required by *ANSY 506*, and conferred with the Broadmeadow Train Controller (HTCC) to report their arrival time. The Train Controller then advised the crew that their departure time was 10.50am. The crew recorded the departure time in the Train Register Book, an action which is not supposed to occur until a train actually commences its departure. OTSI notes that *ANSY 506* states that at such unattended locations, if rail traffic cannot clear a section and stand wholly within the yard limits of the exit-end location "departure must be reported only after the rail traffic has cleared the departure-end yard limit of the location". OTSI also notes that in this instance DS184 was not, and could not be, standing wholly within the yard limits before reporting departure because the length of the train was such that this would have required it to be forward of signal TN16, which had not cleared, and across some, if not all of the main lines.¹² The reporting actions of the crew of DS184 therefore need to be seen in context.

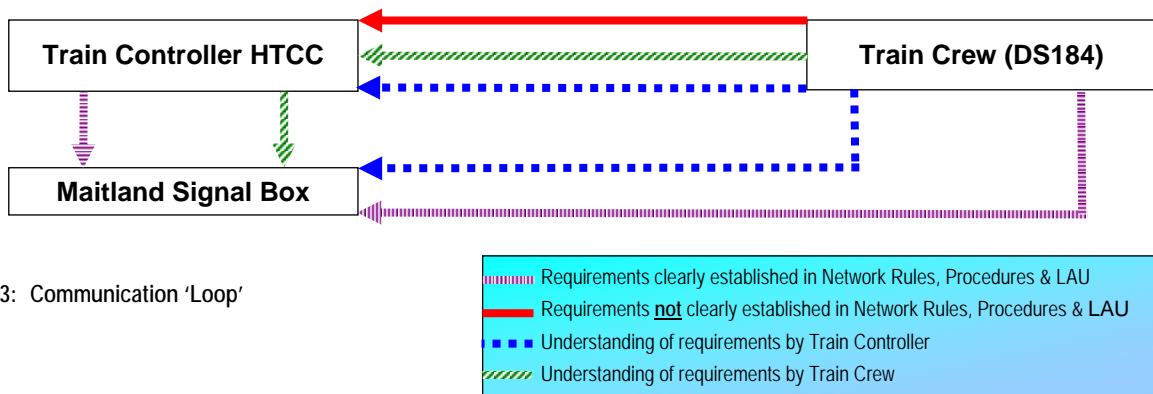
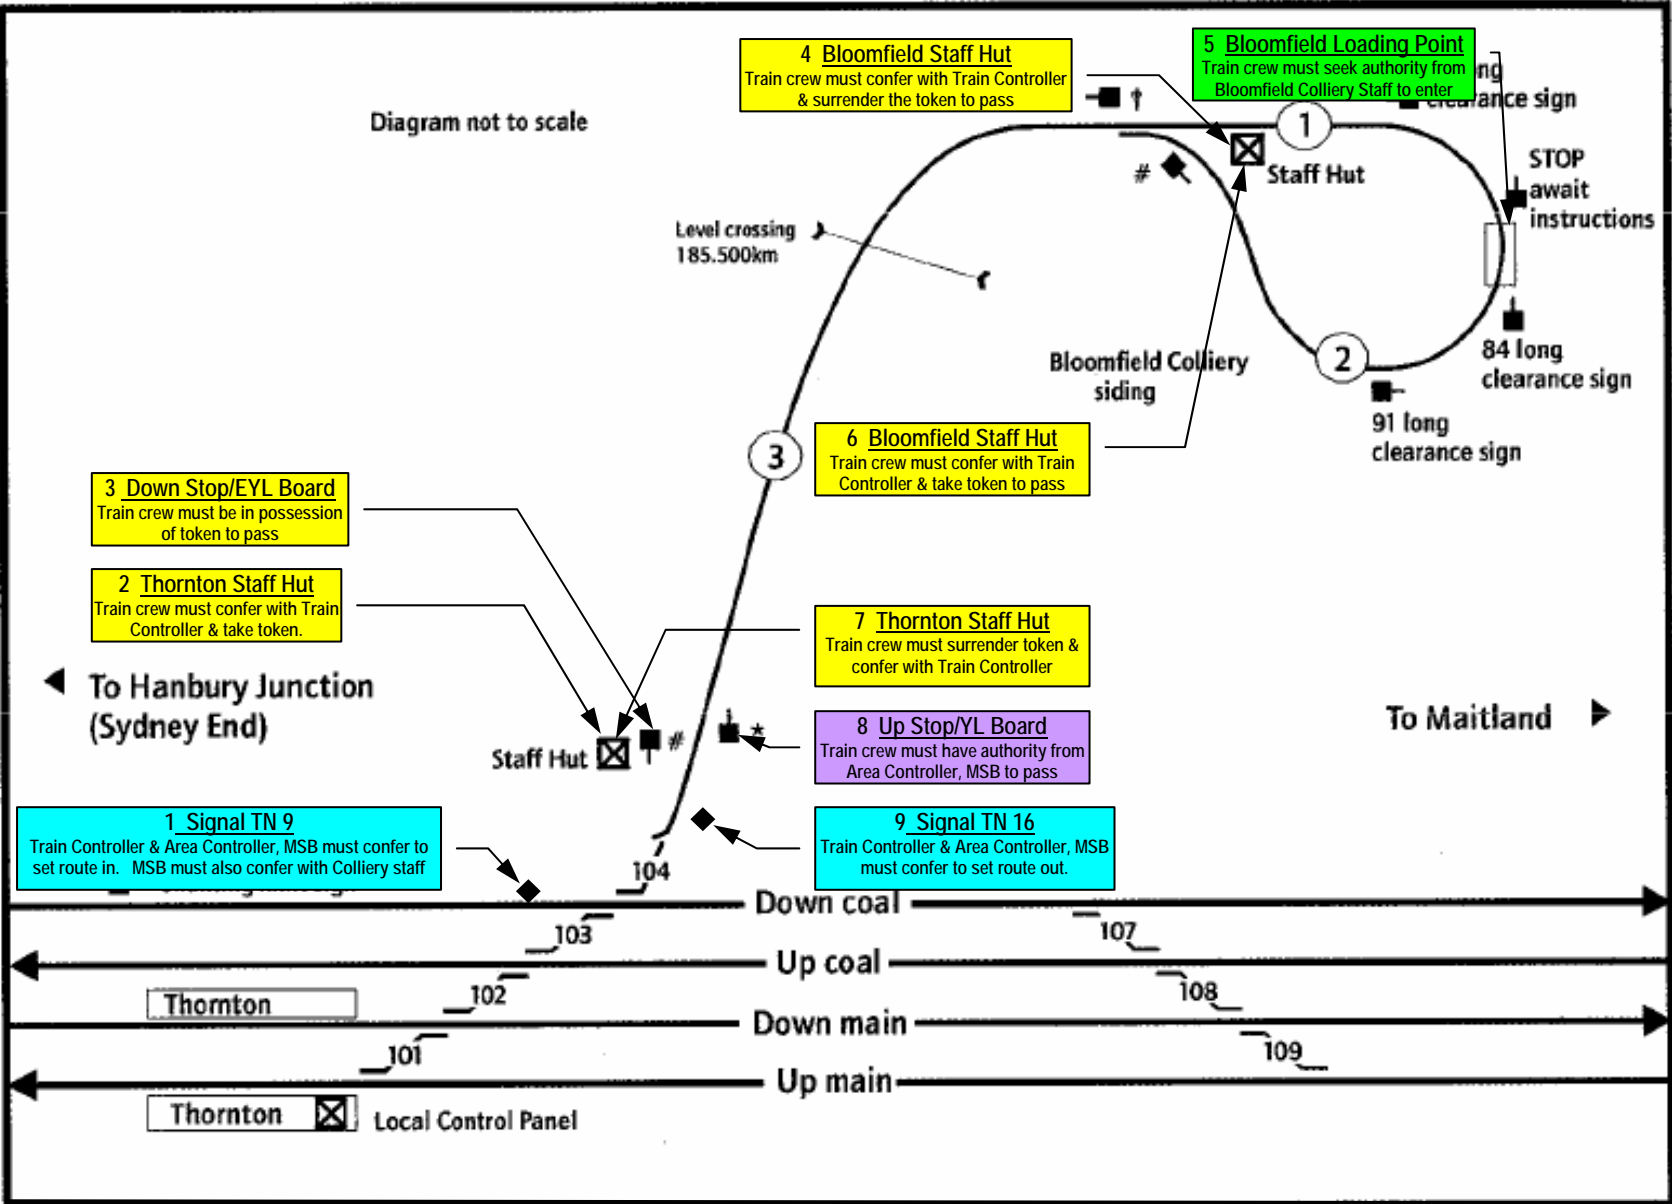
3.5 A number of crews informed OTSI that, because of the steep grade, it was usual practice at the Thornton staff hut to confer with the Broadmeadow Train Controller (HTCC) then wait until the Maitland Area Controller (MSB) cleared Signal TN 16 before they proceeded past the Up YL sign. They believed that once TN 16 had cleared, it served as the authority from the Area Controller to pass the Up YL sign. *Figures 3 and 4* depict the control locations and arrangements.

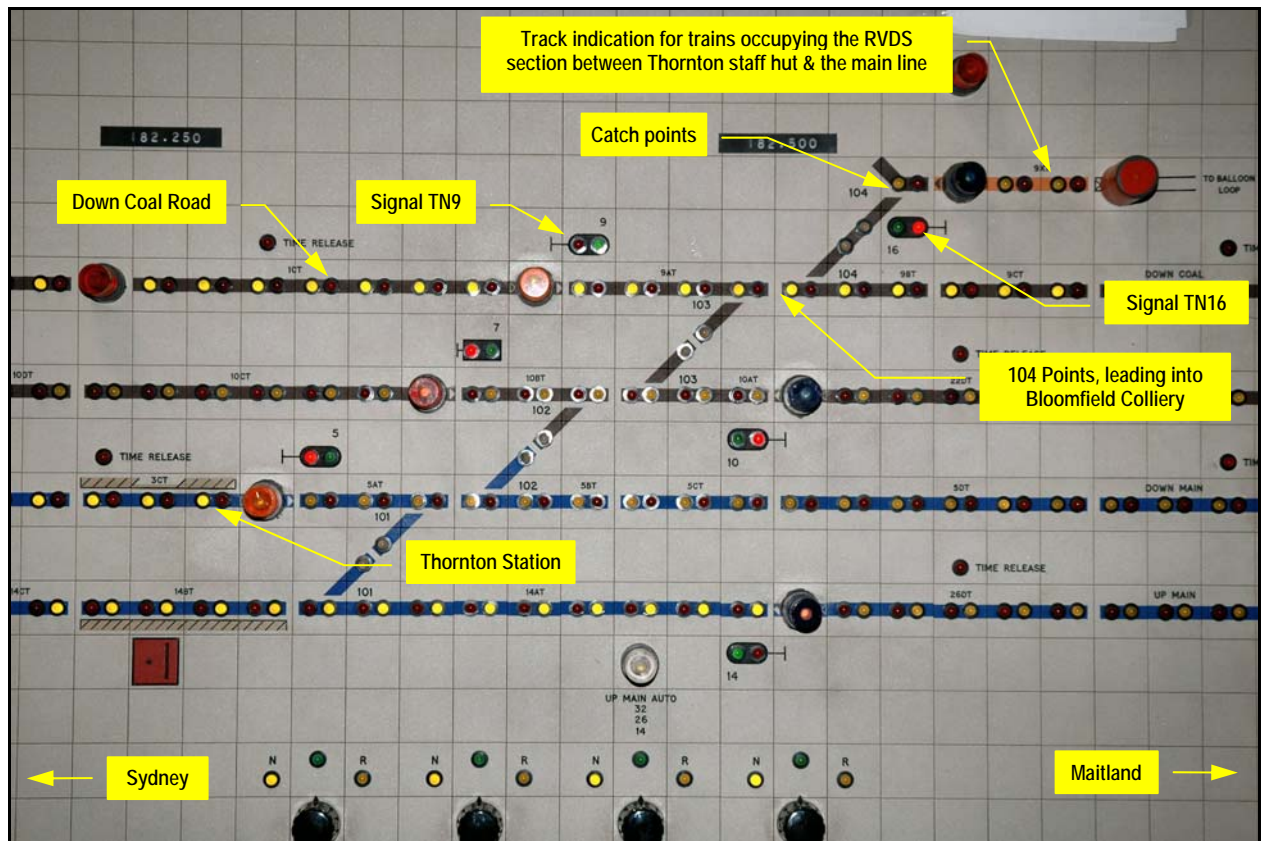
Photograph 5: RVDS Indication Panel of Bloomfield Colliery line at Maitland Signal Box.

3.6 In the absence of communication from the Broadmeadow Train Controller (HTCC) or the crew of DS 184, and in the absence of RVDS equipment in the immediate area, the Maitland Area Controller lost visibility of DS184 as he set the route for DS233 to enter the Bloomfield Colliery line. Had the crew of DS184 sought authority to pass the UP YL (see *Photograph 4*), the Maitland Area Controller (MSB) would not have cleared the route for DS233. Had RVDS been extended up past the UP YL sign, the Area Controller would have been alerted to DS184's presence at the Thornton staff hut by his track indication panel (see *Photograph 5*) in the process of setting the signals necessary to allow DS233 to enter the Colliery line.

In conjunction with the Australian Rail Track Corporation, extend the area of track detection on the Bloomfield Colliery line to include the detection of trains standing on the colliery side of the Up stop board at Thornton staff hut.

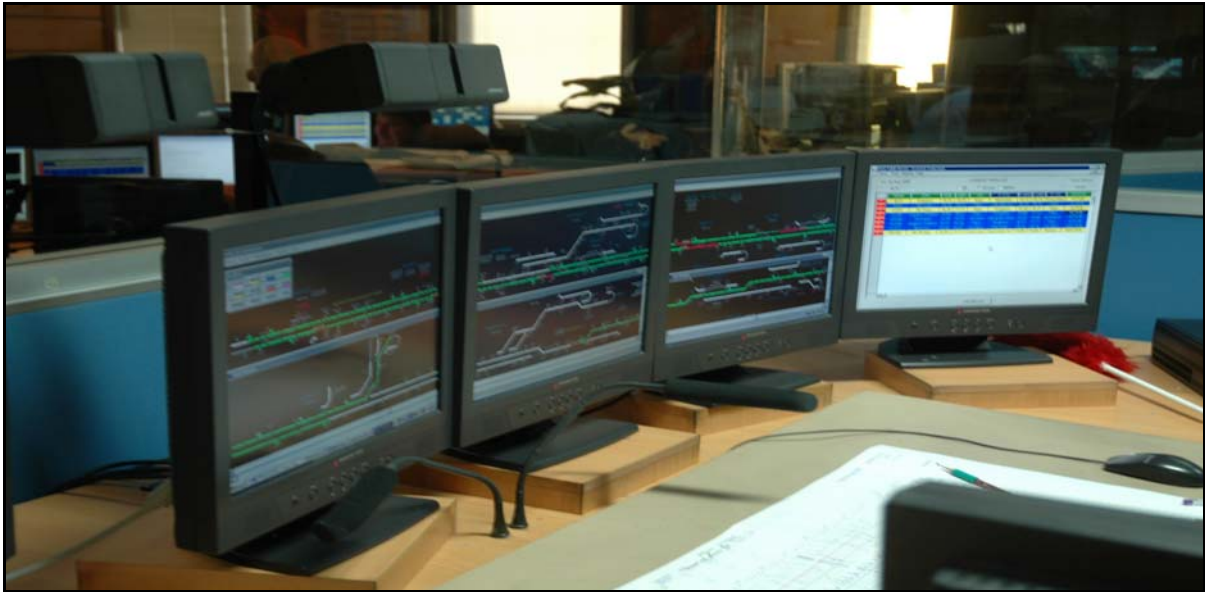
Photograph 6: Train Controller's Indication Panel at HTCC. (Photo supplied by ARTC)

- 3.13 Voice recordings of conversations between HTCC and MSB reveal that the Train Controller (HTCC) was surprised when informed that DS184 had not exited the Bloomfield Colliery line. When made aware of the opposing movement, the Train Controller (HTCC) instructed the Area Controller (MSB) that DS184 and DS233 were to remain where they stood until such time that he had dealt with the points failure at Whittingham, after which he would provide further instructions. Despite admitting DS183 into Bloomfield Colliery earlier in the morning, the Area Controller had failed to appreciate that the train, albeit now designated as DS184, was still somewhere on the Bloomfield Colliery line. DS183 would have disappeared from the Area Controller's track indication panel, as seen in *Photograph 6*, after the train departed the Thornton staff hut and entered the Bloomfield Colliery line.

- ii. This oversight was caused by the fact that the Broadmeadow HTCC Train Controller was pre-occupied with the requirement to reschedule train movements elsewhere, due to a points failure at Whittingham, approximately 50kms North West of Thornton. In addition, because DS184 was not standing on circuited track, neither the Broadmeadow HTCC Train Controller nor the Area Controller at Maitland Signal Box (MSB) had the benefit of having the train's position illuminated on their track indication panels.
