Rail Incident Factual Statement

Clarence

4 July 2005

Fatality – Zig Zag Railway

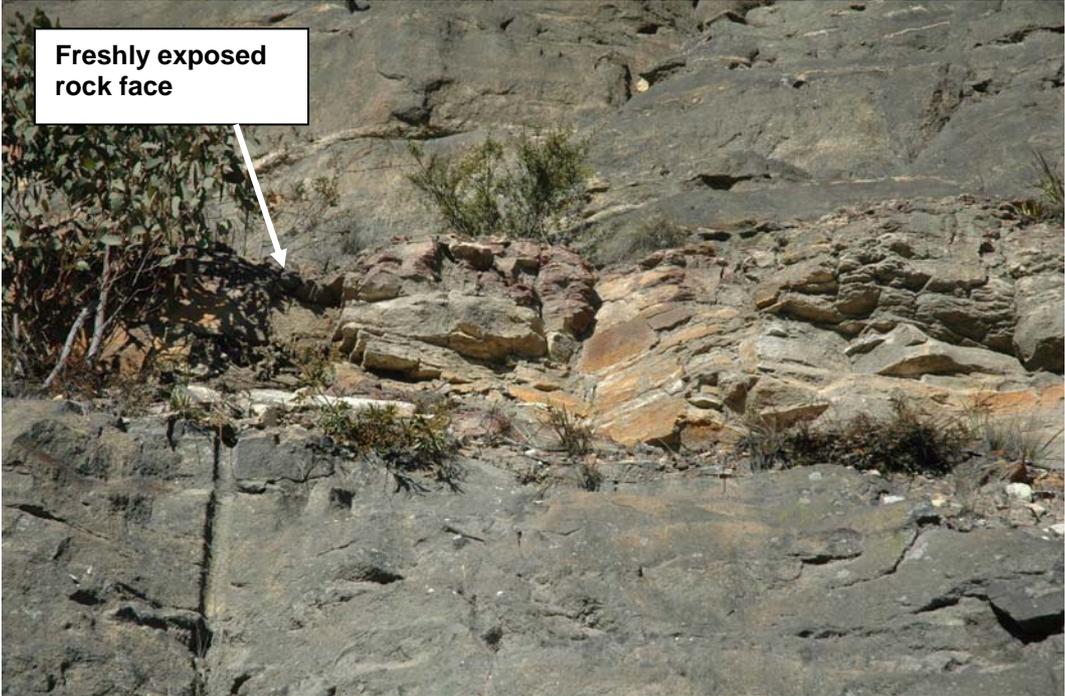
Figure 2 – Collapsed Rock Shelf

When they reached the vantage point, the deceased climbed down onto a rock shelf located directly above the railway line between Top Points and Clarence Station. His companion could not negotiate this descent and remained on higher ground. Sometime after, but before the train had passed the Top Points Signal Box, the rock shelf collapsed and the deceased fell onto the track below. Refer to Figure 2.

The deceased fell approximately eight to ten metres from the rock ledge to the track surface. Markings on the ground were consistent with the deceased being rendered either unconscious or dead as a result of this fall. His motionless condition was corroborated by the observations of his companion. Refer to Figures 2, 3 and 4 for a pictorial representation of the collapsed rock ledge.

The deceased was struck by the Zig Zag train as he lay across the track in a motionless state. His position and condition across the track was caused by an eight to ten metre fall down a rock face when the rock ledge on which he had been standing collapsed.

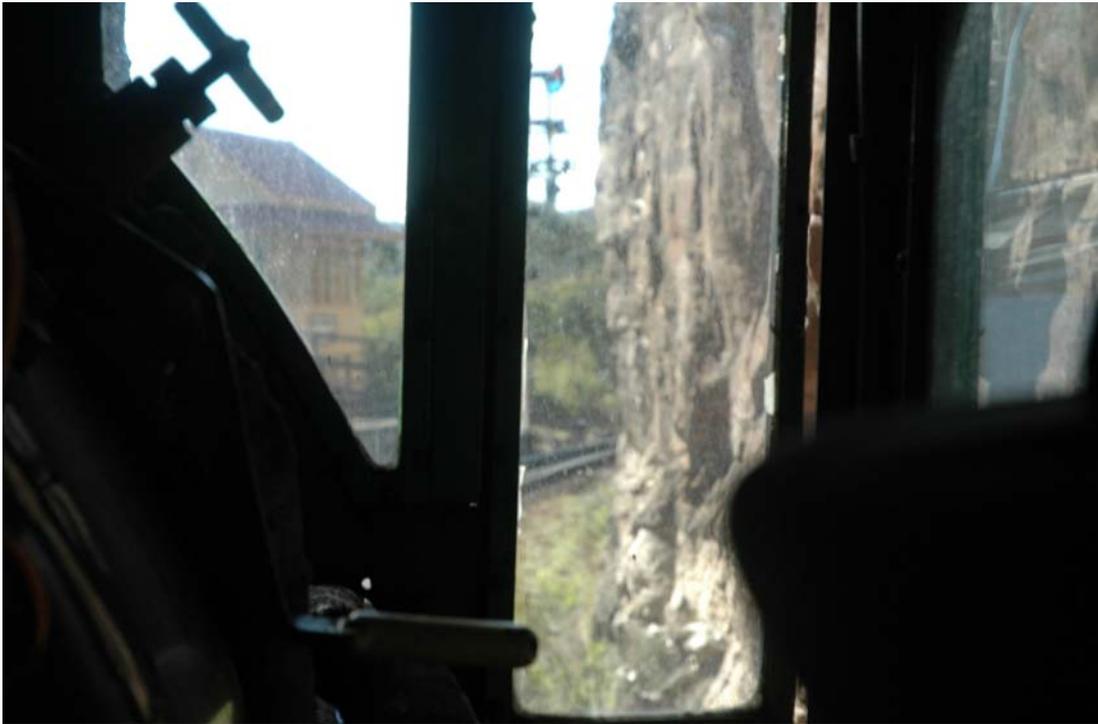
Figure 5 – Driver's Perspective Approaching Top Points Signal Box

The location of this fall was part way through a right hand bend in the rail track. The rock face on the right hand side of the track obscured the driver's vision of the track ahead. In addition, the nature of operating a steam locomotive requires the driver to constantly switch attention from the track ahead to the manual controls and gauges at the driver's operating station.

Vision from the locomotive is significantly restricted. Refer to Figures 5 and 6 for the forward view from the steam powered locomotive as it approached the accident site.

Despite the train operating and visibility limitations, and the restricted field of vision imposed by the terrain and track geometry, the driver did see the deceased across the track but the closing distance was insufficient to permit braking to stop before striking the deceased.

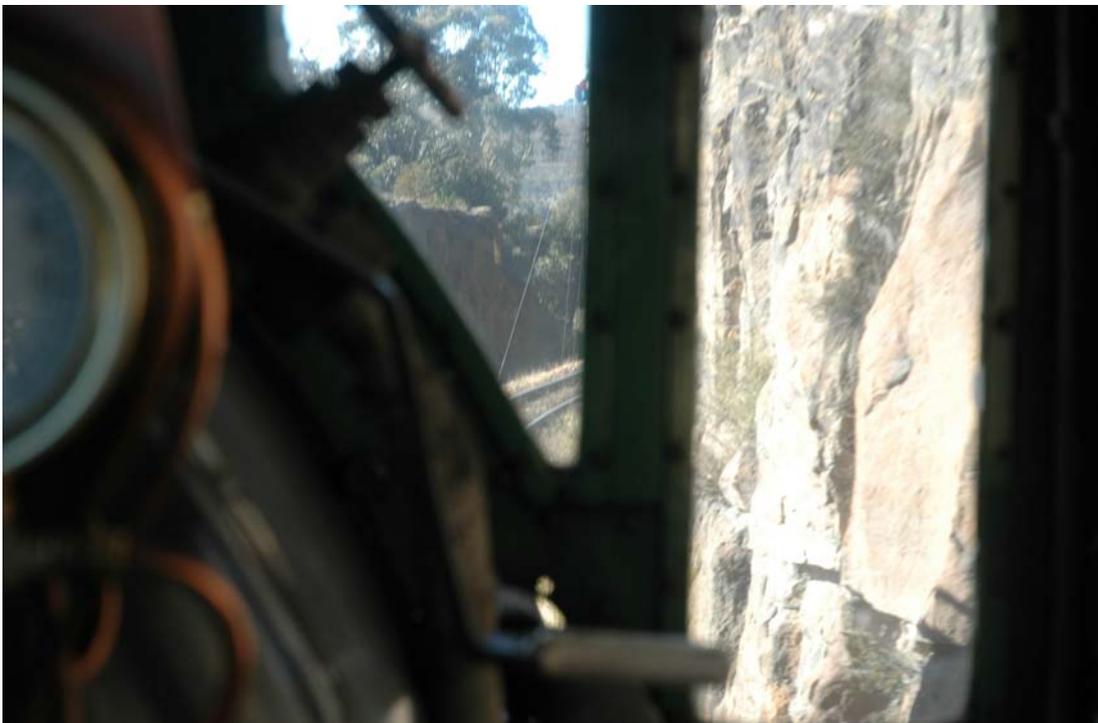
Figure 6 – Driver's Perspective Approaching Accident Site.

The curves in the Zig Zag track, together with the ergonomics of the driver's operating station, impose limitations on the driver's visual perspective of the track ahead. In this case, these factors did not contribute to the initiating sequence of events, and even though the train struck the deceased, the actual cause of death is yet to be established.
