RAIL SAFETY INVESTIGATION REPORT

FATAL LEVEL CROSSING COLLISION GRAWLIN PLAINS

31 MAY 2005

OTSI File Ref: 04085

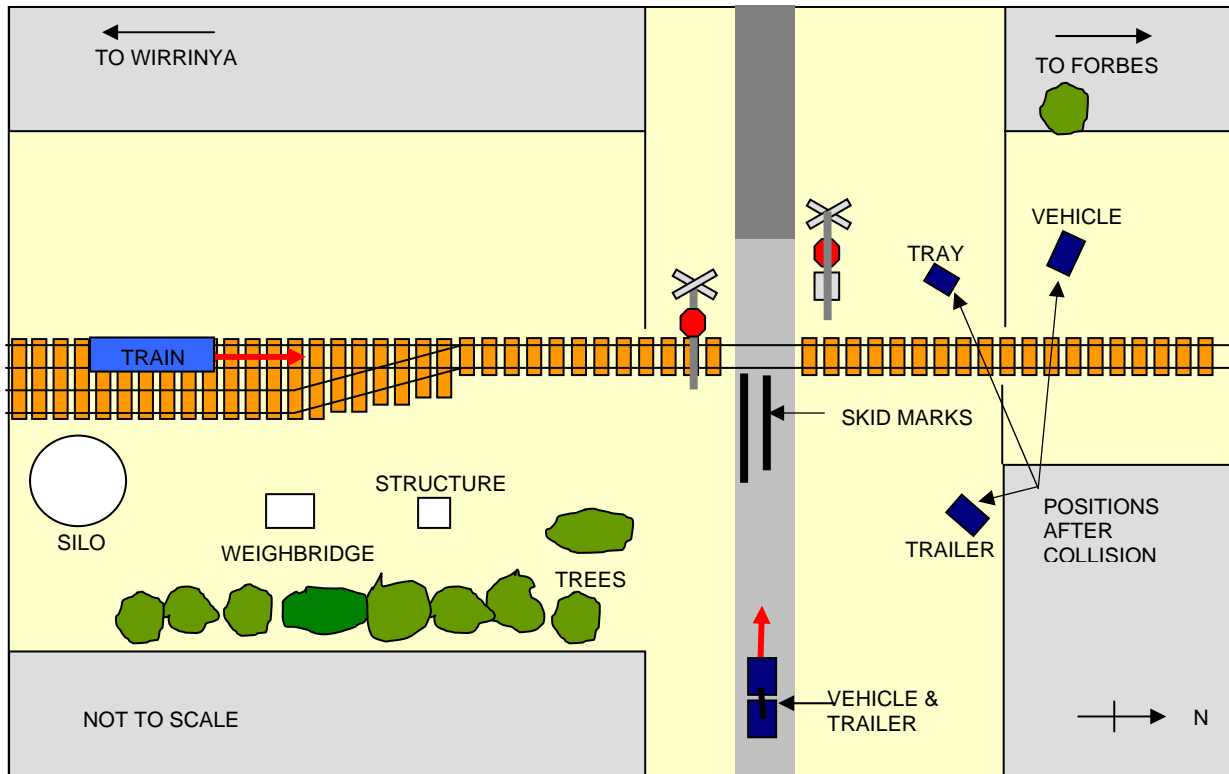
Figure 2: Site Diagram of Grawlin Plains

- 2.10 The driver of the motor vehicle involved in the collision, a local farmer, owned property on both sides of the railway track. He was travelling West on a public road as he approached the level crossing. His visibility of the approaching Locomotive would have been partially obscured by trees and scrub.

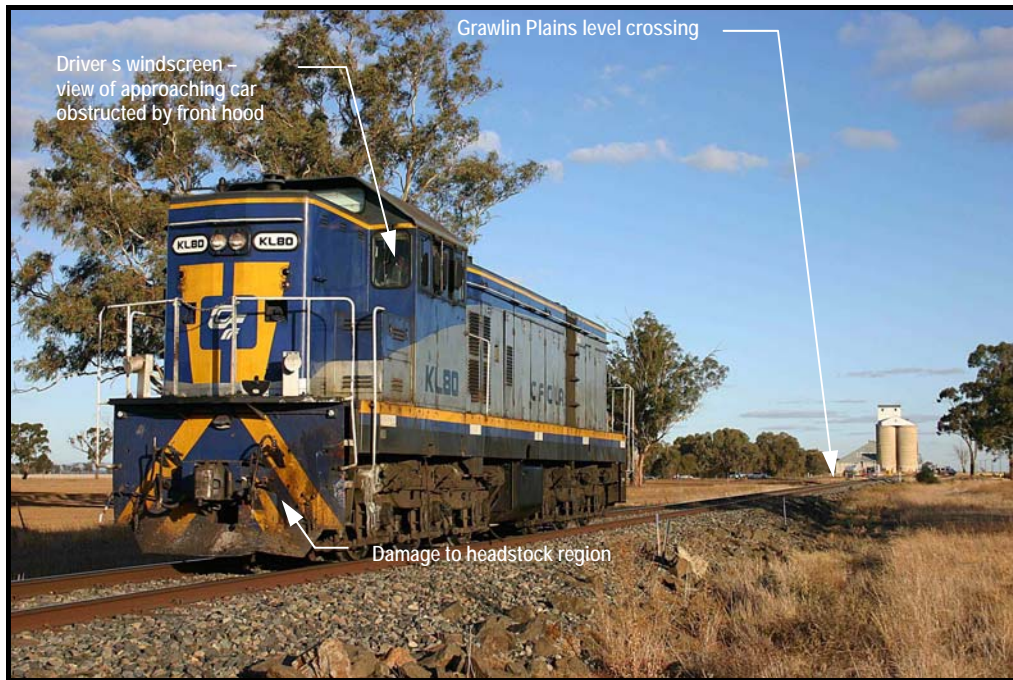
Photo 3: Locomotive's position after the collision

2.20 The locomotive sustained minor damage as a result of the collision. There was damage to the front, left and right side of the locomotive. This included damage to the left-side front steps, hand rails, automatic coupling release handle, right-side fuel tank and the breather and fuel pipes. Some of this damage can be seen in *Photo 3*.

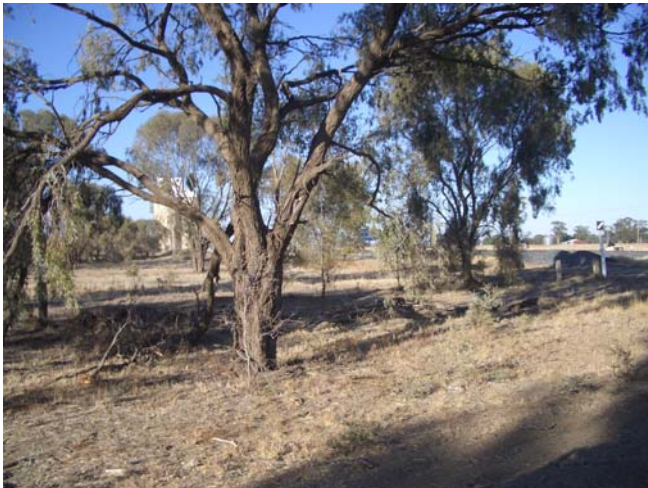
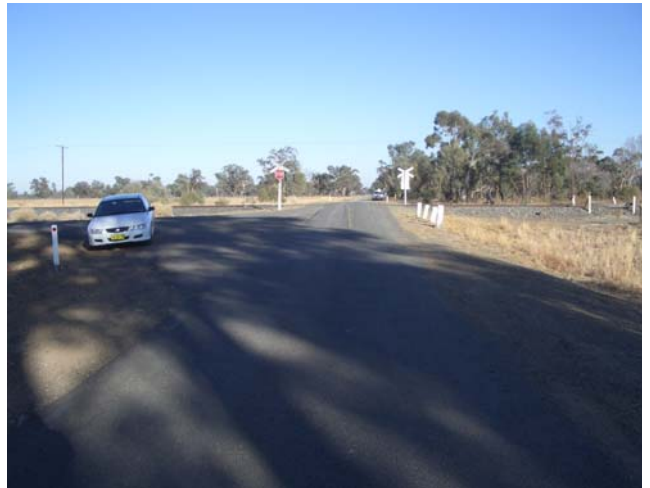
- iv. Road users approaching the level crossing from the East have their visibility of trains approaching from the South obstructed by the presence of trees, vegetation and a wheat silo.

- 3.5 *Weather & Visibility.* The weather was fine and dry at the time of the accident. Although the sun was setting in the direction in which the vehicle was travelling, it was not at an elevation which would have blinded the driver to the presence of an approaching train. There was nothing inside the Landcruiser that should have obstructed the view of the driver. The view from any motor vehicle of any train approaching from the South is partially obscured by trees and other vegetation until approximately 30m from the crossing. This might have been the first point at which driver of the Landcruiser became aware of the approaching train and would explain the skid marks commencing 23m from the crossing. OTSI acknowledges that ARTC is under no obligation to provide road users with an unobstructed view of approaching trains; indeed it would be impossible for it to do so in many circumstances. STOP signs at passive level crossings are an indication to road users that they do not enjoy an unrestricted view of an approaching train and that they must stop. That said, any driver who stops at the STOP sign indicated in *Photo 11* enjoys an unobstructed view of any train approaching from the South for over 300m, which is within the minimum sighting distance recommended by the Roads and Traffic Authority Standard (Traffic Engineering Manual, Section 6, Railway Level Crossing, 1994). The photos below depict the view, as seen by a road user on the Eastern approach to the level crossing. *Photos 6, 7, 8 and 10* depict the view, on the same approach to the South, i.e., towards the direction from which the Locomotive approached.

- i. Give consideration to the removal of trees and vegetation inside the ARTC leased area on the South-Eastern side of the level crossing at Grawlin Plains to improve the view that road users have of trains approaching from the South.
- ii. Act to improve communication with Forbes Shire Council in relation to the inspection and maintenance of level crossings.

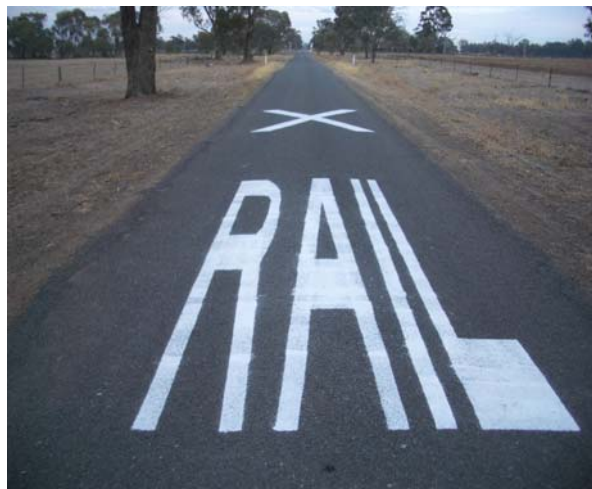
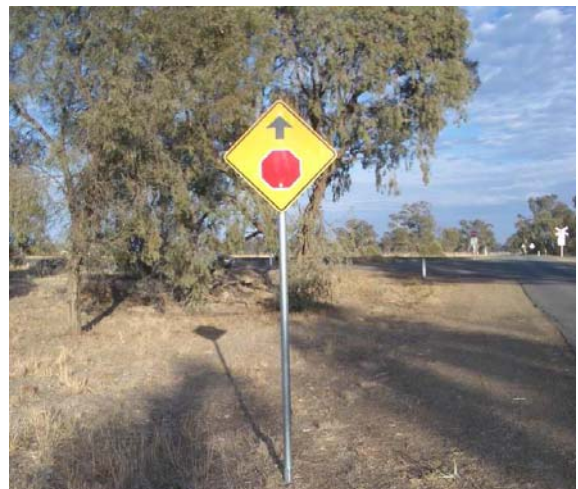
Photo 14: Road marking post-accident

Photo 15: Warning sign post-accident

3.13 OTSI established that responsibility for the level crossing and the maintenance is divided between the ARTC and the Forbes Shire Council. ARTC is responsible for the provision and condition of trackside signage (see *Photos 12 and 13*) and the Council is responsible for the provision and condition of signage on the approaches to the crossing (see *Photos 14 and*
