RAIL SAFETY INVESTIGATION REPORT

FATAL LEVEL CROSSING COLLISION GRAWLIN PLAINS

31 MAY 2005

OTSI File Ref: 04085

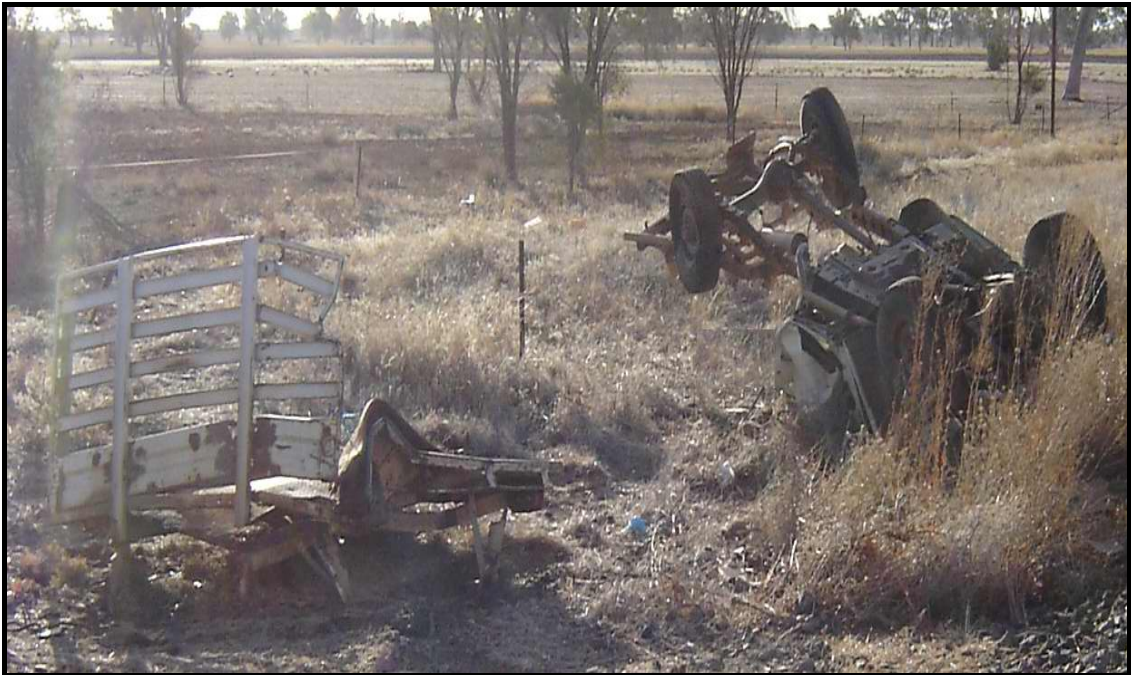
- 2.11 Upon impact, the coupler on the front of the Locomotive struck the passenger-side of the motor vehicle, a Toyota Landcruiser, behind the cab section. The profile of the coupler was clearly imprinted on the flat steel tray mounted onto the chassis of the Landcruiser. The force of the impact with the train turned the Landcruiser towards the Western side of the crossing and separated it from a steel trailer it had been towing. The trailer was pushed to the Eastern side of the crossing; the tray was separated from the chassis and the Landcruiser rolled a number of times before coming to rest upside down in a paddock on the Western side of the railway line, as seen in *Photo 1*.

Photo 1: Toyota Landcruiser and tray following accident

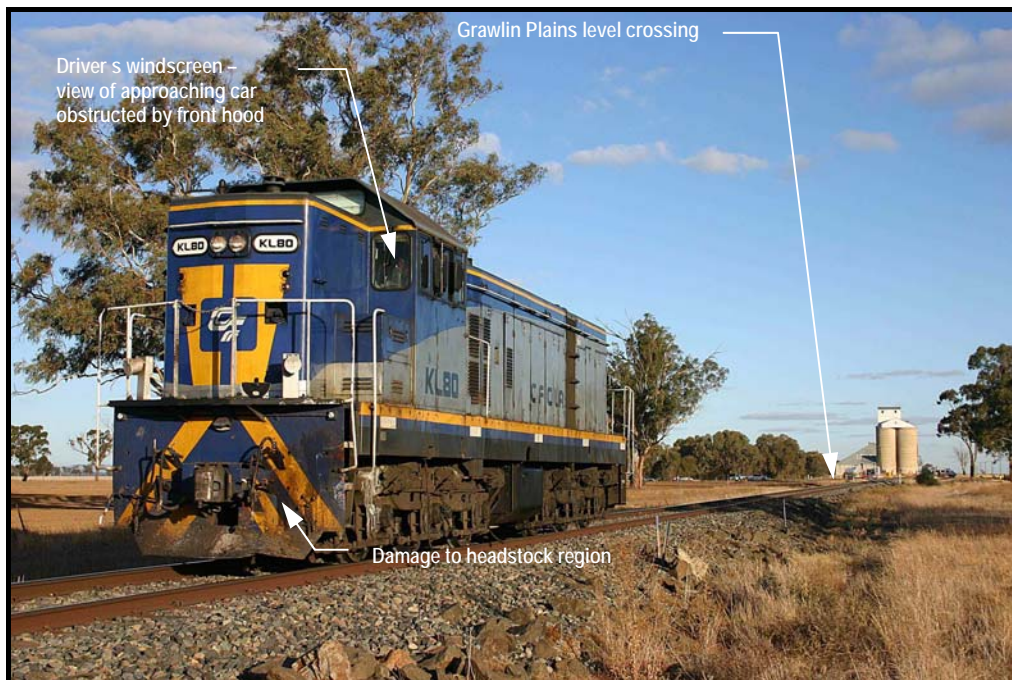
2.20 The locomotive sustained minor damage as a result of the collision. There was damage to the front, left and right side of the locomotive. This included damage to the left-side front steps, hand rails, automatic coupling release handle, right-side fuel tank and the breather and fuel pipes. Some of this damage can be seen in *Photo 3*.

Photo 3: Locomotive's position after the collision

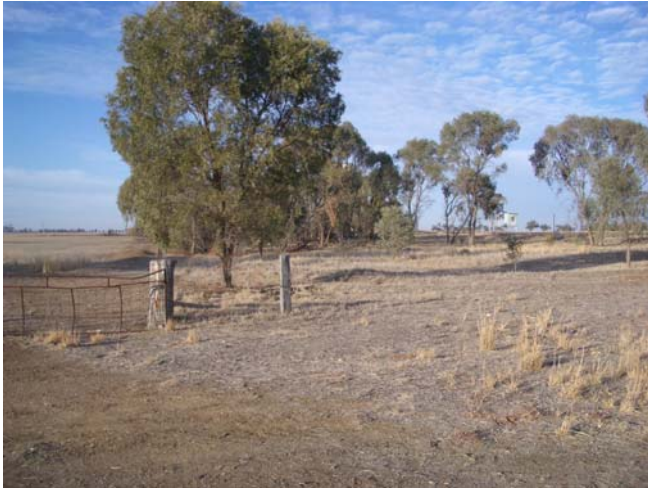
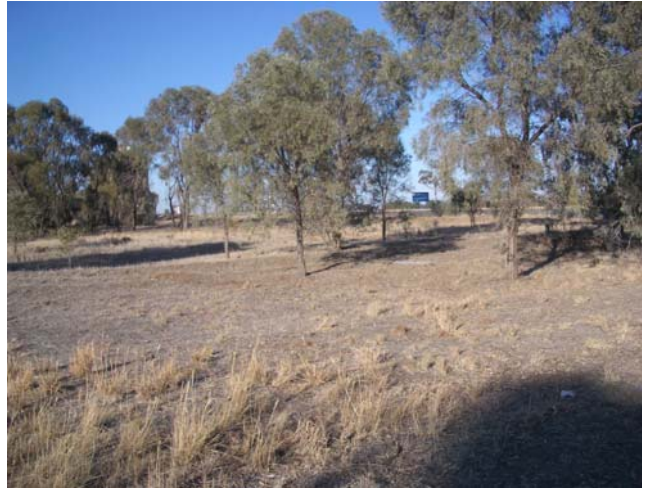
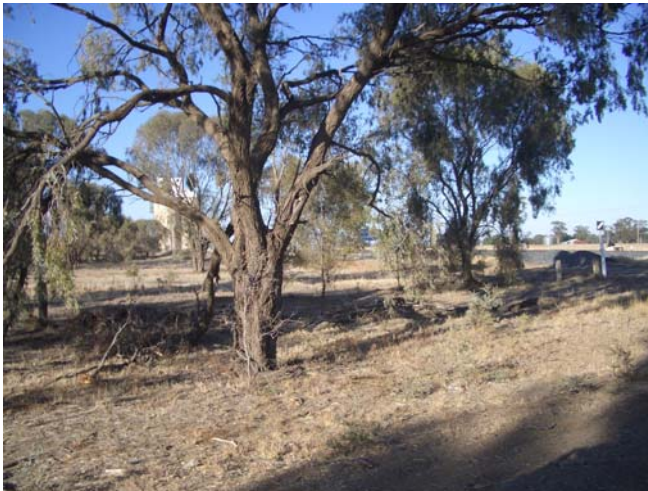
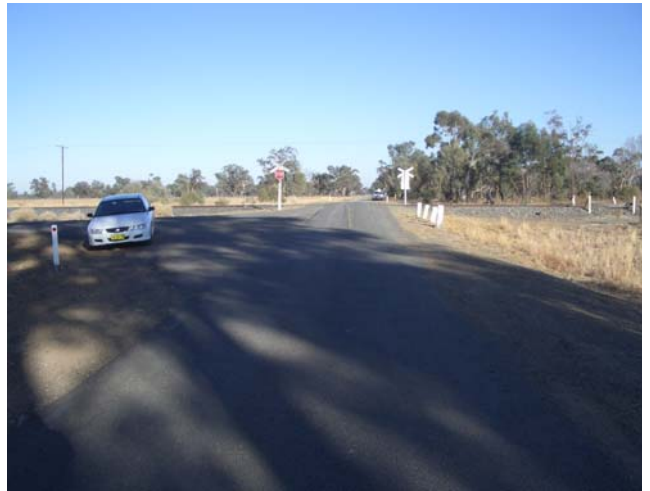
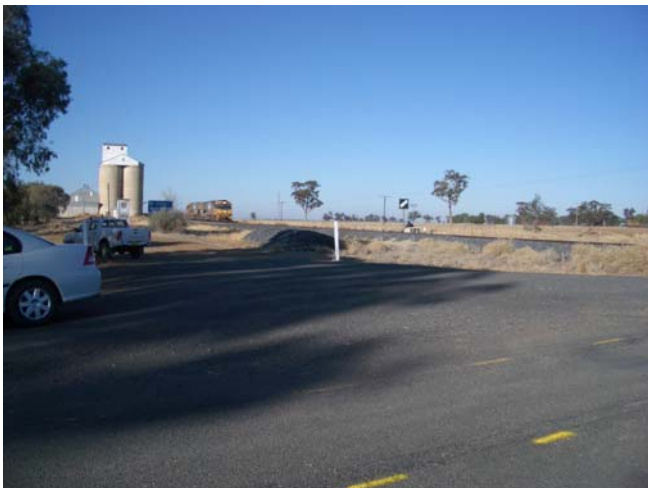
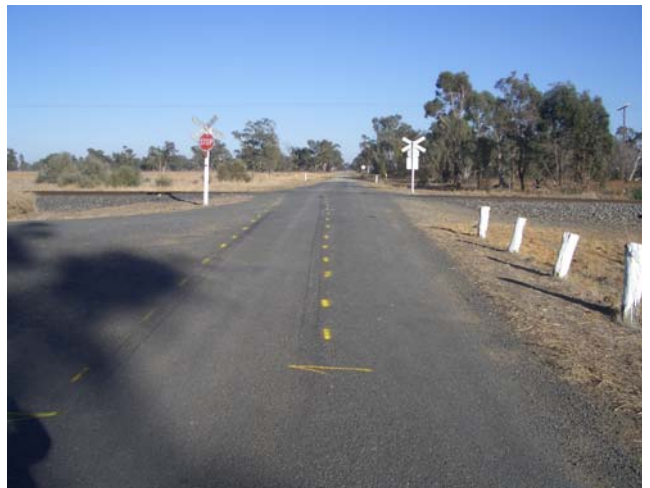
- 3.5 *Weather & Visibility.* The weather was fine and dry at the time of the accident. Although the sun was setting in the direction in which the vehicle was travelling, it was not at an elevation which would have blinded the driver to the presence of an approaching train. There was nothing inside the Landcruiser that should have obstructed the view of the driver. The view from any motor vehicle of any train approaching from the South is partially obscured by trees and other vegetation until approximately 30m from the crossing. This might have been the first point at which driver of the Landcruiser became aware of the approaching train and would explain the skid marks commencing 23m from the crossing. OTSI acknowledges that ARTC is under no obligation to provide road users with an unobstructed view of approaching trains; indeed it would be impossible for it to do so in many circumstances. STOP signs at passive level crossings are an indication to road users that they do not enjoy an unrestricted view of an approaching train and that they must stop. That said, any driver who stops at the STOP sign indicated in *Photo 11* enjoys an unobstructed view of any train approaching from the South for over 300m, which is within the minimum sighting distance recommended by the Roads and Traffic Authority Standard (Traffic Engineering Manual, Section 6, Railway Level Crossing, 1994). The photos below depict the view, as seen by a road user on the Eastern approach to the level crossing. *Photos 6, 7, 8 and 10* depict the view, on the same approach to the South, i.e., towards the direction from which the Locomotive approached.

- 3.6 OTSI noted that the presence of a single locomotive would have been more difficult to detect than one or more locomotives hauling wagons. It also noted that the Landcruiser's passenger-side window had been closed and in combination with the general noise level associated with the vehicle's operation, including that emanating from the trailer and equipment rattling about, may have drowned-out the sound of the train's horn.

- i. Give consideration to the removal of trees and vegetation inside the ARTC leased area on the South-Eastern side of the level crossing at Grawlin Plains to improve the view that road users have of trains approaching from the South.
- ii. Act to improve communication with Forbes Shire Council in relation to the inspection and maintenance of level crossings.

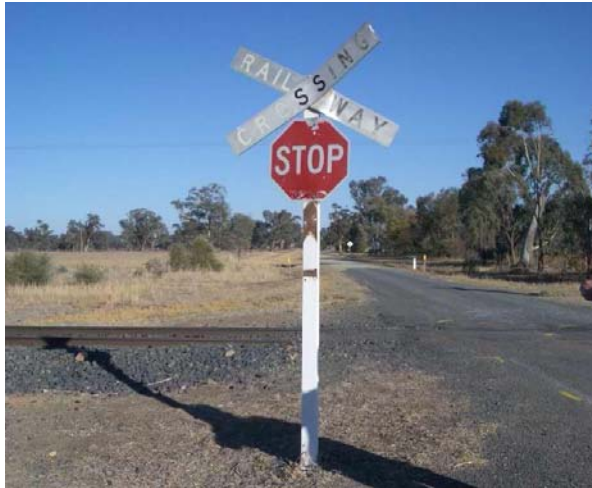
- 3.12 *Signage*. The signage at, and prior to, the level crossing did not meet the relevant Australian Standard for passive level crossings (AS1742.7-1993). The RAILWAY CROSSING crossbucks, featured on the cover sheet of this report, was in poor condition, and the requirement for a LOOK FOR TRAINS sign, a symbolic steam train sign, a symbolic stop roadside sign and painted RAIL X warning sign on the road in advance of the level crossing were not met. *Photo 12* and *Photos 13-15* indicate the signage in place before and shortly after the accident respectively. Had the appropriate signage been in place, the driver of the Landcruiser should have encountered warning signage at least 180m before the crossing and then another warning sign and road markings 70m from the crossing. That said, Eck (2002) suggests that drivers

Photo 12: Condition of signage at time of accident

- i. Develop a program for the regular inspection of all level crossings in the shire to ensure that road users using such crossings have the benefit of markings and signage that conform with Australian Standard AS1742.7:1993, Manual of Uniform Traffic Control Devices, Part 7: Railway Crossings.
- ii. Act to improve communication with ARTC in relation to the inspection and maintenance of level crossings.

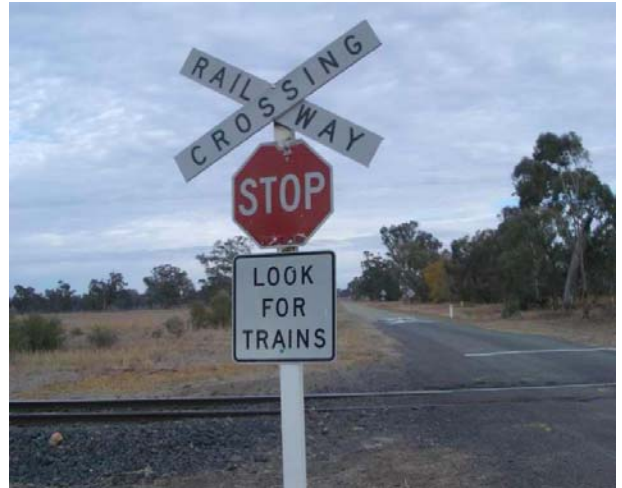
Photo 13: Signage at crossing after the accident

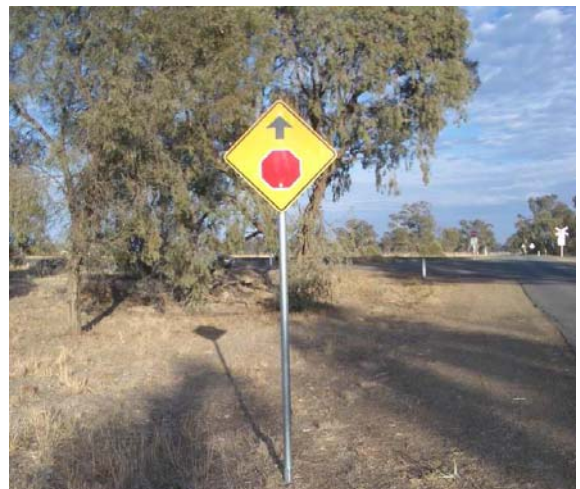
Photo 14: Road marking post-accident

Photo 15: Warning sign post-accident

3.13 OTSI established that responsibility for the level crossing and the maintenance is divided between the ARTC and the Forbes Shire Council. ARTC is responsible for the provision and condition of trackside signage (see *Photos 12 and 13*) and the Council is responsible for the provision and condition of signage on the approaches to the crossing (see *Photos 14 and*

15). OTSI noted that an audit undertaken in December 2002, by the Rail Infrastructure Corporation, recorded that approach signage was missing. The crossing had also been audited a number of times more recently. The most recent audit, by ARTC on 18 May 2005, found the crossing to be in order. If this was the case, the LOOK FOR TRAINS sign which was missing at the time of the accident must have disappeared in the two weeks between this audit and the accident.
