RAIL SAFETY INVESTIGATION REPORT

FATAL LEVEL CROSSING COLLISION GRAWLIN PLAINS

31 MAY 2005

OTSI File Ref: 04085

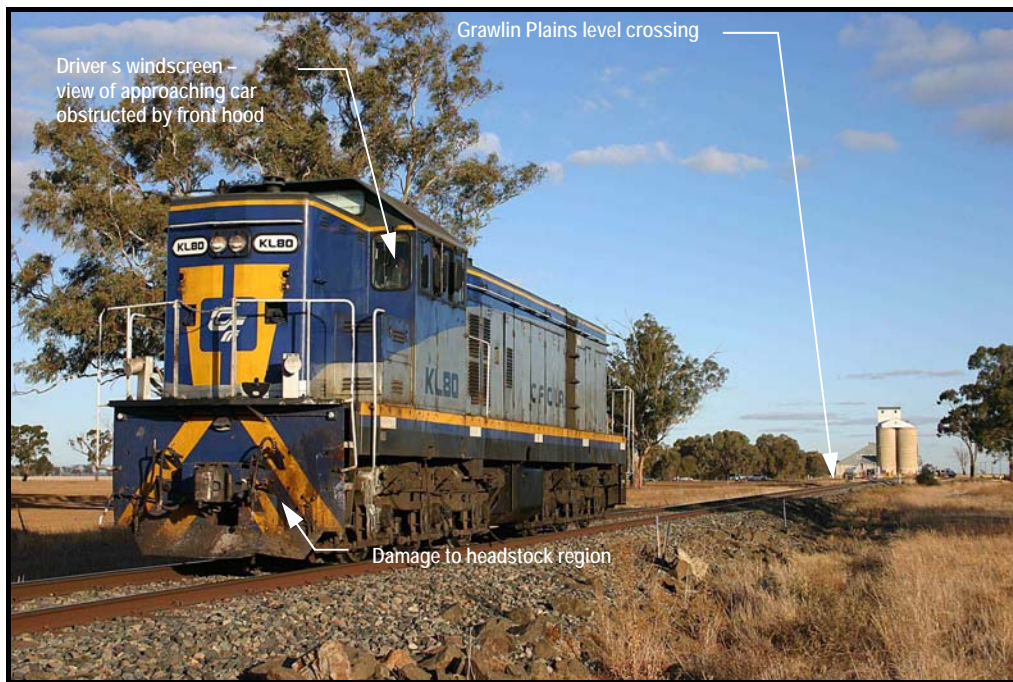
2.20 The locomotive sustained minor damage as a result of the collision. There was damage to the front, left and right side of the locomotive. This included damage to the left-side front steps, hand rails, automatic coupling release handle, right-side fuel tank and the breather and fuel pipes. Some of this damage can be seen in *Photo 3*.

Photo 3: Locomotive's position after the collision
