Office of Transport Safety Investigations

RAIL SAFETY INVESTIGATION REPORT

DERAILMENT OF 4BM7 LIDCOMBE

4 NOVEMBER 2005

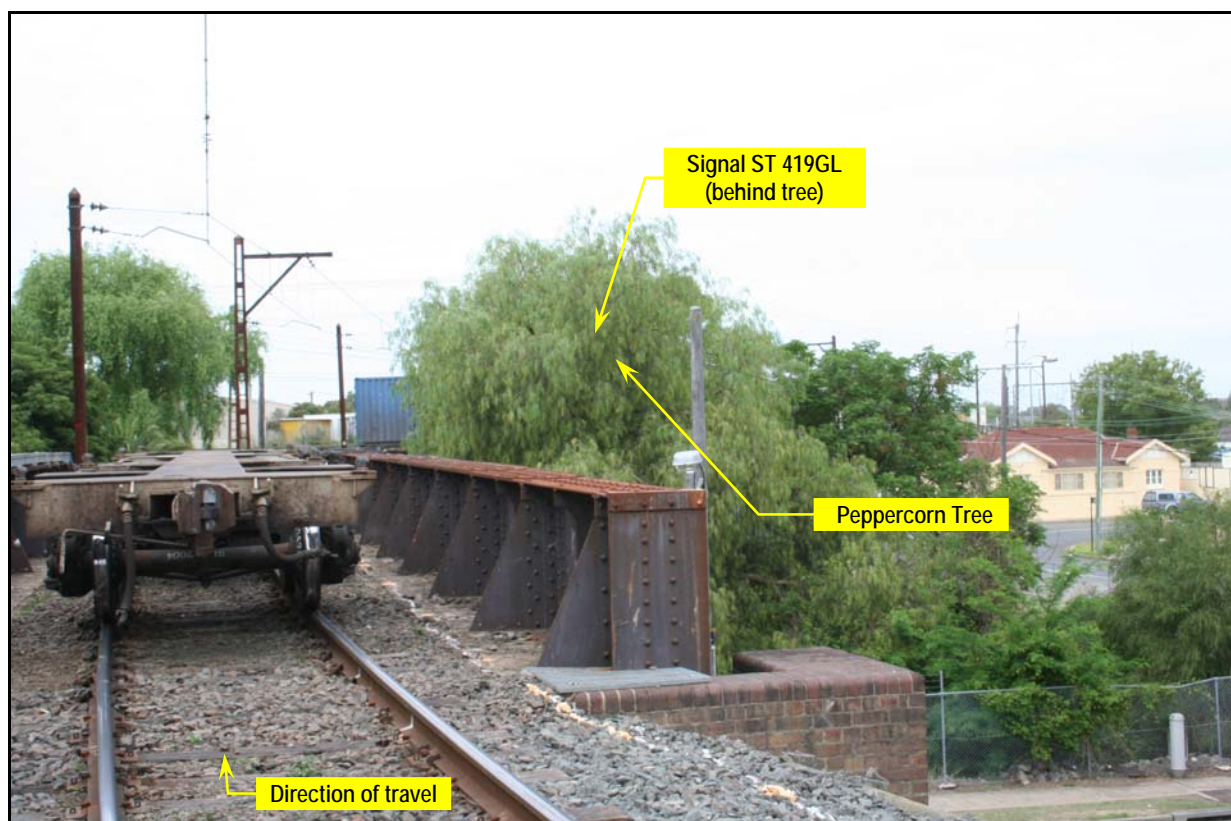
Photo 1 Looking towards Signal ST 419GL, with sighting obstructed by a peppercorn tree

- 3.5 While at the incident site, and in the light of day, OTSI noted that a large peppercorn tree, on the Western side of the embankment, obstructed visibility of signal ST 419GL up to a point 93 metres from it (See *Photo 6*).

- 3.6 The tree also obstructed the sighting of Signal ST 429GL. Given the size of the tree, it had clearly been obscuring Signals ST 419GL and ST 429GL for a long time. However, OTSI noted that this had not been the subject of reporting by drivers or by those responsible for inspecting and maintaining the

- iii. RailCorp has a program to check on matters that might impact on the operation or visibility of signals, but this program failed to detect what was an obvious and long-standing obstruction, caused by a large peppercorn tree on the Western side of the track, 93 metres from Signal ST 419GL.

- d. rectify the deficiencies previously identified with No. 717 catch points, and
- e. review the effectiveness of the methods employed in signal sighting inspections.

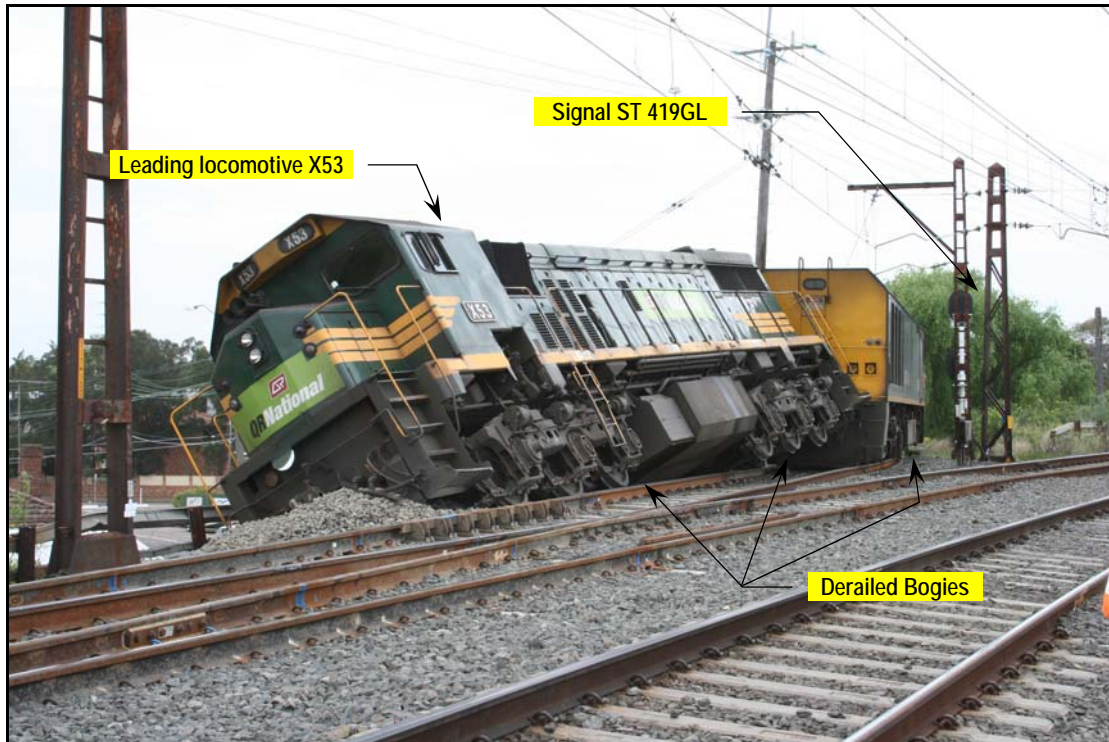
- 2.6 Upon sighting Signal ST 419GL at 'Stop', the driver immediately applied the emergency brakes. However, he was unable to stop 4BM7 and its leading locomotive (X53) travelled over the open set of catch points (No. 717) and

derailed. Both of the locomotive's bogies derailed and the locomotive came to rest in loose ballast on top of an eight metre-high embankment approximately 40 metres beyond Signal ST 419GL (see *Photo 2*). The leading bogie on the trailing locomotive (EL58) also derailed.

Photo 2 Derailed locomotives of 4BM7 at daylight on day of incident

- 2.20 Both of 4BM7's locomotives suffered minor damage. Six concrete sleepers and various components within No. 717 catch points were crushed during the derailment. A short section of signal troughing and a timber retaining wall also suffered impact damage, but the integrity of the signalling and track systems was not affected. Fire crews remained on-site to respond to any fluid that might have leaked from the derailed locomotives.
- 2.21 Concerns over the stability of the derailed locomotives and the security of the train's load, resulted in the site of the derailment being cordoned-off to prevent the access of other than response personnel.

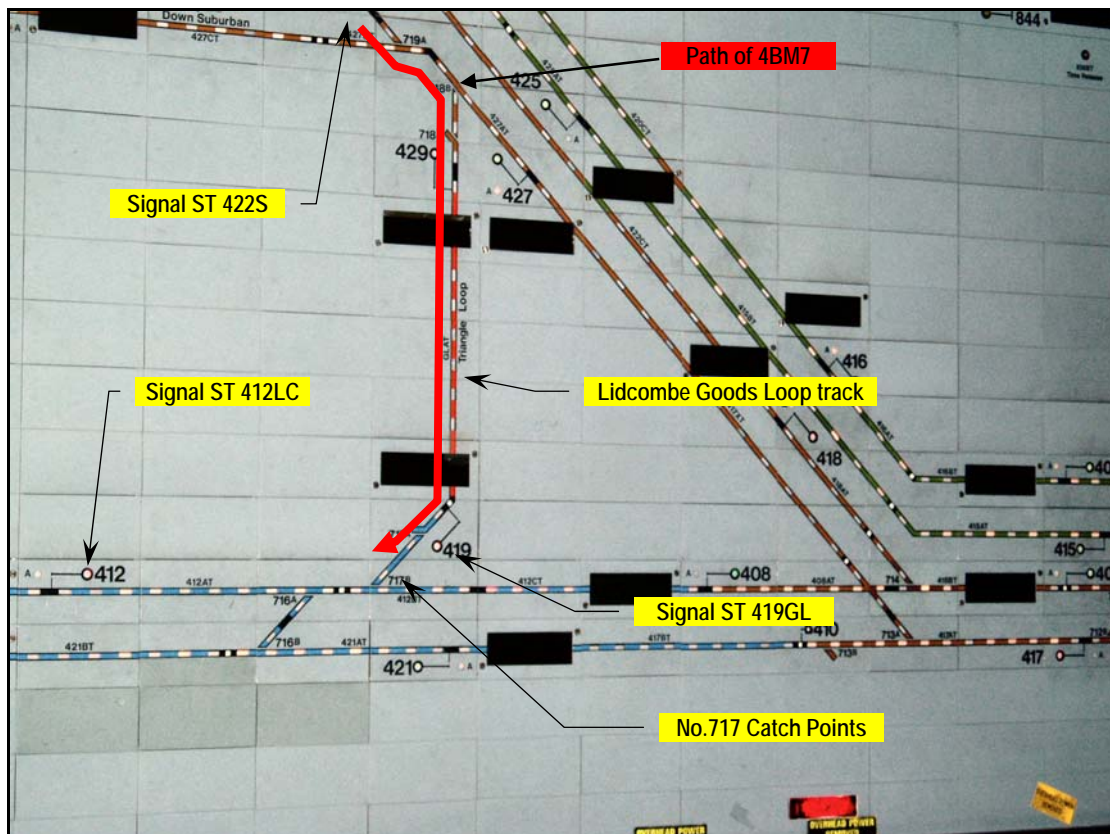
Photo 3 The Area Controller's Track Indication Panel, with the Lidcombe Goods Loop indicated

- 2.9 In the absence of a means for a SPAD to be displayed on his indication panel, the Area Controller believed that a technical fault existed with track-side equipment and advised the driver of 53-U that a problem existed with the signalling. He then authorised the driver of 53-U to pass Signal ST 412LC at 'Stop' but report any problems encountered. The driver of 53-U proceeded past Signal ST 412LC with an appropriate degree of caution.
- 2.10 Having passed Signal ST 412LC, the driver of 53-U saw what appeared to be two white lights, 4BM7's marker lights, as he approached the Lidcombe Goods Loop but assumed them to be street lights because of the odd angle at

- vii. the design of the Track Indication Panel which failed to provide an alarm to alert the Area Controller that Signal ST 419GL had been passed at 'Stop' without authority;

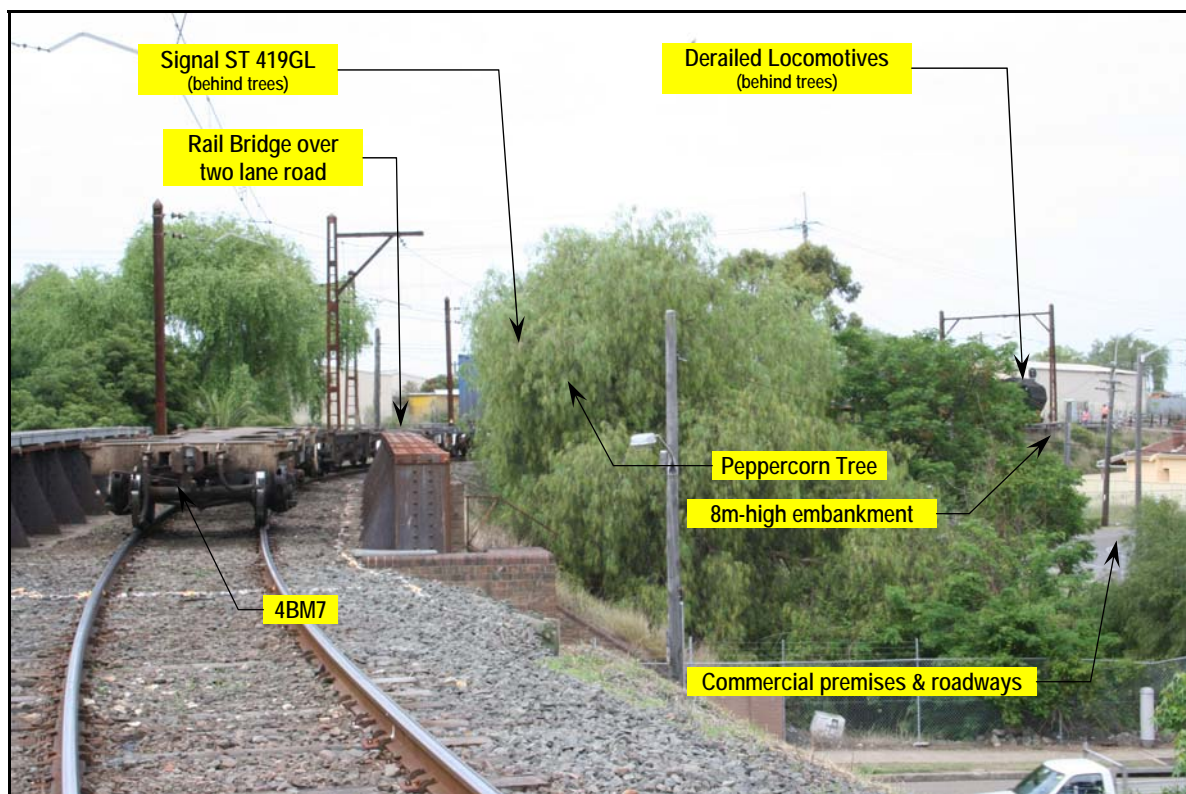
- 2.17 The proximity of the loop line to roads, commercial premises and facilities is depicted in *Photos 4 and 5* (over page).

Photo 4 Lidcombe Goods Loop Line, approaching Signal ST 419GL, showing roads and commercial premises

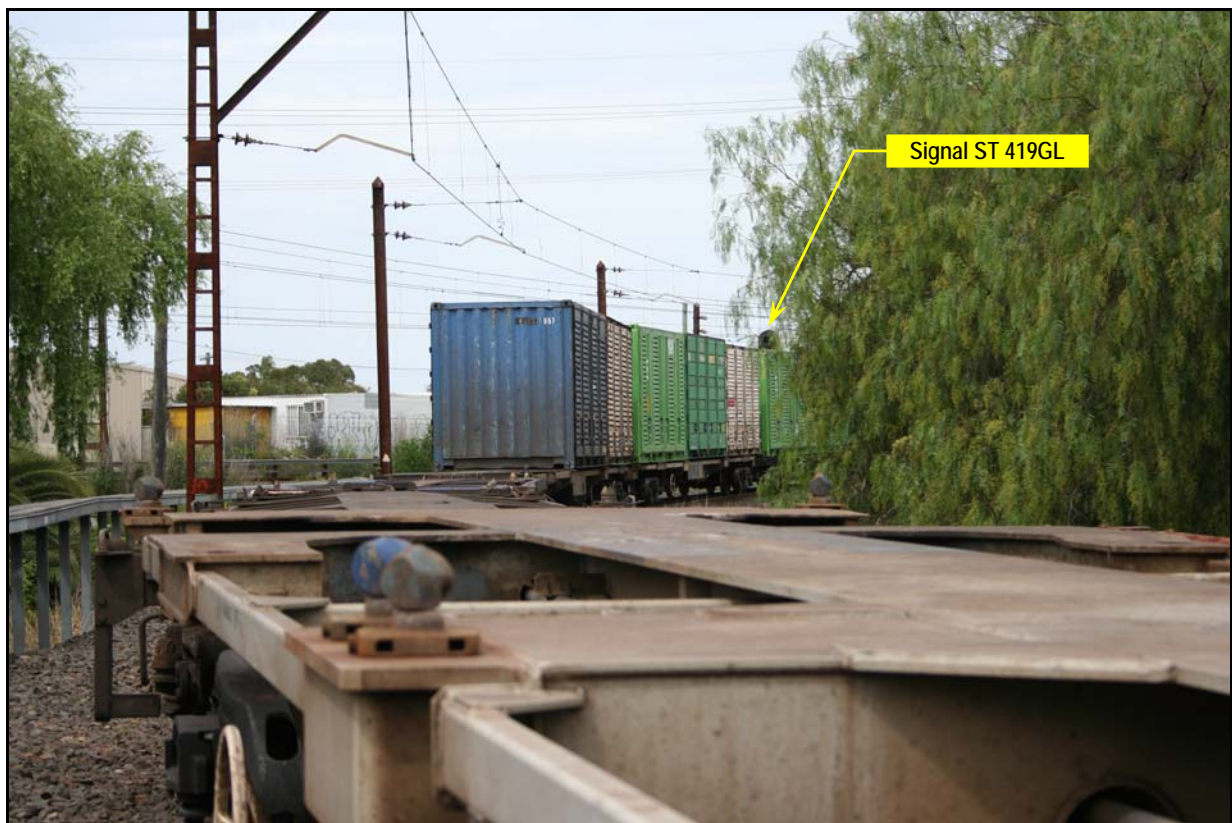
Photo 6 Point 93m from Signal ST 419GL, at which sighting first becomes unobstructed

- 3.7 RailCorp's "Signals Engineering Standard Construction Specification" SC-00-47-00-00-SP requires a signal to be visible for a minimum of six seconds at line speed. The specification also states "*running signals shall be located to provide so far as practical, the longest, most continuous sighting of the signal after passing the signal in the rear*" and "*preferably, a minimum of 200 metres sighting distance for speeds to 100 kph and 300 metres for speeds over 100 kph wherever the environment permits*". As previously noted, Signal ST 419GL first becomes visible at a distance of 93 metres which is at the point where the locomotive driver passes the peppercorn tree (as depicted in *Photo 6*). At 28km/h, OTSI calculated that Signal ST 419GL would have remained visible to the driver for approximately 11.9 seconds. At the maximum permitted speed of 25km/h while 4BM7 was still clearing points on the West Suburban lines, this signal would have been visible for approximately 14.1 seconds. Calculations on rates of braking estimated that, at full service braking⁸, a freight train similar to 4BM7 requires a minimum of 86 metres to stop when travelling at the speed of 28km/h. The implication is that at the point at which Signal ST 419GL first became visible, the driver had sufficient time and distance to have maintained proper control of 4BM7 had he been sufficiently alert. A sufficiently alert driver would have slowed 4BM7 down to below 25km/h on the basis of the 'calling on' indication at the preceding signal (ST 422S) because this indicated to the driver that he needed to be prepared to stop at any time before ST 419GL if the line was obstructed.
