RAIL SAFETY INVESTIGATION REPORT

**SIGNAL PASSED AT DANGER BY CITYRAIL SERVICE 67-R
RESULTING IN AN OPPOSING MOVEMENT**

NORTH STRATHFIELD

2 SEPTEMBER 2006

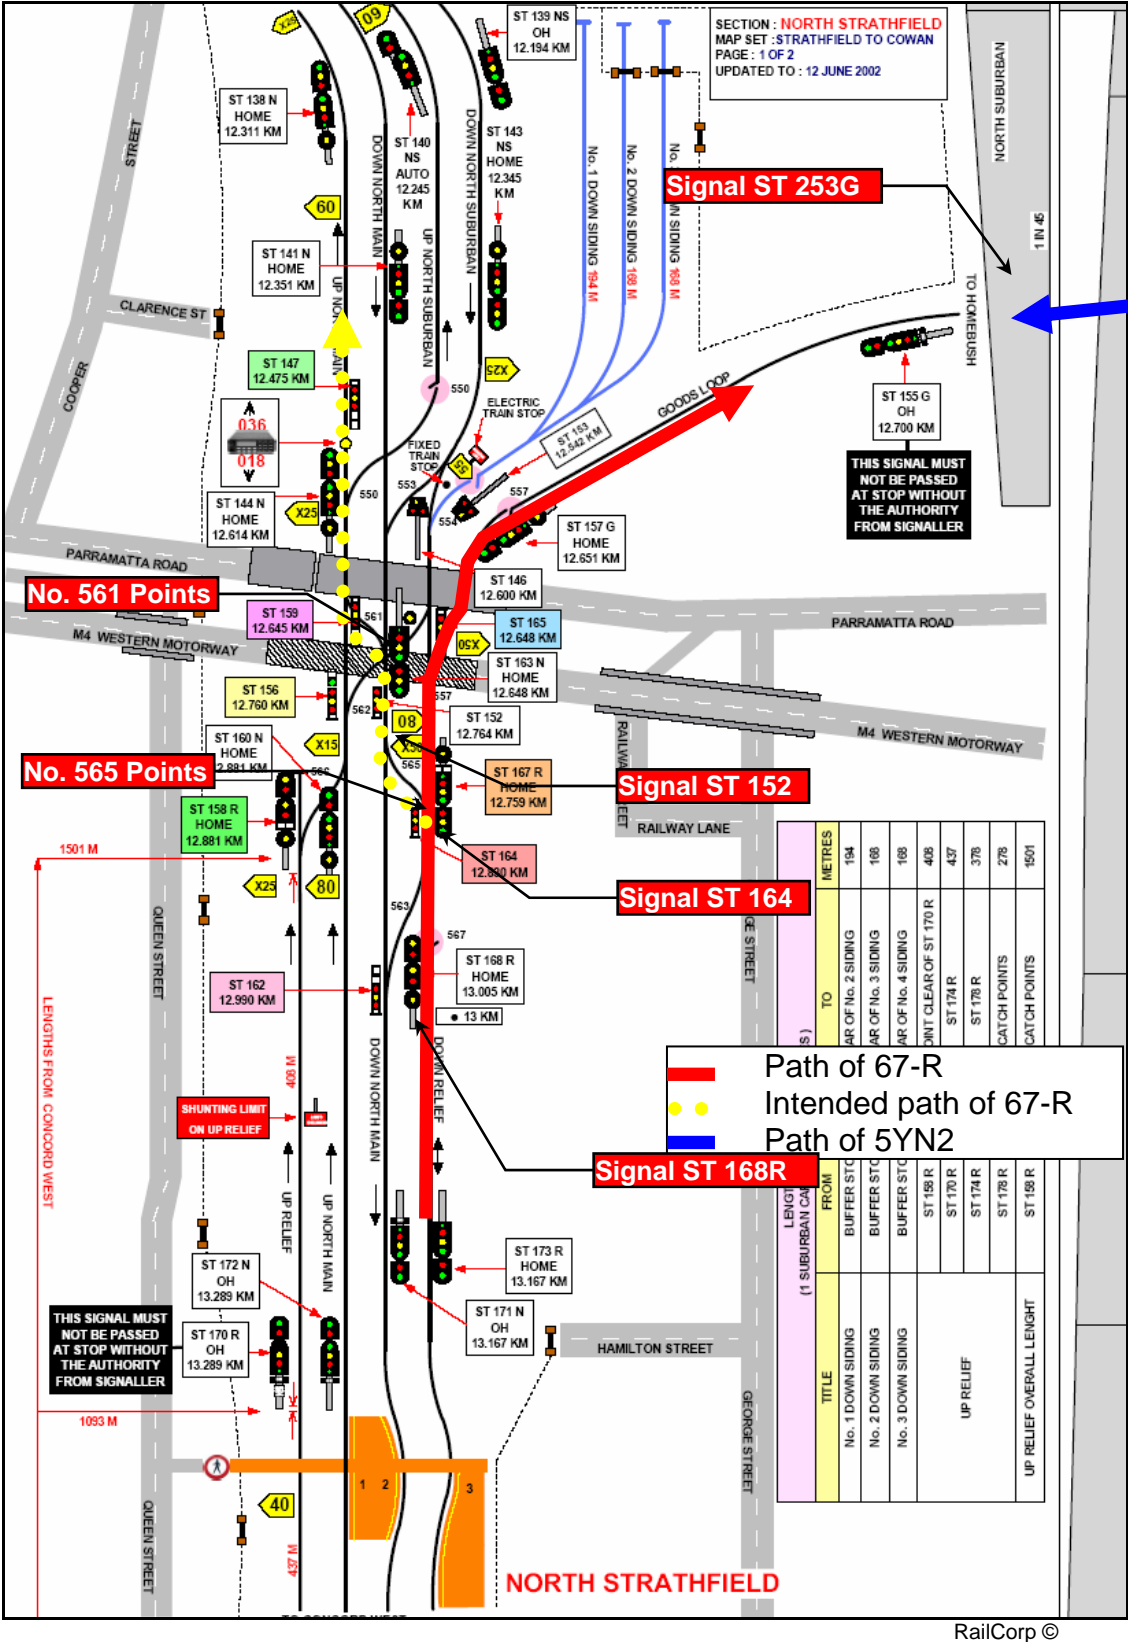
Figure 2: Track and Signal configuration at North Strathfield showing Actual and Intended Routes of 67-R

- 2.9 Signal ST 164 was displaying a two-red-light indication and 67-R was obliged to stop at the signal. Instead, it continued on and in the absence of a train stop and with the points set towards the 'Goods' line, 67-R deviated from its intended route and continued along the line towards Homebush (the intended and actual routes are depicted in *Figure 2*).

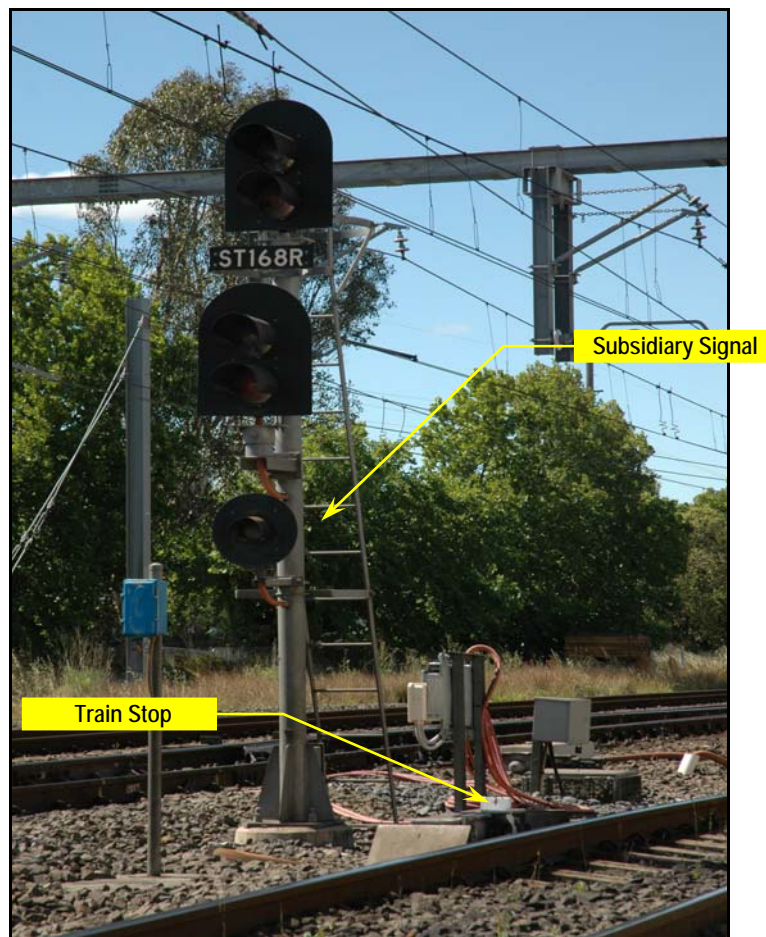
Photo 3: Signal ST 168R

3.4 Signal ST 168R is a 'double light / colour light' signal; the signal lights are aligned vertically and each head is fitted with two lights. Below the double lights is a single 'calling-on' subsidiary shunt signal (see *Photo 3*).

3.5 The purpose of the subsidiary signal is to authorise the train to proceed into the next section⁵. This signal is fitted with a train stop. The Driver

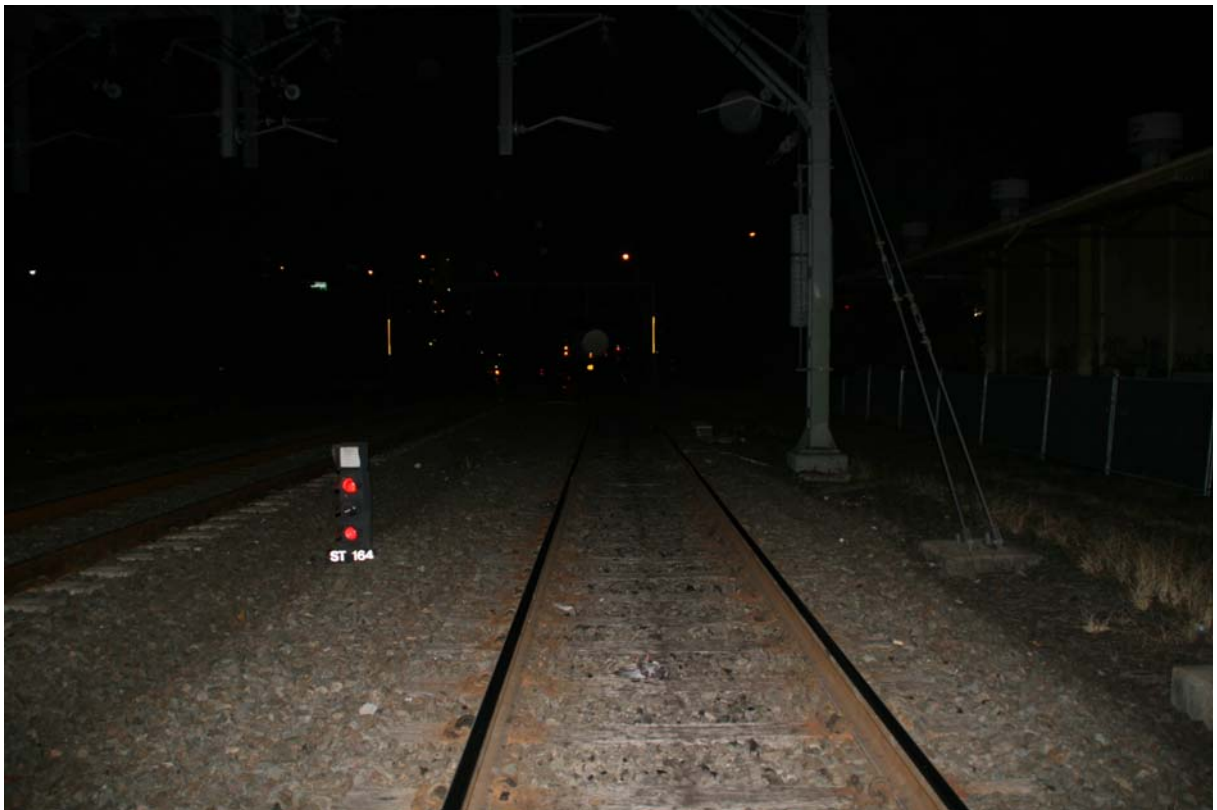
Photo 4: Signal ST 164

- 3.7 Signal ST 164 is a dwarf shunt signal or 'ground dolly' located 1.2m to the left of the 'Down Relief' track (see *Photo 4*). This is in contrast to the previous Signal, ST 168R, which was positioned at a level comparable with a driver's eyes in the train's cab. Notwithstanding this difference, the positioning of Signal ST 164 complied with RailCorp's Signalling Design Principles, ESG 100.1. Clause 1.12.2.4 of these principles specifies that subsidiary and shunt signals should be clearly visible from a distance of at least 50m. This Signal was clearly visible at a distance of 80m. RailCorp's testing also confirmed that this signal was fully operational.

- 3.8 The Driver of 67-R considered that his ability to see Signal ST 164 might also have been adversely affected by the excessive brightness of the previous signal (Signal ST 168R). While the signal is brightly lit, OTSI observed that it was not excessively bright and discounted the possibility that it might have affected the Driver's night vision. It was established, through testing, that Signal ST 164 was fully operational at the time of the incident. While the signal is not currently an LED-type signal, RailCorp has indicated that this signal and others surrounding it will be upgraded to LED-type signals in the 2007/2008 Major Planned Maintenance Schedule.

- i. Signal ST 164 is sited in a manner and location that meets the required technical parameters; as such it should have been readily apparent. However, as a 'ground dwarf signal', it is lower than other signals in the immediate area and may have been overlooked by the Driver in favour of two Main Line signals in advance of it, which were showing proceed indications.
- ii. The Driver of 67-R and the Area Controller had worked for nine and eight consecutive days respectively and were due to proceed on rest days at the end of their shifts. While these rosters and the hours shown therein were within industry and RailCorp's scheduling parameters, research¹⁰ indicates that both members were operating in a 'zone' where there was an increased likelihood of them making an error.

- i. ensure that Signal ST 164 is upgraded to an LED-type signal;
- ii. issue instructions to Strathfield Area Controllers to reinforce the implementation of Local Instruction NOS02/2006, which requires Area Controllers to hold trains at Signal ST 168R that is protected by catch points, before setting Signal ST 164 to clear;

- iii. install a train stop at Signal ST 164;
- iv. identify any locations where a similar SPAD could occur and implement remedial safety action to eliminate the potential for collision as a result of opposing or following movement;

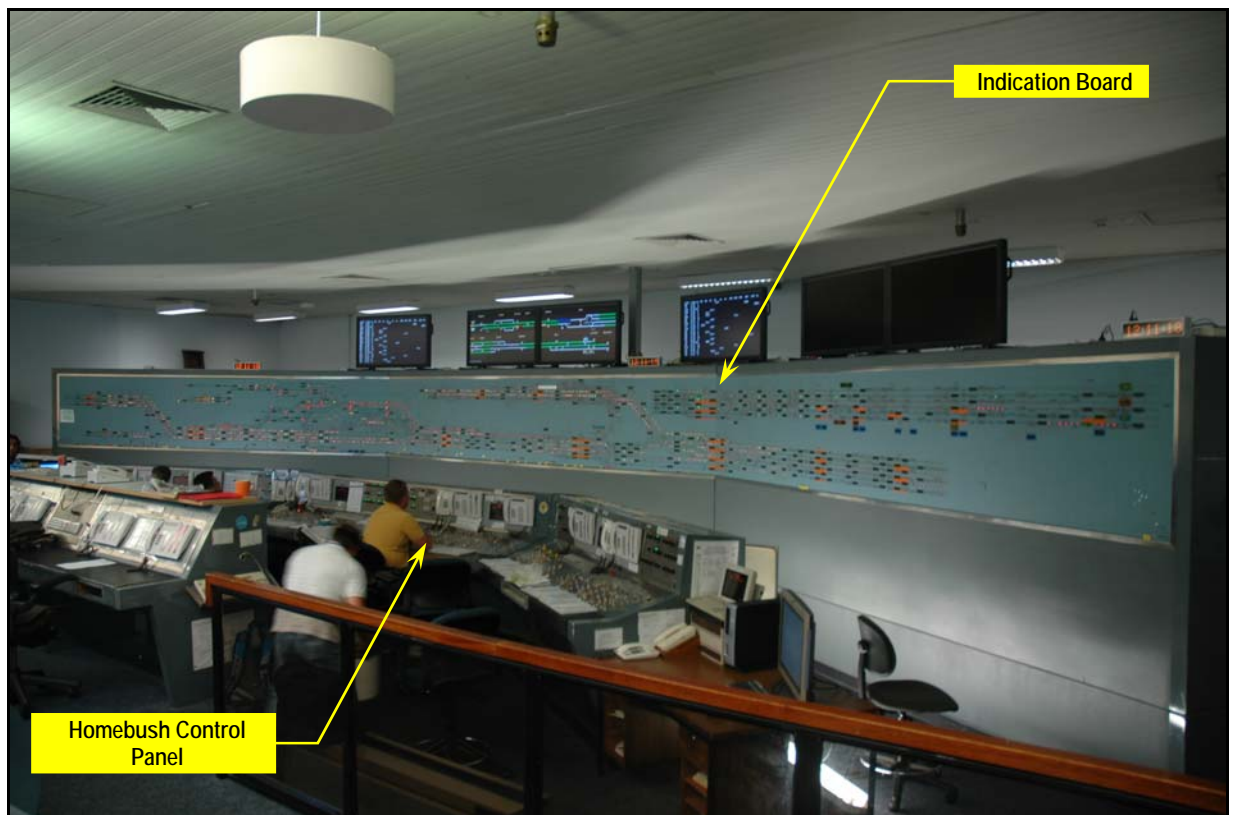
Photo 5: Control Panels Strathfield Signal Box

3.10 The routes over which 67-R and 5YN2 were travelling immediately prior to the incident were being controlled from the Strathfield Signal Box. This facility is located on the Northern side of the main line between Strathfield and Homebush railway stations and adjacent to the 'Goods' line where the incident occurred. It is one of the largest signalling complexes in the Sydney Metropolitan area and train movements incorporating the triangle between Strathfield, Homebush and North Strathfield, are controlled from within it. Specific sections of track are allocated to Area Controllers who are responsible for setting the route into, through and out of their area of operation. There is a control panel for each track section and the Area Controller can manipulate signals and track settings via the control panel. There is also a large indication board on view to all Area Controllers which shows the position of trains covered by the Strathfield Signal Box. Trains are represented by a series of lights on the indication board which show which section of track the train is occupying (see *Photo 5*).

- 3.11 However, there are no alarms to indicate that a SPAD or an opposing movement has occurred in the section. On the night of the incident, there were seven Area Controllers in the Strathfield Signal Box; six were operating the various control panels and one person was on office duties.

- v. alarm its control panels and indication boards, where it has not already done so, so that Area Controllers are automatically alerted to situations where signals have been passed at stop and/or to opposing movements;

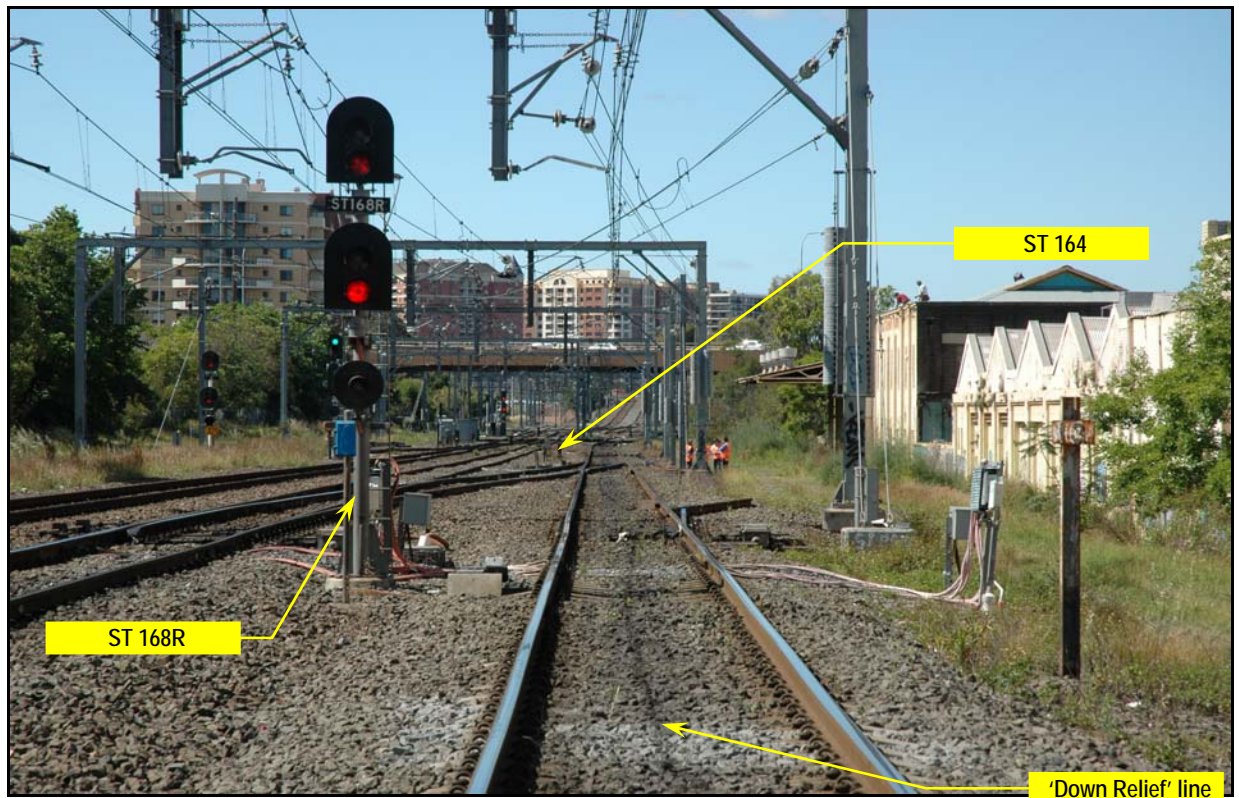
Photo 6: Signal ST 168R and 'Down Relief' line looking South

- 3.13 Although the Area Controller was entitled to set the route as he did, a number of other area controllers described an alternative setting that would have held the Driver at Signal 168R (see *Photo 6*) until it was possible to have provided him with a clear path across all signals from the 'Down Relief' line to the 'Up North Main' line, instead of requiring the Driver of 67-R to stop and then calling him forward to again stop at Signal ST 164.

- 3.34 As a result of this incident, RailCorp issued an instruction to Area Controllers at Strathfield Signal Box (Local Instruction NOS02/2006) requiring them to hold trains at Signal ST 168R, which is protected by catch points, before setting Signal ST 164 to clear.
- 3.35 RailCorp has also planned to replace Signal ST 164, and others nearby, with an LED type signal as part of a signals upgrade program in 2007/2008.
