RAIL SAFETY INVESTIGATION REPORT

DERAILMENT OF PACIFIC NATIONAL WHEAT SERVICE 5424 OLD BURREN 6 APRIL 2005

OTSI File Ref: 03724

17 November 2005

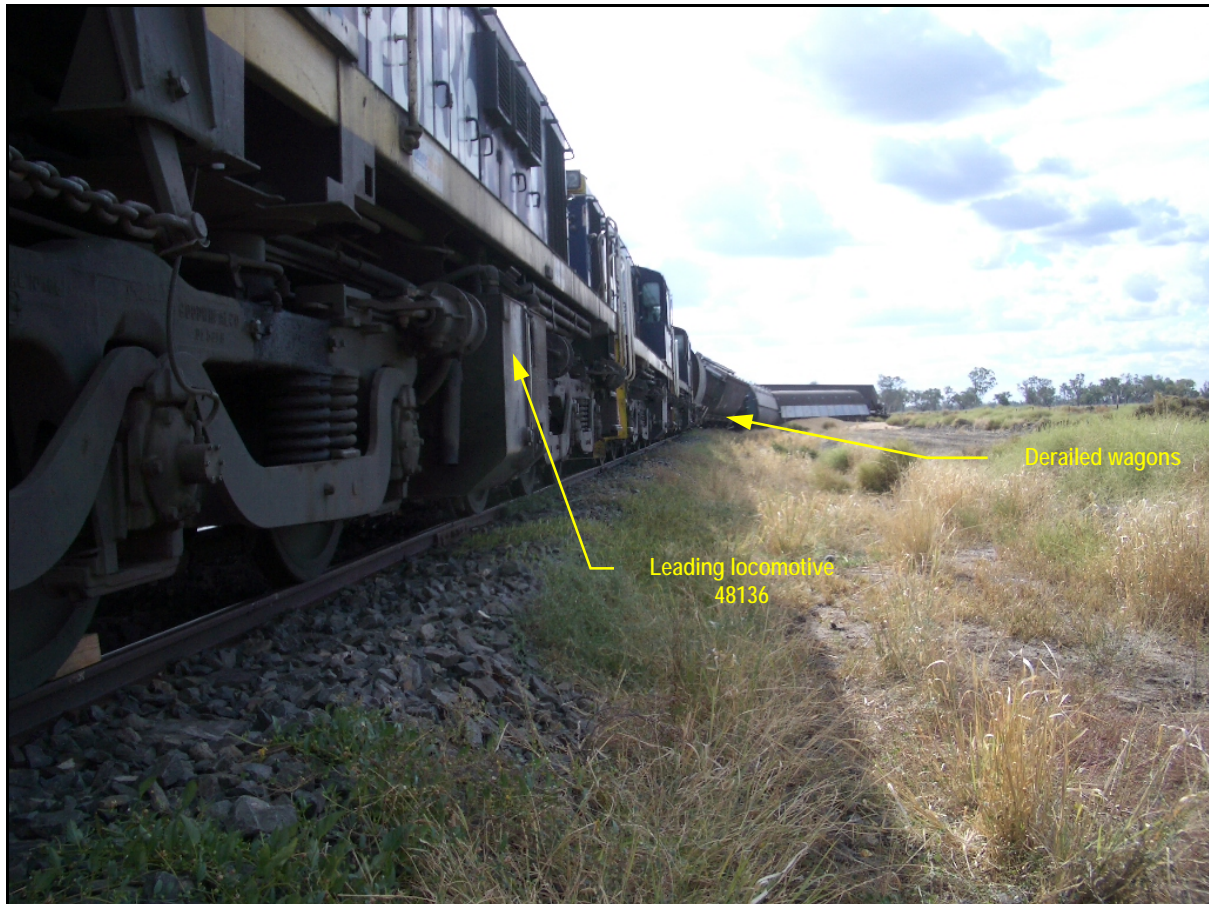
leading wagon remained on the track, the following six wagons derailed and came to rest at various angles on the northern, or up, side of the track. Two of the derailed wagons tipped onto their sides and approximately four tonnes of wheat was spilled through opened loading hatches and damaged bottom dump doors. The results of the derailment are depicted in Photos 1 and 2.

Photo 1: View of derailed wagons from the front of the train on the Driver's, or Northern, side

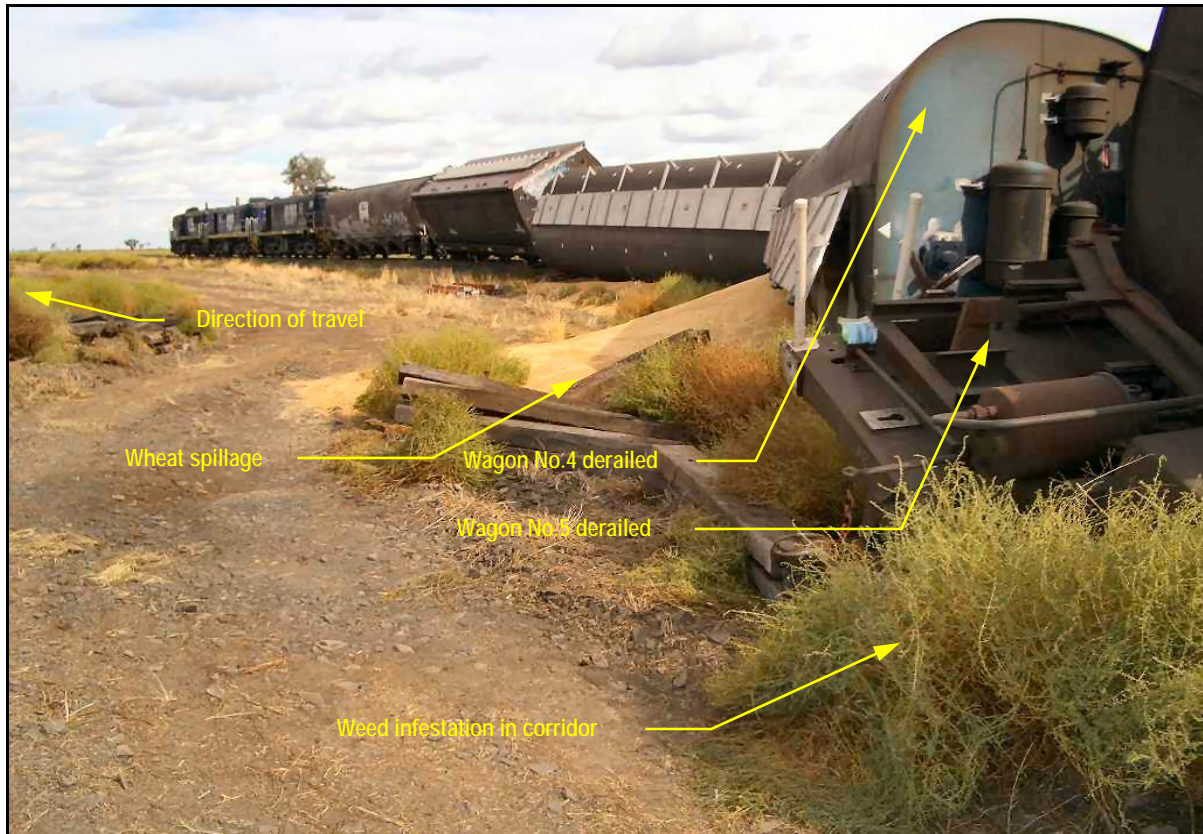
Photo 2: North side of incident. Derailed wagons (2 – 7) showing extent of wheat spillage.

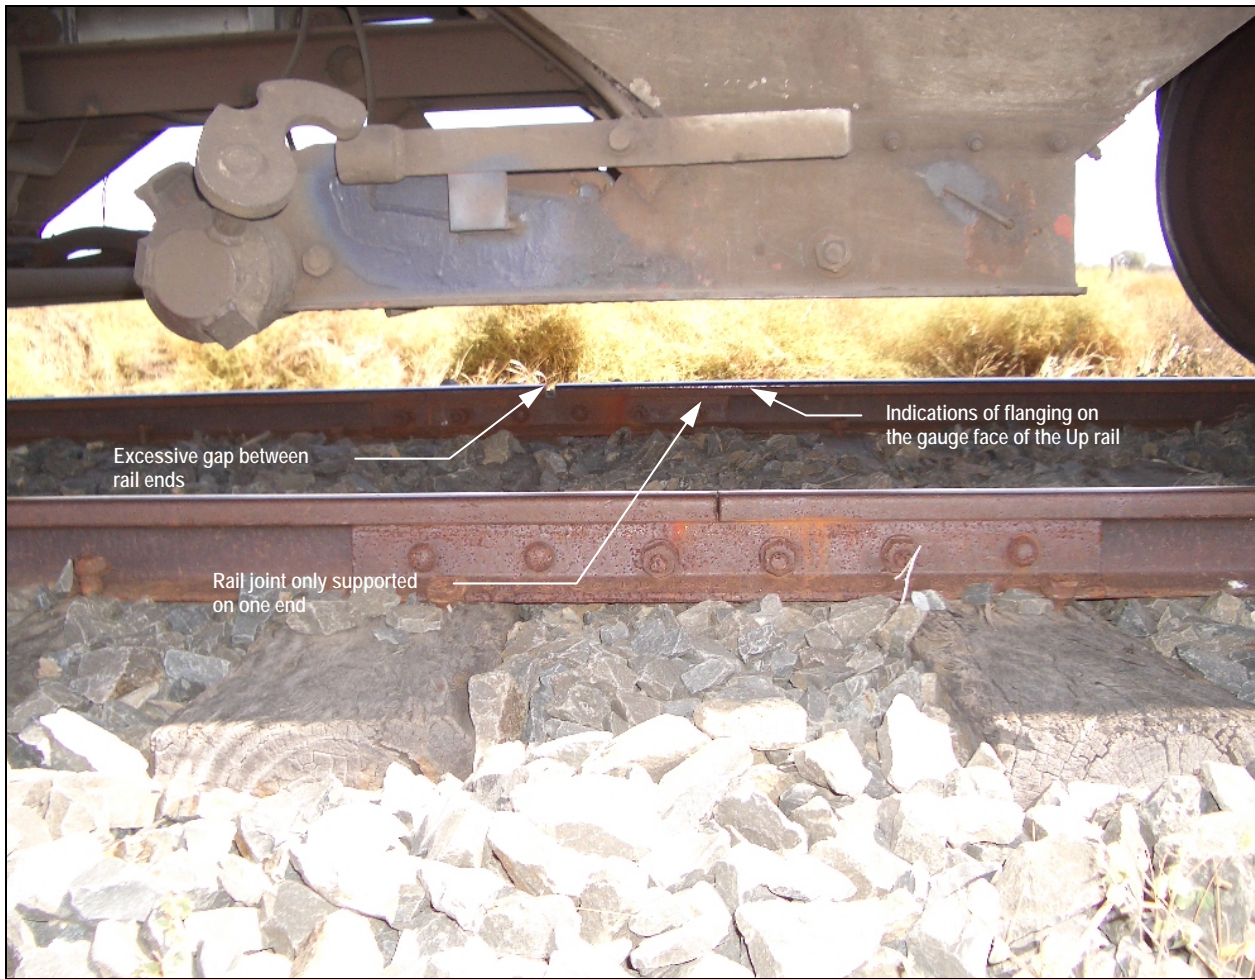
Photo 3: Evidence of heavy flanging on gauge face.

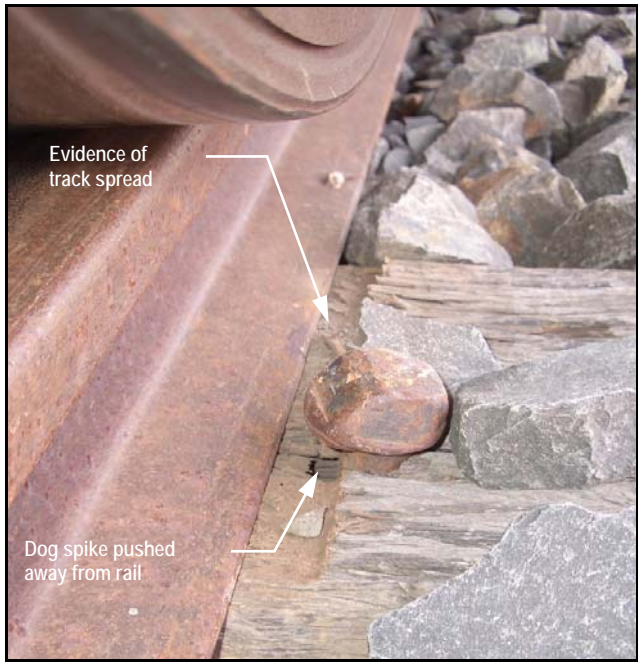
The derailment was caused by misaligned and unstable track which spread under the load of train 5424.

Photo 4: Evidence of track spread at point of derailment.

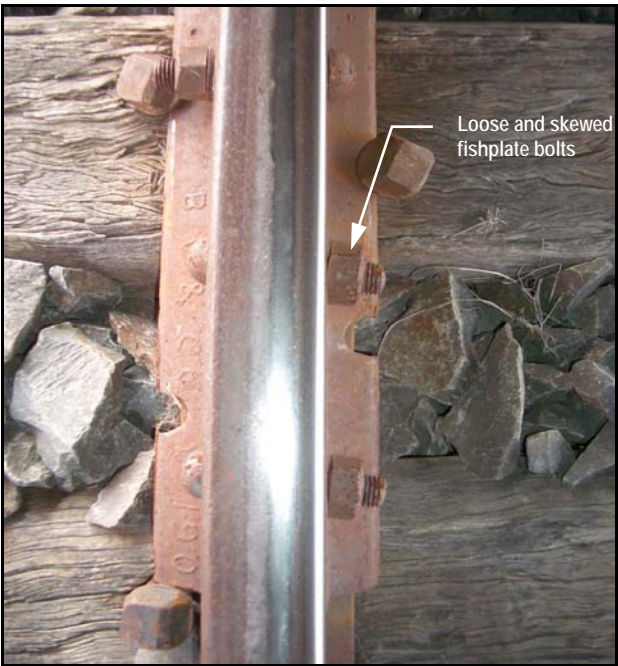
Photo 5: Typical condition of fishplate bolts

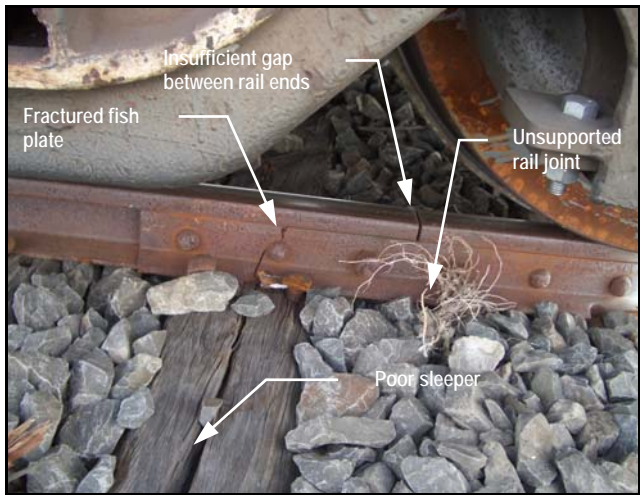
- g. The fishplates at a number of mechanical (plated) joints had fractured through the bolt holes (see Photo 6).
- h. The expansion gap between rail ends at the mechanical (plated) rail joints varied between nil and 25mm (see Photo 7), whereas the standard indicates that such gaps are normally set between zero and 12mm. It was also noted that there was either little or no gap between some consecutive sections of rail, whilst others had wide gaps between the rail ends. This variation in gapping indicated significant longitudinal movement of the rails which could reasonably be attributed to the fishplate¹³ bolts and poor fastening of the rail to the sleepers. The closing of gaps on some consecutive rail ends and the excessive gap and longitudinal movement in other rail lengths in the area, prior to the derailment, may also have been an indication of 'bunching'. It is likely that such bunching existed in the vicinity of a section of steel sleepers used in repairs following a derailment in 2002. However, the extent of the damage to the track on 6 April 2005 prevented OTSI from definitively establishing this to be the case.

Photo 6: Fractured fish plate.

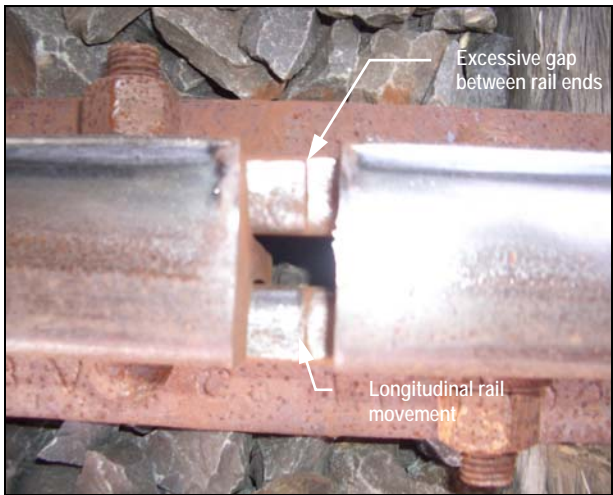
Photo 7: Typical condition of open rail joint

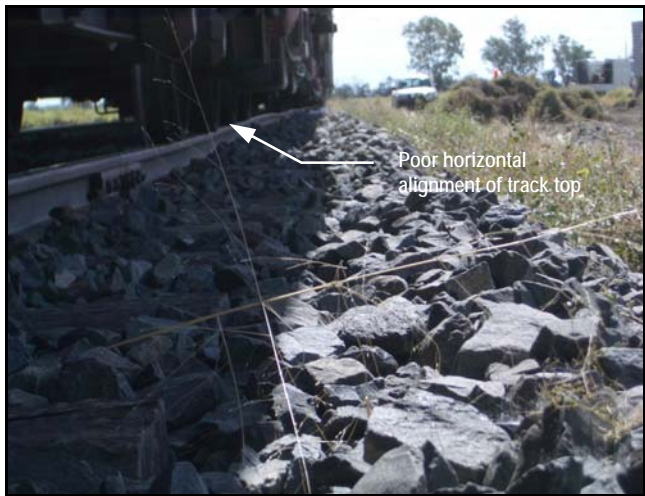
Photo 8: Alignment of track top just prior to the point of derailment.

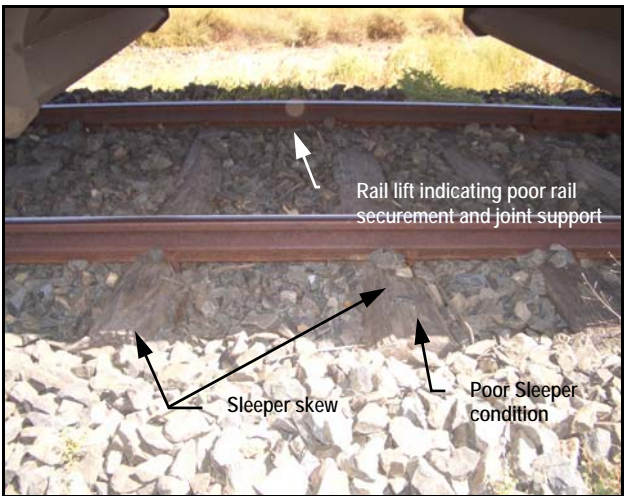
Photo 9: Rail lift or bow.

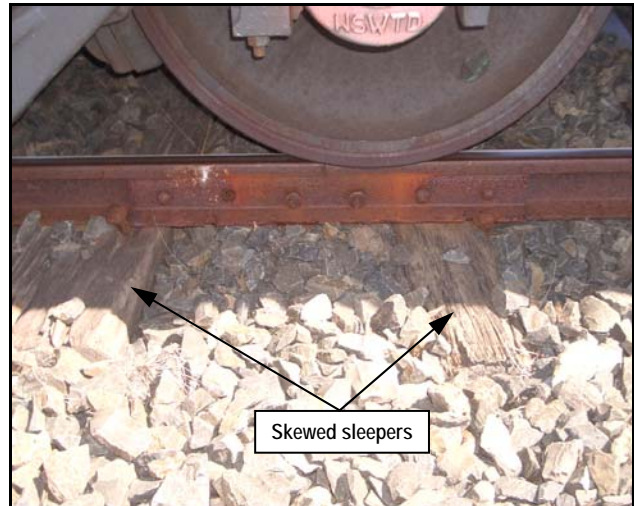
Photo 10: Track condition under 5424.

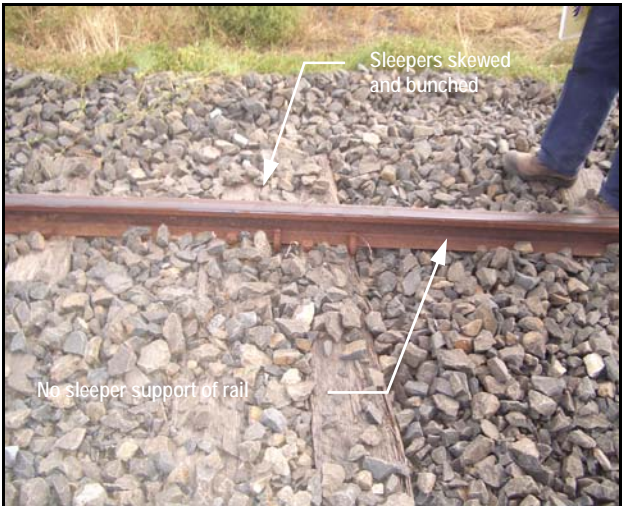
Photo 11: Track condition in front of 5424.
