RAIL SAFETY INVESTIGATION REPORT

SHUNTING FATALITY PORT BOTANY RAIL YARD 1 JULY 2004

1 JULY 2004

OTSI File Ref: 02325

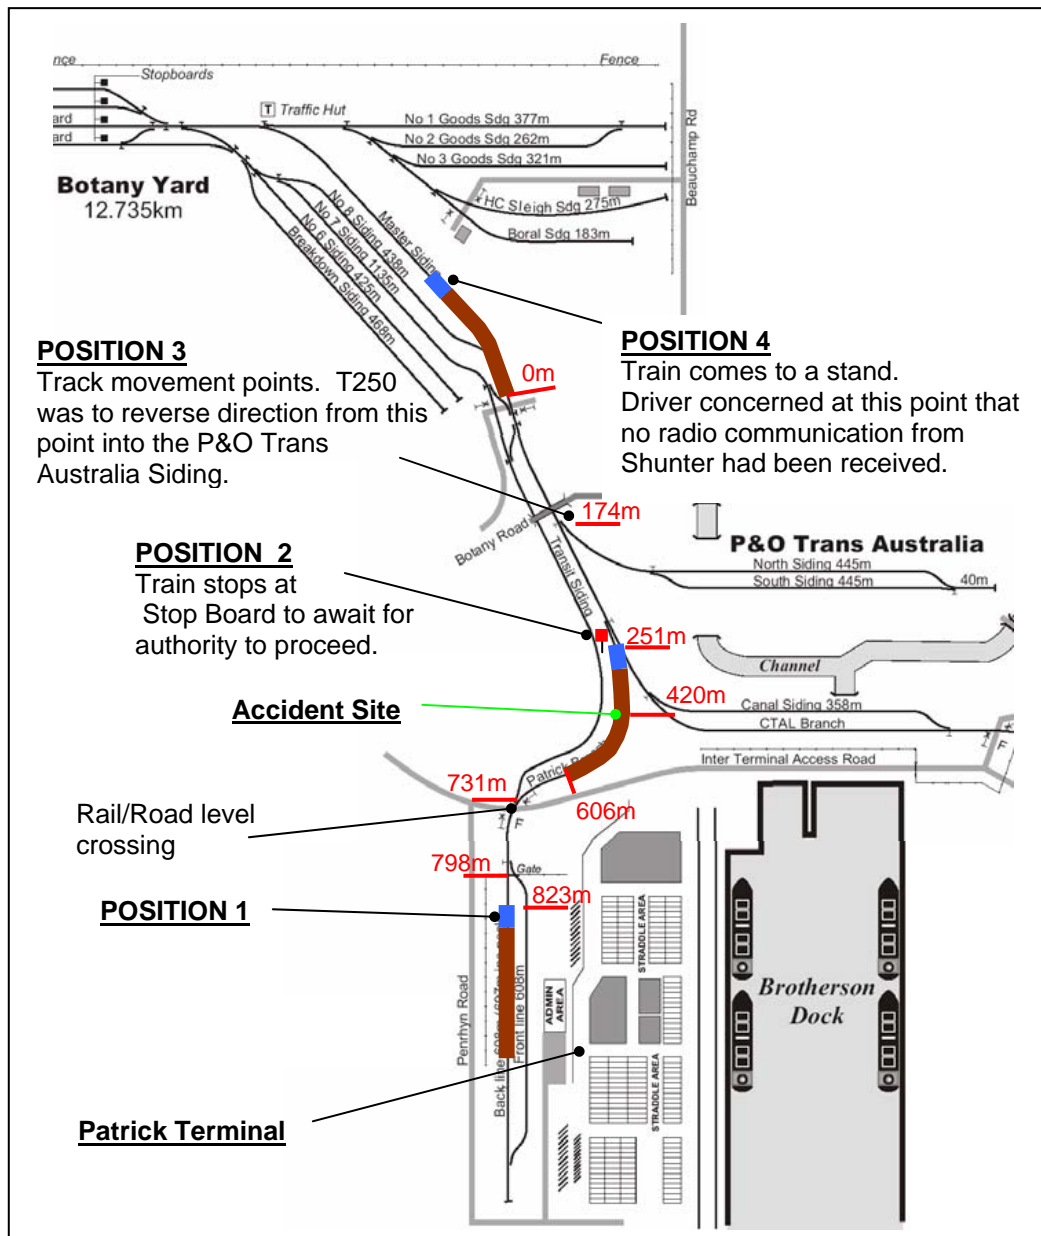
Figure 1 – Port Botany Rail Yard layout and progressive movements of LVRF T250

- 2.6 Not having received a response, the Driver stopped the train (See Figure 1, Position 4) and attempted to establish radio and then mobile phone contact with the Shunter. These calls were not returned. The Driver then asked the RIC Yard Controller to attempt a radio check with him to ensure that his (the Driver's) radio was functioning correctly.

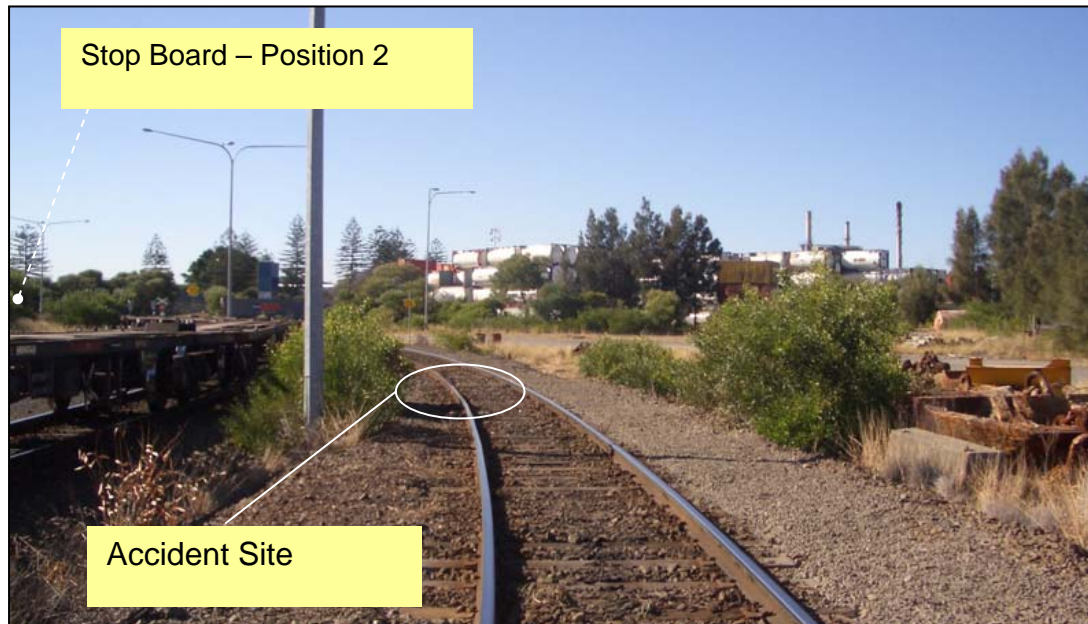
Figure 2 – Accident site at approx. 16.250 km facing the Up direction towards Stop Board.

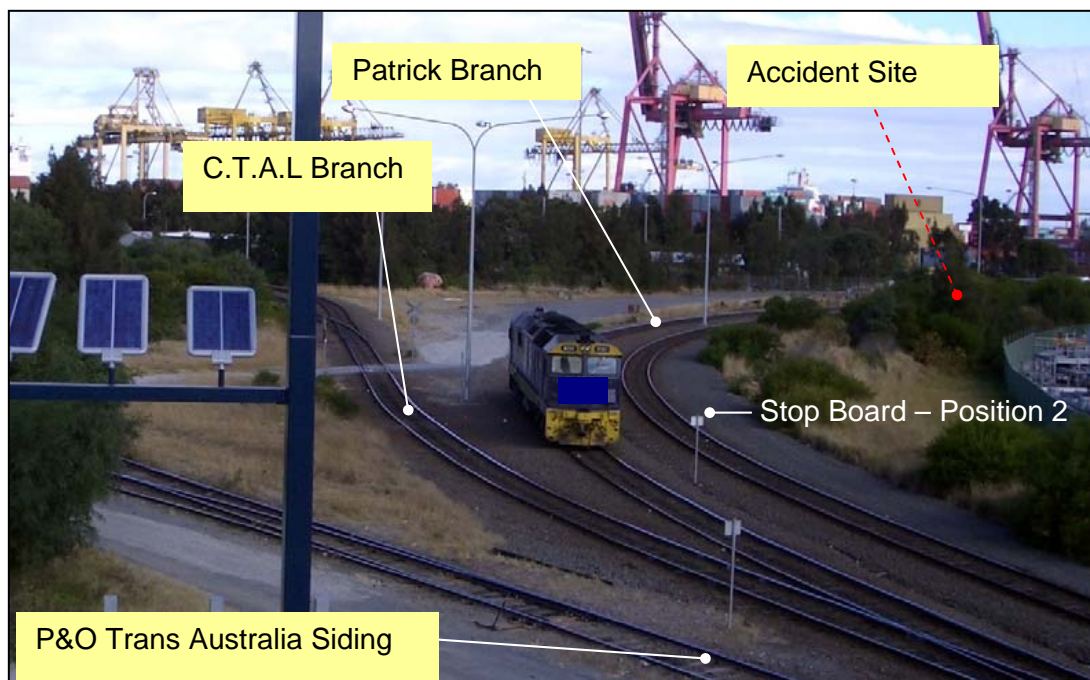
Figure 3 – Stop Board and accident site facing the Down direction towards Stop Board.

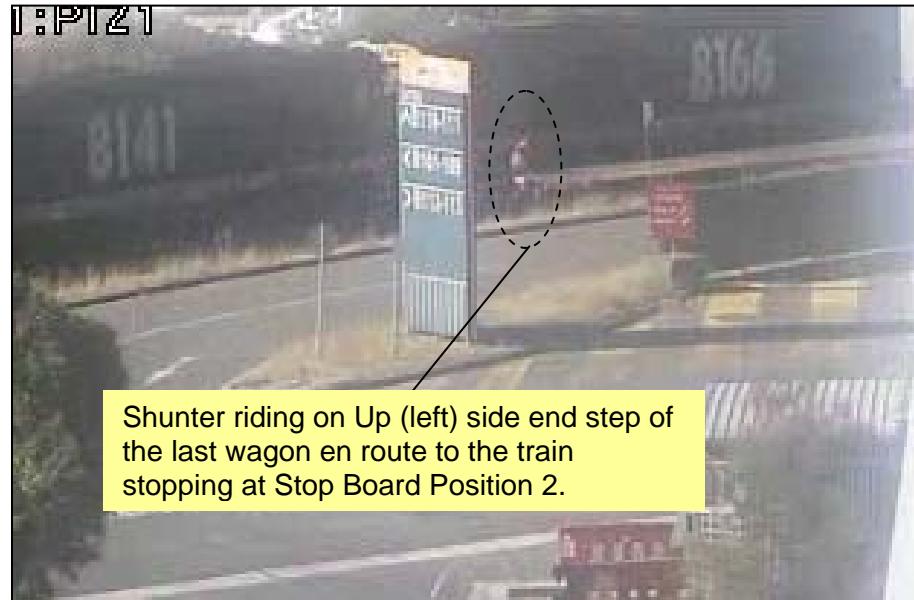
- 2.16 Patrick provided CCTV footage of the Shunter riding on the last wagon as the train departed from the Patrick rail terminal and level crossing. A sample of this footage can be viewed in Figure 4.

Figure 4 - Port Botany CCTV taken from Patrick Container Terminal Building at 1341 on 1 July 2004.

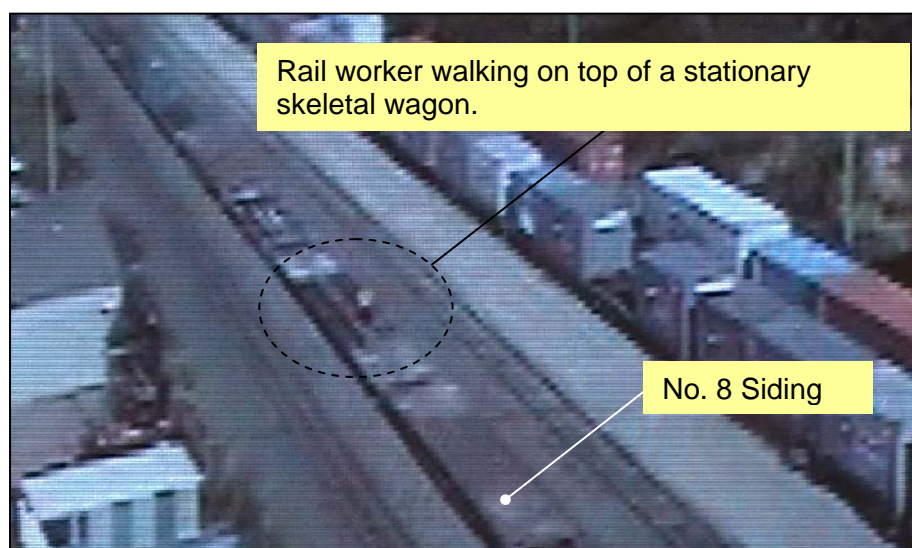
- 2.17 CCTV footage taken from the Port Botany Rail Yard was reviewed for one week prior to the accident and one week following the accident. This review identified one instance where a rail worker walked on top of an unloaded container flat wagon whilst it was stationary. A sample of this footage has been captured as a still photograph and can be viewed in Figure 5.

Figure 5 – Port Botany CCTV – Rail worker walking along stationary skeletal wagon.

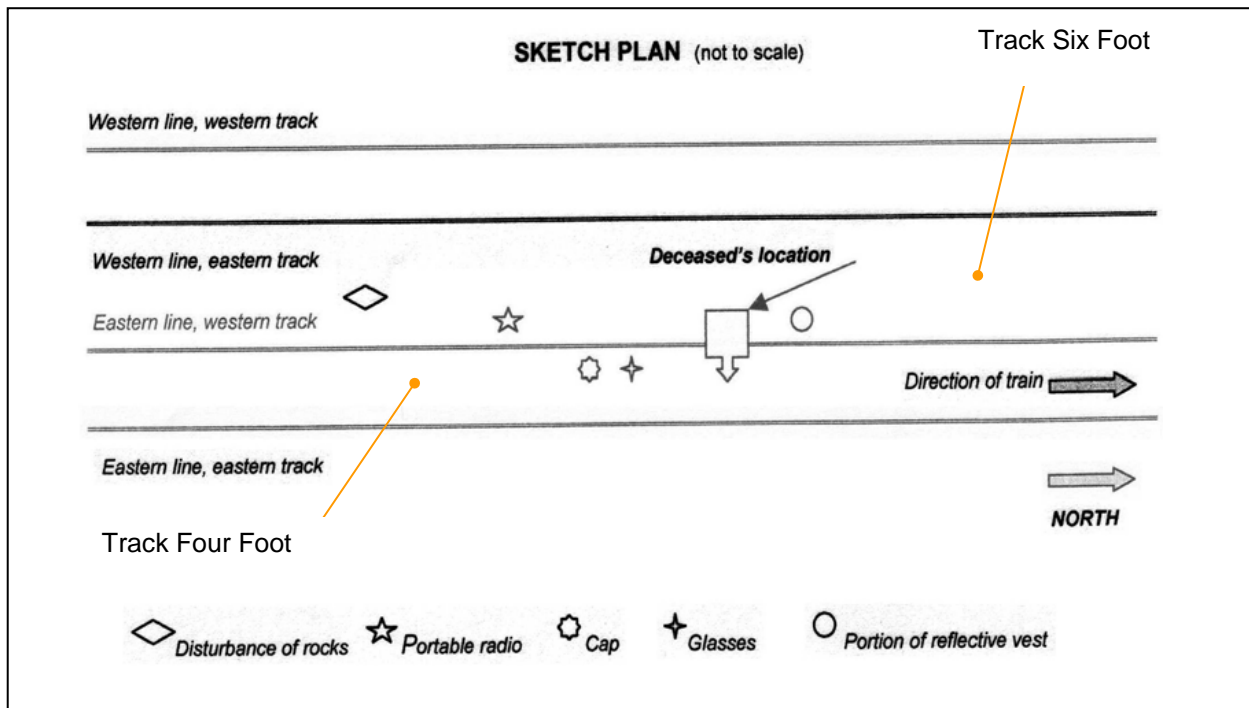
- 3.2 Glasses and a Baseball Cap belonging to the Shunter were found in the "four foot" approximately 2.1m and 2.8m respectively to the south of the Shunter's body. The Shunter's radio was found approximately 4.4m to the south of the Shunter's body in line with the outside line of the sleepers. A notable disturbance in the ballast approximately 0.5m adjacent to the outside sleeper line was identified approximately 5.6m to the south of the Shunter's body (refer to Figure 6 and Figure 7 depicting the orientation and location of site evidence).

Figure 6 - Sketch of accident site evidence located in the track area

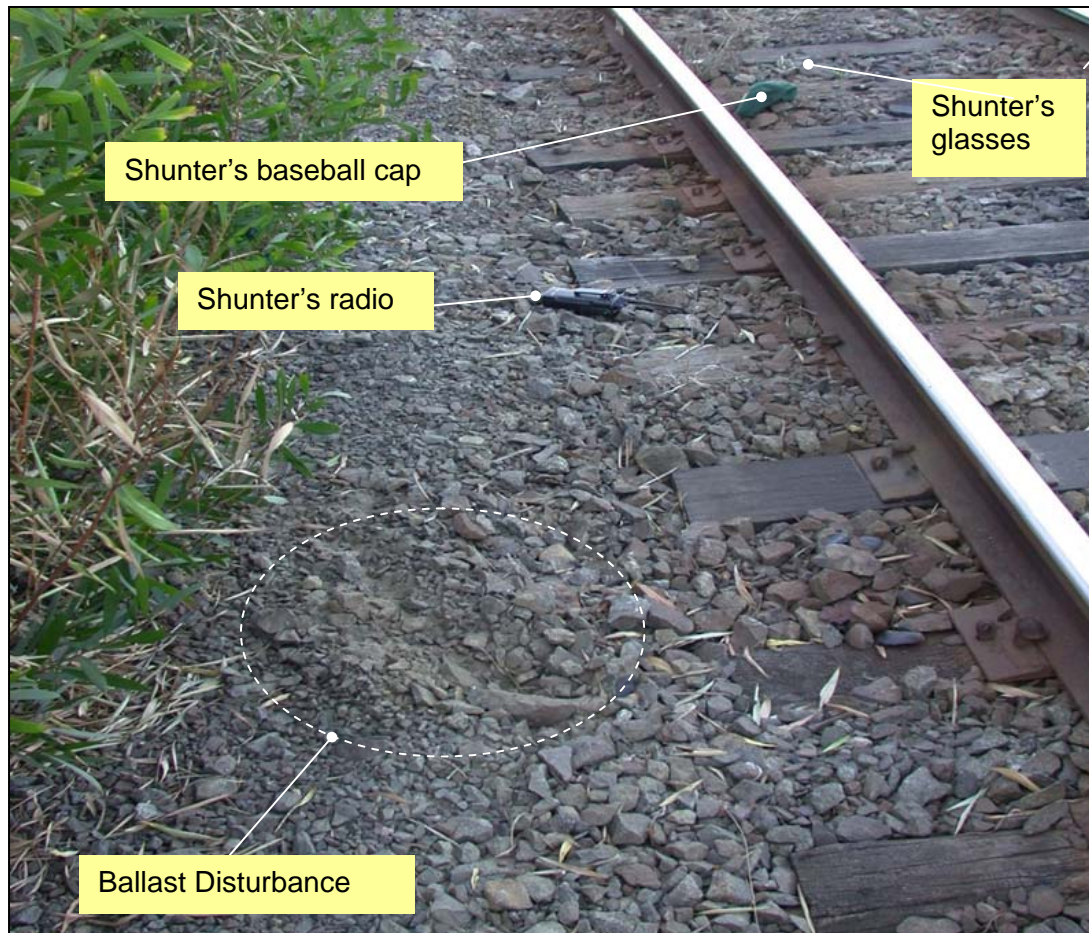
Figure 7 - Photograph of Ballast Disturbance, Shunter's Radio and Shunter's Glasses

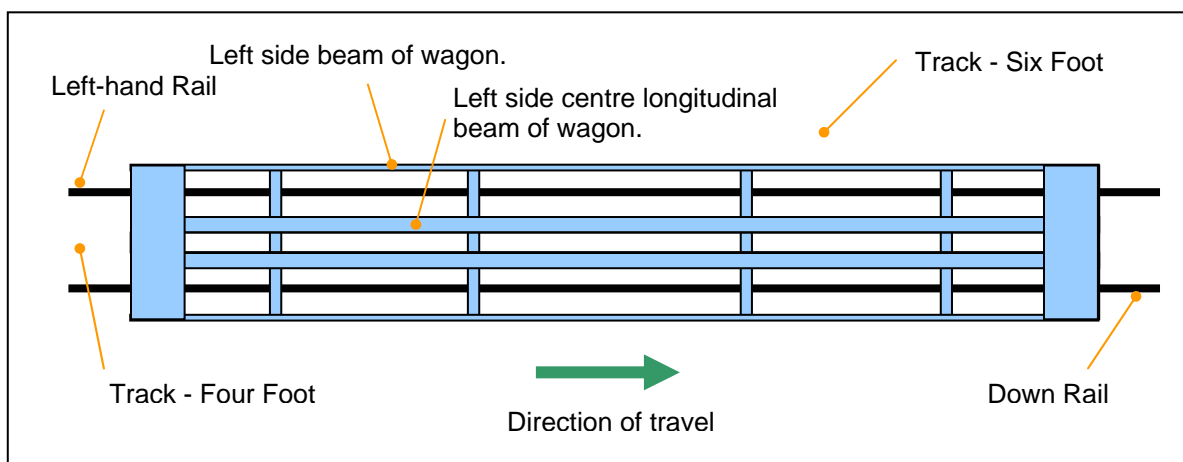
- 3.7 Based on the above information and forensic reports, OTSI's view is that the most probable sequence of events leading to the fatality included the following.
- a. The Shunter lost his footing, through either a jolting movement, a slip or as a consequence of a momentary loss of concentration, whilst standing on top of an un-walled and only partially decked wagon during shunting.
 - b. On falling, the Shunter pivoted, in an anti-clockwise direction as his legs dropped down into the gap between the left side centre longitudinal beam and the wagon's left side beam (the gap between these two beams measured 81cm – see Figure 8).
 - c. Having fallen approximately 1.2m to the ballast, the Shunter has then fallen backwards with the middle of his back resting across the left-hand rail. In this position the Shunter has then been run over by the approaching trailing wheels.

Figure 8 - Representation of wagon decking relative to rail (approximate scale 1:13)

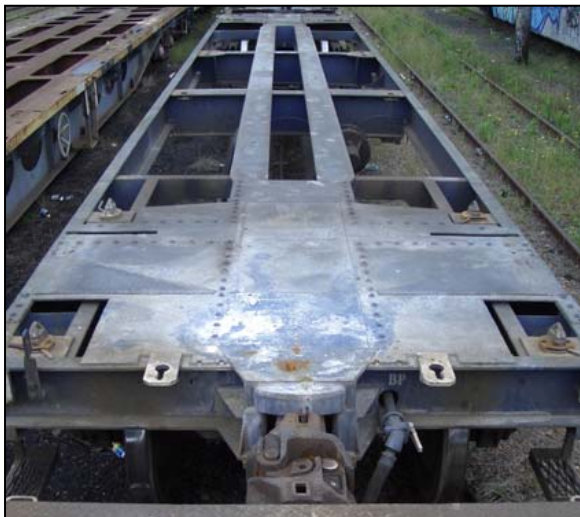
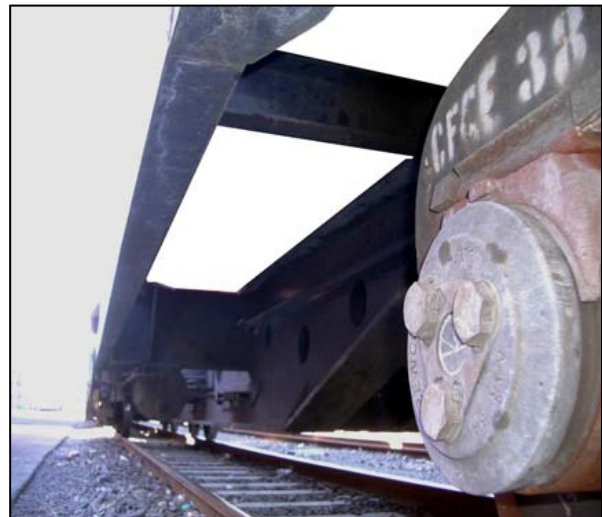
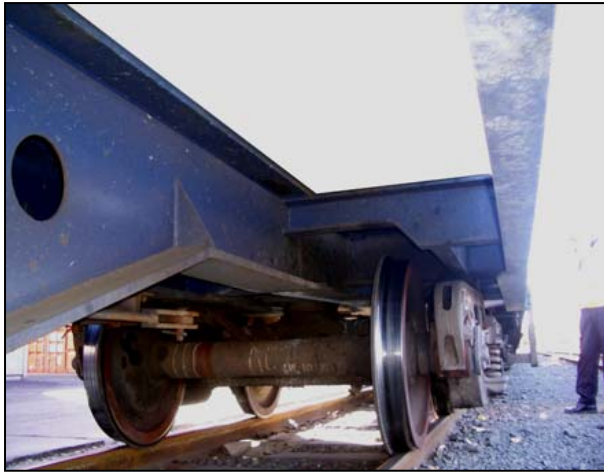
- 3.14 The wagons being hauled within T250 varied in type. The 2nd last wagon consisted of a skeletal load-bearing frame with two wagon bogies supporting this frame, as depicted in Figures 9, 10 & 11. The limited decking surface on this wagon was noted to be of a smooth painted finish. In contrast, the last wagon on T250 was fully decked with a non-slip chequered plate surface, as depicted in Figure 12. Wagons of this type typically have a ground clearance of 80cm.

- 3.15 No physical or administrative (warning signs) barriers, that might have reduced the likelihood of a person falling through the wagon's decking, were found on the wagons. OTSI also noted the centre longitudinal beams of wagon CQDY 054S, which had clearly been used as a walkway (see Figure 13), did not meet the Australian Standard design for a walkway (AS 1657:1992). This standard requires the width of a walkway to be no less than 55cm and for any metal surface to be chequered, indented, or other suitable slip-resistant type. The centre longitudinal beams of wagon CQDY 054S were spaced approximately 35.5cm apart and were each approximately 27.5cm in width. The surface of these beams was of a smooth painted finish (see Figure 13). Multiple boot imprints were identified on the deck of the last and second last wagons of T250. Some of these imprints were consistent with the size and type of boot worn by the Shunter. Police Investigators noted that the platform appeared (by the number and types of impressions) to be commonly used as a walkway.

Figure 9 - CQDY 054S skeletal wagon

Figure 10 - Underside view of CQDY 054S facing direction of travel

Figure 11 - CQDY 054S Underside view facing opposing direction of travel

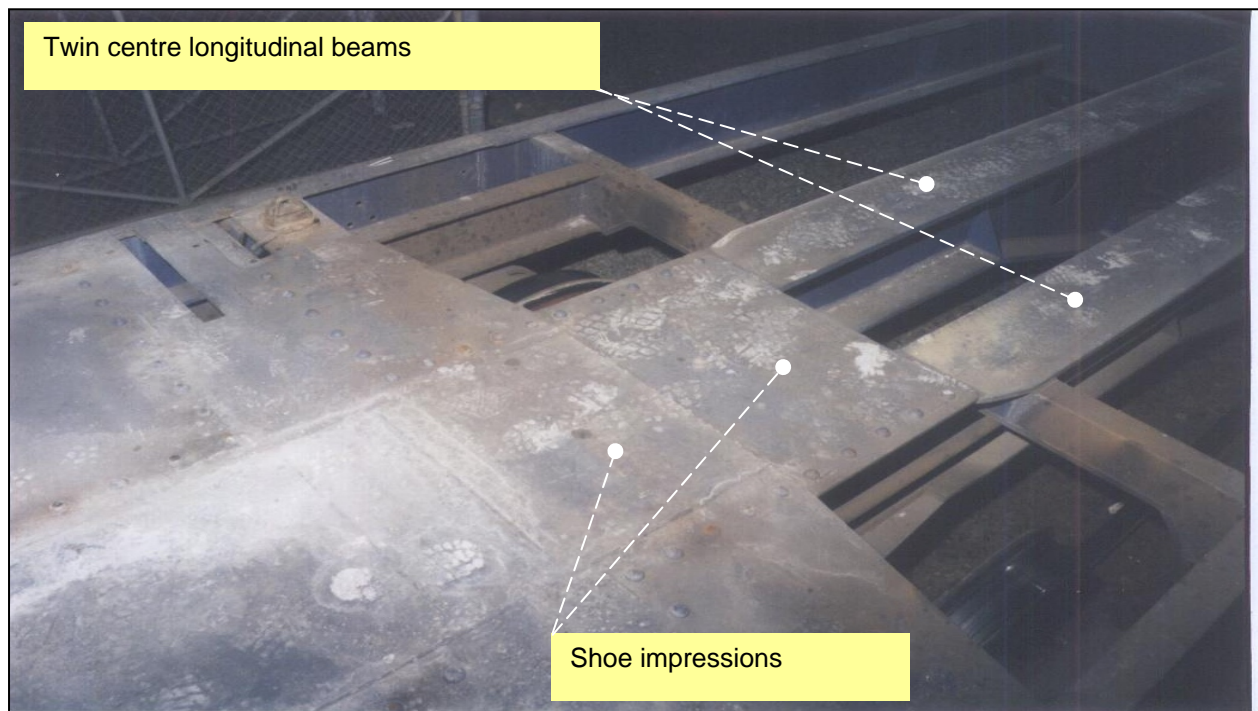
Figure 13 - Multiple shoe impressions identified on Wagon CQDY 054S

15. Having assessed the likely motivators for riding and walking on the wagon decking, OTSI reviewed the site evidence in conjunction with this scenario. OTSI noted that footprints were located on top of the 2nd last wagon decking and that some of these were similar to those of the Shunter's (see Figure 13). Whilst these footprints were not positively identified to have been imprinted by the Shunter's boots, the presence of the footprints indicated that the wagon decking had been used as a walkway. The position of the Shunter's radio, cap and glasses; disturbance to the ballast in the immediate area; and the orientation of, injuries to, and markings on the Shunter's body (see Annex B) are consistent with a fall from the wagon's decking. Blood found on the trailing wheels of the 2nd last wagon matched that of the Shunter's and is consistent with a fall through the wagon's decking.

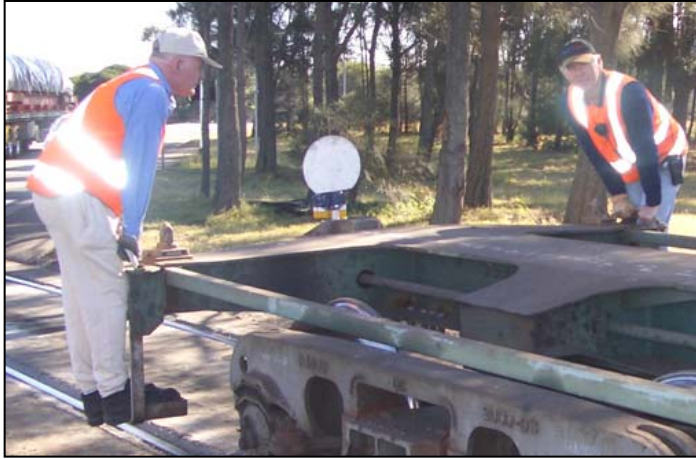
- 3.16 The investigation also noted a large variation in the ergonomic design of wagon side and end steps. The variations require shunters to adopt differing riding postures as illustrated in Figures 14 and 15. These positions offer varying degrees of practical functionality and safety. OTSI noted that some of the designs might also encourage shunters to adopt the less difficult option of riding on top of a wagon. OTSI further noted that shunters equipped with hand held radios would need to release one hand from a holding point to successfully operate the radio, thereby adding an additional risk factor.

Figure 14. CQBY type wagon with shunters riding on side steps¹⁰

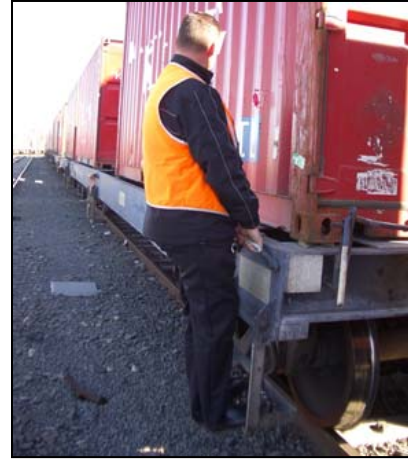
Figure 15. Rail worker simulating the Shunter's riding position on wagon CQDY 054S.

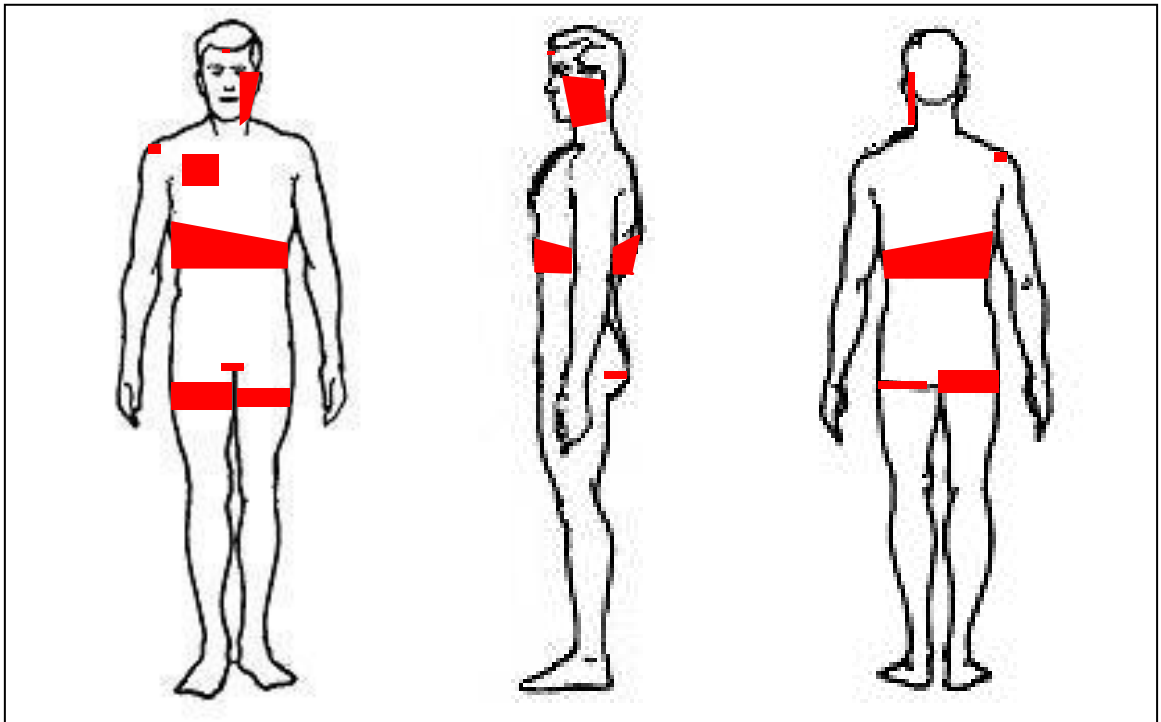
1. The Department of Forensic Medicine Pathologist Autopsy report (Autopsy Report) described the Shunter as receiving extensive crushing injuries, consistent with being run over by the wheels of a train or similar mechanism. The most extensive injury was referenced by a band-like area of abrasion, circumferentially extending around the entire trunk, measuring approximately 70 mm in width and passing in a horizontal plane 60 mm above the umbilicus. On the right laterally this wound expanded to measure 160 mm in width. No significant pre-existing disease was identified. Toxicology was negative¹⁸:
2. The Shunter also received a "faint patterned area of bruising measuring 150 x 100 mm" across his "left ear, the left cheek and the left side of the neck."
3. Figure 16 below indicates those areas of the Shunter's body that sustained injuries as noted in the Autopsy report.¹⁹

Figure 16 - Representative size and location of injuries sustained to the Shunter
