Rail Safety Investigation Report

ROCKY PONDS

7 November 2002

Pacific National train 4YN2 derailed due to misalignment.

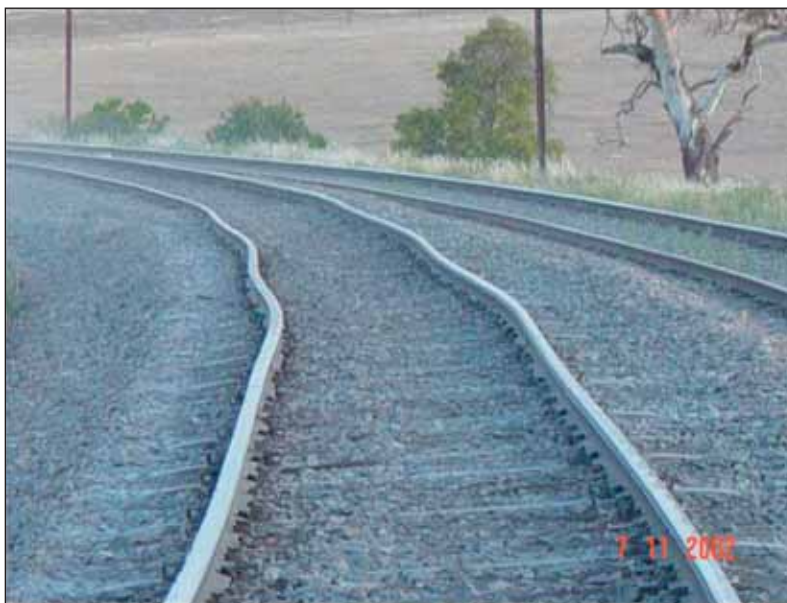
4YN2 derailed the trailing bogie of its last vehicle on the Up Main South in the afternoon of 7 November 2002. Shortly after the derailment the train crew detected dust emanating from the train's rear. The Driver then made an emergency brake application bringing the train to a stand some 2 kilometres after the initial derailment. An inspection of the track revealed a misalignment at the derailment location as depicted in Figure 4.1.

Figure 4.1 Misaligned track at 377.960km

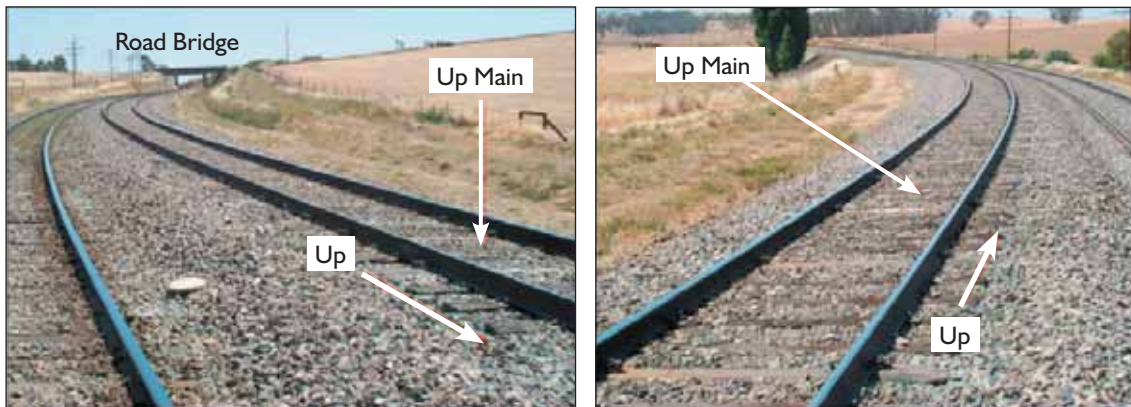
Figure 4.2 Up Main at misalignment location facing down direction (left) ,Up Main at misalignment location facing Up direction (right) following track restoration

Track repairs were subsequently carried out on the misalignment at 377.960km with the track being certified fit for traffic at 21:05 by the local track maintainer. A 20km/h speed restriction was also applied over the misalignment curve at this point.

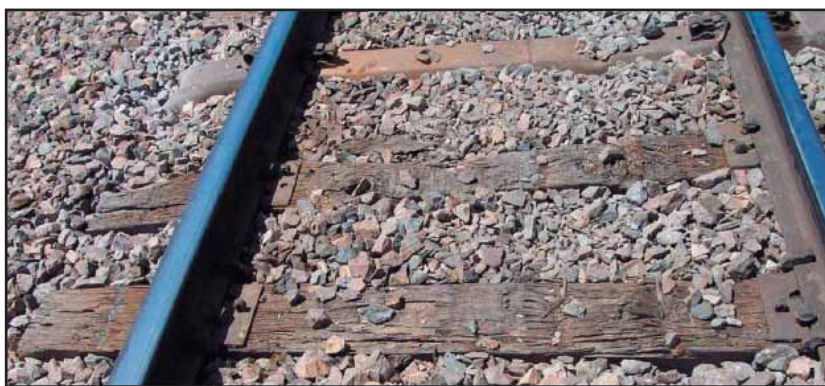
Minor track damage was sustained due to the derailment. This damage included minor sleeper damage, broken shoulders on steel sleepers. Refer to Figure 4.4 depicting typical sleeper damage sustained during the derailment.

Figure 4.4 Sleeper damage sustained during derailment

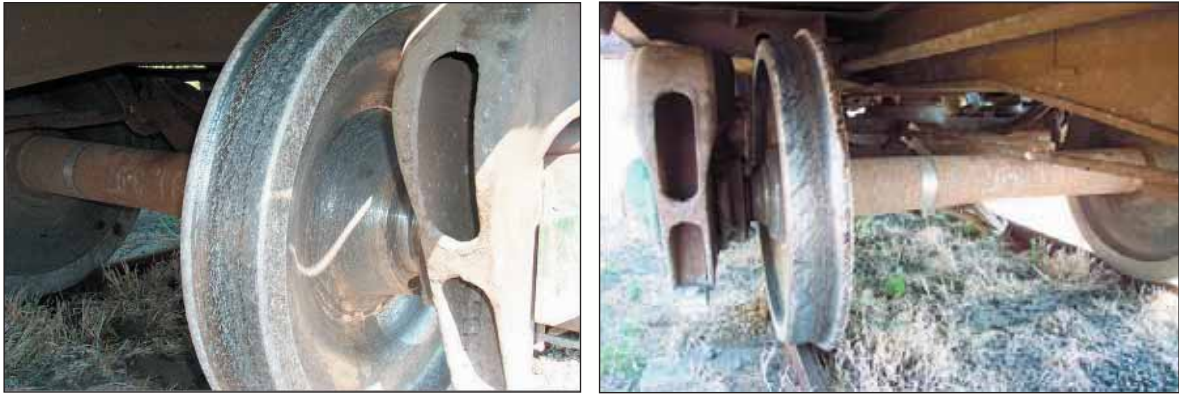
The number 2 bogie of RQBY 15028F sustained gouging damage from being dragged in the ballast for approximately 2km. This bogie was replaced prior to the movement of RQBY 15028F from Harden North. No other substantial damage was identified on the derailed RQBY 15028F vehicle. Refer to Figure 4.5 depicting the ballast damage to the trailing bogie of RQBY 15028F.

Figure 4.5 Bogie and Wheel Ballast Gouging Damage Sustained on the No.2 Bogie of RQBY 15028F

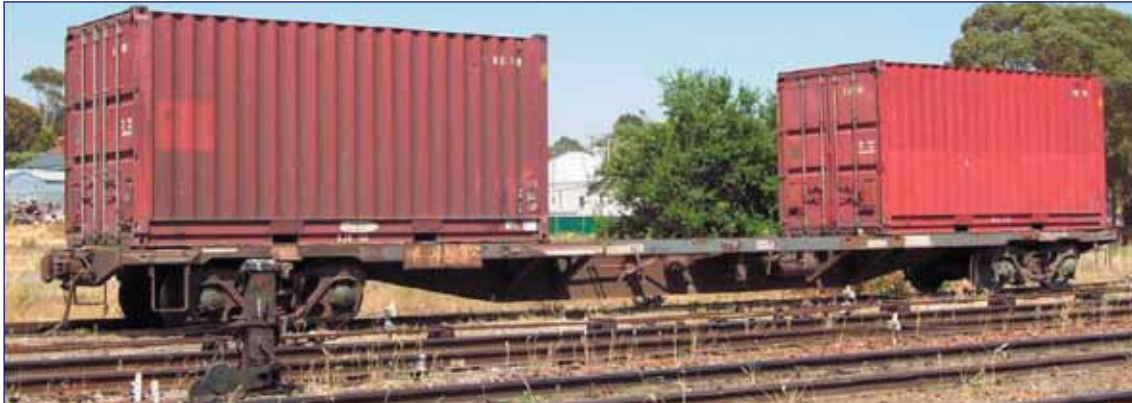
Figure 4.6 Vehicle RQBY 15028F

RQBY 15028F pending a bogie change. Refer to Figure 4.6 depicting vehicle RQBY 15028F and the empty container configuration loaded on this vehicle on 7 November 2002.

An inspection of the derailed train by infrastructure maintainer representatives identified a number of suspected mechanical conditions that could have potentially contributed to the occurrence of a misalignment. An inspection to either verify or reject these items was not provided by any of the Pacific National rolling stock representatives that attended the derailment site. The mechanical conditions identified by the infrastructure maintainer representatives included:

- Loose axle liner bolts (bolts in this condition pose the potential to jam the axle box within the pedestal liner)
- Uneven wheel wear (this condition was not defined to any greater extent)
- Bogie springs identified to be almost fully compressed (a measurement between the spring coils not taken)

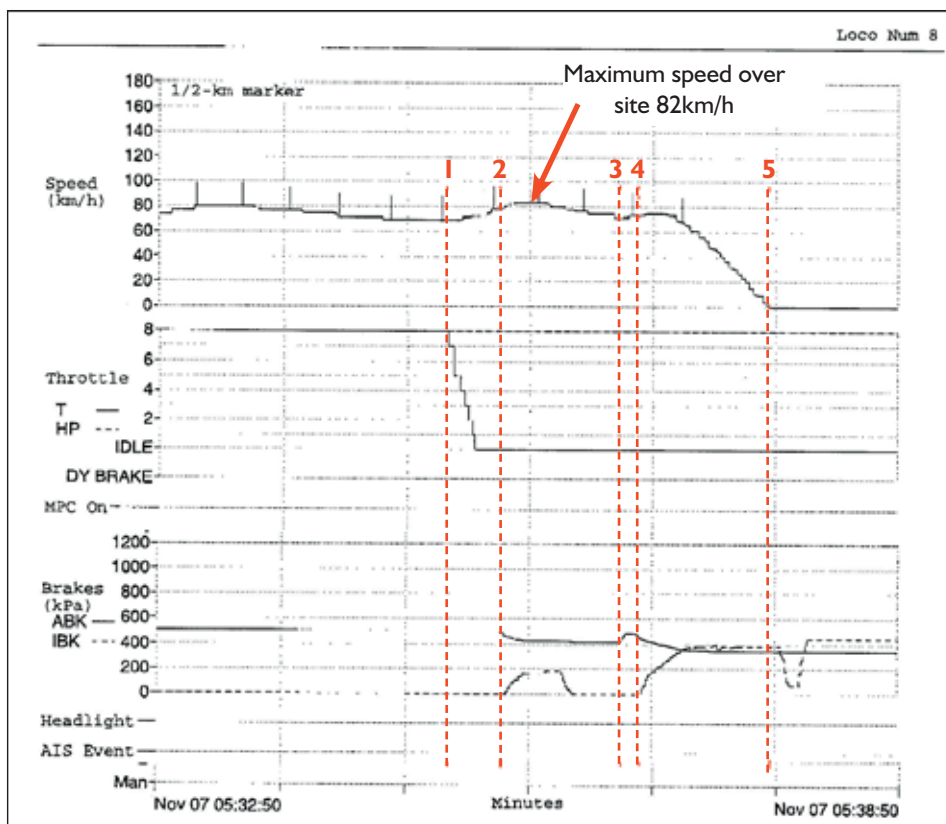
Figure 4.7 4YN2 Data Logger Print Out 7 November at 16:35

Figure 4.7 confirms that the rear of 4YN2 was travelling at approximately 82km/h at the time of derailment. The calculation of this speed is based on the facts that;

As noted in Section 4.6.3, the automatic brake application initiated at 377.75km was 80kPa and the application was held for 59 seconds. Compliance with the train handling management standard described above is therefore identified.

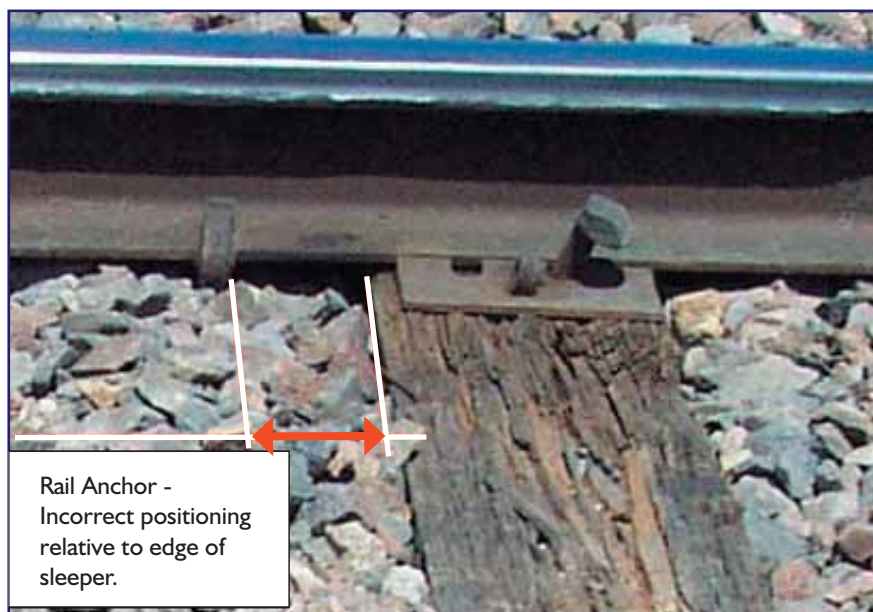
The anchor condition as assessed in the pre misalignment WTSA report was noted as “good”, resulting in a 2% loss of stability as calculated in C2443 Table 5. A review of the anchor condition post derailment, and following track restoration did however identify some anchors spaced away from the sleeper edge. Refer to Figure 4.8 depicting a rail anchor spaced away from the sleeper edge. A small number of those anchor placements depicted in Figure 4.8 would still result in a WTSA assessment of “good” depending on the overall anchor condition of the 500m section.

Figure 4.8
Incorrectly positioned anchor located within misalignment site.

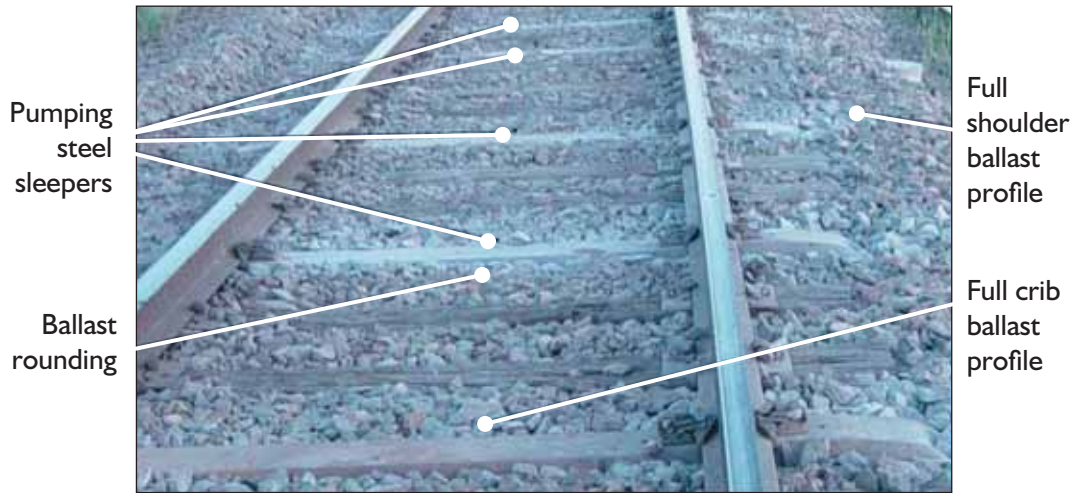
Figure 4.9 Typical Shoulder and Crib Ballast Profile throughout Misalignment Site.

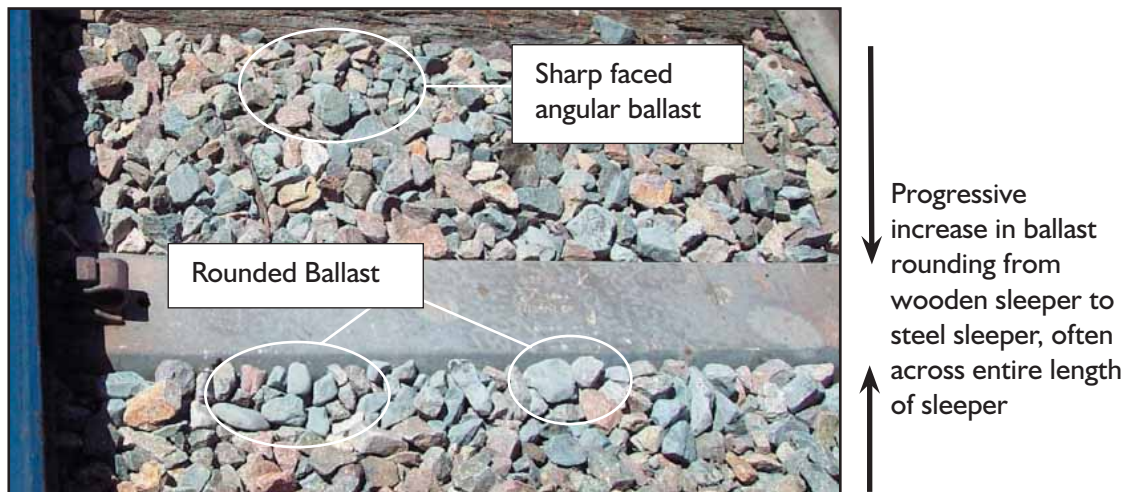
A number of pumping⁹ steel sleepers were identified throughout the misalignment site. The ballast condition near these pumping steel sleepers varied, in terms of the individual ballast angularity¹⁰. Refer to Figure 4.10 depicting ballast condition evident in the vicinity of pumping steel sleepers within the misalignment curve. Note the loss of ballast angularity close to the pumping steel sleeper located on the misalignment curve.

Figure 4.10 Rounded Ballast Evident Close to Pumping Steel Sleepers at Misalignment Site.

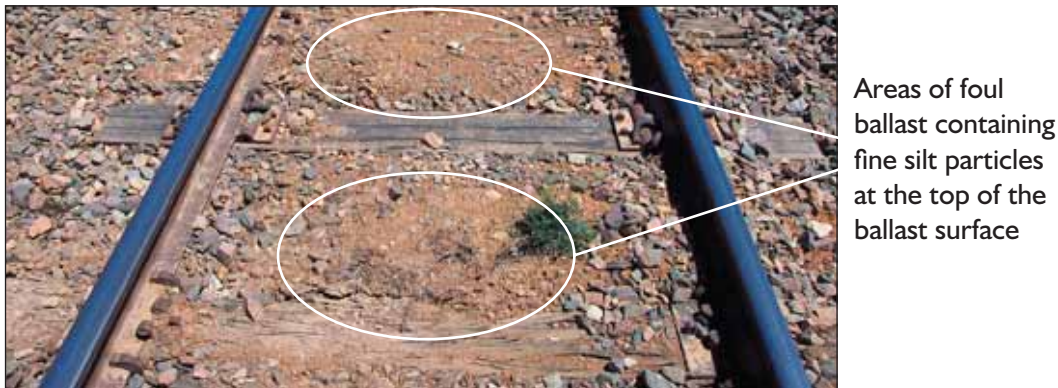
A short length of track (20m) exhibited a high degree of foul ballast within the WTSA 500m length at approximately 378.300km (refer to Figure 4.11) and as such was registered within the WTSA calculation for the 500m section. This length of track is located some 350m from the misalignment site, being located on the down side of Linden Road bridge (Refer to Figure 4.3). The foul ballast at this point was not considered to have had any influence on the misalignment curve. Foul ballast however was detected in the immediate vicinity of 377.960km at an inspection carried out in August 2003 as depicted in Figure 4.18.

Figure 4.11 – Foul ballast identified within the 500m WTSA section at 378.300km.

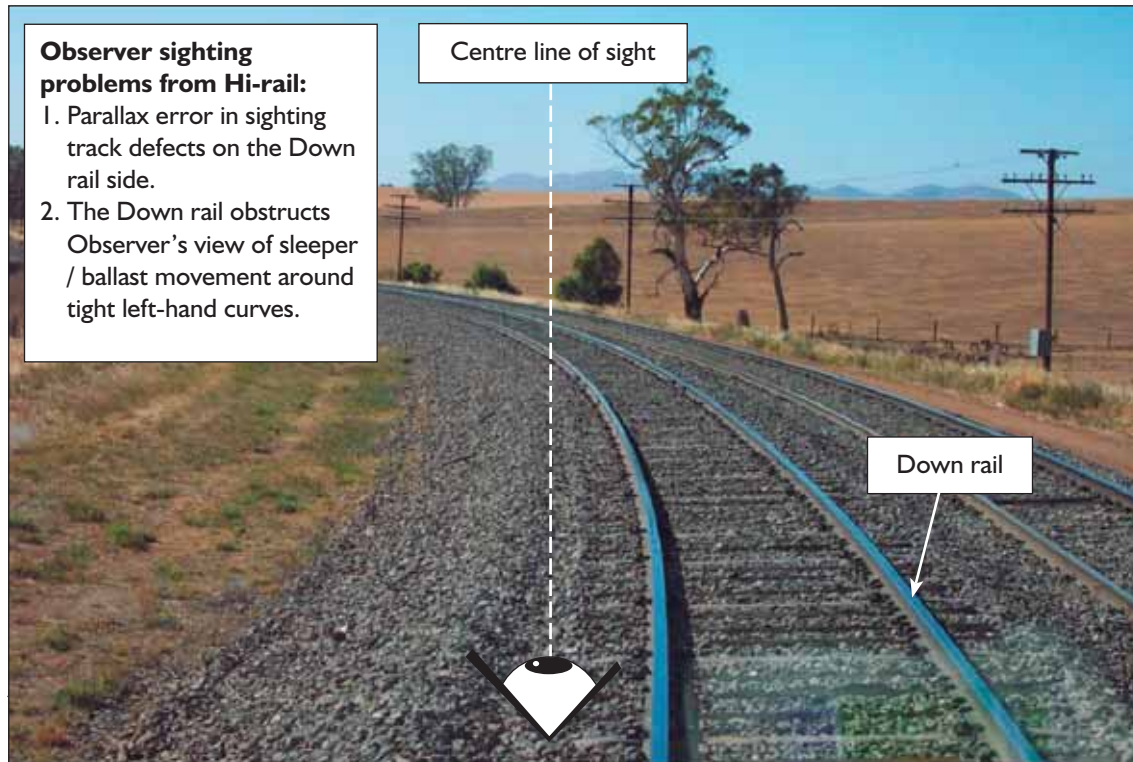
The accuracy of detecting track defects around tight radius left-hand curves would reduce for an Observer due to the parallax sighting errors and rail head obstructions that are apparent when conducting the inspection from the Observer's position. Refer to Figure 4.12 depicting the Observer's view from a hi-rail.

Figure 4.12 View from Observer's seat in Hi-rail at 377.960km
