# Rail Safety Investigation Report

## UNANDERRA

20 June 2003

**Signal Passed at Danger resulting in derailment  
of Pacific National Service B9162.**

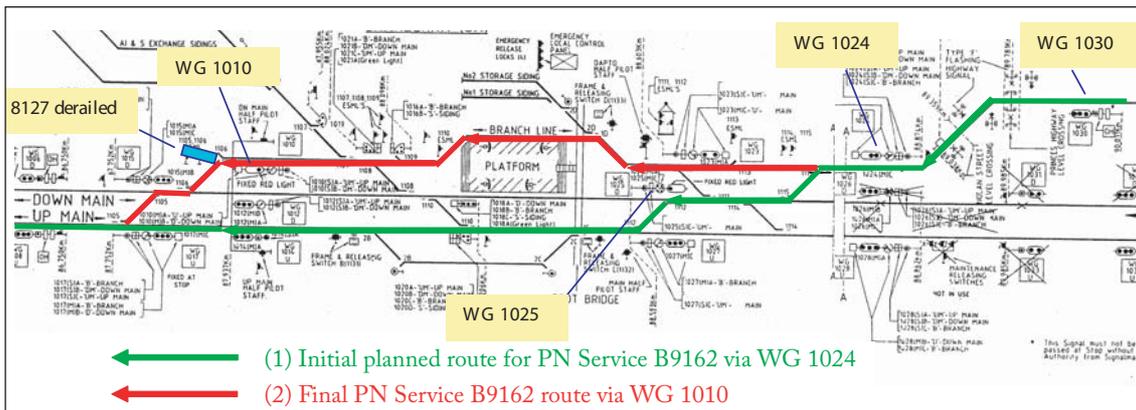
Figure 4.2 Change in Route Selection for B9162 through Unanderra Platform

The change in set up of these operational movements occurred approximately 4 minutes prior to the incident by the signaller controlling the South and Coast panels (Signaller 1)<sup>4</sup>. In resetting the crossover movement of B9162, Signal WG 1024 was initially set to Stop and then cleared. This signal manipulation resulted in Signal WG 1024 displaying a Caution indication. Signal WG 1010 was subsequently left at Stop and Signal WG 1030 would have then automatically displayed a Clear indication as Signal WG 1024 displayed the Caution indication. The event of Signal WG 1030 changing from a Caution indication to a Clear indication was witnessed by the train crew of B9162 as previously described.

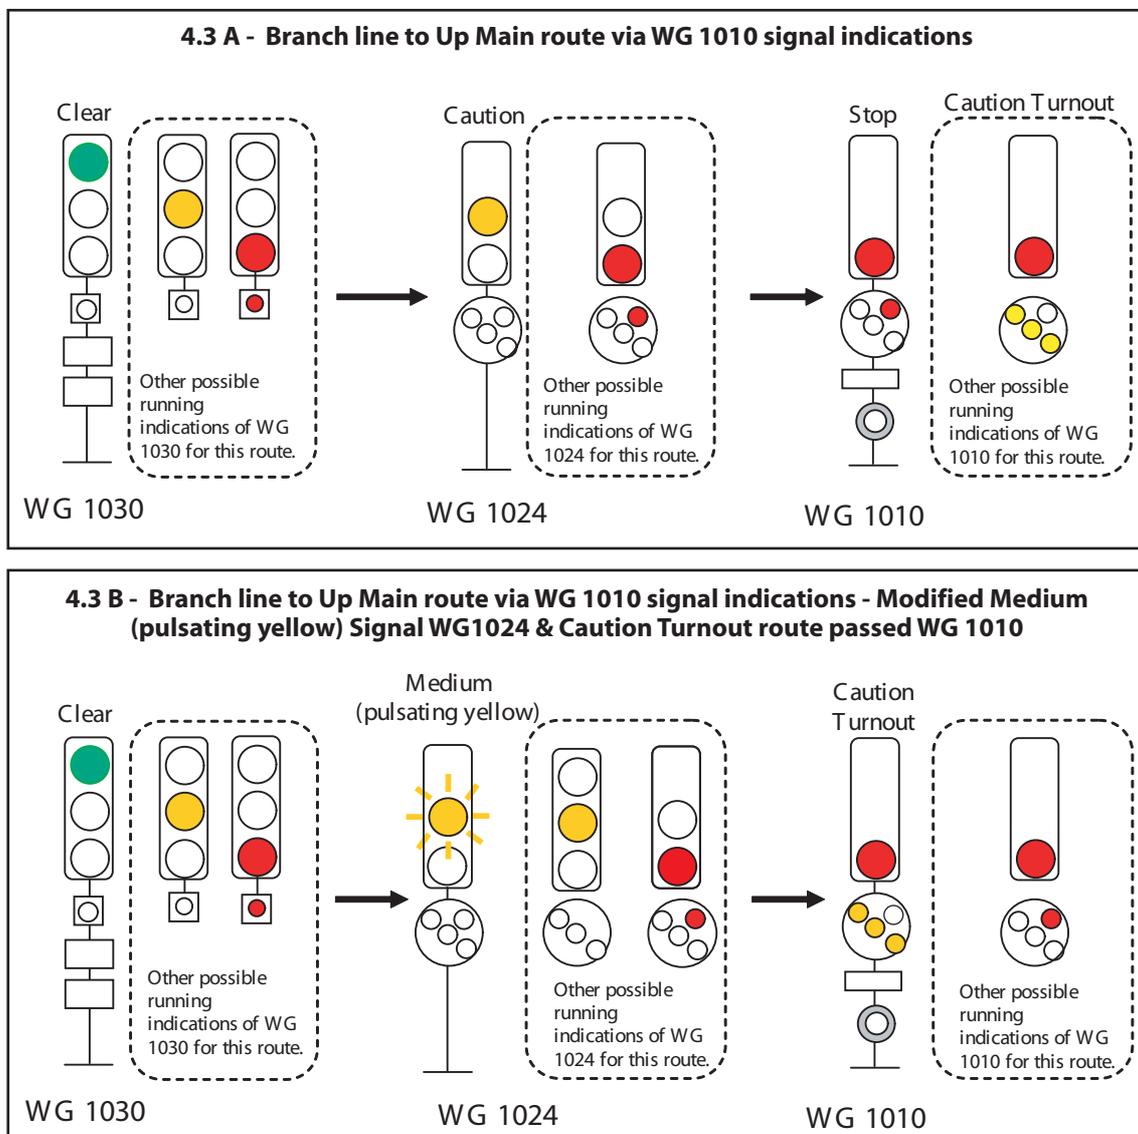
Figure 4.3 – Unanderra Branch Line Signals – Route Indications on 28 June 03 and other possible route indications leading to Signal WG 1010.

The main route signals leading up to and including Signal WG1010 are of the single head 3 light type. The signal indications that would have been displayed to the train crew of B9162 prior to the derailment are shown in Figure 4.3 A. In addition to these indications, Figure 4.3 A also depicts the remaining possible running indications of these signals.

Since the introduction of single head signals in the early 80's there have been further improvements in signalling indication control technology for these types of signals. The improvements have allowed the yellow signal to pulsate thereby representing a Medium indication as defined by the RIC Network Rules at NSG 606 (refer to Appendix 8.12). This Medium signal indication provides drivers with a definitive indication that the next main route signal will be set as a minimum at Caution. At least two signals controlled by the Wollongong Signal Complex have been modified to allow the yellow or yellow turnout signals to pulsate in this manner. If the current signalling design principles contained in RIC's standard SC 00 13 01 01 SP were applied to Signal WG 1024 as a new installation, the signal would be configured with a Medium aspect as shown in Figure 4.3B.

It is recommended that RailCorp conduct a human factors review of the potential risks associated with a driver's response to single head signal configurations that have a limited number of coloured light indications. Such a review is recommended to determine if the existing pulsating yellow Medium signal enhancement is considered an appropriate modification to address the human factor concerns of removing the predictive information associated with standard single head signals. The review is also recommended to assess the suitability of those locations on the NSW network in which the pulsating medium indication is currently implemented.

It is also recommended that RailCorp determine the suitability of Signal WG 1024's signalling configuration considering current medium signalling design principles and those other signals within the Unanderra junction configuration that have been modified to include a medium (pulsating yellow light) indication. Following from this review, RailCorp is recommended to correct the configuration of Signal WG 1024 where deemed necessary.

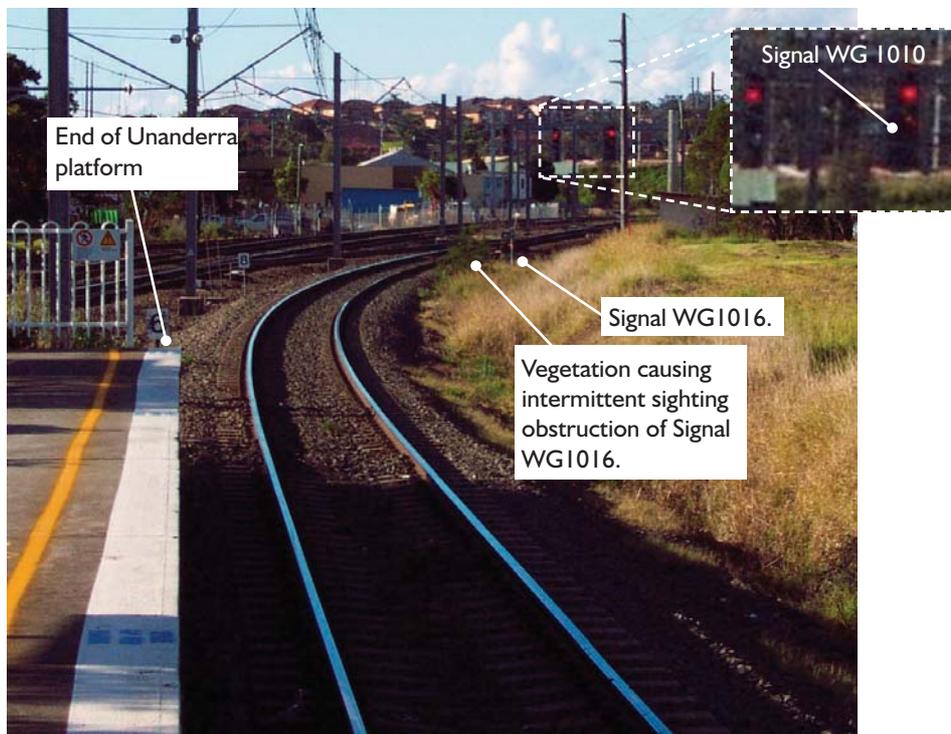
Figure 4.4 Signal Sighting of Signal WG 1010 at 88.244km.

There exists a number of intermittent signal sighting obstructions that obscure the aspect of Signal WG 1010 on approach of trains to this signal. At 88.244km there exists an unobstructed view of Signal WG 1010's red light indication as a train proceeds to the base of this signal. Overhead wiring structures do however intermittently obstruct one or more of the yellow turnout indicators of this signal. Any obstruction of this nature would place further emphasis on the Driver to closely monitor the turnout signal aspect. Refer to Figure 4.4 depicting the signal sighting view of Signal WG 1010.

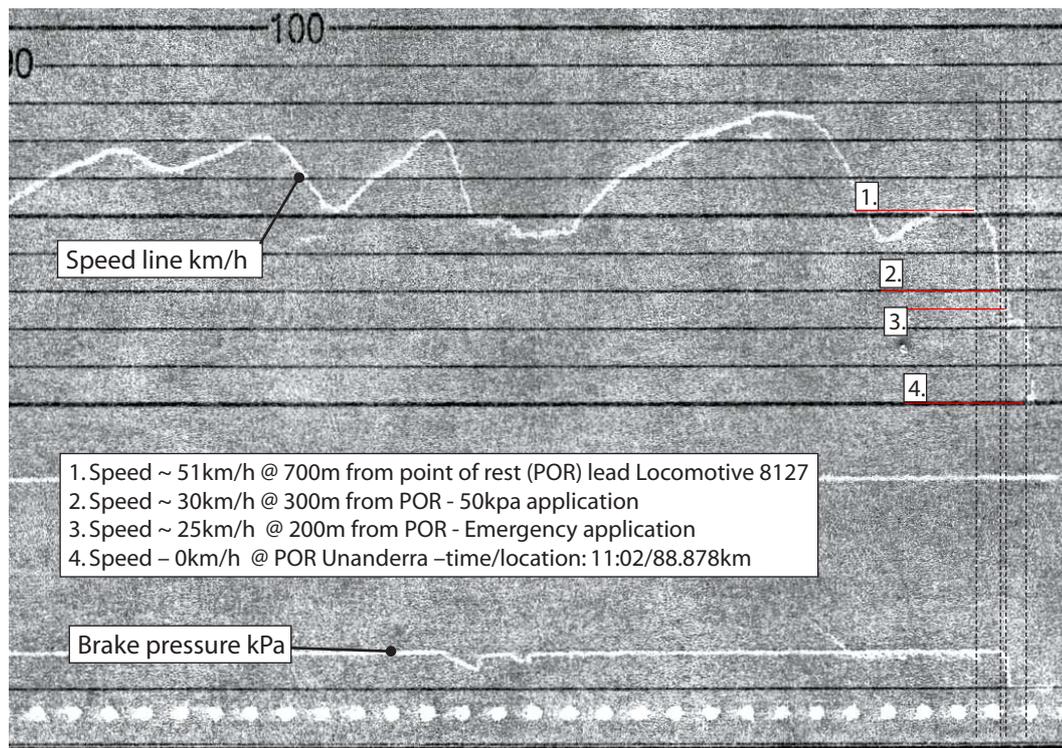
Figure 4.5 81 Class 8148 Hasler tape

The analysis information provided above has been transcribed onto the braking and speed diagram in Figure 4.1 and can also be referenced within Figure 4.5.

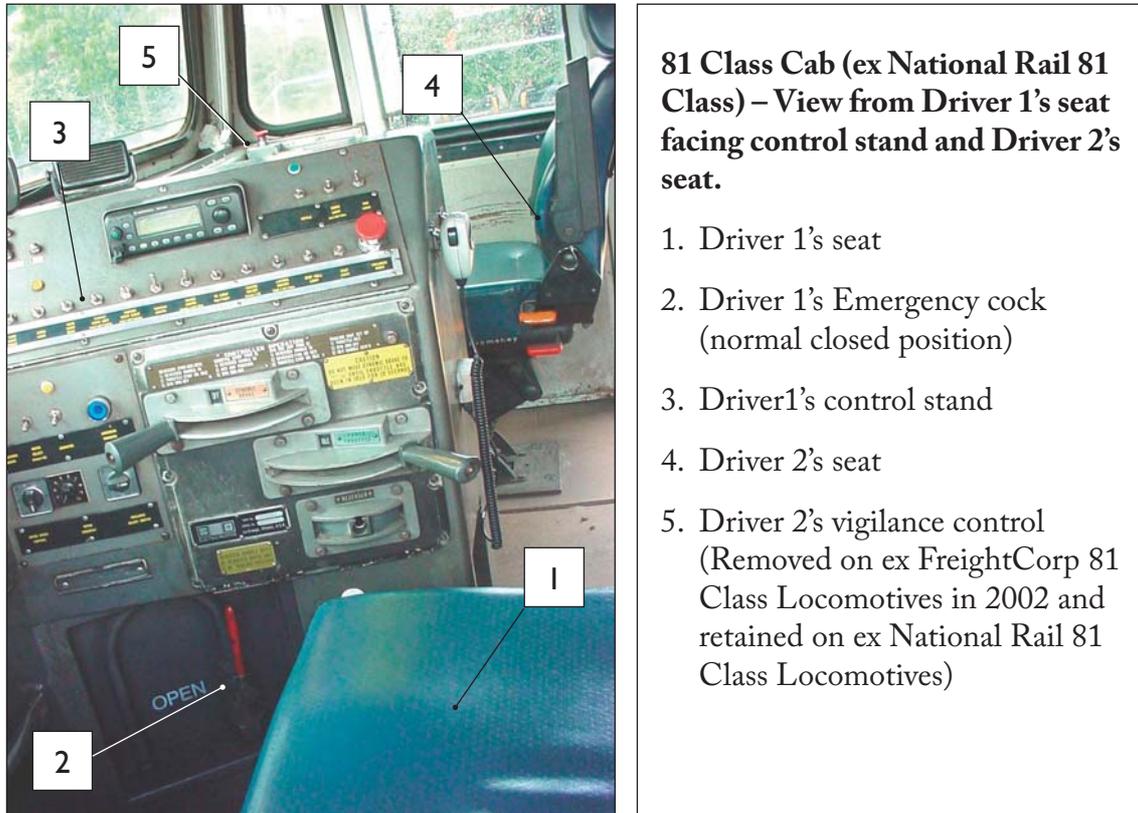
position is adjacent to the driver's right foot. Should Driver 2 be required to apply the emergency brake cock he/she would have to leave their seated position and reach down between the control stand and the Driver 1's right leg. Refer to Figures 4.6 and 4.7 depicting the views of the emergency brake cock from both the Driver 1 and Driver 2 seats.

**81 Class Cab (ex National Rail 81 Class) – View from Driver 1's seat facing control stand and Driver 2's seat.**

1. Driver 1's seat
2. Driver 1's Emergency cock (normal closed position)
3. Driver 1's control stand
4. Driver 2's seat
5. Driver 2's vigilance control (Removed on ex FreightCorp 81 Class Locomotives in 2002 and retained on ex National Rail 81 Class Locomotives)

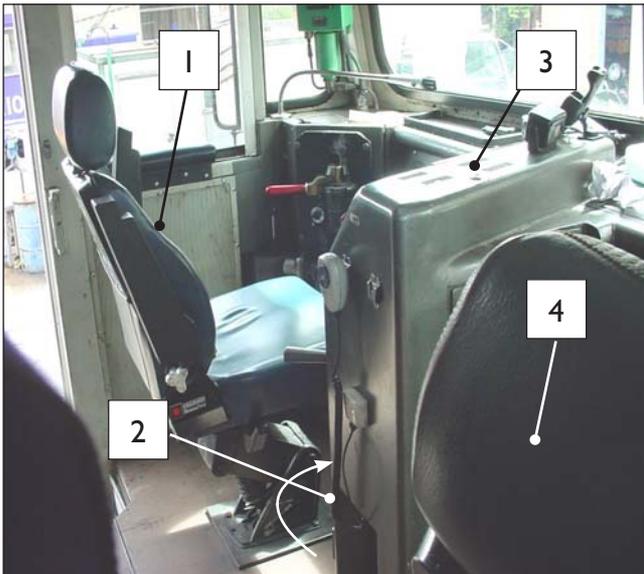
**81 Class Cab – View from Driver 2’s seat facing back of control stand and Driver 1’s seat.**

1. Driver 1’s seat
2. Driver 1’s Emergency cock (behind control stand)
3. Driver 1’s control stand
4. Driver 2’s seat

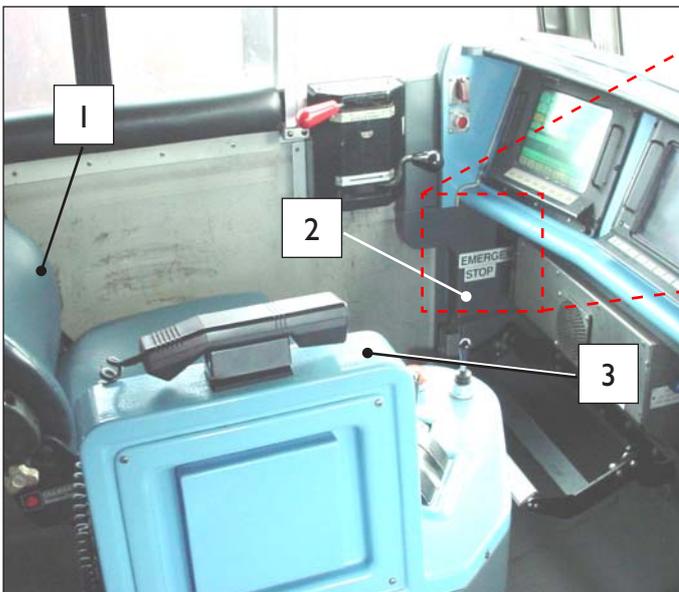
Figure 4.8 NR Class Cab – Driver 1’s Emergency Brake Cock - View from Driver 2’s seat facing control stand

**NR Class Cab – View from Driver 2’s seat facing Driver 1’s seat.**

1. Driver 1’s seat
2. Driver 1’s Emergency cock (closed position)
3. Driver 1’s control stand

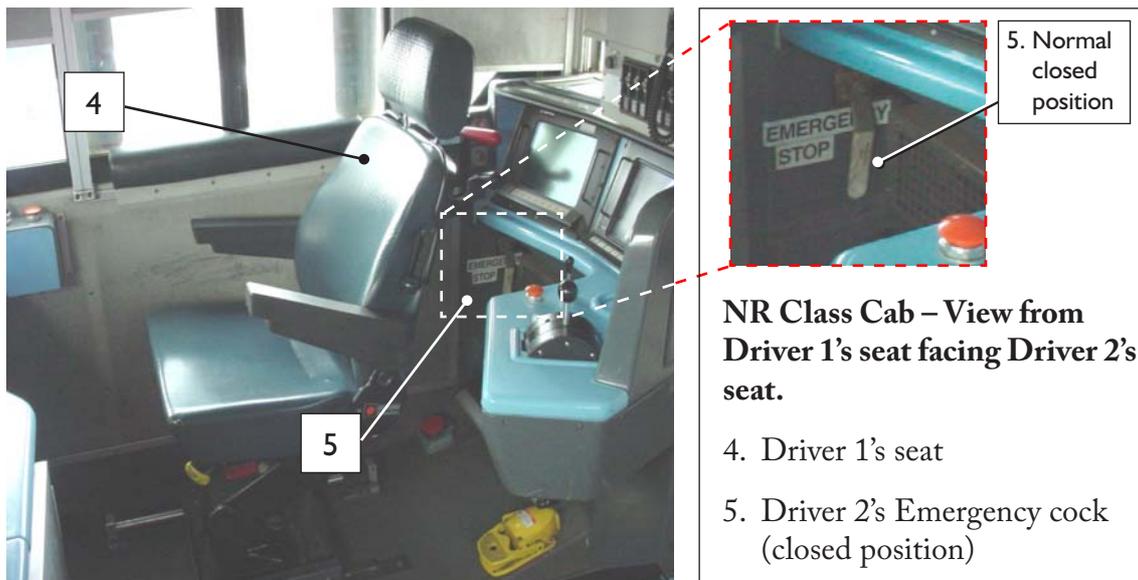
Figure 4.9 NR Class Cab – Driver 2's Emergency Brake Cock - View from Driver 1's seat facing Driver 2's seat

NR Class emergency brake cocks are placed primarily to cater for drivers operating the locomotive in either direction. The emergency brake cock located at the rear of Driver 2's seat is positioned for when a driver is operating the locomotive in the No. 2 end leading direction.
