RAIL SAFETY INVESTIGATION REPORT

DERAILMENT OF PACIFIC NATIONAL FREIGHT SERVICES CB76 AND 1WB3

LAPSTONE (CB76) 1 MARCH 2005

WAUCHOPE (1WB3) 7 MARCH 2005

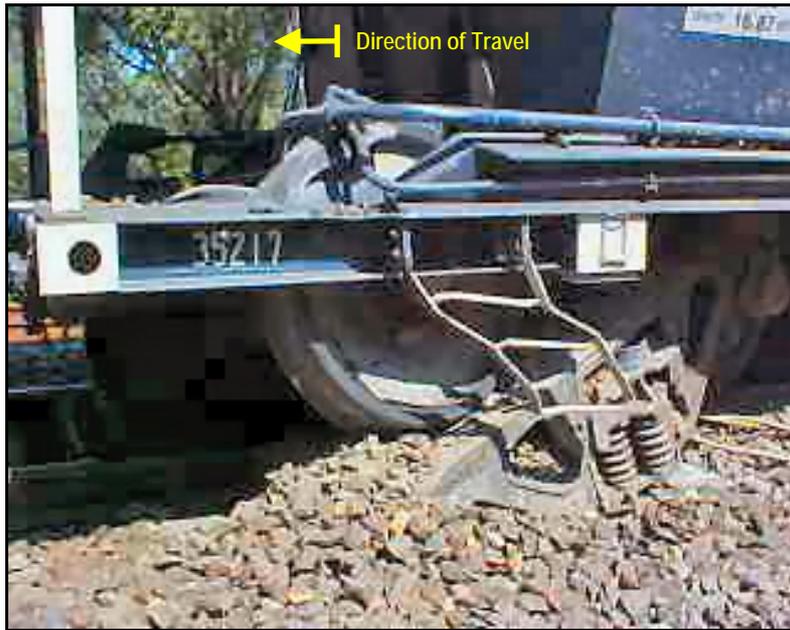
Photo 1 Damaged Wagon on CB76 (Lapstone)

- a. **CB76 (Lapstone).** In addition to the damaged bogie on wagon NHVF 35217U (see *Photo 1*), 436 concrete sleepers between kilometrage 65.770 and 65.200 and guard rail fastenings between 65.515 and 65.535 required replacement. Extensive repairs were also required to the Lapstone emergency crossover and associated signal equipment. In addition, the ballast formation between kilometrage 65.770 and 61.490 required reshaping to be returned to the required formation.

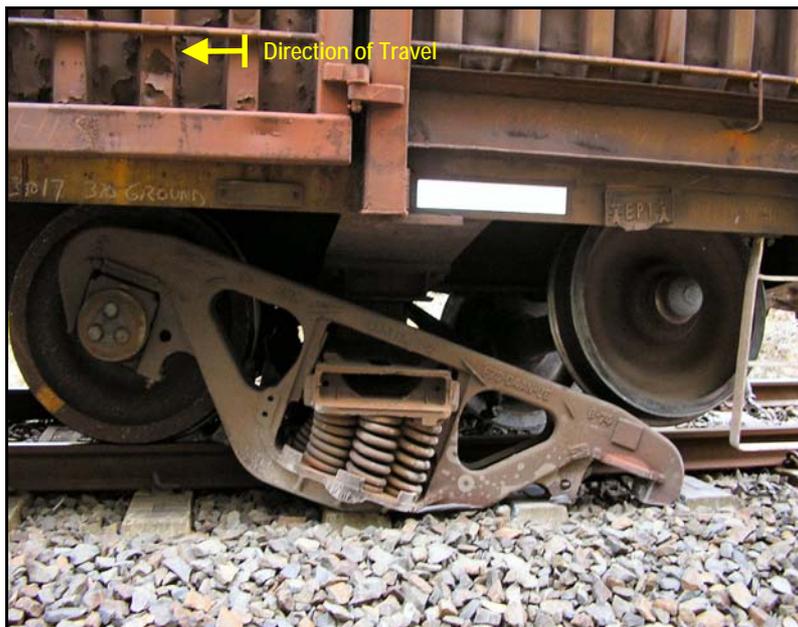
Photo 2 Damaged Wagon on 1WB3 (Wauchope)

- b. **1WB3 (Wauchope).** In addition to the damaged bogie on wagon RKDF 20411Q (see *Photo 2*), approximately 3km of track, between kilometrage 462.111 and 465.200, was extensively damaged. The Saltwater Creek rail bridge, located within the area of track that was affected, was also damaged but to a lesser extent.

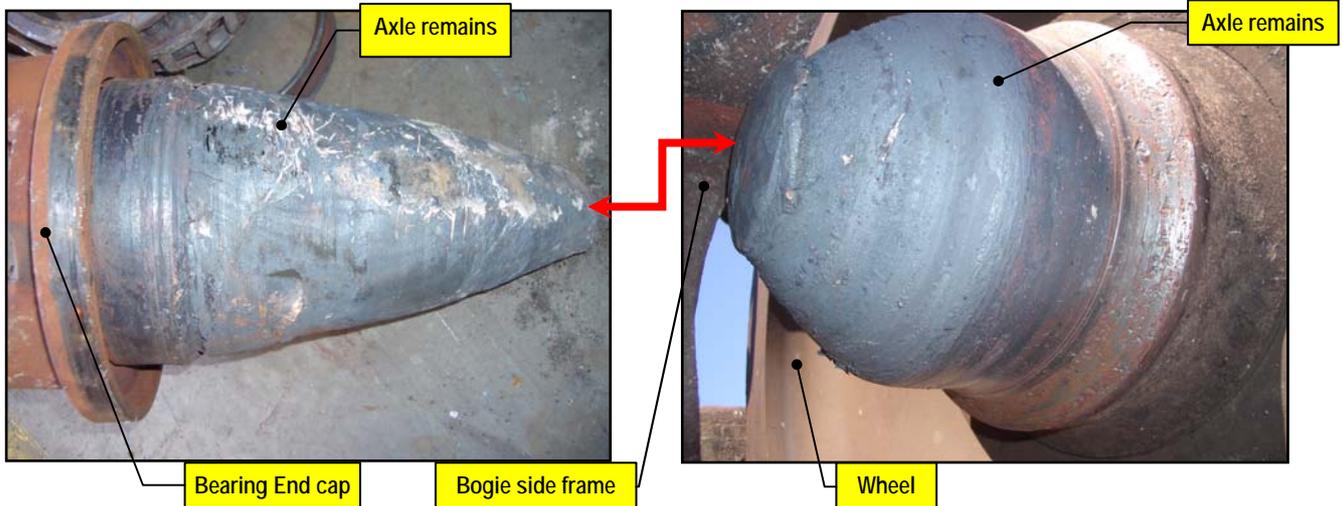
Photo 4 1WB3 (Wauchope) Axle Journal Remains

'lathed' off the axle. The remains indicated in *Photos 4* and *5* are from the journal that failed on 1WB3 (Wauchope), with the red arrow indicating the point at which the axle separated. The tapered effect in *Photo 4* is the consequence of the axle rubbing on the underside of the bogie frame and being 'lathed' as described above.

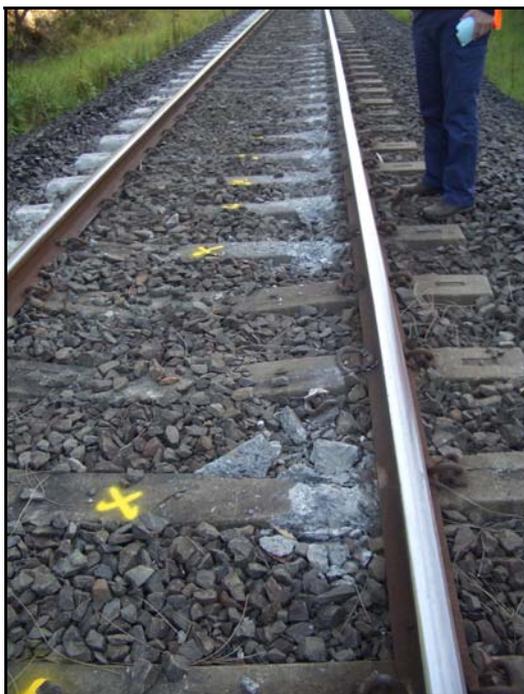
Photo 6 Commencement of Sleeper Damage at Wauchope

3.6 Such a condition can occur in a relatively short time or distance and results in the derailing of the affected wagon, and sometimes others. If the derailed wagon remains upright and coupled, the axle and/or pedestal will usually impact on every sleeper over which it passes, as illustrated in *Photos 6* and *7*.

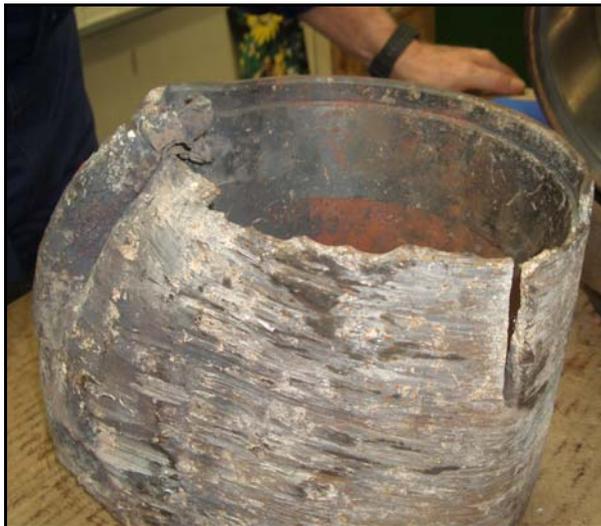
Photo 8 Damage to Bearing Cup from PUB off 1WB3 (Wauchope)

3.18 Determining the exact cause of a screwed journal is complicated by the fact that such events are normally associated with catastrophic mechanical failure. The PUB will often disintegrate and, even when the various components are found, the combined effects of heat, pressure and disintegration may mask or obliterate signs that would otherwise indicate the actual failure mode (see *Photos 8 and 9*).

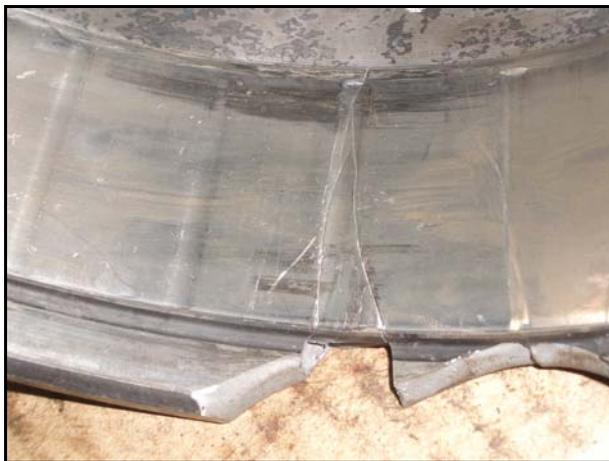
Photo 10 Brinelling Marks in the Cup from the 'Mate' PUB on CB76 (Lapstone)

- 3.21 The specialist examinations of the two PUBs did not establish conclusively why these bearings failed. Two of the four specialists who examined the failed PUB on CB76 noted that one or both of the cups on CB76 had been hit with considerable force at some stage. One specialist further suggested that the impact was a consequence rather than a cause. Another noted that there was evidence that suggested that moisture, or some other foreign material, had penetrated the inner workings of the PUB (See *Photos 10 and 11*).
